ISLANDER ENGINEERING

Memorandum

Project: 2181

Re: **Environmental Monitoring Inspection (May 10, 2021) at 4415 Bedwell Harbour Road, North Pender Island BC**

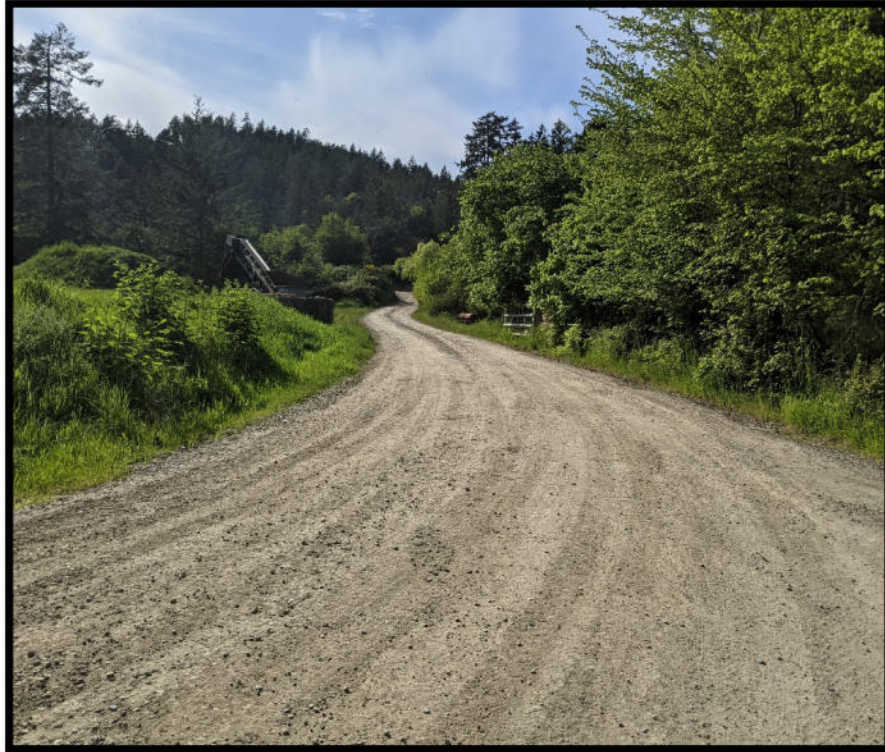
Photo 1 – Site Access 'B' currently used as primary access to Site.

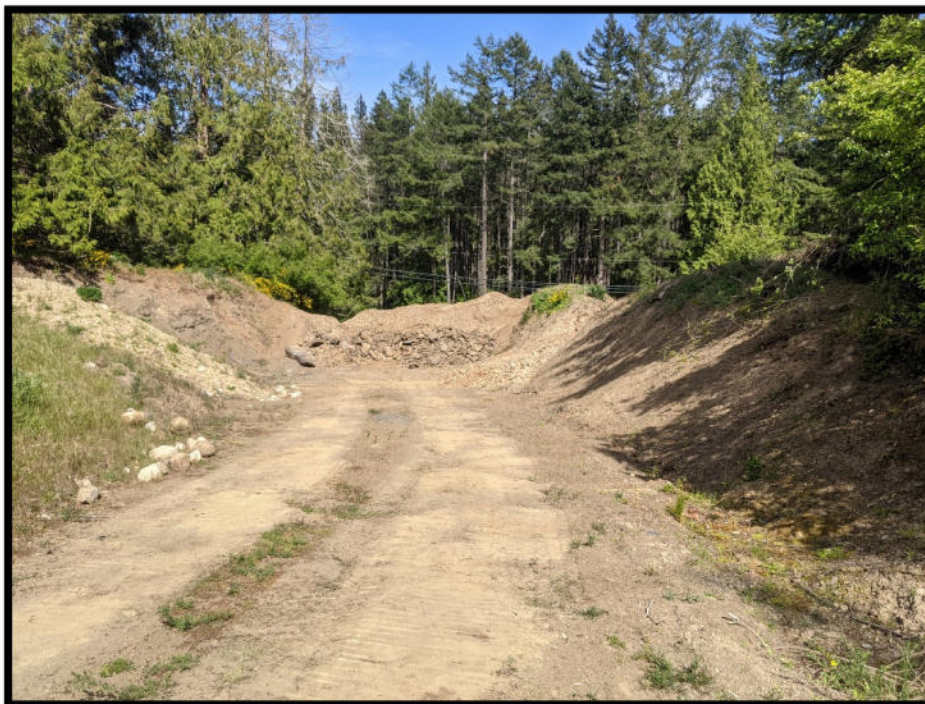
- If possible, retain woody debris and organic matter on-site as mulch;	Yes	Acknowledged by GEL.
- Roughen or terrace slopes to prevent erosion. Limit slope steepness and length to reduce runoff velocity;	Yes	Existing slopes appear to have adequate vegetation to prevent erosion. GEL should consider erosion control along new slopes lining the newly constructed Site Access 'A' prior to rainy season. (Photo 2)

Photo 2 – Current progress of proposed Site Access 'A'.

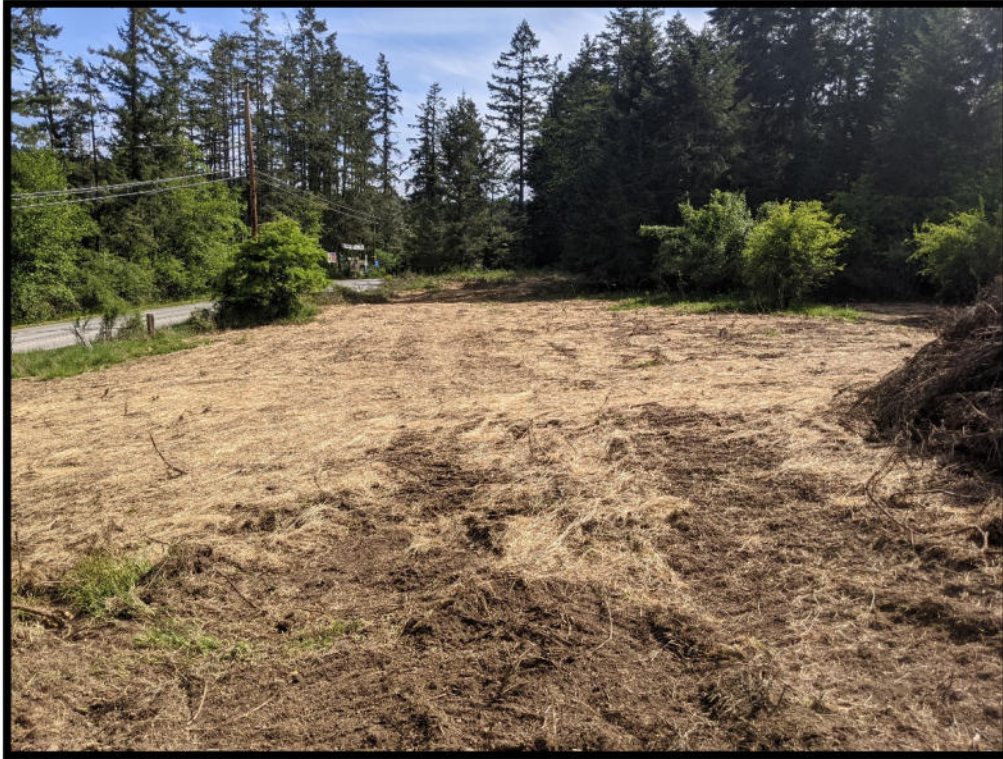
- Preserve natural vegetation where possible;	Yes	GEL intends to maintain current vegetated areas, not specified to be altered within the TUP. Clearing of the grassy area to the south of Site Access 'A' has occurred per the TUP landscape plan. (Photo 3)

- Re-vegetate or landscape disturbed areas of the Site as soon as possible. If areas of the Site must be left disturbed during the rainy seasons, sow a temporary cover crop,	Yes	Landscaped area south of Site Access 'A' has been seeded but it is recommended that the area be monitored to evaluate the success of the seed growth over the summer.

- apply mulch or lay geotextile to stabilize exposed soils;	Yes	Hay has been laid over disturbed soils south of Site Access 'A'. (Photo 3)
- Keep machinery within specific access areas. Limit the extent of machine access areas to the minimum necessary to conduct operations in a feasible and practical manner;	No	It is noted that several pieces of equipment, possibly related to the operations noted within the TUP are currently stored outside of the designated Temporary Use Area lists in Schedule B of the TUP. (Photo 31)

Photo 3 – Natural grassed area, south of Site Access ‘A’. Vegetation has been cleared and seeded, exposed ground is covered with hay as a means to prevent erosion.

Additional Comments:	
1.	Recently cleared area to the south of Site Access 'A' has been covered with hay and seeded but it is recommended that silt fencing or hay bales be placed along the bottom of the slope to prevent erosion / sedimentation from the bare soils from migrating offsite into the ditching along Bedwell Harbour Road.
2.	It is suggested that GEL consider installation of a groundwater monitoring well down gradient from the concrete batch plant and water management area to allow for monitoring of groundwater quality as a result of TUP activities.
3.	IEL notes that GEL is considering reconfiguration of the waste water management area as well as installation of a pH treatment system (CO ₂ bubbling, or similar).
4.	It is recommended that all recommended actions listed within this report be completed before the start of the rainy season.

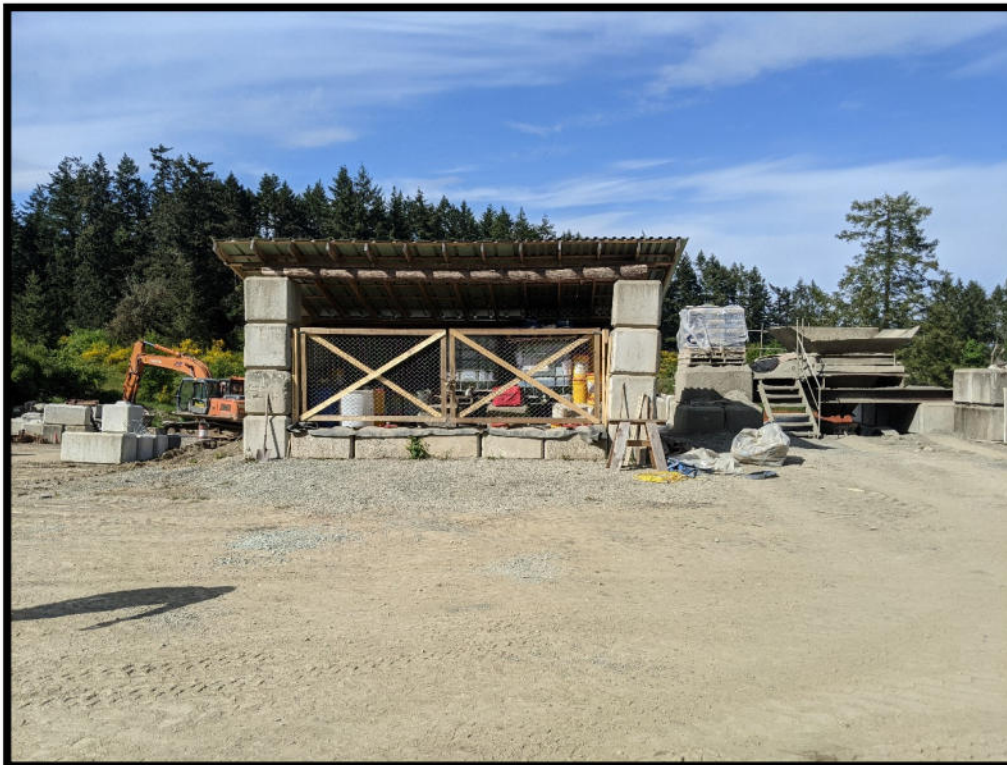
- Provide with a means of preventing water reactive and pyrophoric materials from coming in contact with accumulated water (i.e., roofed enclosures)	Yes	Roofs present as needed. (Photo 4)

Photo 4 – Looking northeast at modified chemical storage shed, including new roof and lockable doors.

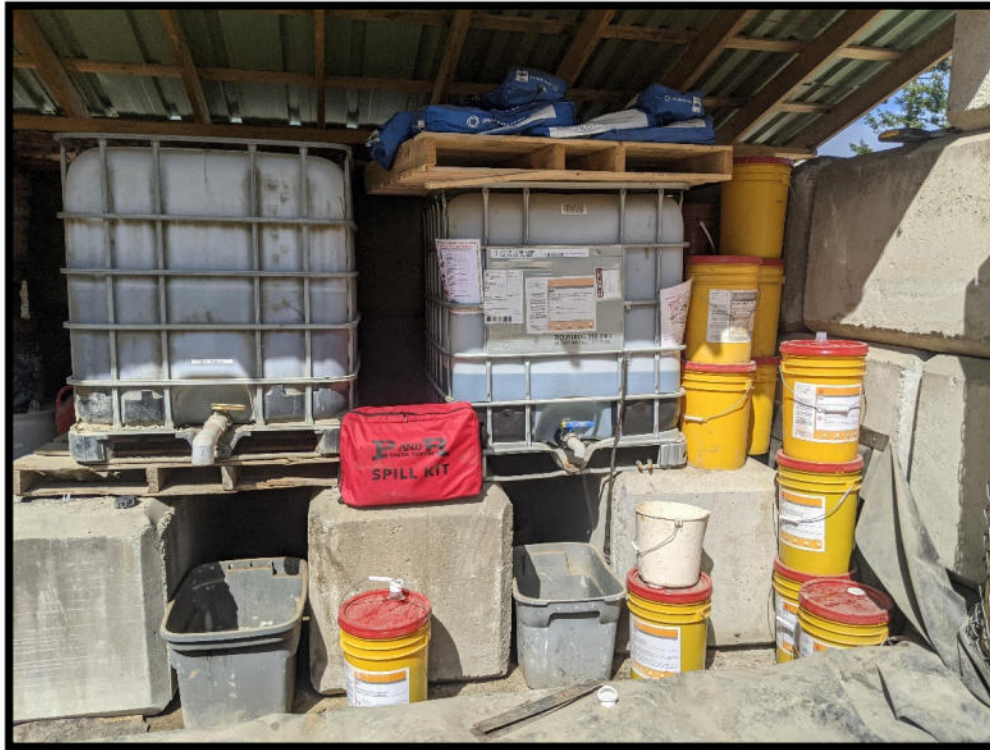
Photo 5 – Interior of chemical storage shed includes concrete additives (stabilizer & water reducers). The shed is lined with 45 mil poly liner as a means of secondary containment. Note spill kit and spill response plans posted on 1000L totes.

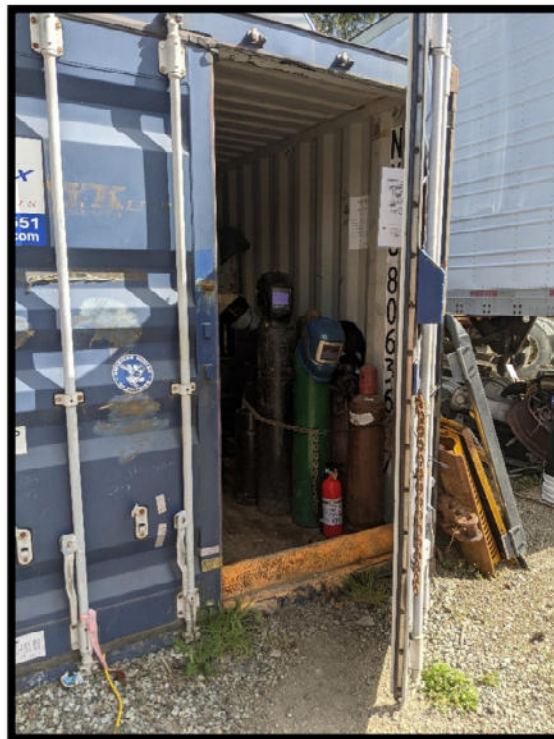
Photo 6 – Hydrocarbon storage sea container. Note orange toe board, welded to edge of container as a means of providing secondary containment to fluids within the container.

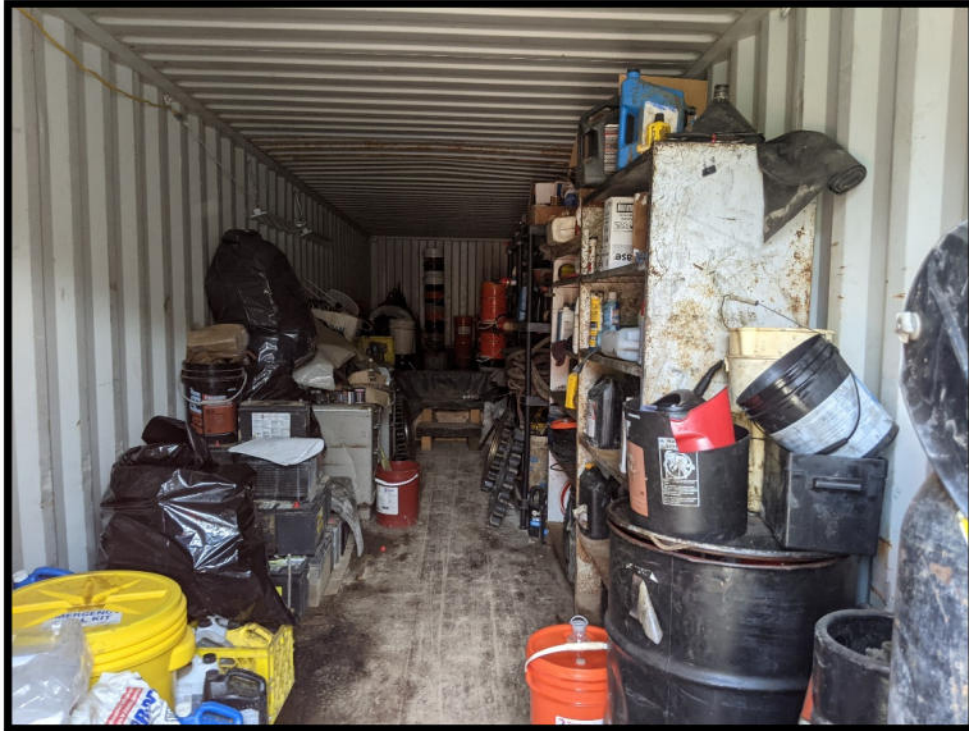
Photo 7 – Interior of hydrocarbon storage container. Note yellow spill kit and supplies to the left. Waste oils and bulk fluids stored within lined cell at rear of unit.

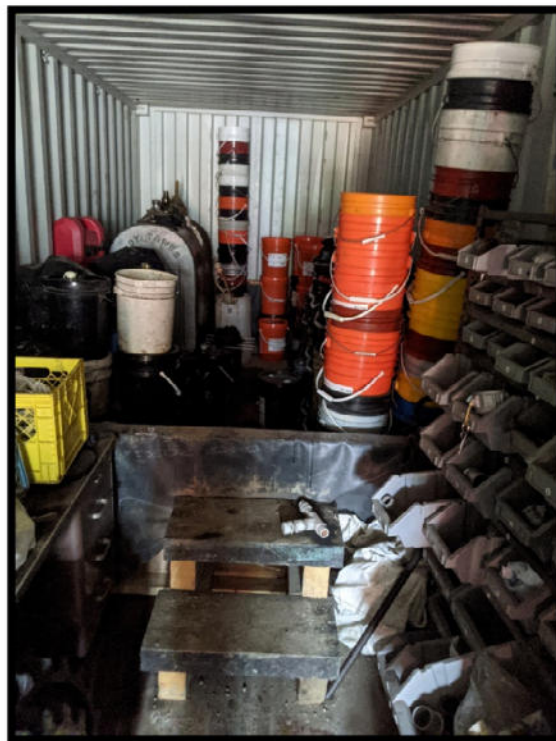
Photo 8 – At rear of storage container, used oil and bulk fluids are stored within a poly lined cell.

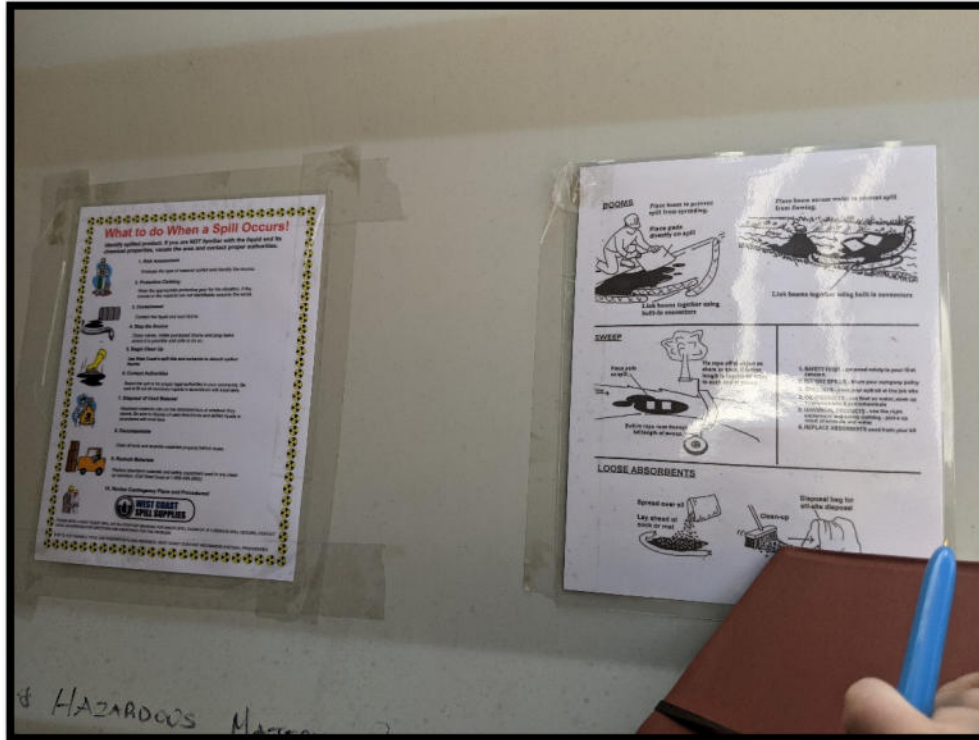
- Spill Response Steps posted in appropriate areas	Yes	Within mechanical fluid shed and additive shed. (Photo 9)
7.2 Spill Response Equipment		
- Standard Spill Kit	Yes	Spill kits are located within the mechanical fluid shed, the additive shed, the batching area and within all active vehicles. (Photo 17)

Photo 9 – Spill response plans posted within hydrocarbon storage container. Emergency contact information is provided below posted signs.

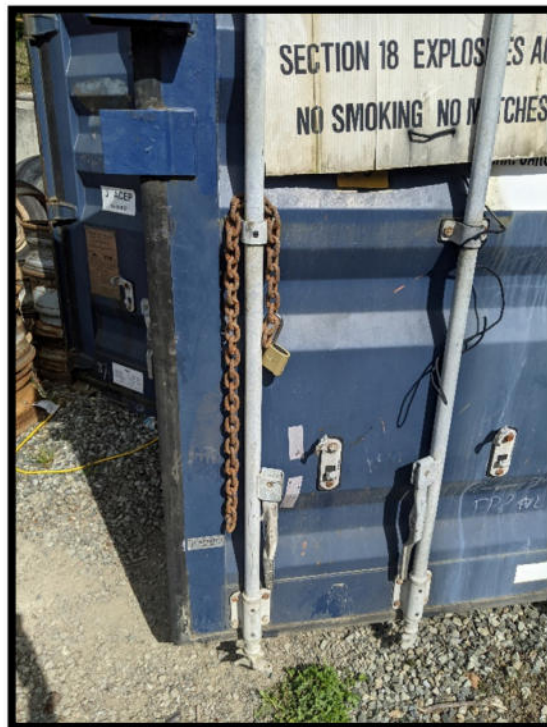
Photo 10 – Hydrocarbon storage container is locked daily. Also note signage indicating “No smoking, ignition permitted in area”.

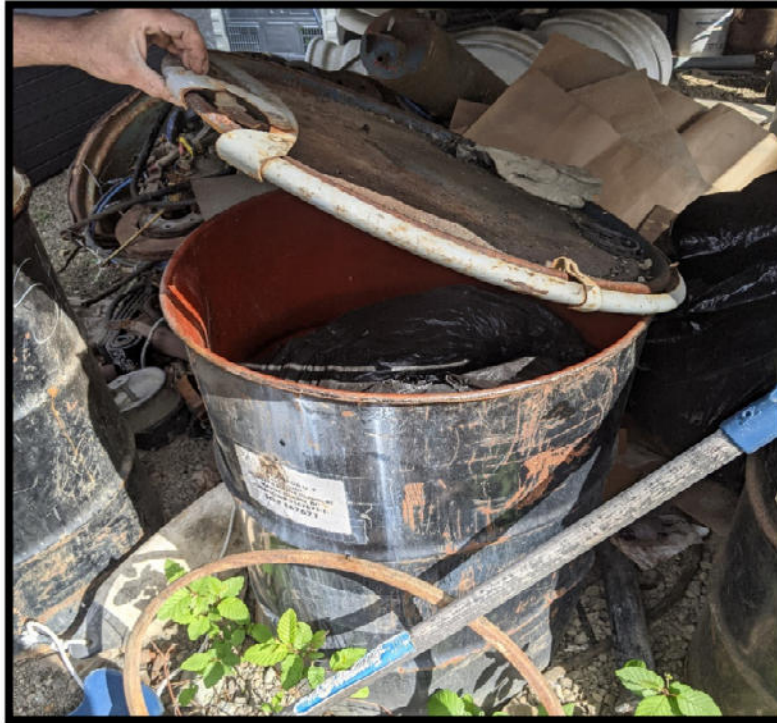
- Grease and oil required for maintenance will be properly applied. Excess will be cleaned up and disposed of in an environmentally appropriate manner, as will all containers, lids, and contaminated cloths and applicators.	Yes	Acknowledged by staff at time of inspection. Oily rags from cleanup are stored in a sealable drum until time of disposal (Photo 11)

Photo 11 – Drums used to store oily rags, used spill equipment, etc.

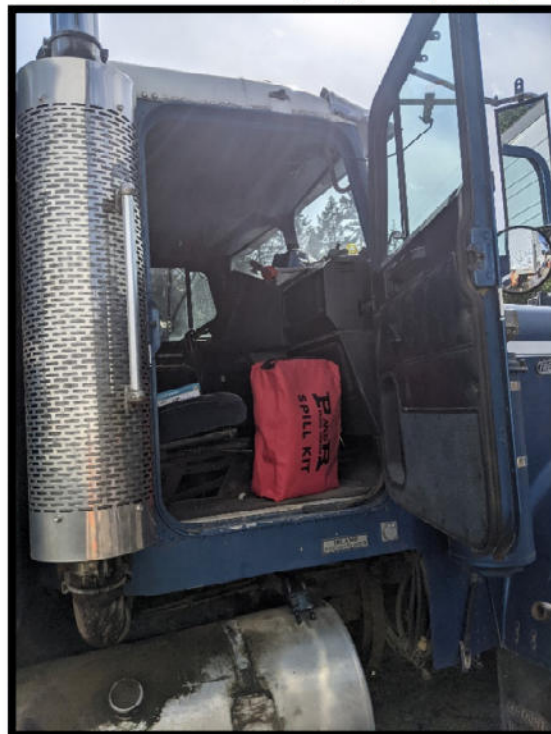
- Vehicle Spill Kit	Yes	(Photo 12)
7.3 Spill Prevention (BMP)		
- Equipment is to be inspected daily to ensure that it is leak-free and functioning as intended. All fuel/oil caps will be manually checked to ensure that they are tightened down. Equipment will be tagged out of service if found to be leaking. Servicing of equipment that is absolutely necessary on-site is to be done within containment areas (i.e., bermed or otherwise isolated) or at an appropriate work yard operated by the contractor or his supplier;	Yes	Equipment is inspected during daily pre-trip inspections.

Photo 12 – Mobile spill kits located in active vehicles onsite.

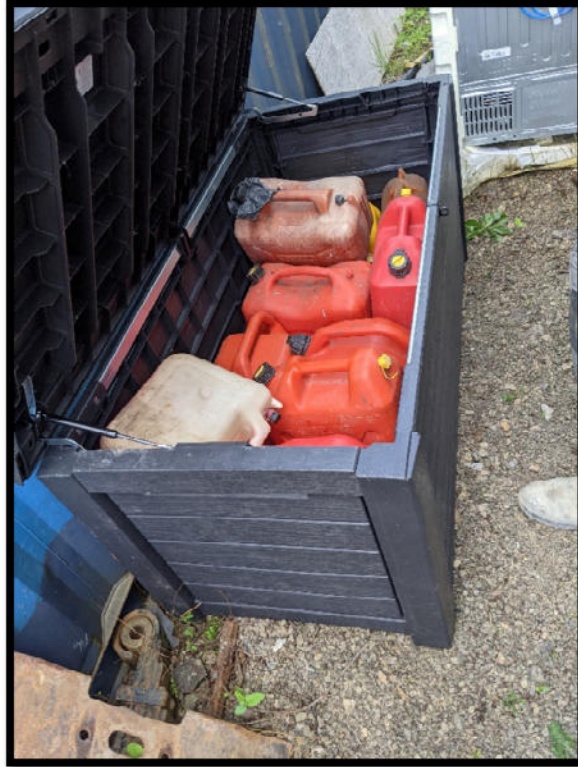
- Jerry cans will be stored within a sealed tool box tray with lid or other suitable storage locker with ventilation, and placed in a containment tray when outside of the storage container.	Yes	Empty cans are stored within a lockable unit. (Photo 13)

Photo 13 – Empty jerry cans stored within lockable container onsite.

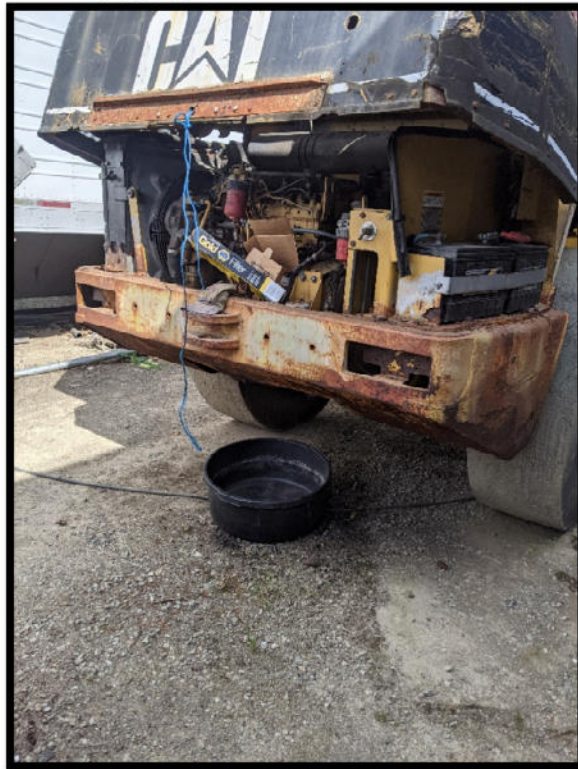
- Equipment or machinery found to be leaking will have containment trays/buckets placed under drips/leaks that cannot be stopped (e.g., cannot be drained into an appropriate container), will have absorbent pads wrapped around leaky connections or placed under areas where a tray or bucket cannot be fitted, etc.). The person identifying the malfunction or accidental leak will notify the foreman or site supervisor, who will arrange repairs or transport	Yes	Equipment appears to have drip trays placed under appropriate components when not in use, overnight and when under repair / maintenance. (Photo 14)

- When heavy machinery is not in use (i.e., overnight, weekends, or idle for the day), a portable drip tray will be placed under the main engine compartment.	Yes	Drip trays noted below all pieces of heavy machinery (Photos 14-16)

Photo 14 – Drip trays were noted under most stationary vehicles at time of inspection.

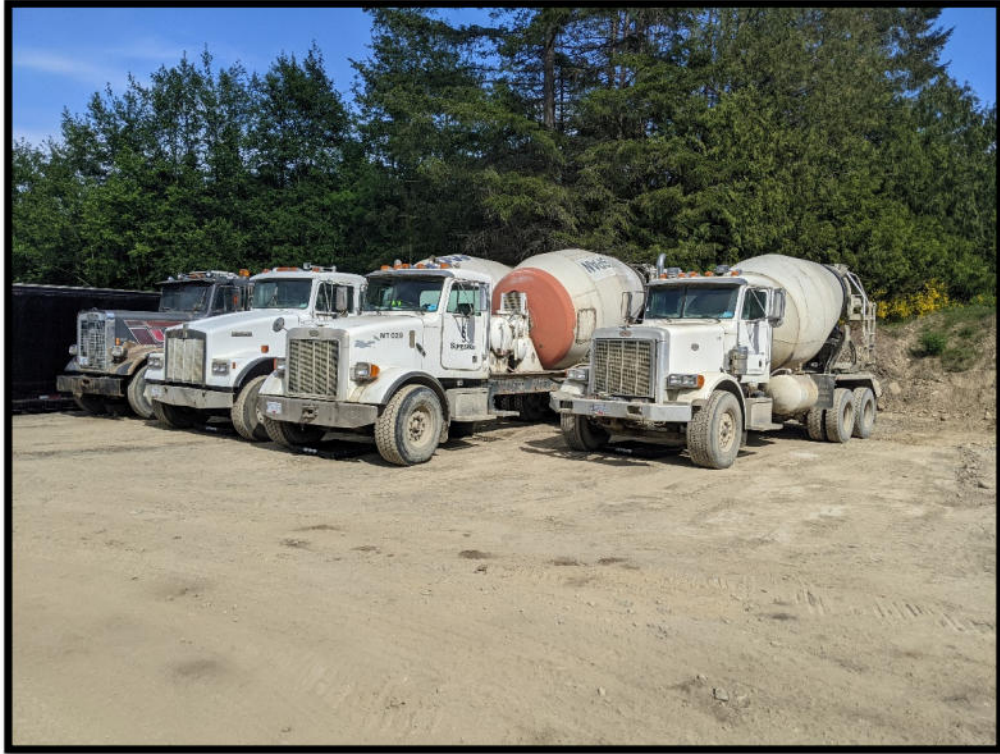
Photo 15 – Concrete trucks with drip trays beneath engine components.

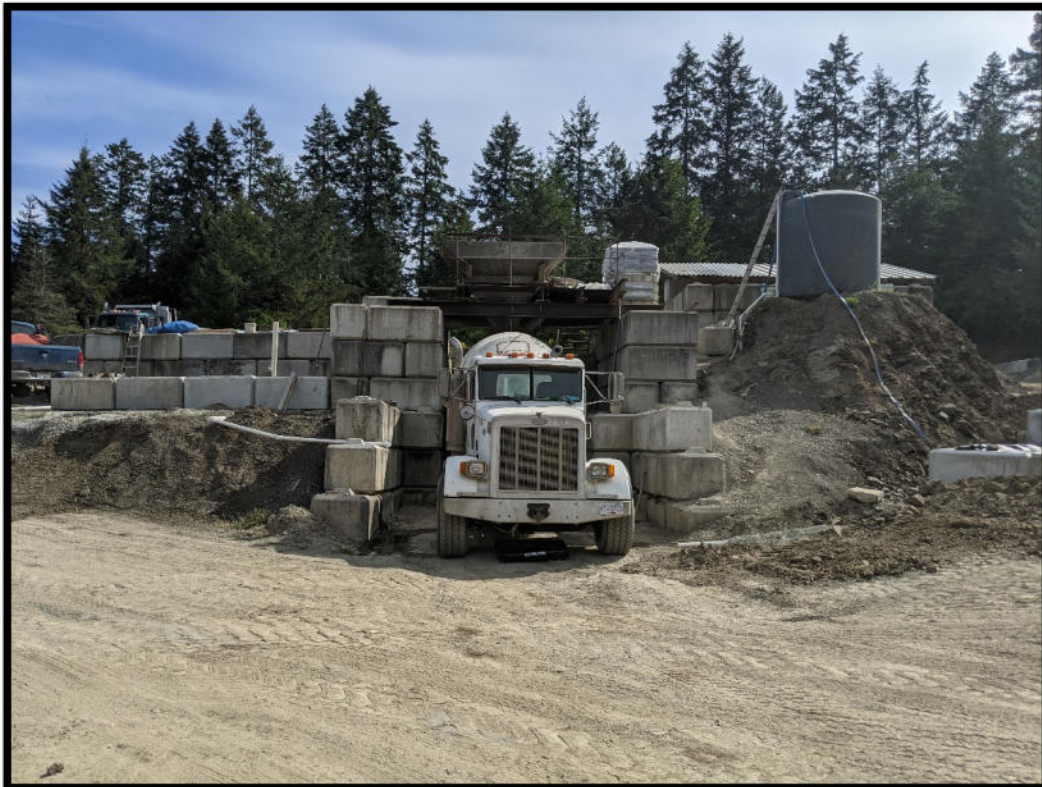
5.1.2 Water Collection/Containment (p.9)		
- All paved surfaces within the batching area should be curbed and graded to allow for effective capture and collection of wastewater;	Yes	Batching area is paved with concrete. Grading within the vicinity of the batching area generally allows for capture and transport of wastewater to the water management area. GEL plans to expand paved area to improve wastewater capture and reduce excess runoff from other parts of Site from entering batching area. (Photo 34, 16)

Photo 16 – Drip trays beneath concrete truck in batch plant bay.

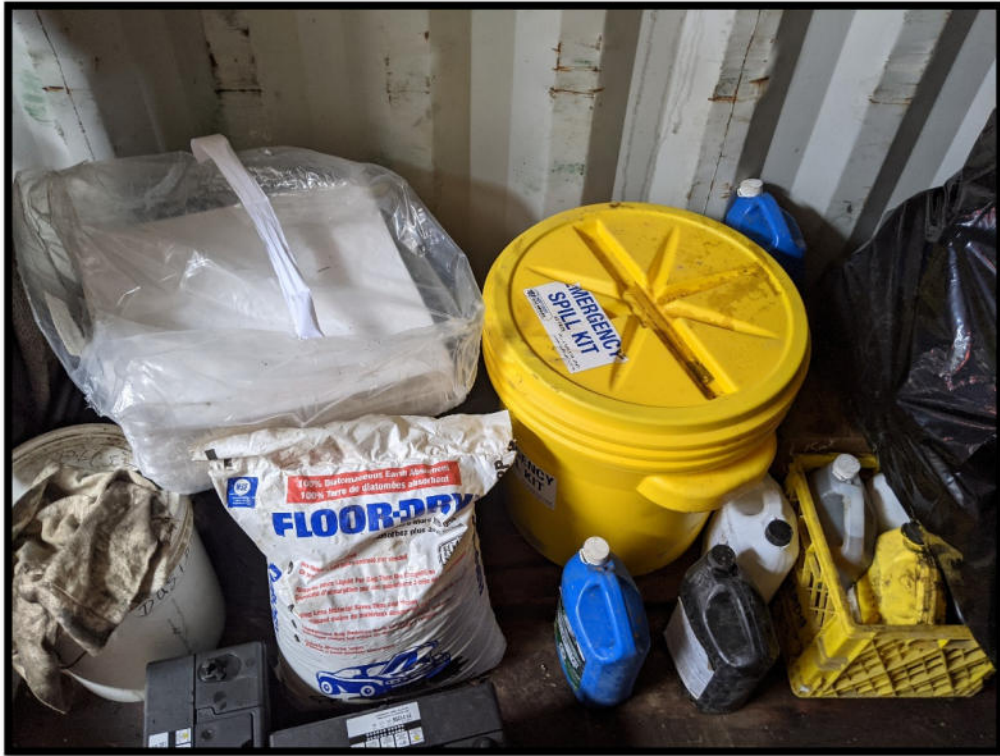
Photo 17 – Spill kit within hydrocarbon storage area.

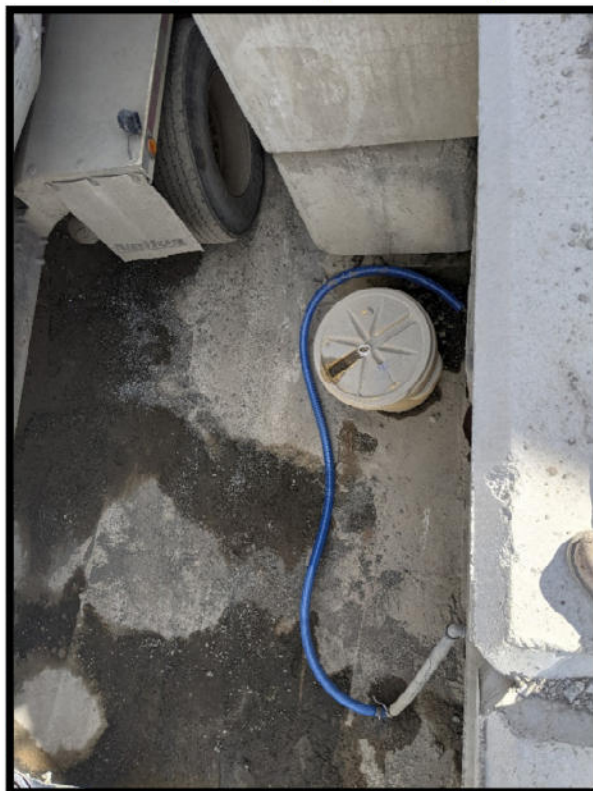
Photo 18 – Spill kit within batch plant area.

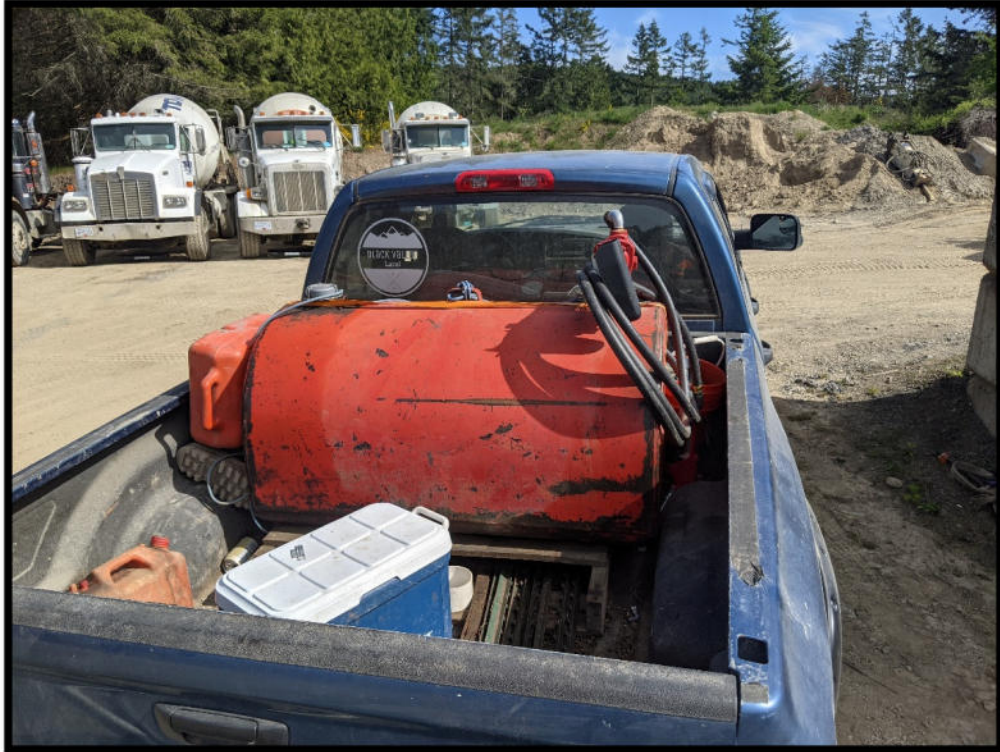
CONDITION/REGULATION	COMPLETED /COMPLIANT (Y/N)	SCHEDULE DATE TO BE COMPLETED/COMMENTS
6. CHEMICAL AND PETROLEUM HYDROCARBON MANGEMENT		
6.2 Storage and Handling		
<ul style="list-style-type: none"> - Concrete additives are currently stored within manufacturer containers within a covered, plastic sheet-lined secondary containment structure at the top of the batch plant. 	Yes	The additive storage shed is adequately lined and covered in a secure manner (Photo 4 &5)
<ul style="list-style-type: none"> - Mechanical fluids (oils / waste oils) are stored within a transportation seacan with a welded lip at the entrance, which provides secondary containment to small jugs of hydraulic fluid within. Waste oil is stored within an above ground storage tank within a separate plastic sheet-lined cell within the seacan. 	Yes	Photo 7 & 8
<ul style="list-style-type: none"> - Fuel is stored within fuel tanks and tidy tanks aboard various vehicles and equipment throughout the Site. There is no bulk fuel storage on Site 	Yes	One tidy tank is used for onsite equipment. (Photo 19)

Photo 19 – Tidy tank found within Site Supervisors truck, used for fueling equipment onsite when required.

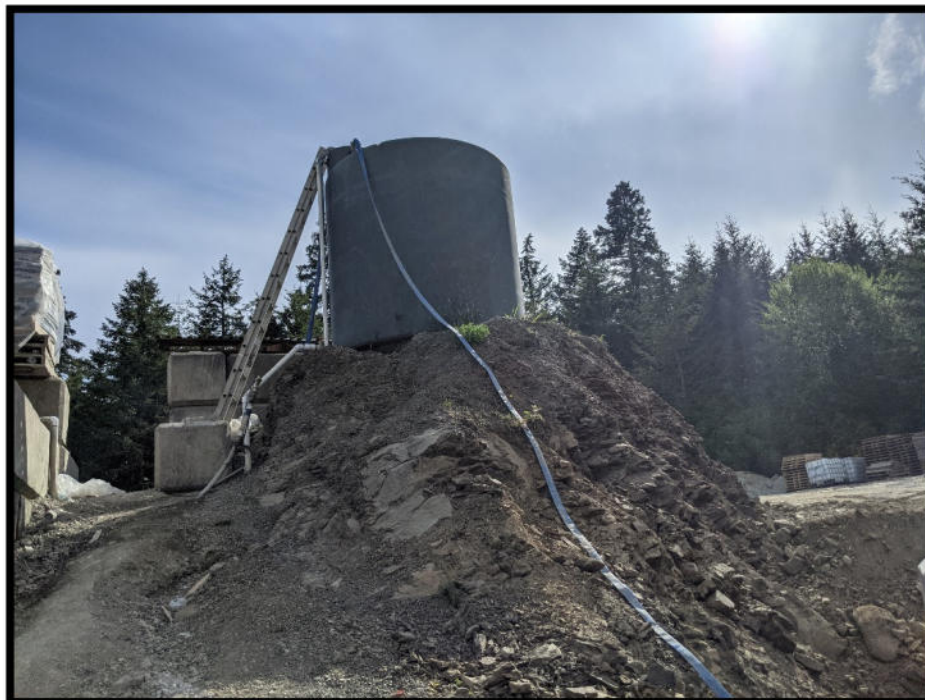
Photo 20 – Water tank used for concrete batching and overflow hose to newly constructed overflow basin / loc-bloc forming area.

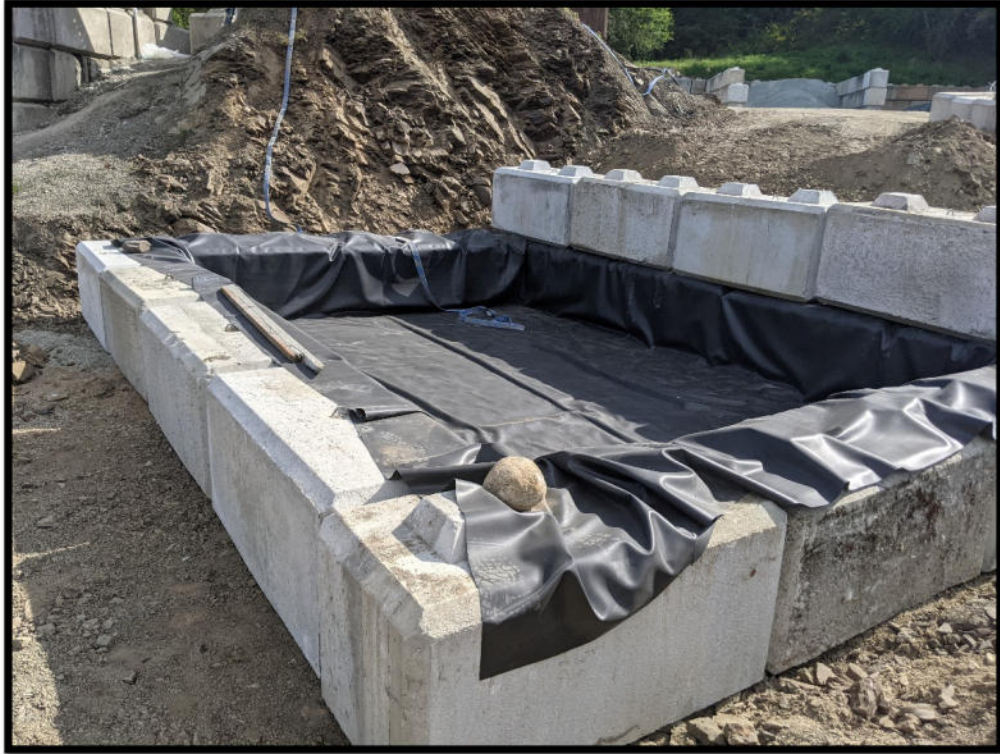
5.3 Water Treatment		
- Protocol in place for overflow incidents	Yes	Several additional poly lined basins have been constructed which can be used in event of overflow. (Photo 21 & 22)

Photo 21 – Lined basin to capture overflow from batch plant water tank and as an area for the forming of concrete loc-blocs. Basin drains to batch plant water retention area.

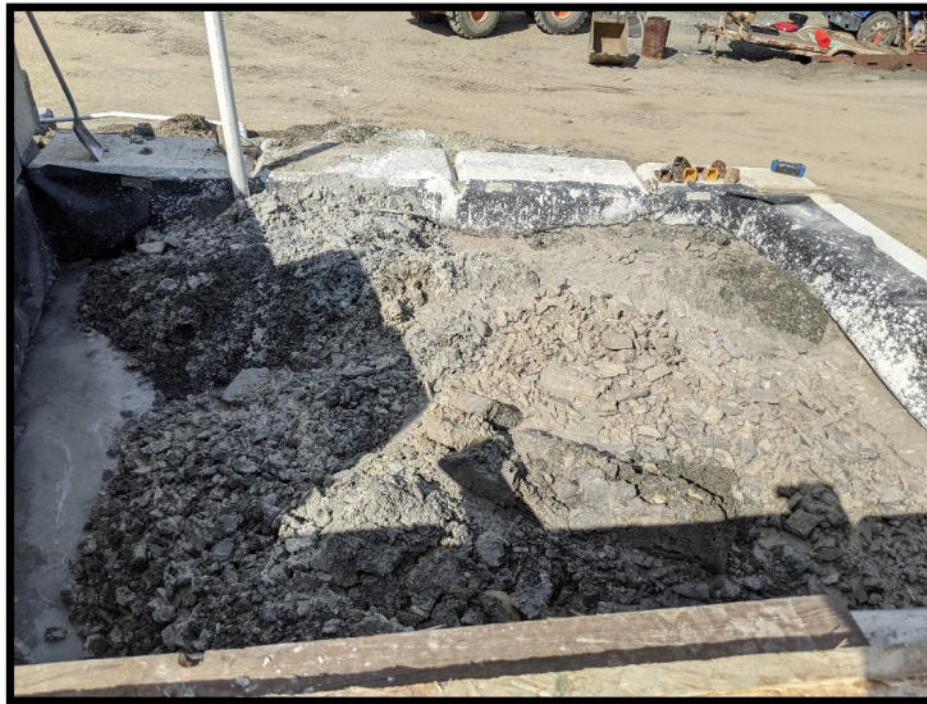
Photo 22 – Solids from concrete truck washout and plant cleaning are deposited within this lined basin to the east of the batching area where they can dry enough to be collected. Basin drains to batch plant water retention area.

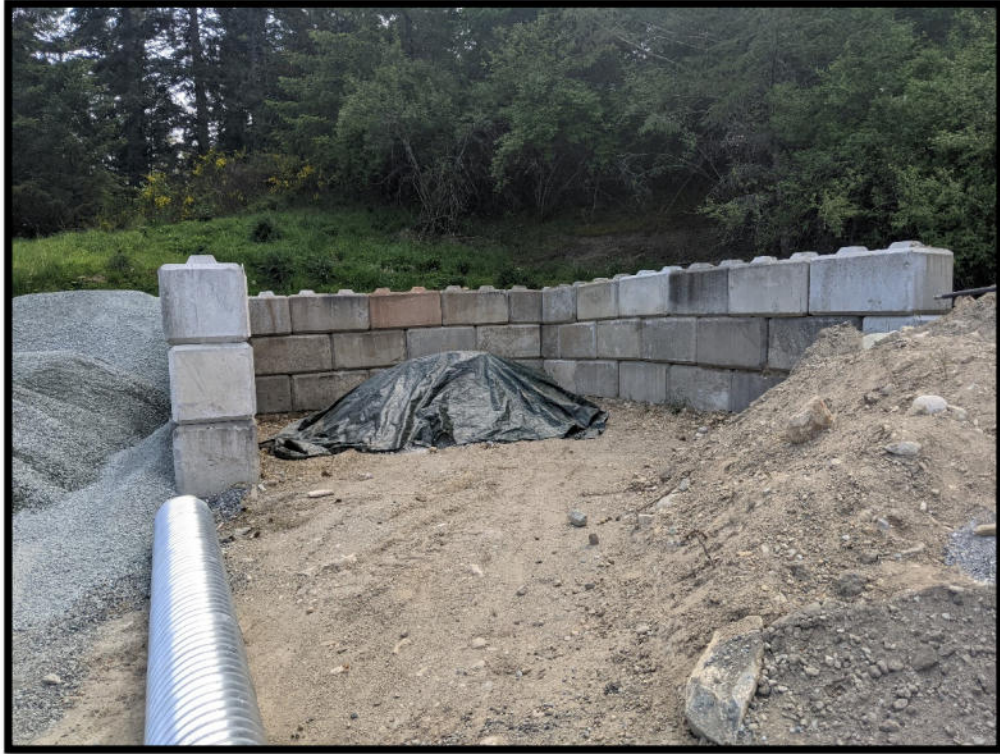
- Cover soil stockpiles and bare slopes with mulch, tarps, etc;	Yes	Dry stockpile of excess concrete noted to have tarp cover (Photo 23). Other stockpiles onsite are accessed with enough frequency to make tarping unfeasible. It is recommended that stockpiles containing silts, sands and other fine materials be tarped ahead of heavy rain events (Photo 24)

Photo 23 – Covered stockpile of excess concrete and dried sludge, to be re-used for loc-bloc production or as structural fill.

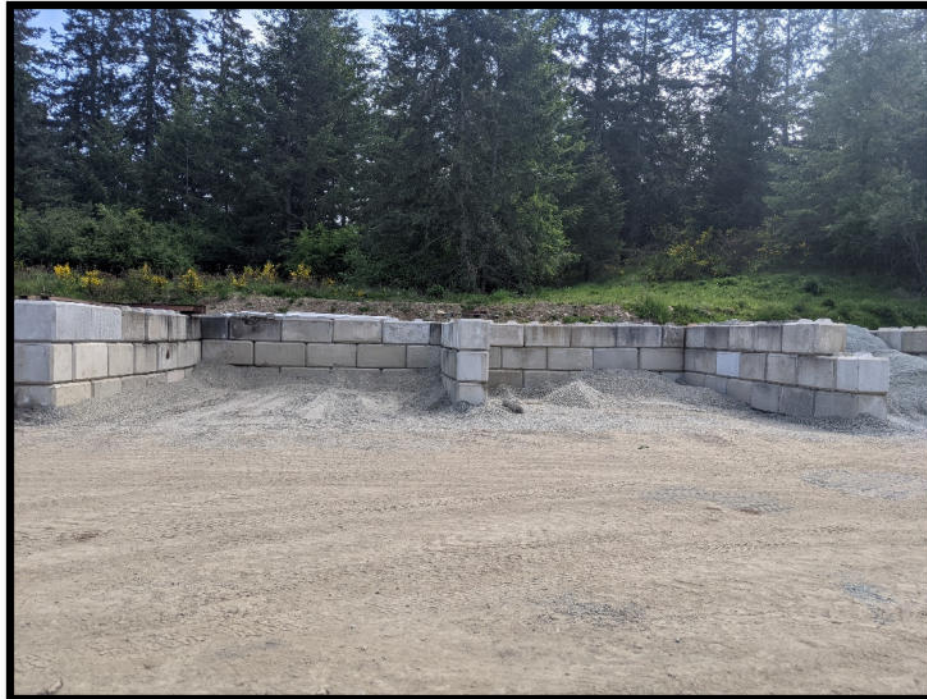
Photo 24 – Uncovered aggregate stockpiles.

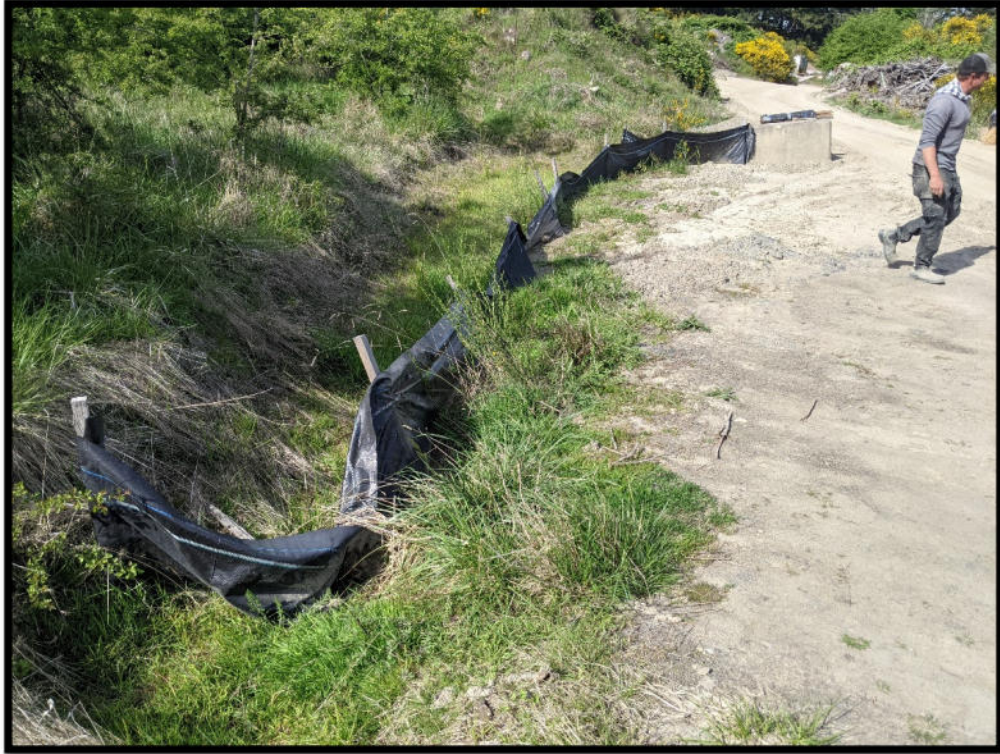
- Inspect all silt fences and other controls (i.e., catch basin inserts, stop logs) on a daily basis prior to the start of work and correct deficiencies immediately. Pay special attention in areas where construction activities have changed natural contours or drainage patterns to ensure that controls are properly located for effectiveness	Yes	Silt fencing appears to be functioning adequately. It is recommended that inspections be documented to allow confirmation of inspection. (Photo 25 & 26)

Photo 25 – Silt fencing in place parallel to Site ditching and access road appears to have been functioning well over the rainy season.

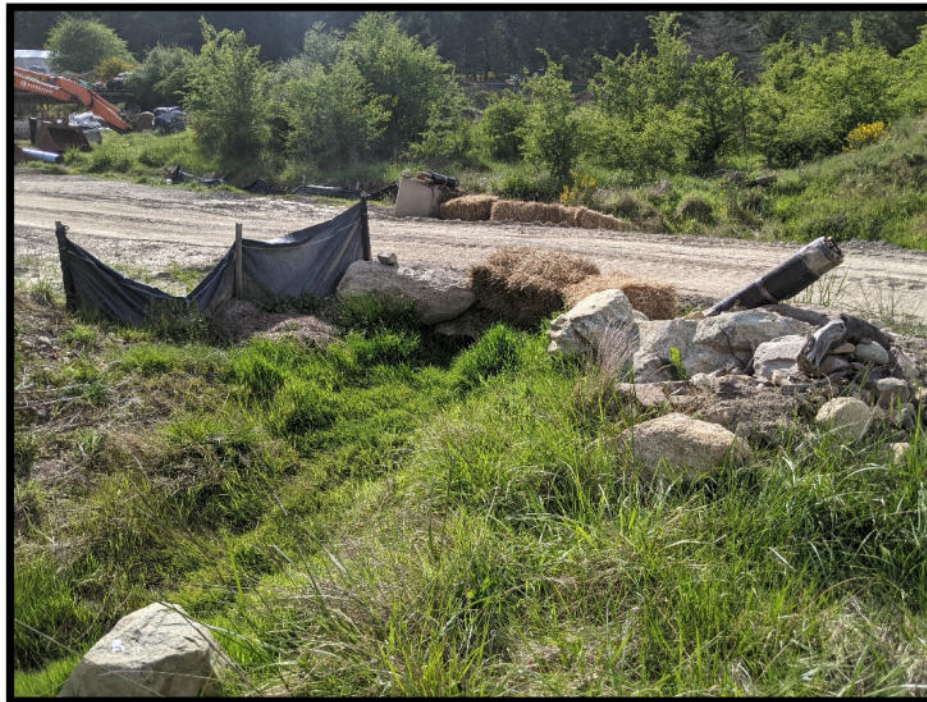
Photo 26 – Silt fencing and hay bales in place at ditch crossing.

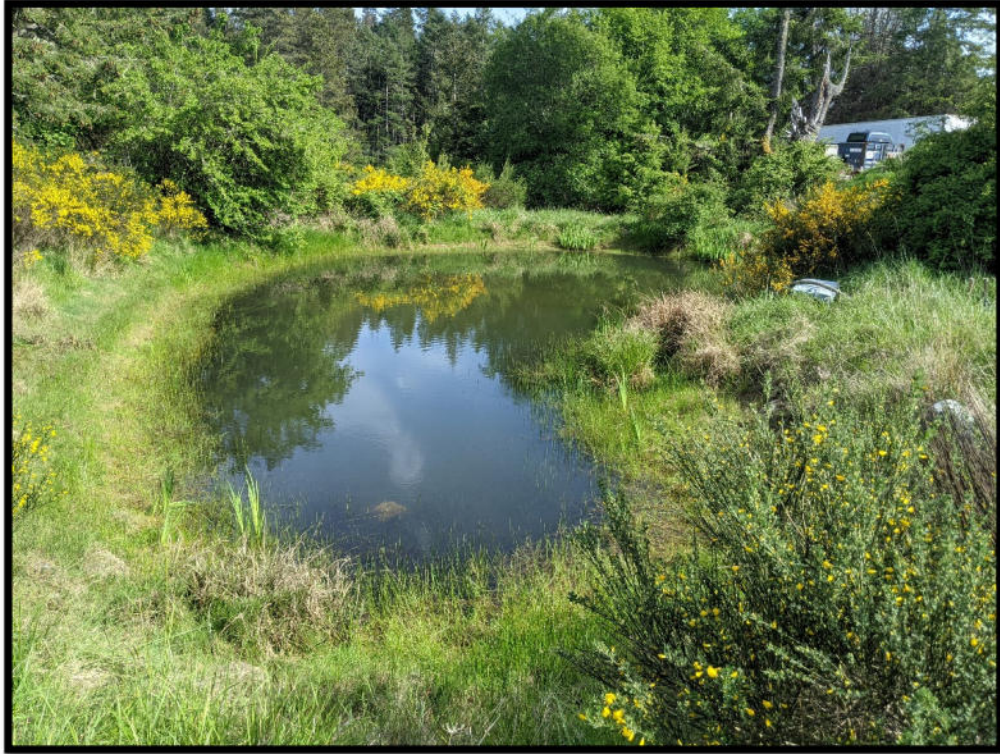
Photo 27 – Upper reservoir pond, looking towards Bedwell Harbour Road. Average field pH measurement within pond was 7.9 at time of inspection.

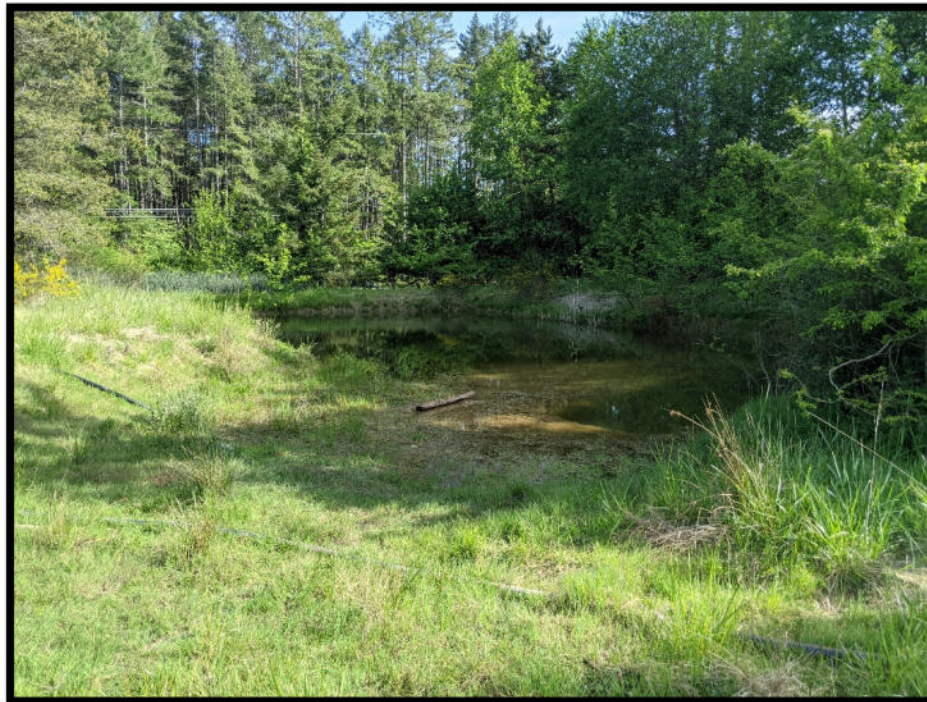
Photo 28 – Lower reservoir pond, looking towards Bedwell Harbour Road. Average field pH measurement within pond was 8.0 at time of inspection.

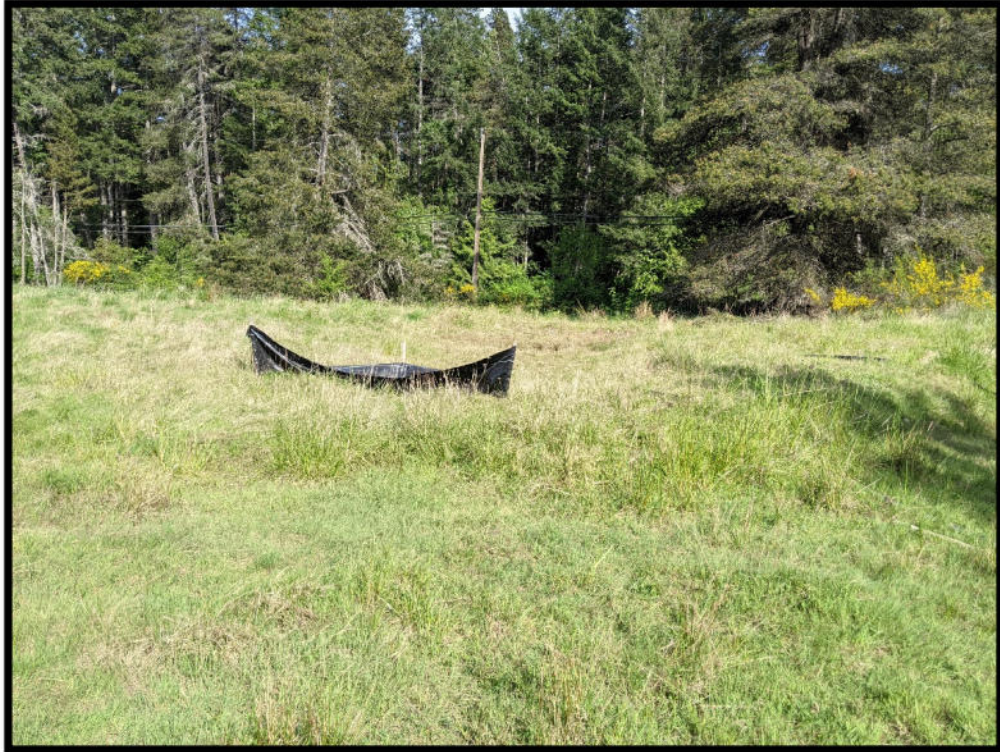
federal, provincial and municipal requirements;		during rainy season. Limited sedimentation was noted at the silt fencing where overflow volumes would exit the site indicating that suspended solids are not being discharged offsite. (Photo 29)

Photo 29 – Silt fencing placed within swale that acts as overflow discharge for reservoirs. Fencing showed little to no evidence of siltation occurring as a result of stormwater discharge to ditching.

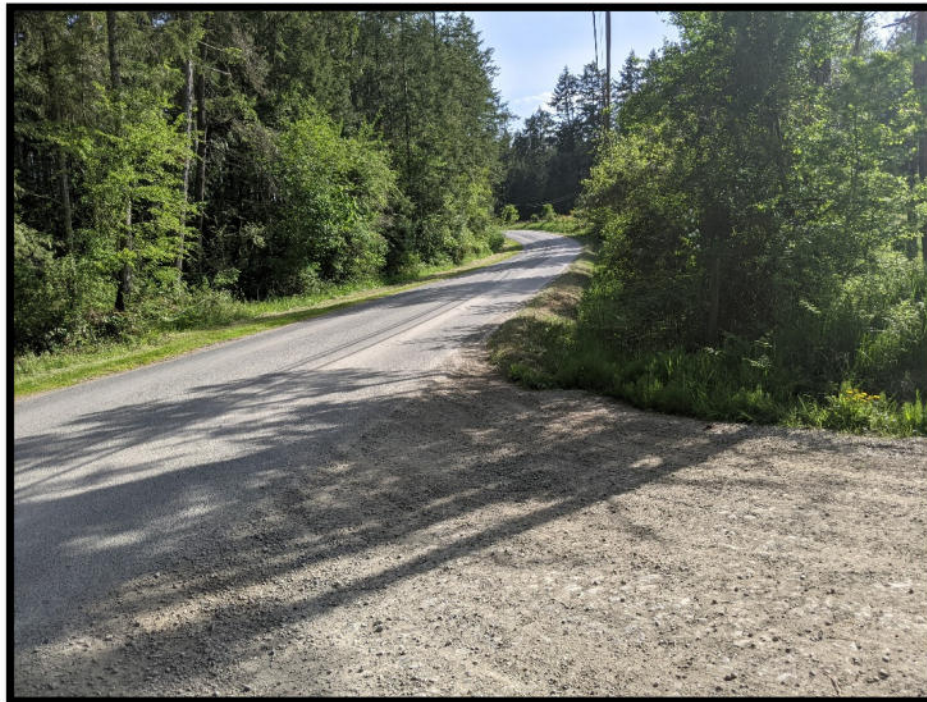
Photo 30 – Looking south along Bedwell Harbour Road at Site Access 'B'. Average pH measurements within ditching were 7.9 at the time of inspection.
