ISLANDER ENGINEERING

Memorandum

Project: 2181

Re: **Environmental Monitoring Inspection (May 10, 2021) at 4415 Bedwell Harbour Road, North Pender Island BC**

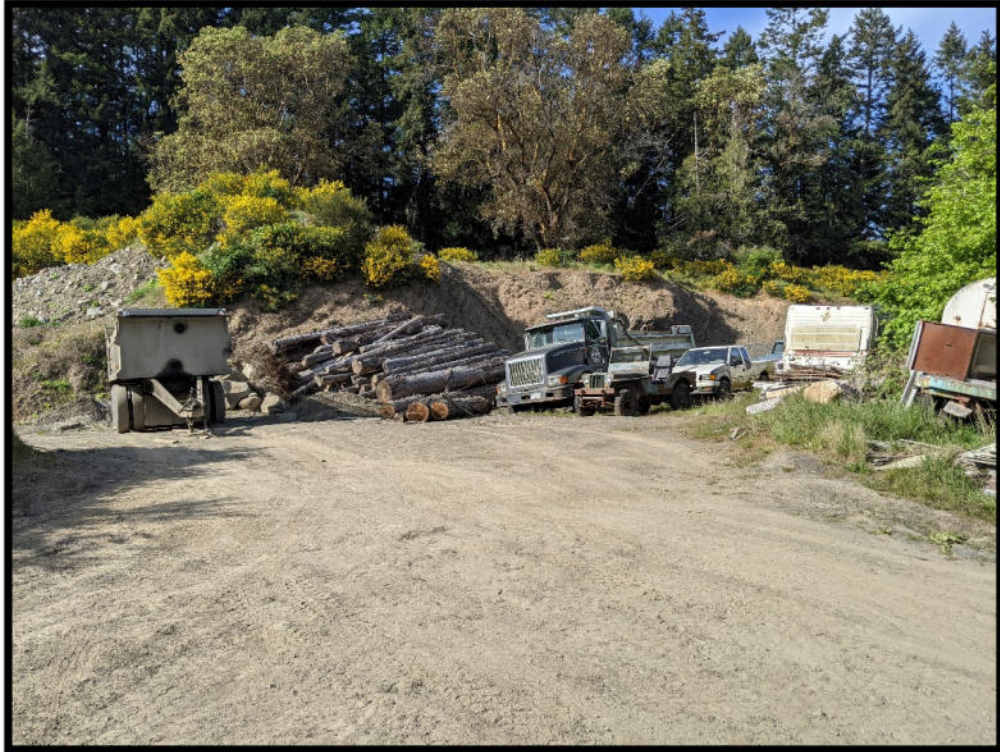
- apply mulch or lay geotextile to stabilize exposed soils;	Yes	Hay has been laid over disturbed soils south of Site Access 'A'. (Photo 3)
- Keep machinery within specific access areas. Limit the extent of machine access areas to the minimum necessary to conduct operations in a feasible and practical manner;	No	It is noted that several pieces of equipment, possibly related to the operations noted within the TUP are currently stored outside of the designated Temporary Use Area lists in Schedule B of the TUP. (Photo 31)

Photo 31 – Equipment stored outside of designated TUP area.

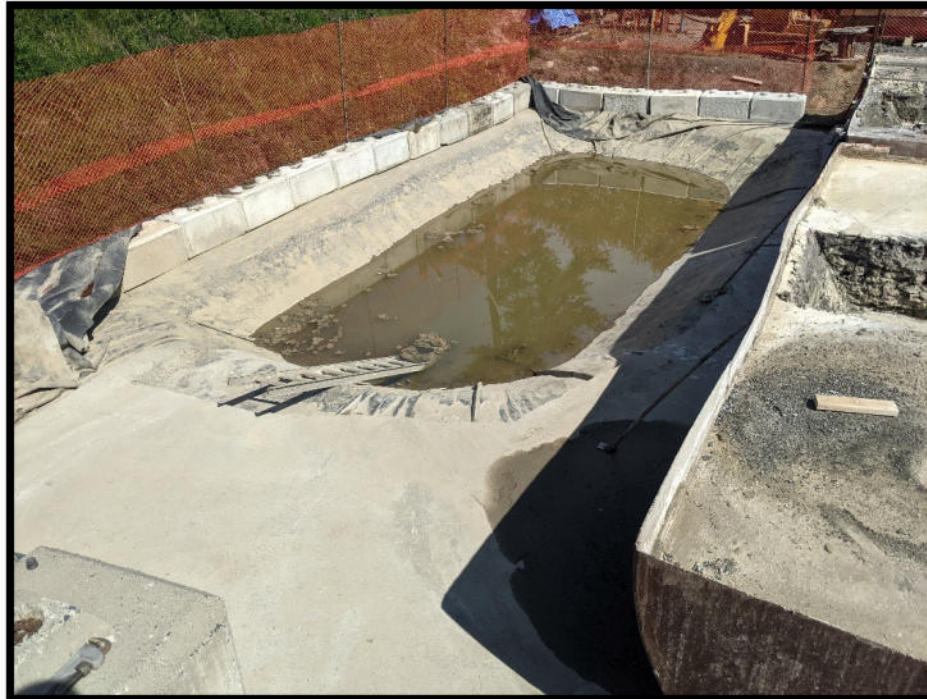
<p>should be minimized through batching area where wastewater may be present;</p>		<p>back in, are filled with concrete and then pull out in the forward direction. This configuration discourages any other vehicular traffic from entering the area. No other equipment is stored within the bay.</p>
<p>- Sufficient capacity must be provided for wastewater holding tanks / basins;</p>	<p>Yes</p>	<p>Water is circulated throughout the closed system to allow for additional capacity as needed. Additional basins have been added that can act as additional storage volume. (Photos 20-22, 32 & 33)</p>
<p>- Wastewater holding tanks / basin shall be impermeable;</p>	<p>Yes</p>	<p>45 mil poly liners are present within all wastewater basins. Primary wastewater basin is a steel drum that is located within a poly lined cell (Photo 32 & 33)</p>
<p>- Sufficient secondary containment (i.e., berms) shall be provided to capture any overflow from wastewater holding facilities.</p>	<p>Yes</p>	<p>At the time of inspection, the secondary containment area was temporarily being used as the primary holding area to allow for cleaning of the primary holding area. (Photo 32 & 33)</p>

Photo 32 – Waste water retention area. Steel tanks were full of concrete solids at the time of inspection, so the lined secondary containment area, seen here, was in use to store waste waters.

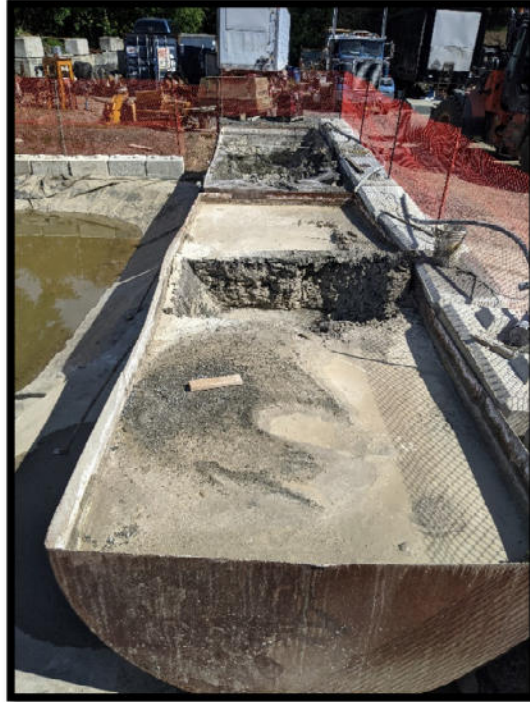
Photo 33 – Primary waste water holding tanks, full at time of inspection. Solids are chipped / removed from tanks and reused for concrete loc-blocs or sold as structural fill.

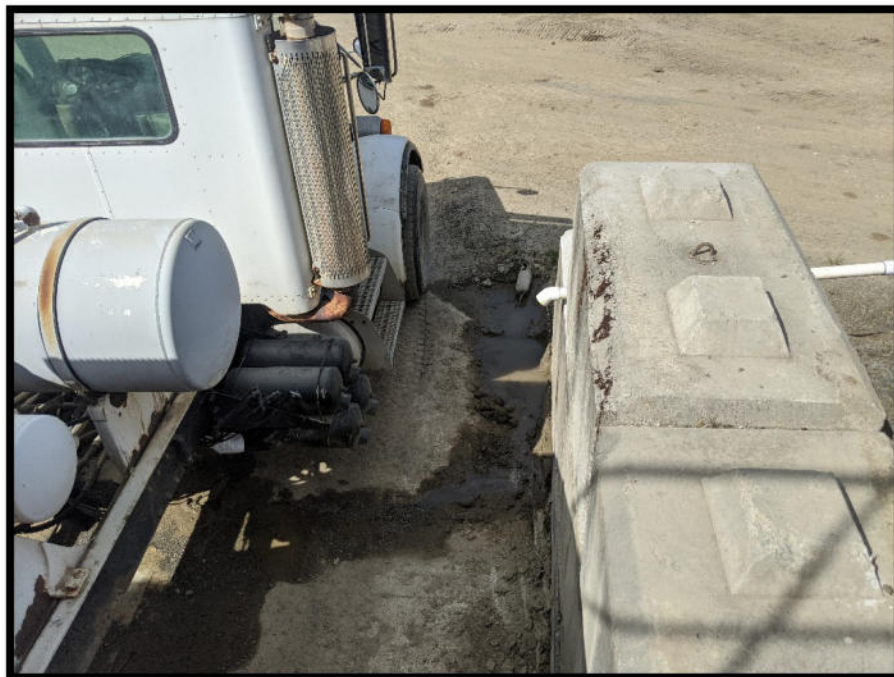
5.1.2 Water Collection/Containment (p.9)		
- All paved surfaces within the batching area should be curbed and graded to allow for effective capture and collection of wastewater;	Yes	Batching area is paved with concrete. Grading within the vicinity of the batching area generally allows for capture and transport of wastewater to the water management area. GEL plans to expand paved area to improve wastewater capture and reduce excess runoff from other parts of Site from entering batching area. (Photo 34, 16)

Photo 34 – Waters from within the batching area are directed to the waste water management area through this inlet.

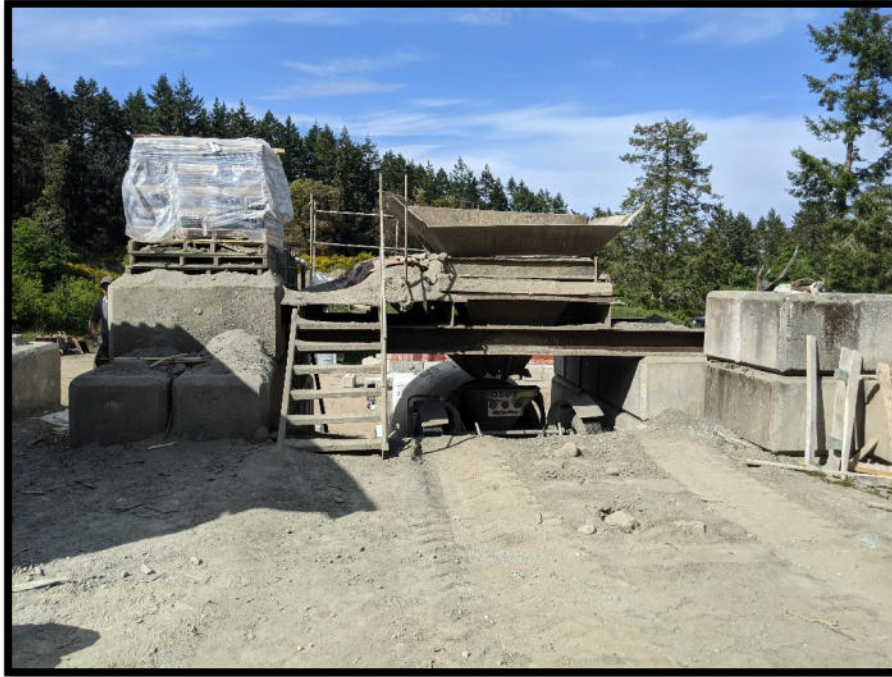
Photo 35 – View of batching area. Generally housekeeping could be improved to prevent dust and potential transport of sediments from the area.
