ELANCO ENTERPRISES LTD.

November 1, 2024

Re: Hydrogeological Assessment of Yield and Source Protection for a Well Located at 1400 Northwest Road, Denman Island, B.C.

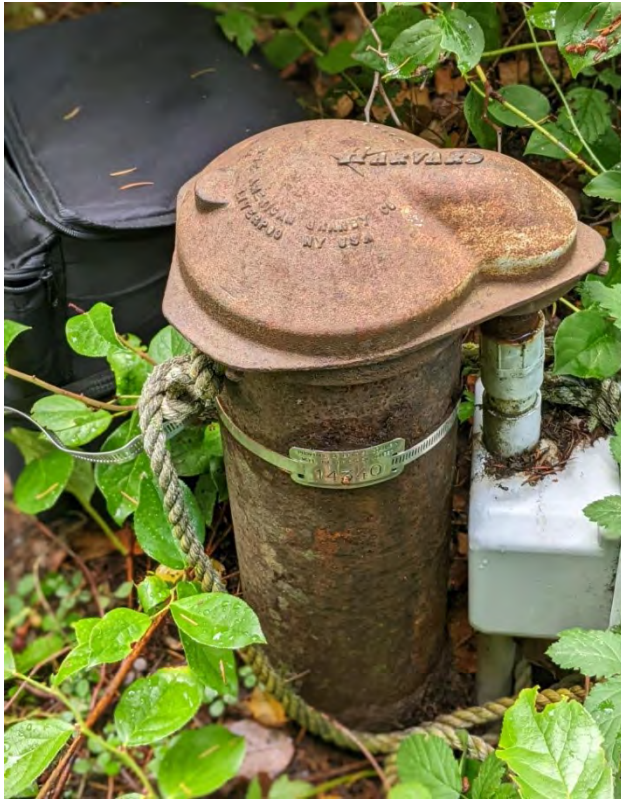
The Emcon well (WTN 34154) on the Property currently supplies water to the Emcon works yard located at 3361 Piercy Road via a pipe that follows an easement on the Property and crosses Northwest Road (see location on Fig. 1). The BC Ministry of Environment's G-wells database has incorrectly assigned the Well Plate Number (WPN) 14340 to Well 27383 located on Emcon's Piercy Road works yard property (see location on Fig. 1). This plate is actually affixed to the Emcon well on the 1400 Northwest Road property (see Photo 1).

Photo 1. Emcon Well Head (WTN 34154 WPN 14340)

1. The area around the existing well should be re-contoured with low permeability soil with a surface graded away from the well casing to a distance of about a metre.
2. Emcon should be consulted to determine their future water needs.
3. Prior to commissioning a water supply, the well and the pipe leading from the well to the pump house should be shock chlorinated to remove potential bacterial growth.
4. If the well water salinity becomes an issue in future, consideration should be given to the feasibility of plugging the lower fracture zone
5. If a higher well yield is required in future, consideration should be given to diverting the discharge at the well head and running a 3-day test at a rate higher than 0.25 L/s during a dry time of the year.

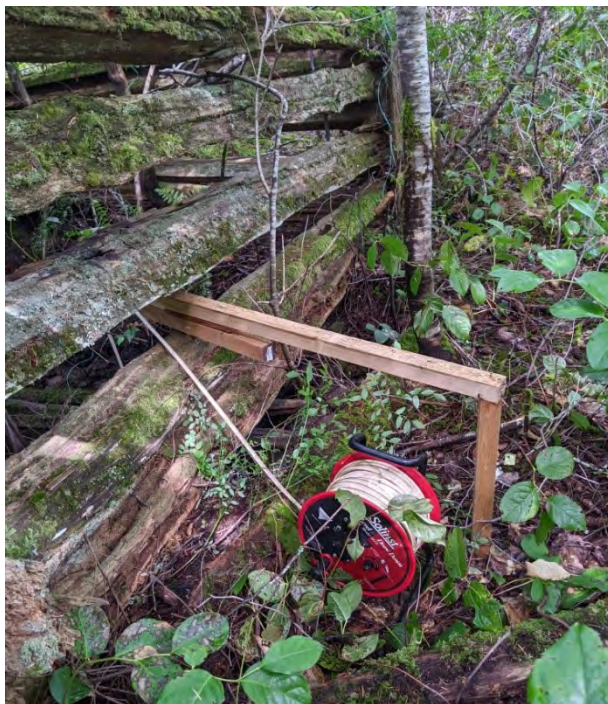
A large diameter dug well is located at a distance of about 9m east of the Emcon Well (see location on Fig. 4 and Photo 2). This well is about 2m deep and there is no record of when it was constructed. The water level in this well was recorded prior to and during and following the both the 5-day and 9-day pumping tests.

Photo 2. Wooden enclosure around the Dug Well with depth to water measurement in progress.

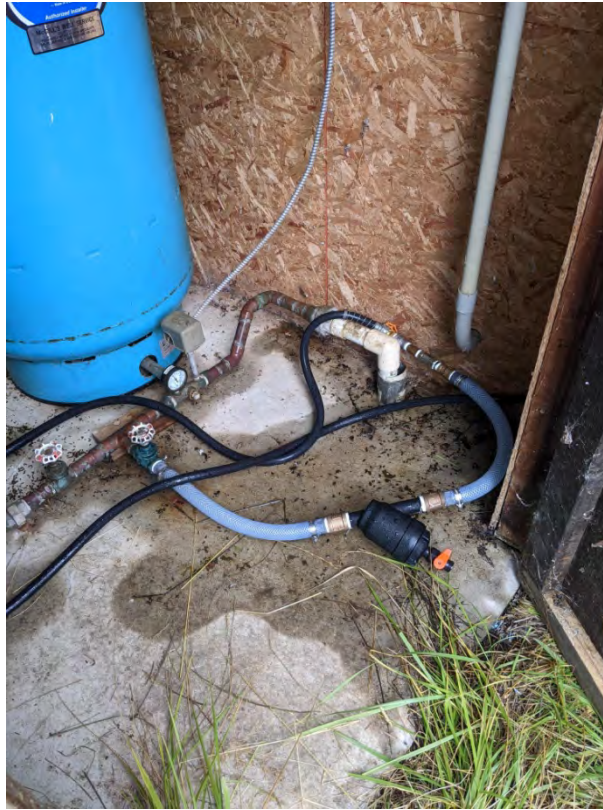
Photo 3. Pressure tank in pump house on Emcon's 3361 Piercy Road property

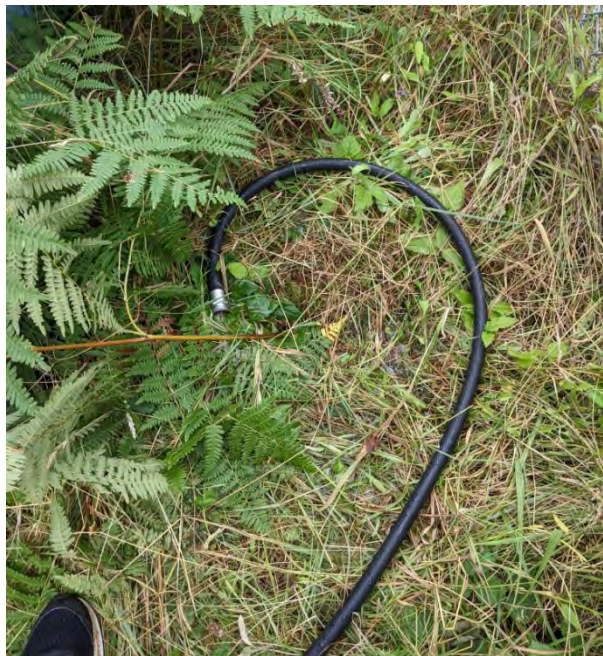
Photo 4. Discharge pipe near the pump house during the 9-day pumping test.

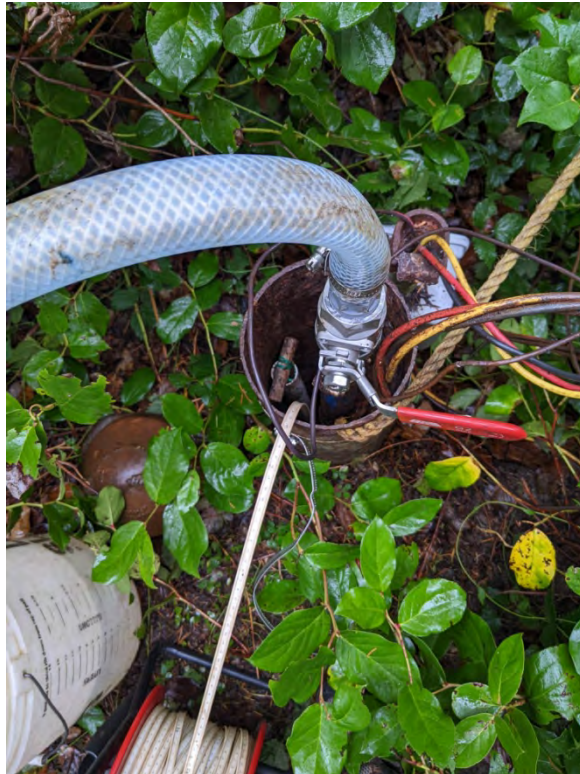
Photo 5. Emcon well head during step test with water level measurement in progress.

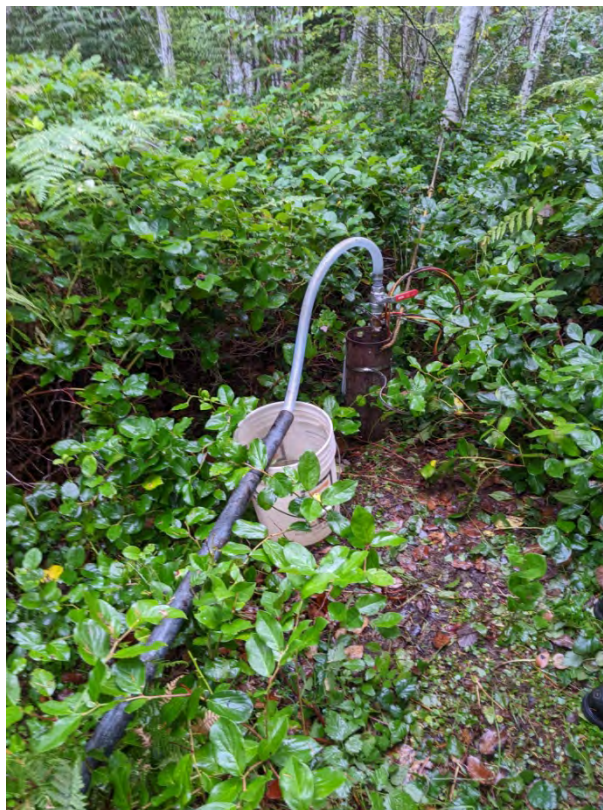
Photo 6. Emcon well with measuring bucket and discharge pipe.

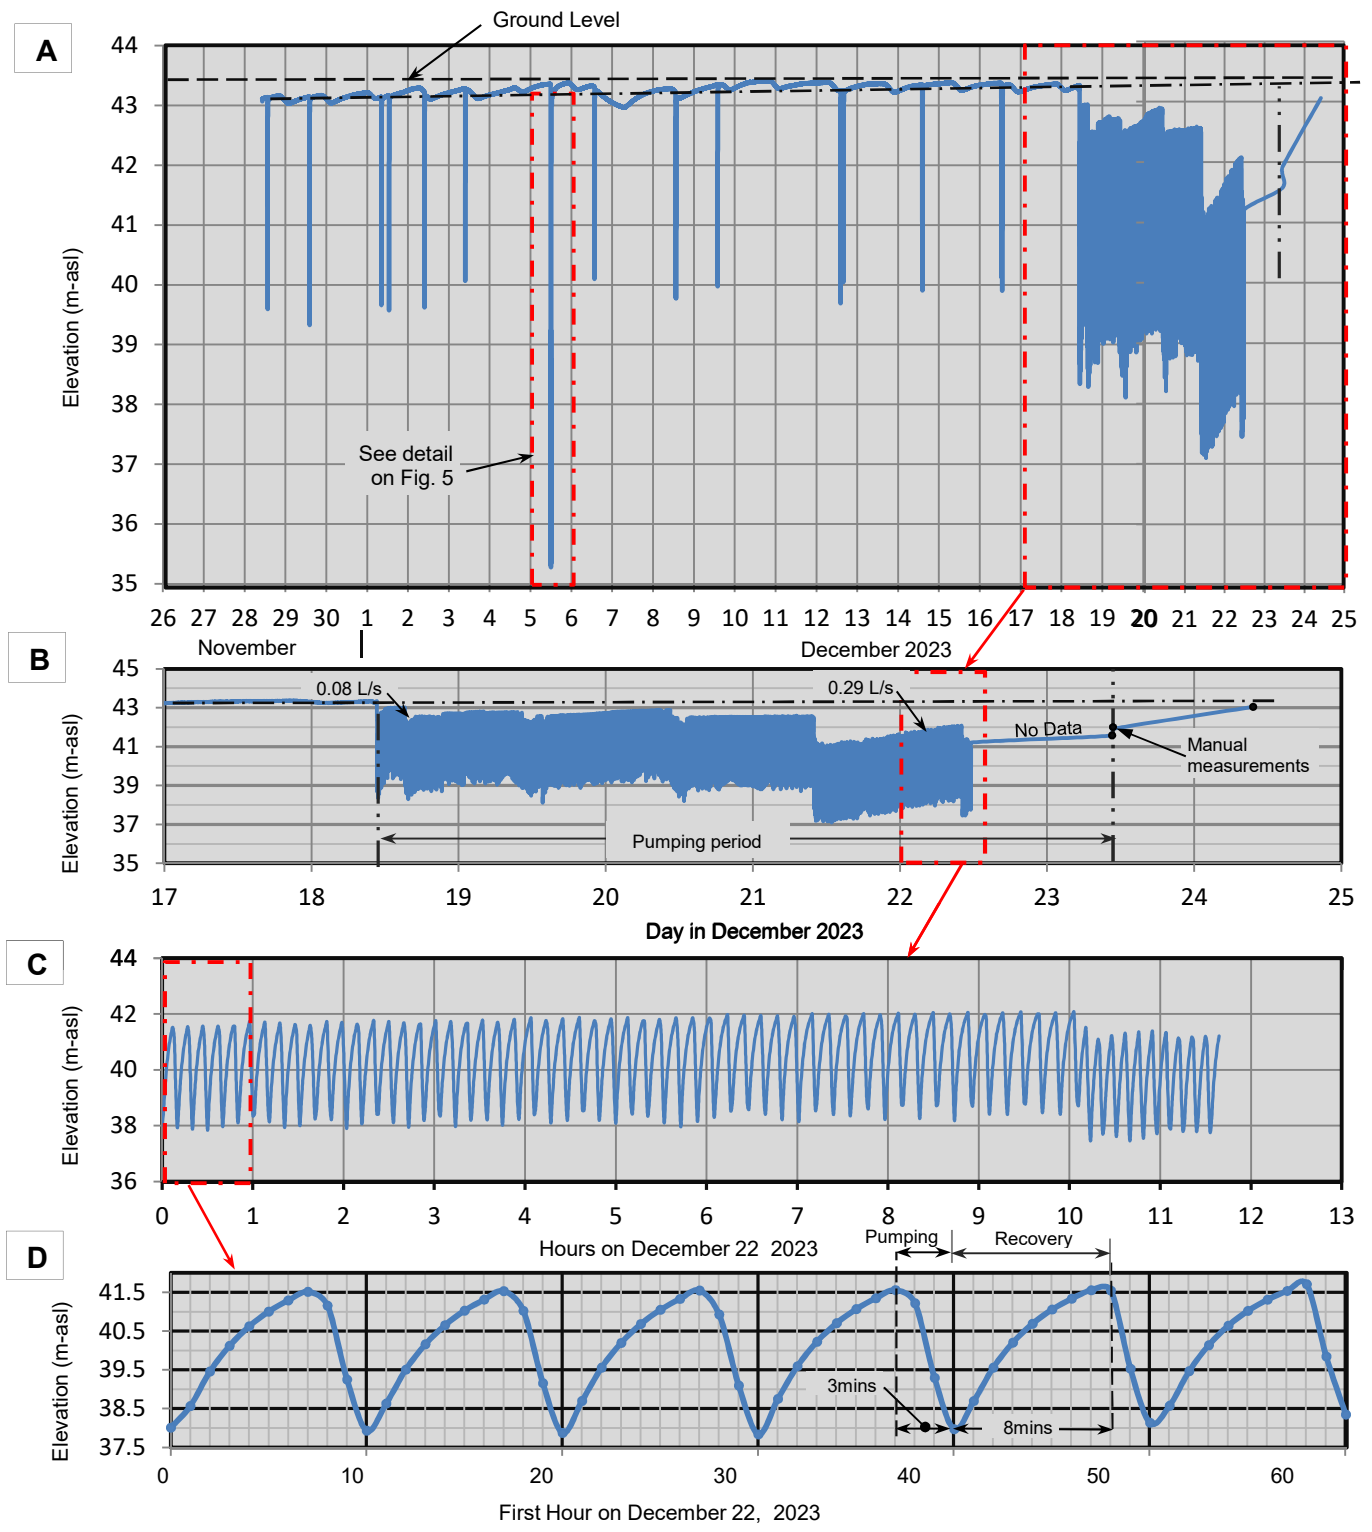
As can be seen in the graphs presented on Fig 6, the water level in the pumped well fluctuated during the test. As indicated on Table II, the pumping rate started at 0.24 L/s but did not remain constant, with the rate fluctuating between about 0.08 and 0.24 L/s. These changes were related to a combination of adjusting the valve on the discharge pipe and the sensors in the pressure tank. As the test proceeded the maximum pumping rate was increased to 0.29 L/s. The average and median rates during the 5-day period were 0.18 L/s and 0.15 L/s respectively.

As can be seen on Fig. 6D the water level typically followed an 11 minute cycle with it declining for 3 minutes and then recovering for 8 minutes. As indicated on the bottom of Table II this indicates that the operating storage volume in the pressure tank was about 85.4 Litres and that the estimated pumping rate during the 3 minute refill period will have been about 0.65 L/s.

The maximum drawdown recorded during the 5-day pumping period was about 6m. In spite of the pumping rate fluctuations the specific capacity over the last two days remained constant at about 0.028 L/s/m (see Table II)..

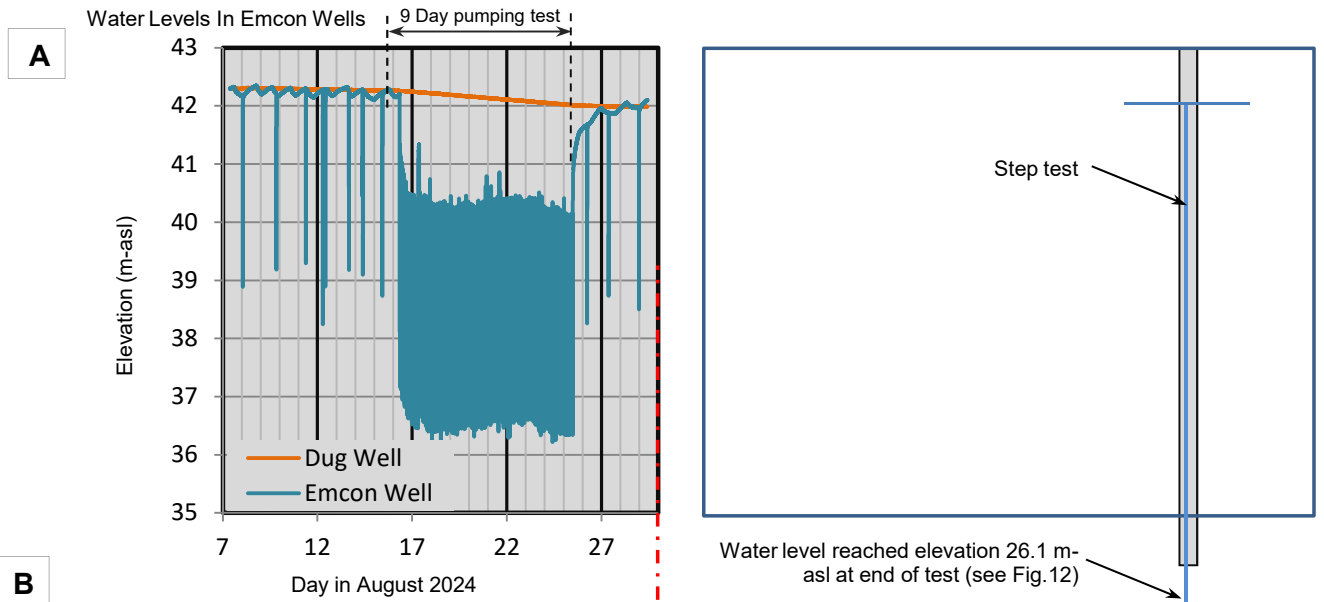
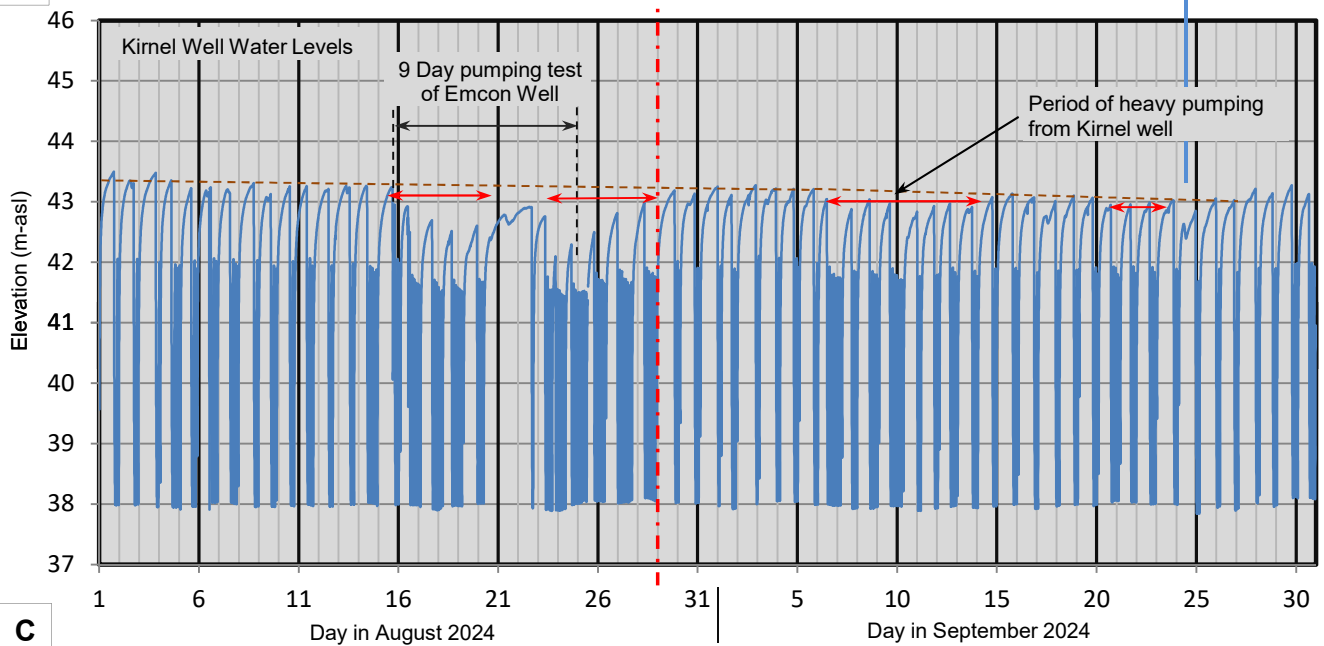
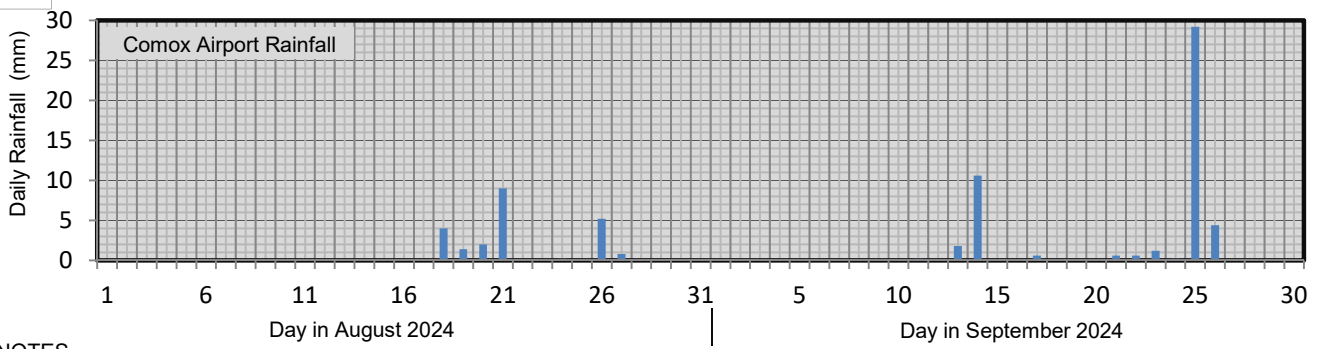
It was noted that the elevation of the water level in the dug well in December 2023 was slightly lower than that of the drilled Emcon Well. This suggests that there is an upward flow of water from the fractured bedrock into the nearby swamp-like surface water bodies during this period. However, in August 2024 the piezometric levels in the dug well were only lower than those of the drilled well for brief periods near the middle of each day (see Fig. 9A).

A graph of water levels recorded in the Kirnel well for the period August to September 2024 is presented on Fig. 9B. This graph clearly shows the impact of the well being intermittently pumped. Also of note is that when the pumping frequency increases the water level in this well is slightly depressed. The red arrows on Fig. 9B span the most significant high frequency periods. While one of these periods almost coincides with the start of the 9-day pumping tests the others do not. The graph presented on Fig 13 clearly illustrates that pumping at a rate of 0.23 L/s from the Emcon Well does not have an impact on the Kirnel well.

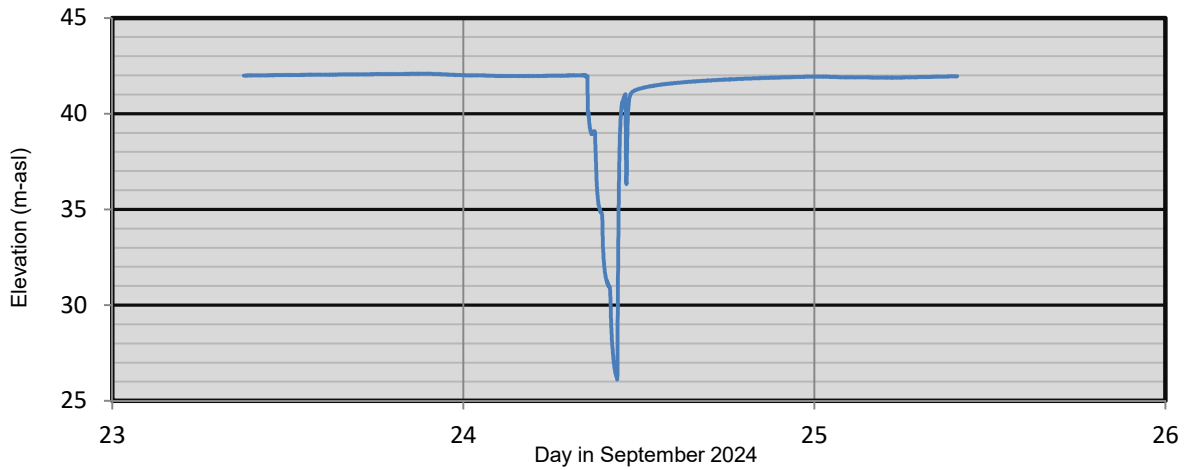
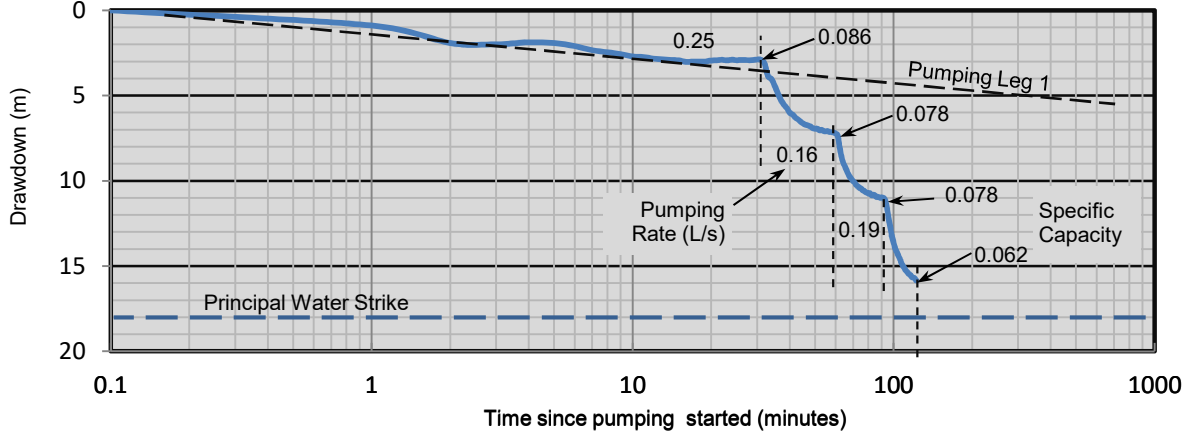
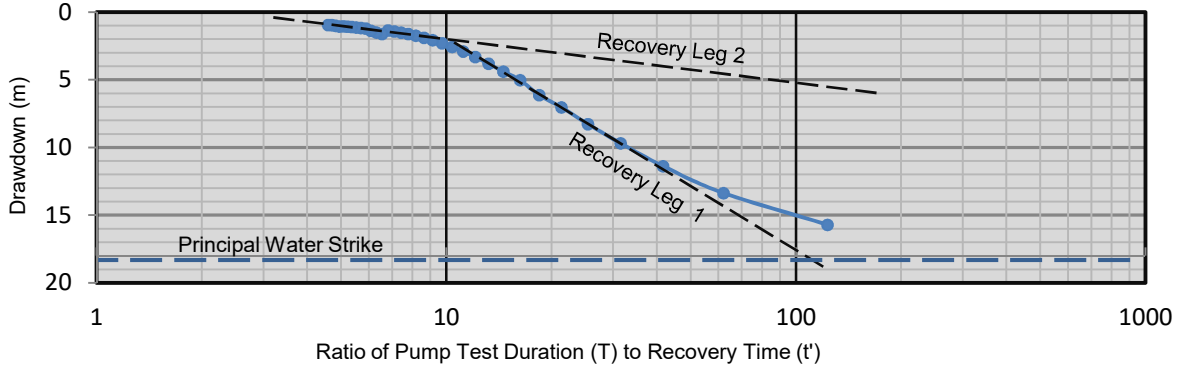
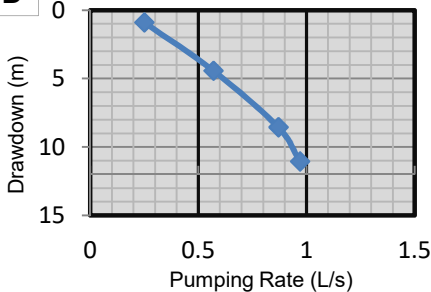
Fig. **12**

As indicated in Table VI and on Fig. 12B, the step test was run at four different pumping rates for 30 minutes that ranged from 0.26 to 1.0 L/s. The specific capacity at the end of each step ranged from an initial 0.086 L/s/m down to 0.062 L/s/m at the end of the test. The pumping level in the well at the end of the test was about 2m above the principal water bearing fracture in the well (see Fig. 3 and graphs on Figs. 12B and 12C).

The drawdown vs. pumping rate graph (Fig. 12D) shows that the relationship between these two parameters is linear except for the last rate. This confirms that the well is relatively efficient and can sustain a rate much greater than the average 0.23 L/s pumping rate during the 9-day test.

The drawdown trend during the first step of the test and the well recovery after the test were used to estimate the aquifer transmissivity. As set out in the Table at the bottom of Fig. 12 the apparent transmissivity is $8.4 \times 10^{-6} \text{ m}^2/\text{s}$ for the steeper portions and in the flatter portions the range is from 1.5×10^{-5} to $3.9 \times 10^{-5} \text{ m}^2/\text{s}$. After accounting for the well casing volume the corrected initial transmissivity is about $1 \times 10^{-5} \text{ m}^2/\text{s}$.
