COMPANY
Comox Valley Regional District

RE
Structural Inspection of Shingle Spit Boat Launch.

DATE
October 29, 2018

MCSL FILE NUMBER: 2211 - 70571

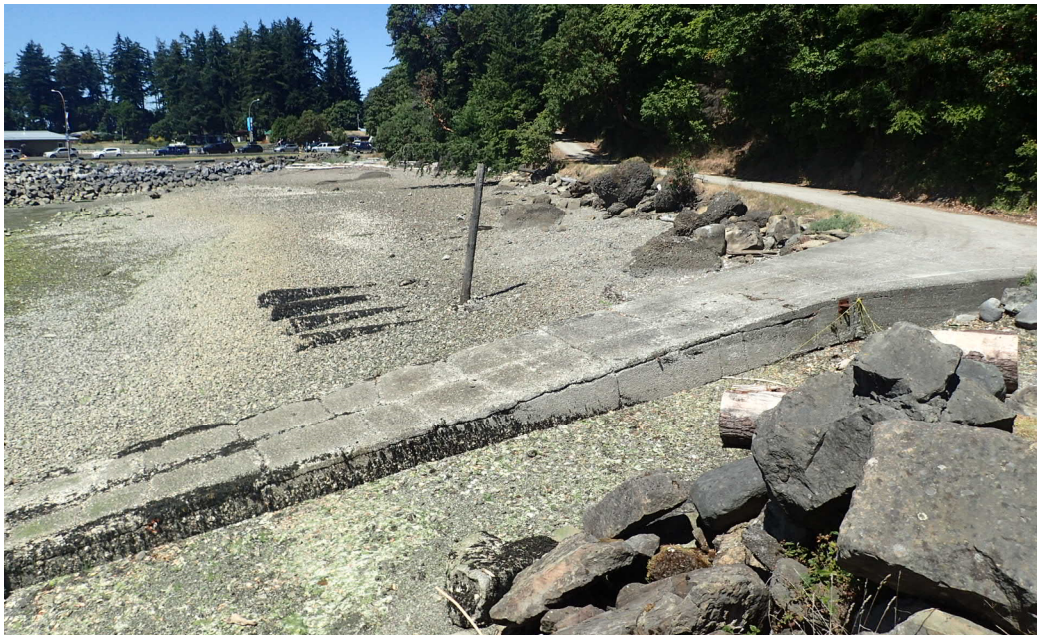
Figure 1 – View of Ramp Towards Ferry

The boat launch is located south of the Shingle Spit B.C Ferry Terminal (Figure 1) and consists of a reinforced cast-in-place concrete slab supported on structural fill, confined by two reinforced cast-in-place walls. It is the only public access boat ramp on Hornby Island.

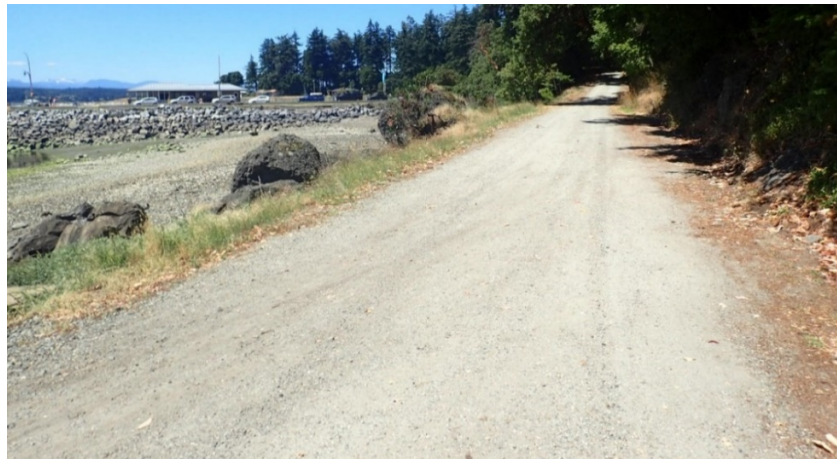
- The road is in fair condition, without any large potholes or collapsing sides (Figure 2).
- The parking lot has room for up to 6 small trailers but would be insufficient for multiple larger trailers (Figure 3).
- The beach generally consists of cobbles, 75-100 mm in diameter, with some larger rocks.
- The beach becomes more sandy and silty as you approach the low tide level at the bottom end of the ramp.
- There is a steady flow of water from the approach area, which runs beneath the ramp and into the ocean.
- The seabed from the end of the ramp is in good condition, as there are no major rocks or debris.

Figure 2 – Access Road

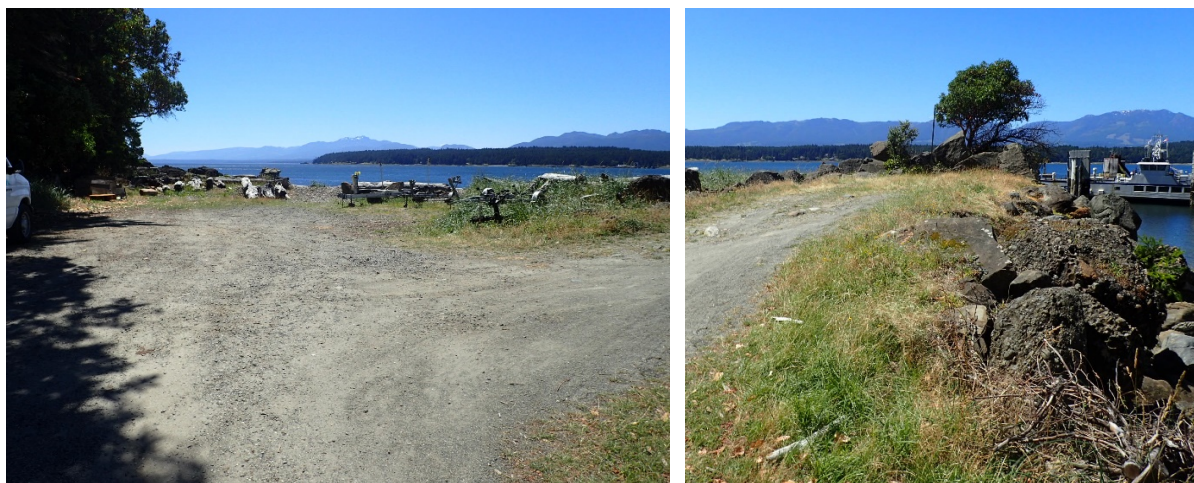
Figure 3 – Parking Lot South of Boat Launch

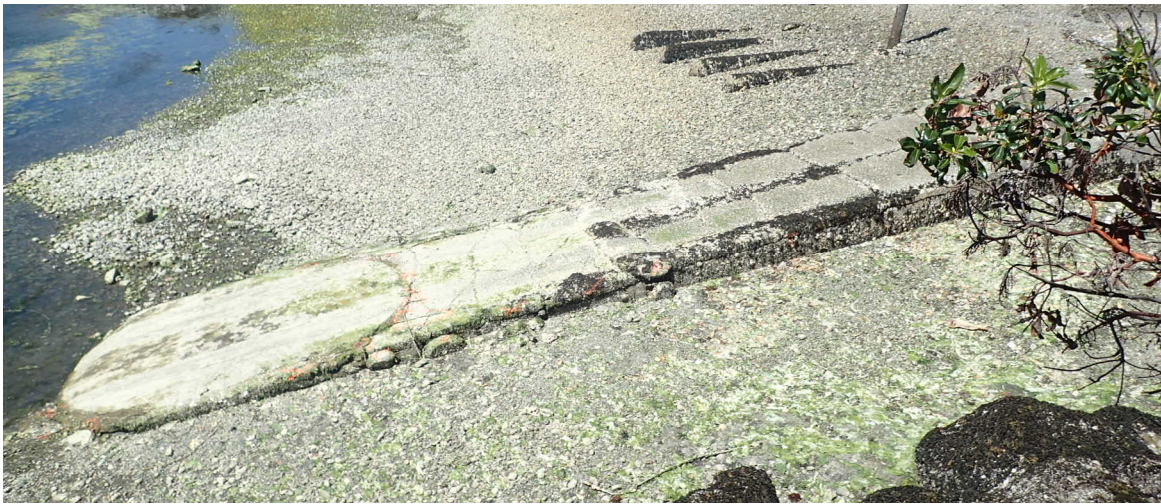
- Cracks run both longitudinally and laterally across the surface, with many extending entirely through the slab.
- Large portions of the lower ramp have delaminated (Figure 4).
- On the north side of the ramp, portions of concrete are spalled, and cracks range up to 115 mm wide.
- Concrete reinforcement has been exposed from surface deterioration. More than 24 scattered ends are protruding out of the topside, to 10mm in height (Figure 5 and 6). Approximately 11 longitudinal lengths of reinforcement are exposed on the surface.
- The portion of the ramp above the tideline is in fair condition, with minor to moderate cracking (Figure 7).

Figure 4 – View of Lower Ramp with Water Damage

Due to the extent of repairs/rehabilitation that would be required, McElhanney recommends replacing the entirety of the boat ramp.

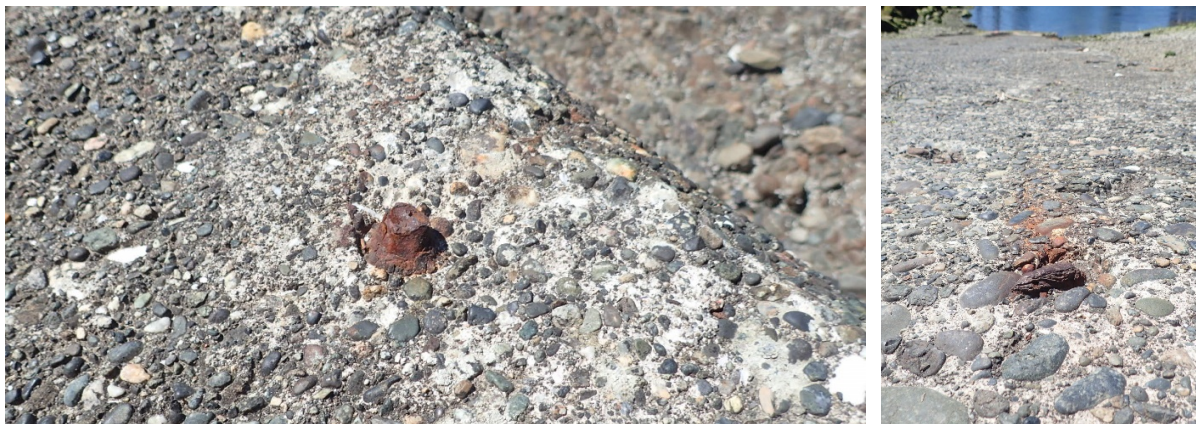
Figure 5 – Rebar Out of Surface

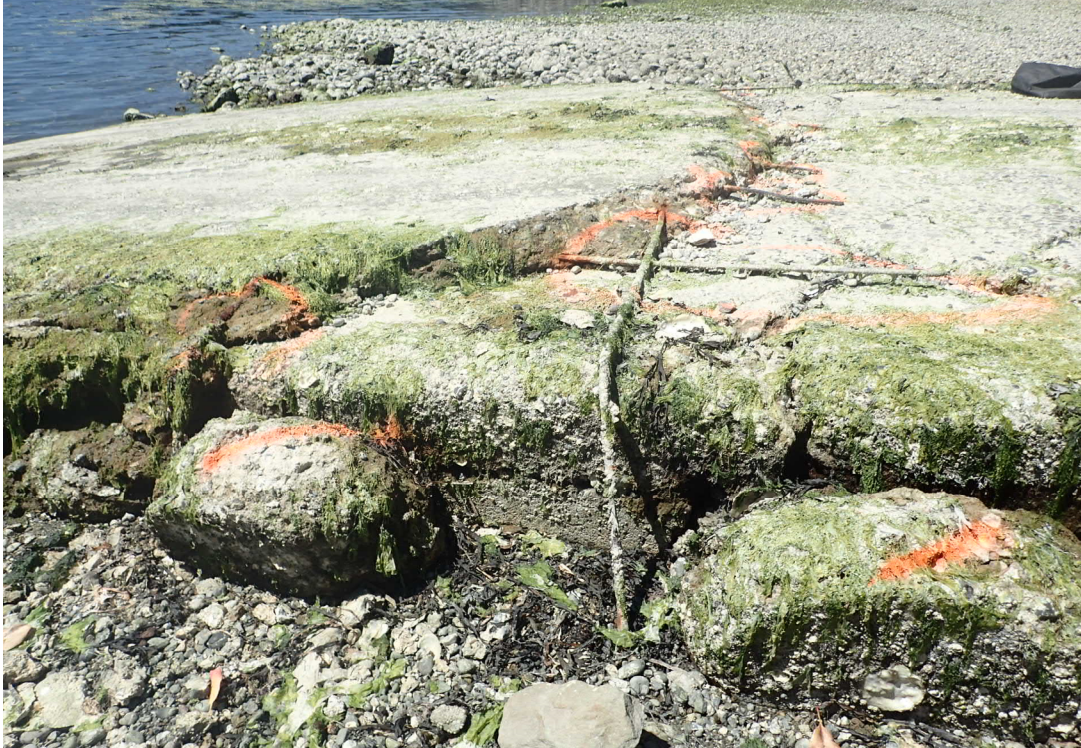
Figure 6 – Bottom End Exposed Rebar and Loose Concrete

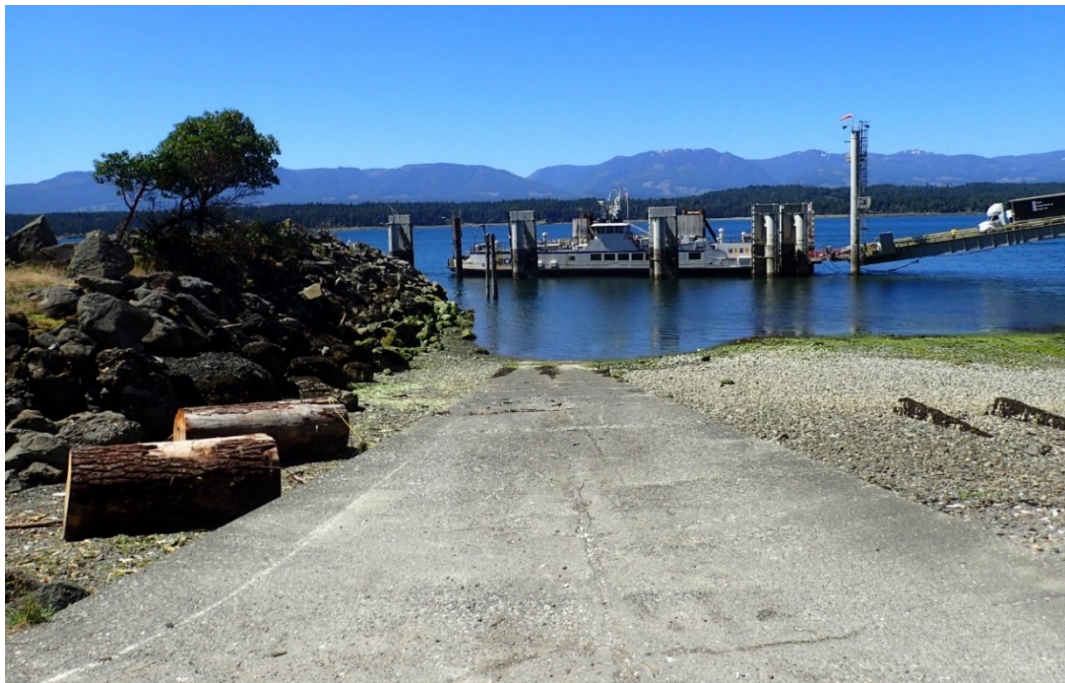
Figure 7 – Top End, Looking Down Ramp

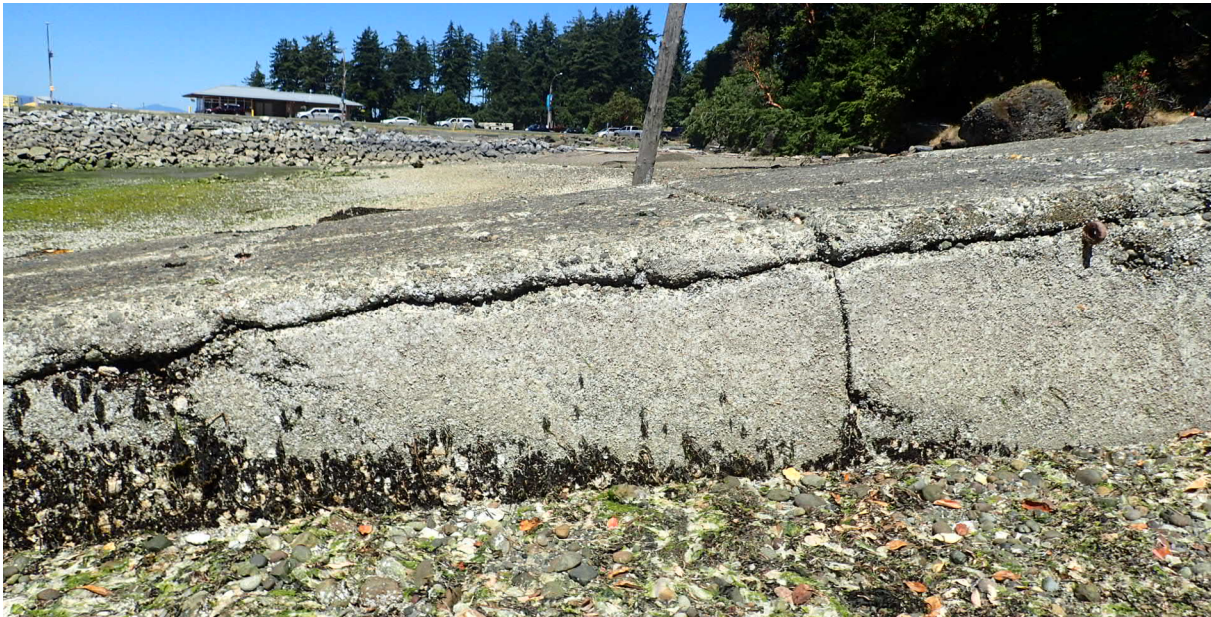
- Along both side walls, approximately 150 mm down from the top edge, a longitudinal crack runs down the entire length of the launch. Several vertical cracks also exist along these walls (Figure 9).
- Spalled concrete lies on either side of lower ramp (Figure 10).
- Erosion is occurring along the bottom edges of the side walls along the entire length of the boat launch. A 50 mm gap can be seen below the wall in a number of locations (Figure 11).

Figure 8 – Longitudinal and Vertical Cracks

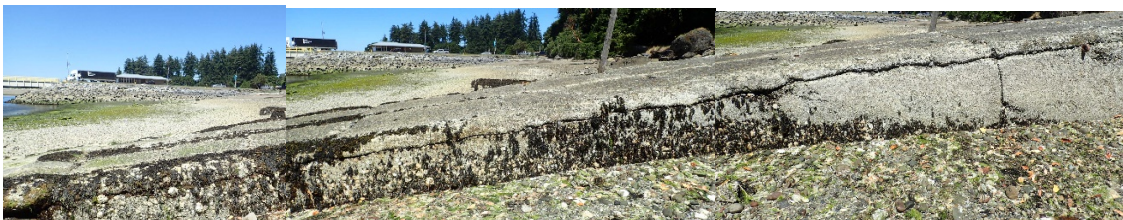
Figure 9 – South Side of Ramp

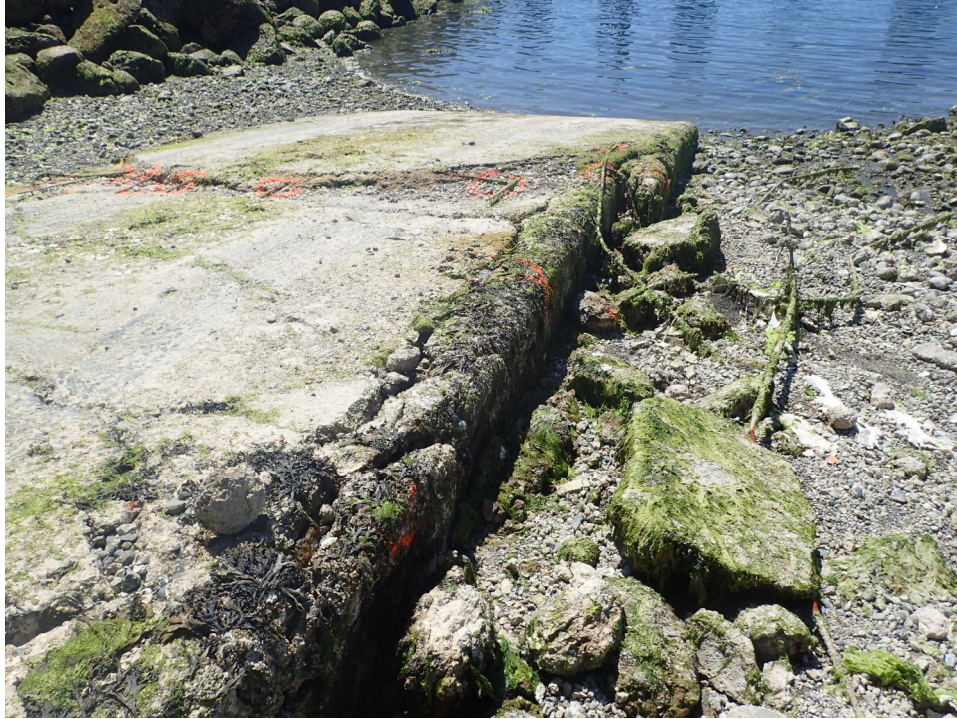
Figure 10 – View of Lower Ramp Spalled Concrete and Reinforcement

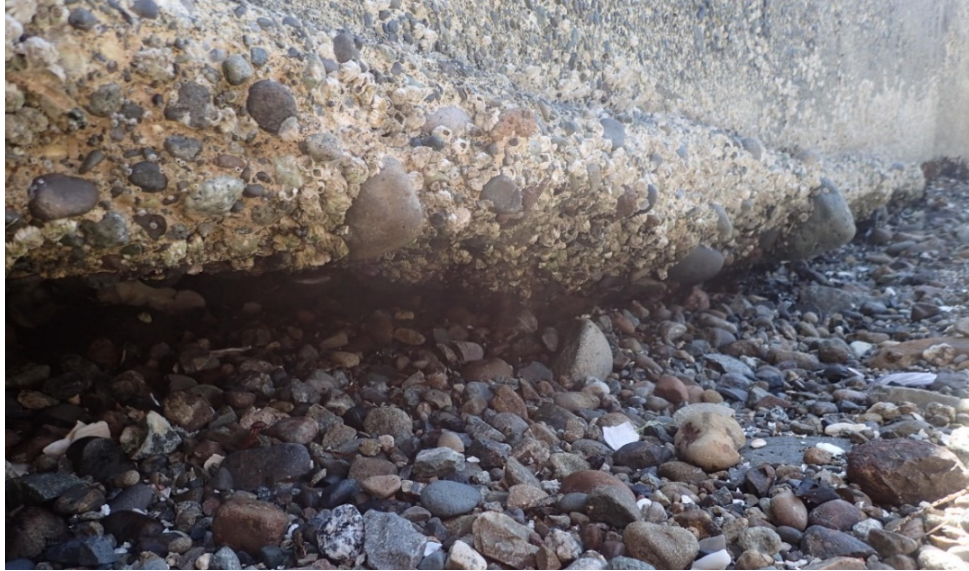
Figure 11 – View of Gap Beneath Wall

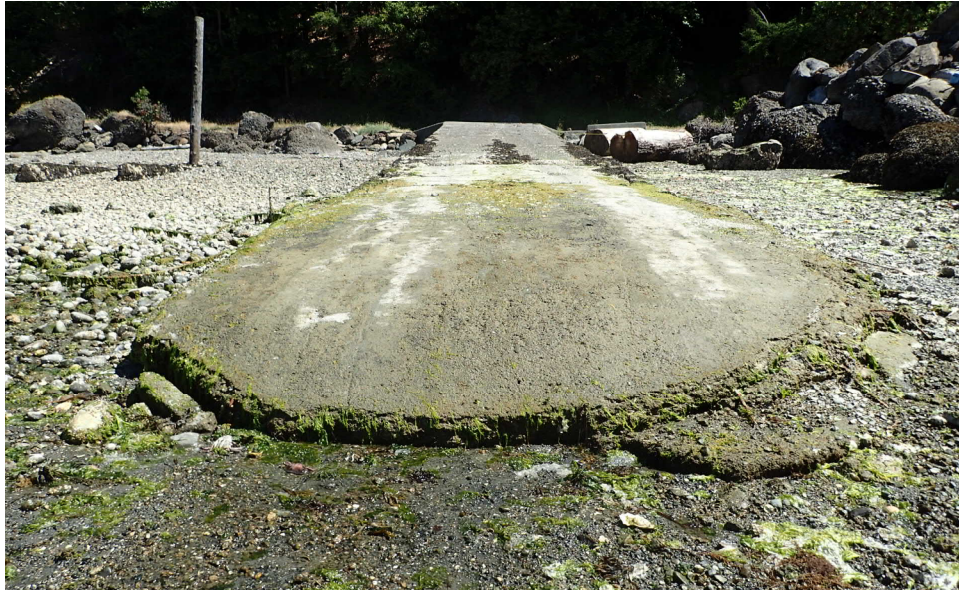
- There is steel reinforcement exposed at the bottom end of the ramp due to severe spalling (Figure 12).
- The end of the ramp drops off 146 mm to the cobbles (Figure 12).
- Water is flowing from under the slab and out the bottom end, visible at low tide (Figure 13).

Figure 12 – View of Bottom End

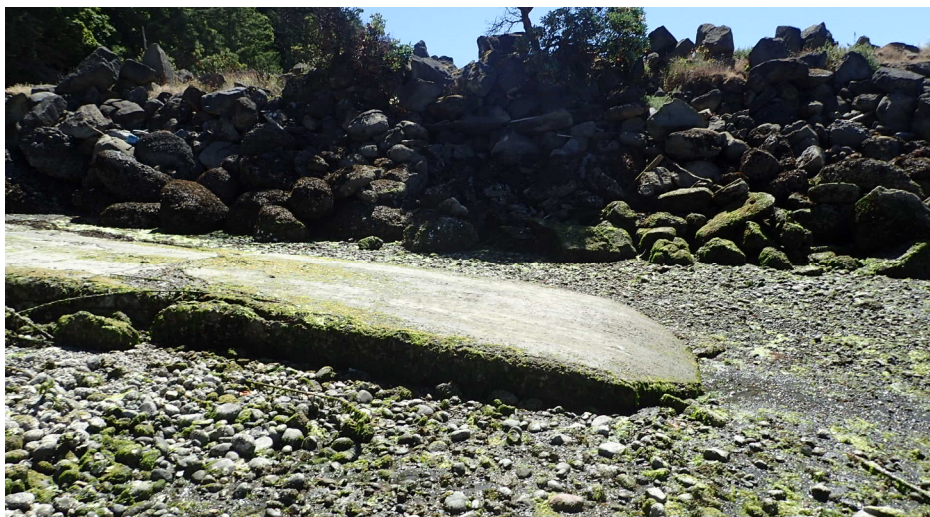
Figure 13 – View of Bottom End Right Side and Water Flow

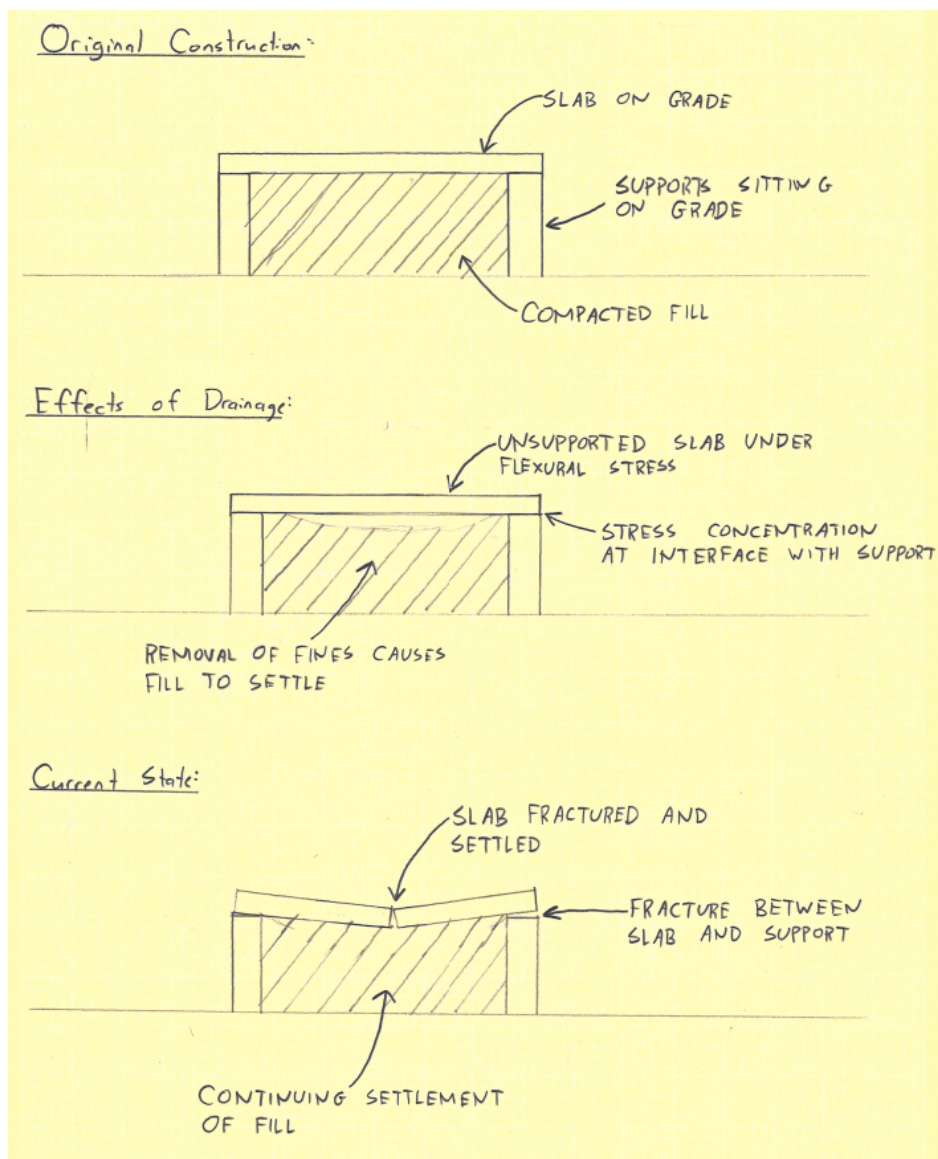
It appears that there is a significant drainage beneath the boat ramp. This drainage has washed away fines from beneath the ramp, causing the structural fill to settle (Figure 14). As the fill settled, the slab had to span between the supporting walls, carrying its own weight as well as the weight of vehicles on the ramp. The concrete slab has likely surpassed its capacity and fractured at the centre of its span. This resulted in the longitudinal crack running down the centre of the slab, as well as the cracks running along the length of the supporting walls. As the drainage continues to wash away more of the structural fill, the slab will deteriorate further, resulting in progressive damage and collapse.

Figure 14 – Diagram of Boat Ramp Deterioration

In the interim, McElhanney strongly recommends that the CVRD install signage which alerts boat ramp users to the conditions and potential risks of accessing the ramp.

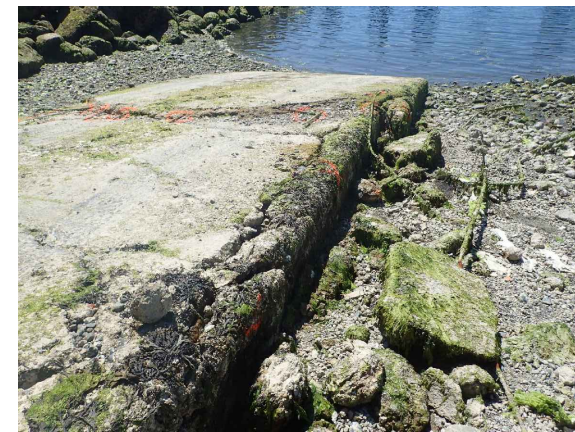
LOWER RAMP WITH SEVERE DETERIORATION TO CONCRETE

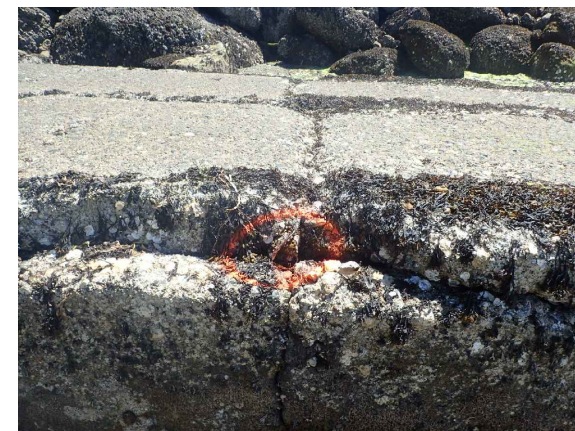
SEVERE OVERSTRESSING ON TOP SLAB OF RAMP
