November 18, 2025

Project No. 2023-056C

**RE: NOVEMBER 17, 2025 INSPECTION SUMMARY OF THE SHINGLE SPIT BOAT LAUNCH,
HORNBY ISLAND**

Calidris Ecological Services Ltd.

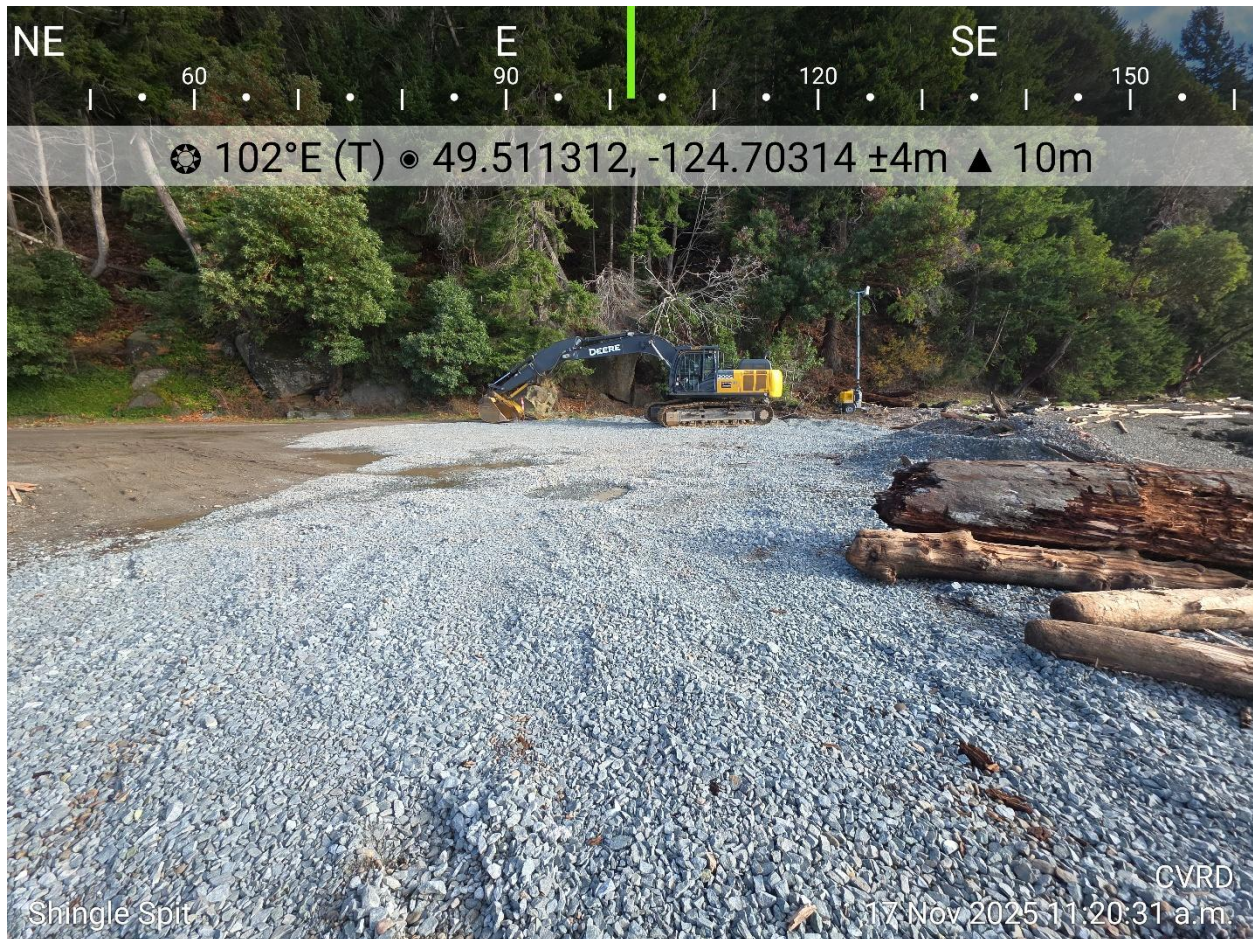
Blast rock has been spread across the landing/parking area (Photo 1). It's not known who did this, however, it is likely useful at reducing mud and sediment transport and is not expected to cause any environmental issues. Driftwood has been pushed into two piles on either side of the landing. It's also not known if this was associated with this project. If it was conducted by the contractors, it should be spread out along the foreshore (above the high tide line) in a "natural" configuration (Photo 8).

Photo 1. Blast rock has been spread across the landing area just south of the boat launch, The material appears clean and likely inhibits erosion and sediment generation. The Deere 300 excavator in the background is not associated with this project. Ownership of the light plant is not known.

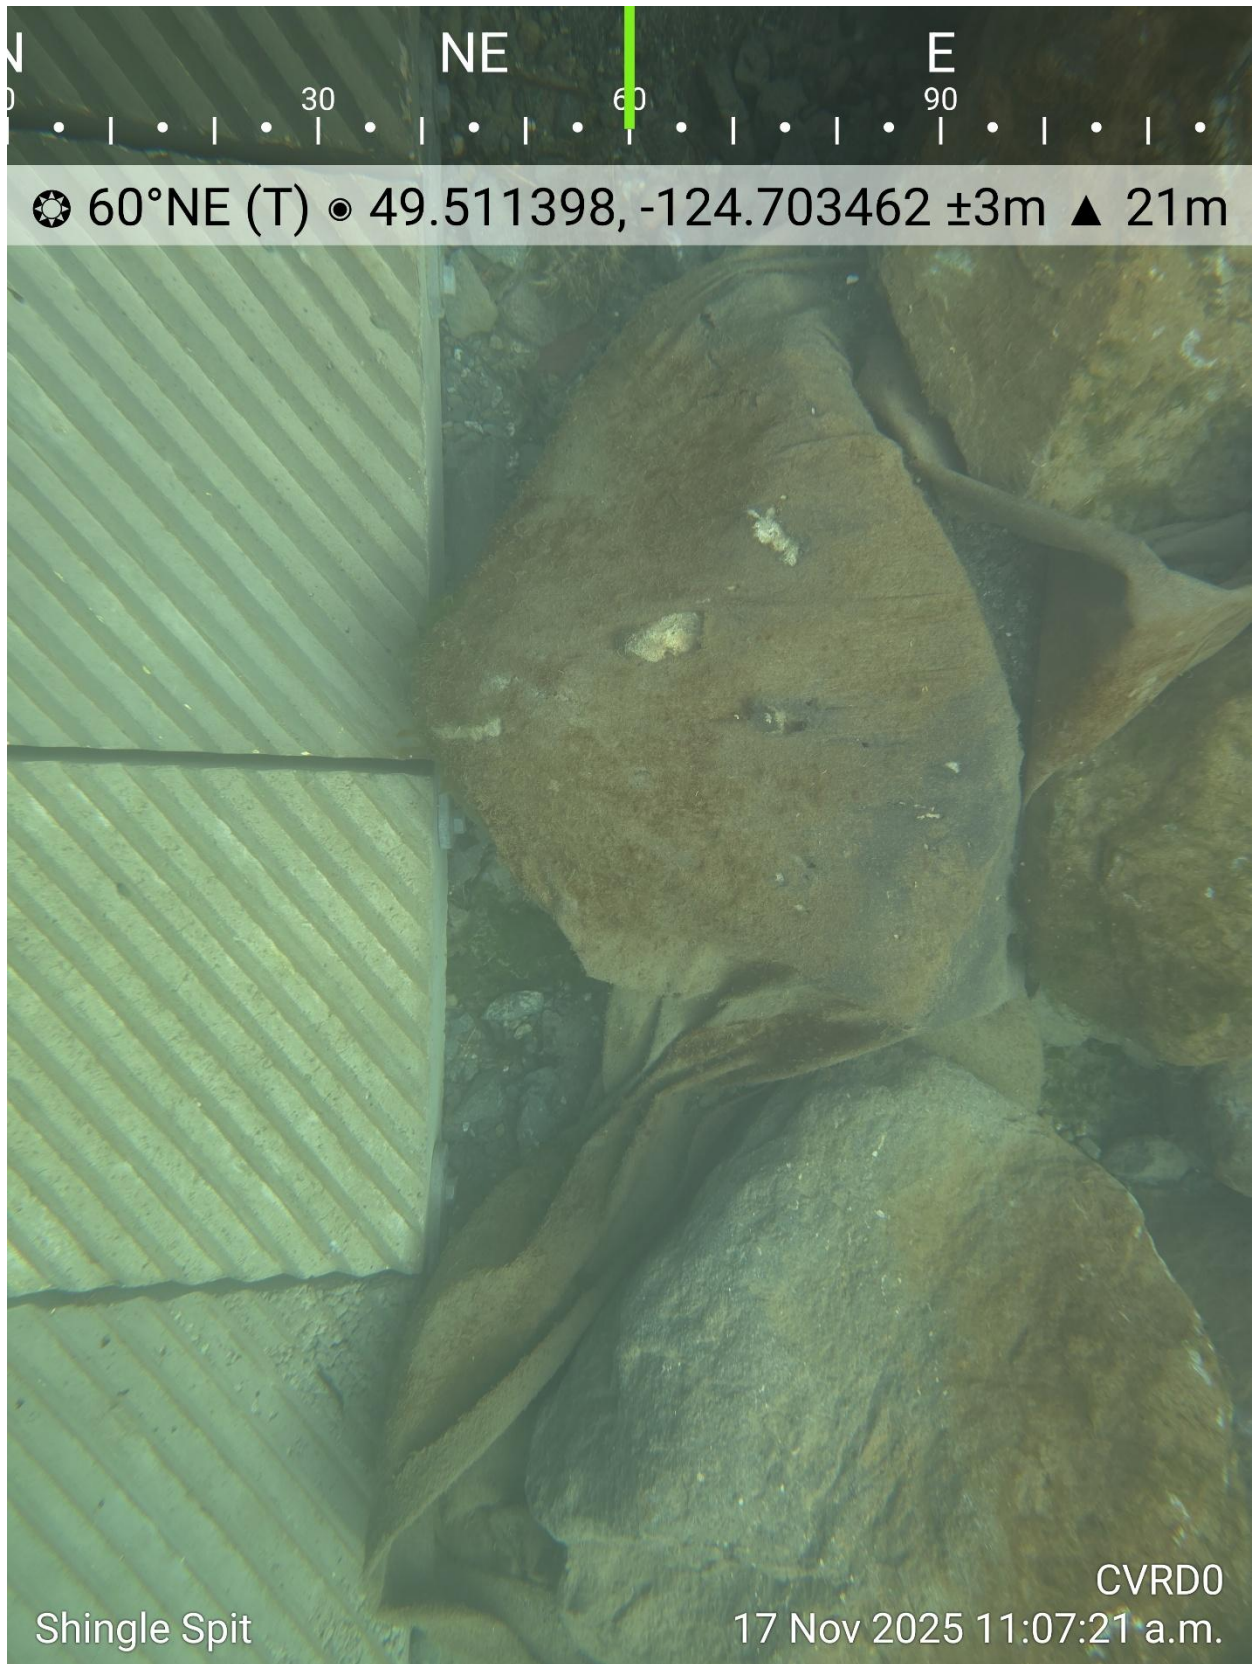
- There is still a lot of geotextile cloth sticking out from around the riprap and a substantial gap between the edge of the riprap and the ramp deck (Photo 2-3). I understand this has also been identified by Cascara. More riprap is required along the margins of the ramp to fill in this gap and completely cover the geotextile cloth. Some combination of trimming and cleaning up excess geotextile cloth may also be required. This was noted along the entire length of the ramp, on both sides.

Photo 2. Showing excess geotextile cloth along the riprap on the north side of the ramp, below the water line during the 17-Nov.-2025 site inspection.

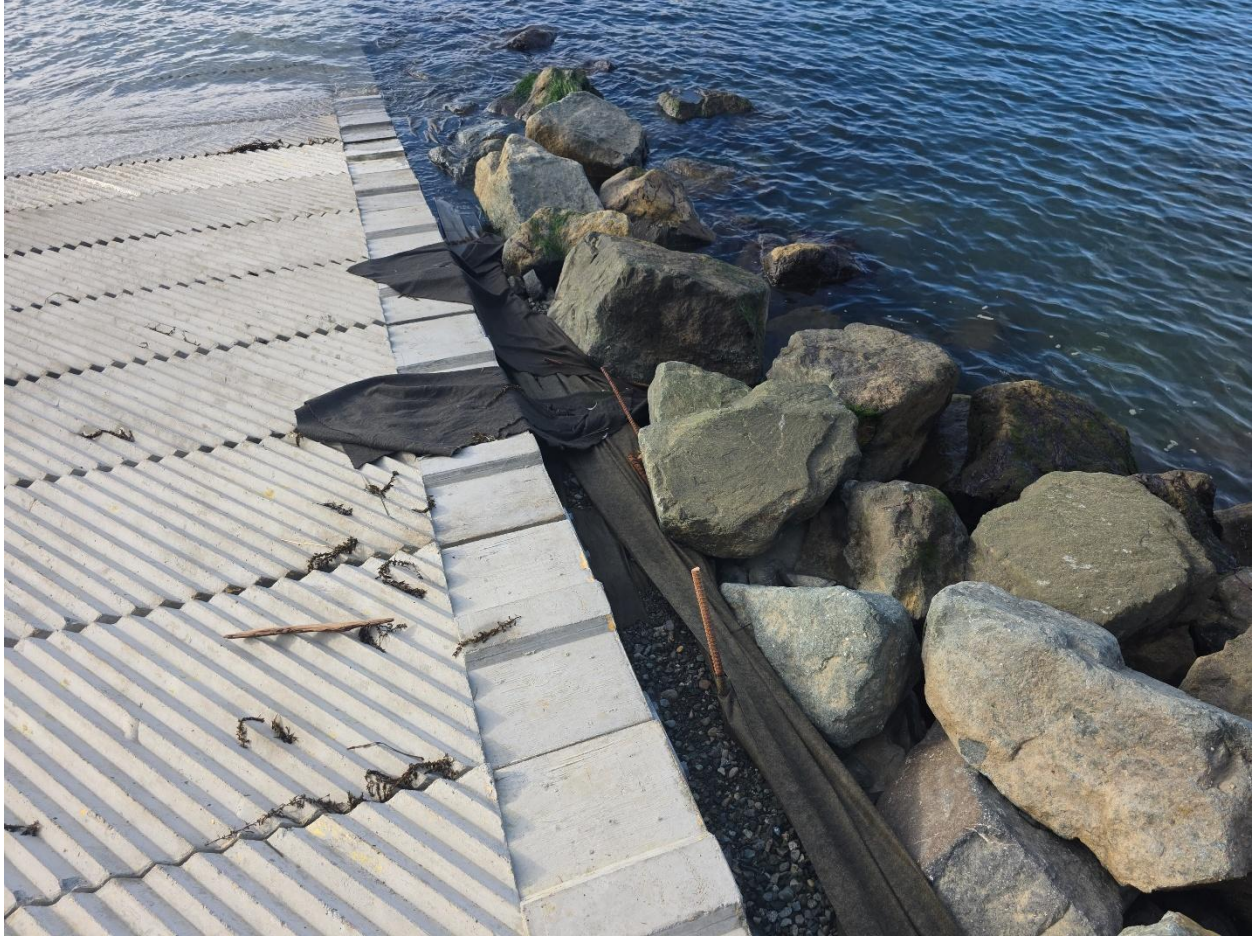
Photo 3. Showing excess geotextile cloth along the riprap on the north side of the ramp during the 17-Nov.-2025 site inspection. Note the large gap between the cloth and the edge of the ramp. Rebar shown in this photo should also be removed.

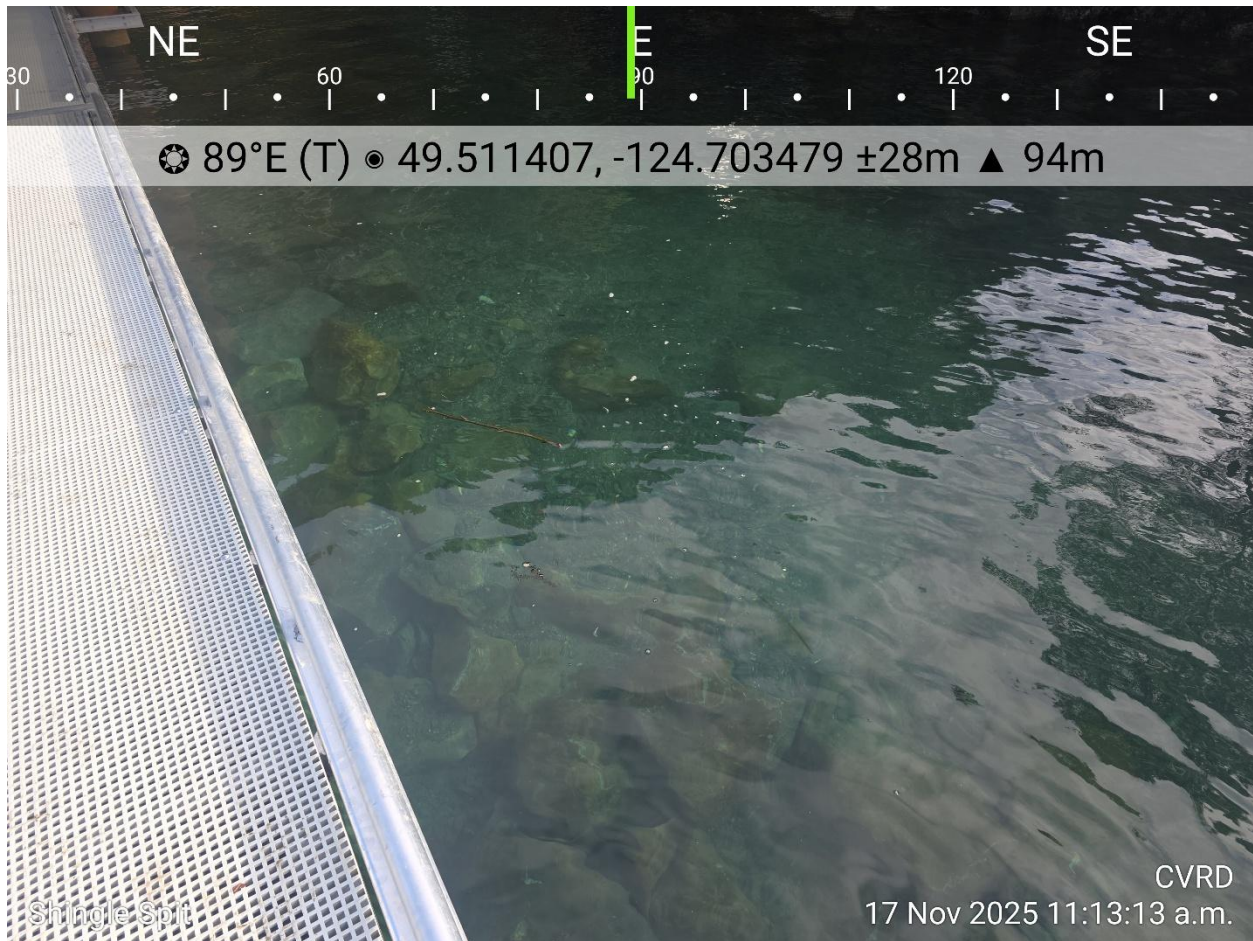
- Material excavated out from under the frame was piled on the edges of the ramp. There is a sizable pile on the south side of the ramp (Photo 4); if the next phase of work is completed at a lower tide and this material is exposed, it would be good to spread this out a bit. There may be more at the end of the ramp that was difficult to discern underwater. The addition of riprap on top of this material (if available), is also recommended as it would likely help attenuate sediment generation and transport into the bay.

Photo 4. Though somewhat obscured by the reflection on the water surface, there is a substantial amount of material piled on the south side of the ramp. If there is an opportunity to spread this material out and/or add riprap on top of it. It would likely attenuate sediment generation from this pile.

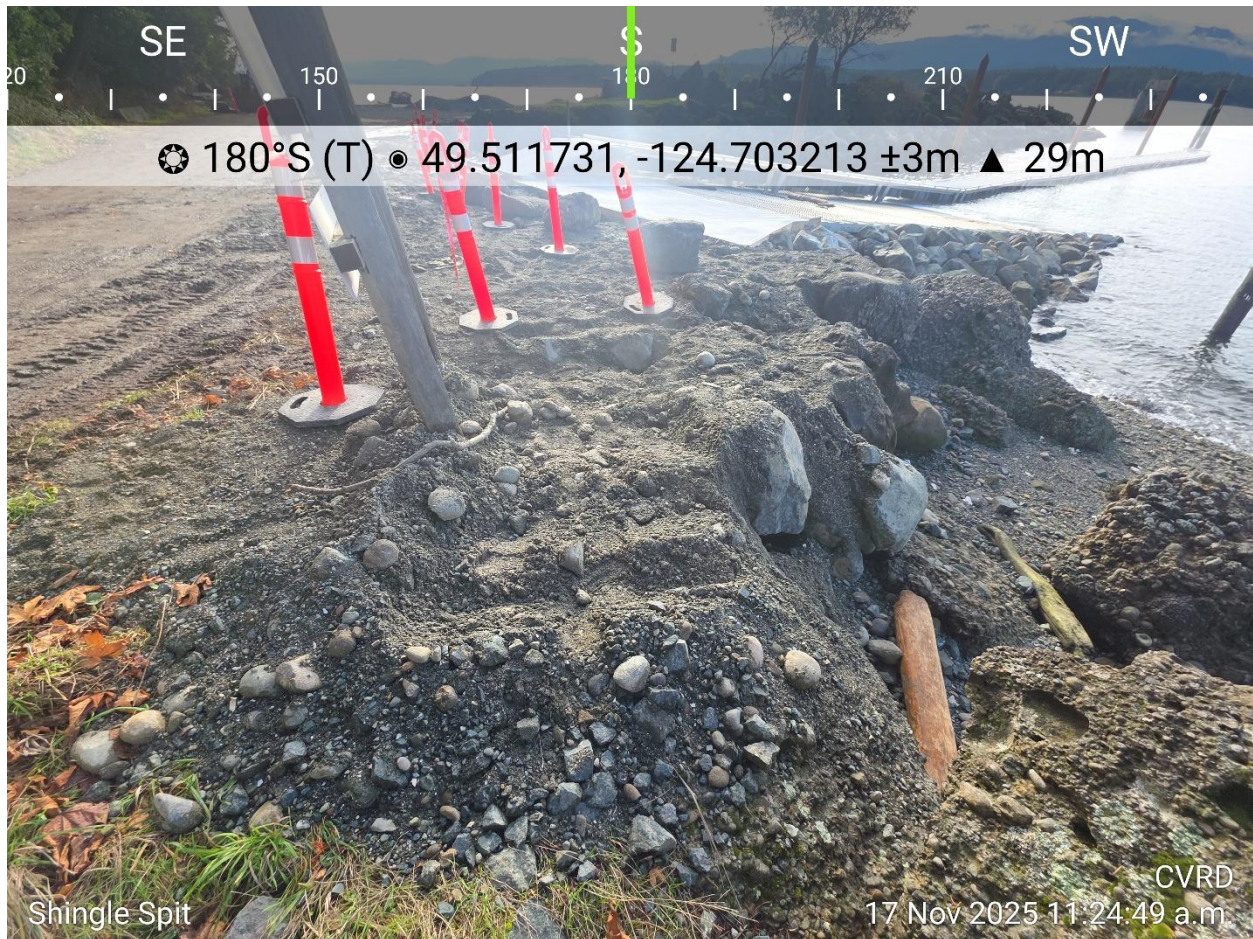
- Loose soil on either side of the top of the ramp (Photo 5) should be pulled back (away from the beach), contoured and compacted. This material could be used to complete the top of the ramp and create a smooth transition from the gravel roadway to the concrete. Any remaining material should be spread on the roadway and compacted to improve drainage (Photo 6).
- The road and parking area should be contoured to shed water and avoid pooling (Photo 7). Remaining exposed soil on either side of the ramp as well as areas of exposed soil at the landward end of the breakwater, should be grass seeded with an appropriate erosion inhibiting mix. Hand seed or hydroseed are both acceptable.
- There is a bit of garbage and construction material around the site that should be clean-up (e.g., re-bar, fencing, buckets, pilons, etc.; Photo 8).

Photo 5. Fill material on the edge of the ramp should be pulled back and used to create a smooth transition from the roadway to the top of the ramp. This area, as well as any other areas of bare soil off of the driving surface, should be grass seeded.

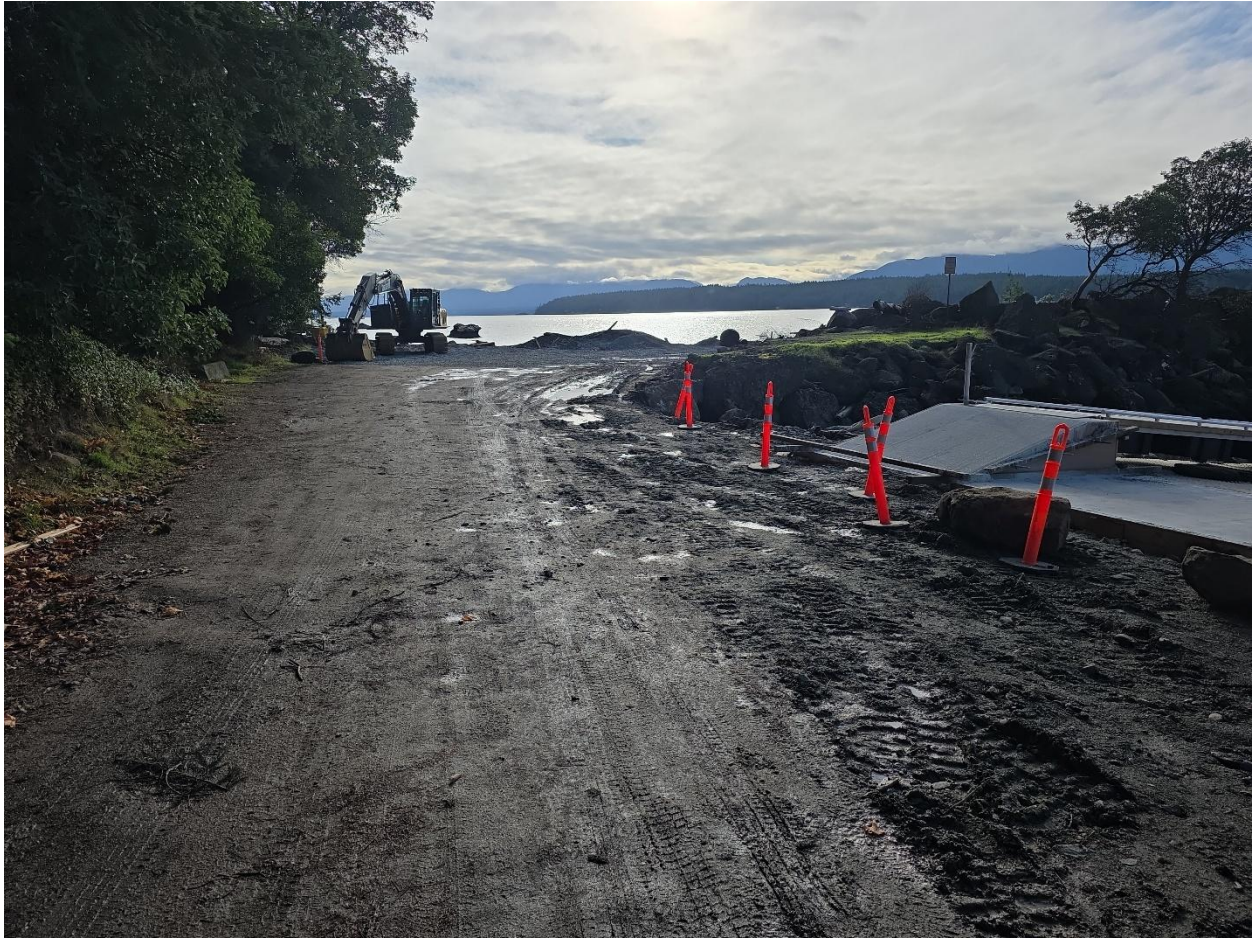
Photo 6. Showing muddy areas and minor water pooling on the driving surface that could benefit from some minor contouring. Exposed soils that remain along the foreshore (at right), should be seeded with an appropriate erosion inhibiting seed mix.

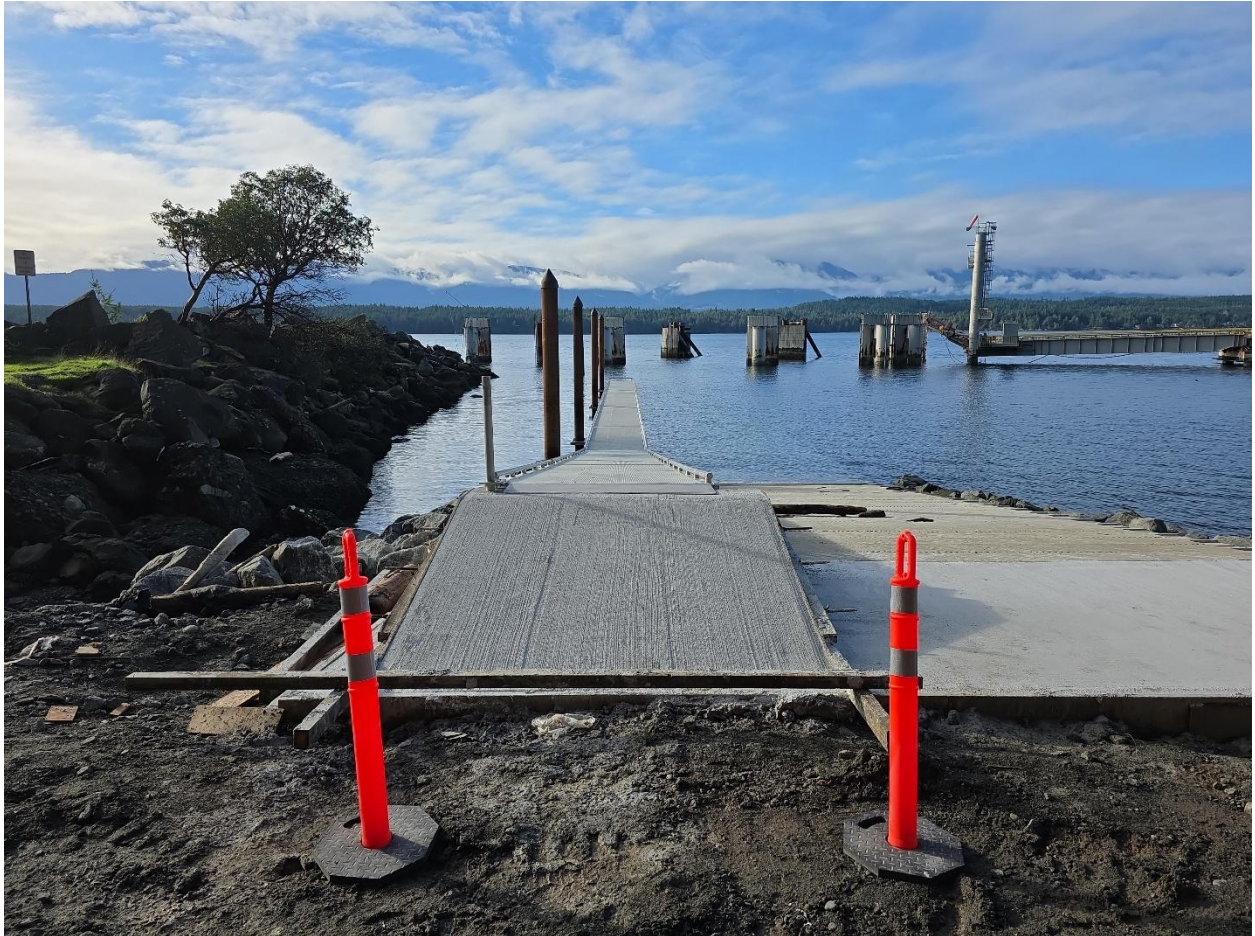
Photo 7. Showing recently cured concrete at the top of the ramp as well as the transition area that needs to be filled in.

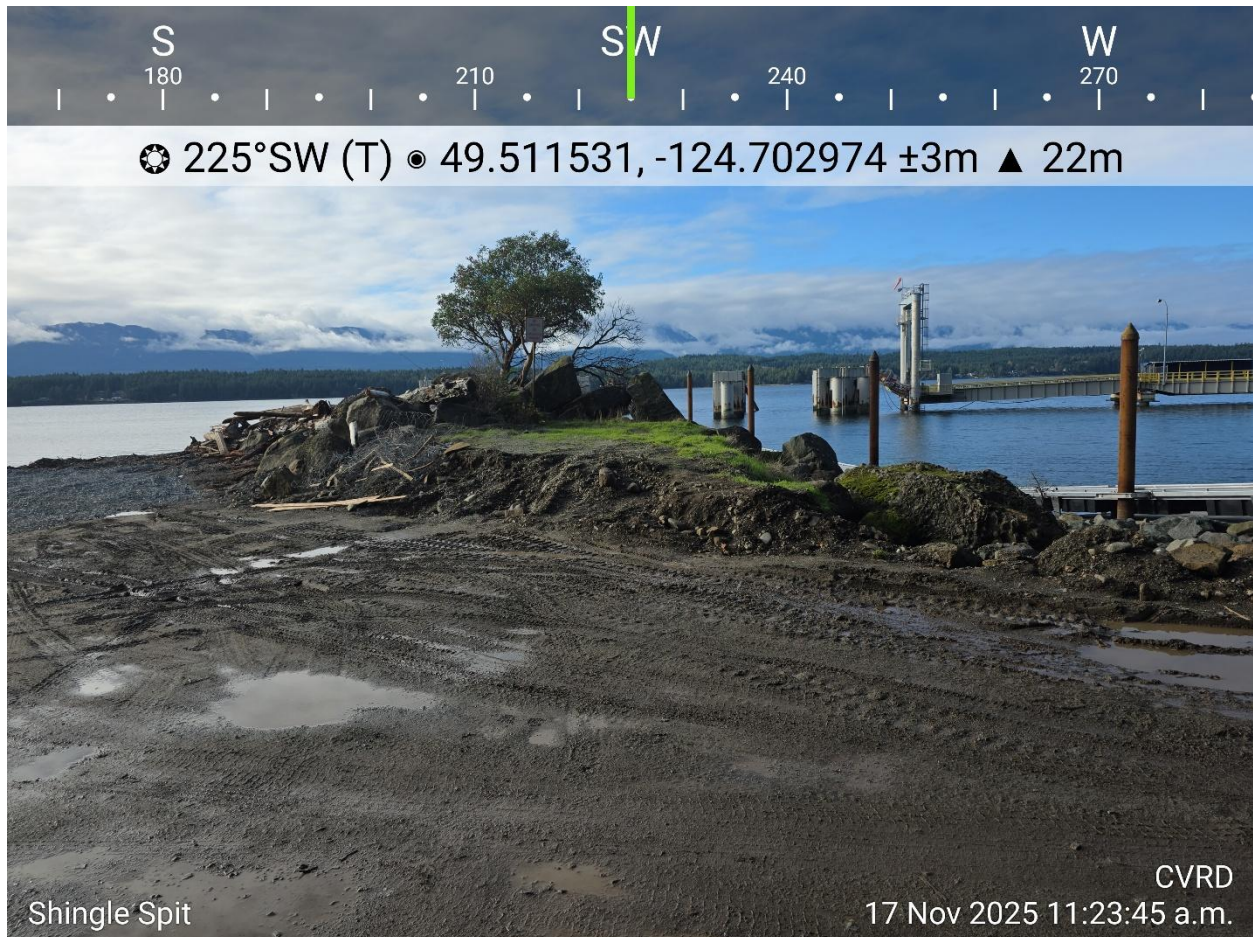
Photo 8. Showing cut-slope at the landward end of the breakwater that should be grass seeded. Also note the waste fencing at center left that should be cleaned up. The pile of beach wood behind the fencing, as well as another small pile at the south side of the parking/barge landing area, should also be distributed in a “natural” configuration across the foreshore.
