Shoreline Stability Assessment: Anson Rd Property, Horton Bay, Mayne Is

prepared for: The Capital Regional District
prepared by: John Harper, P.Geo., Coastal & Ocean Resources
Paul de Greeff, Murdoch de Greeff Inc. Landscape Architects

Summary

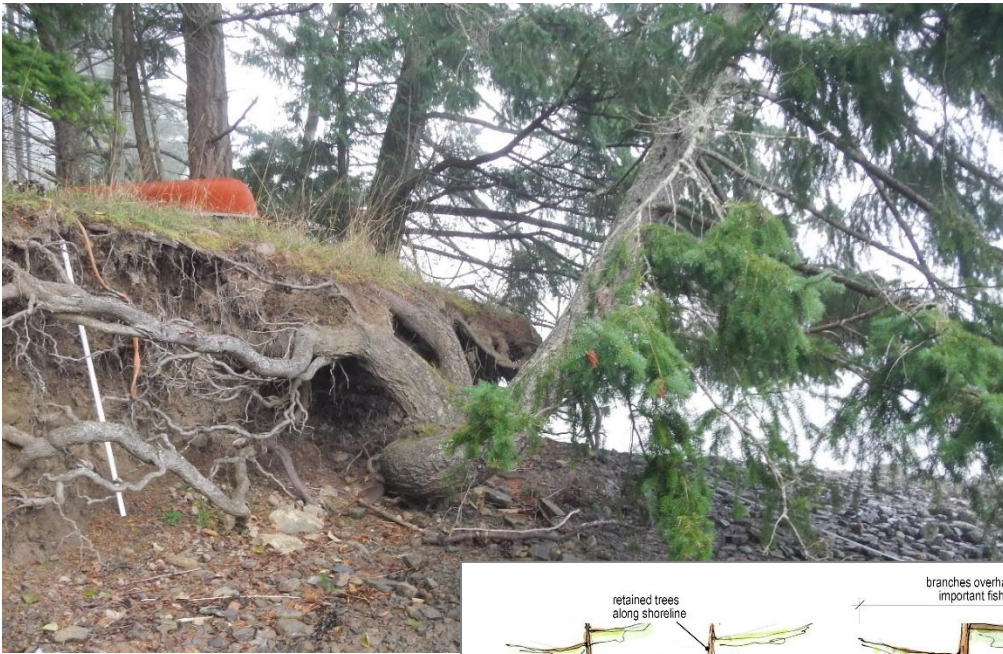
A representative photo of the eroding sea cliff at the Anson Rd property showing trees protruding from the cliff face. The cliff height is approximately 1.5m at this location. Note the coarse pebble-cobble veneer on the beach face (8 Nov 2019).

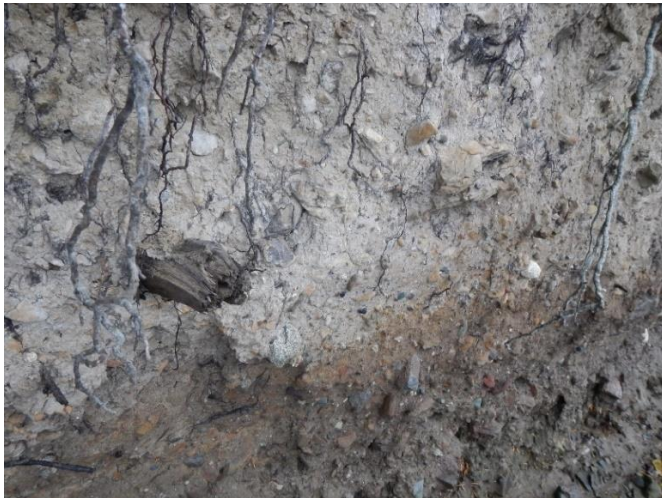
the west of the right of way. The cliff was bare sediment from about the 15-m marker and beyond the 50-m marker to the west. The sediment exposed in the cliff is a silt-clay matrix with pebble-cobble and boulder-sized rocks within the matrix (Fig. 3). Some larger pieces of shale bedrock (boulder-sized) were observed. Wood pieces were observed protruding from the cliff face in places (Fig. 3) suggesting that the material is possibly landfill that was excavated from the slopes above during landscape leveling. There is anecdotal evidence that the site, including property to the west, of the right-of-way was a log dump at some point in the past (M. Dunn, Mayne Island Conservation Society, pers com, 2019).

Figure 3. Close up photo of the cliff face. Note that many of the pebbles and cobble within the matrix are quite angular, which is not typical of a glacial till. Note also the large piece of wood protruding from the cliff; this wood did not appear to be a root but rather a trunk or branch. These observations point to excavated glacial till mixed with bedrock fragments that was pushed over an existing shoreline slope. The darker material to lower right may be the original till deposit at the site (photo collected to the west of the Anson Rd right-of-way).

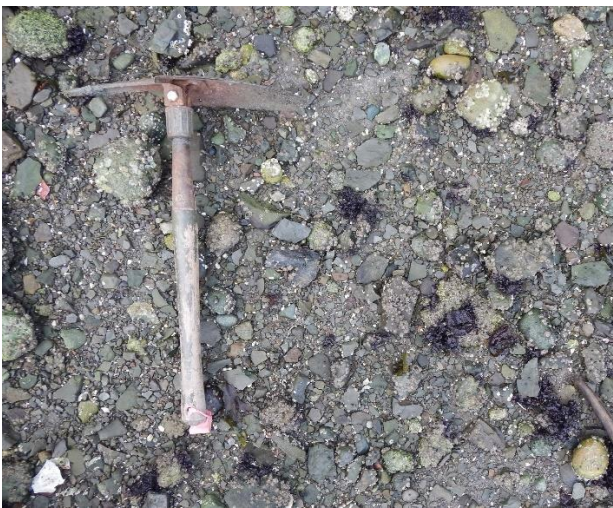
Figure 4a. Photo of typical beach surface showing pebble-cobble veneer.

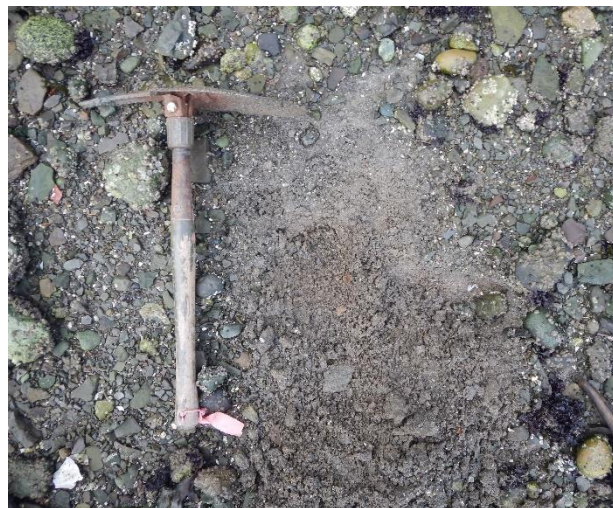
Figure 4b. Photo of same area with surface veneer of pebbles scraped away. Note the predominantly sand substrate in the immediate sub-surface.

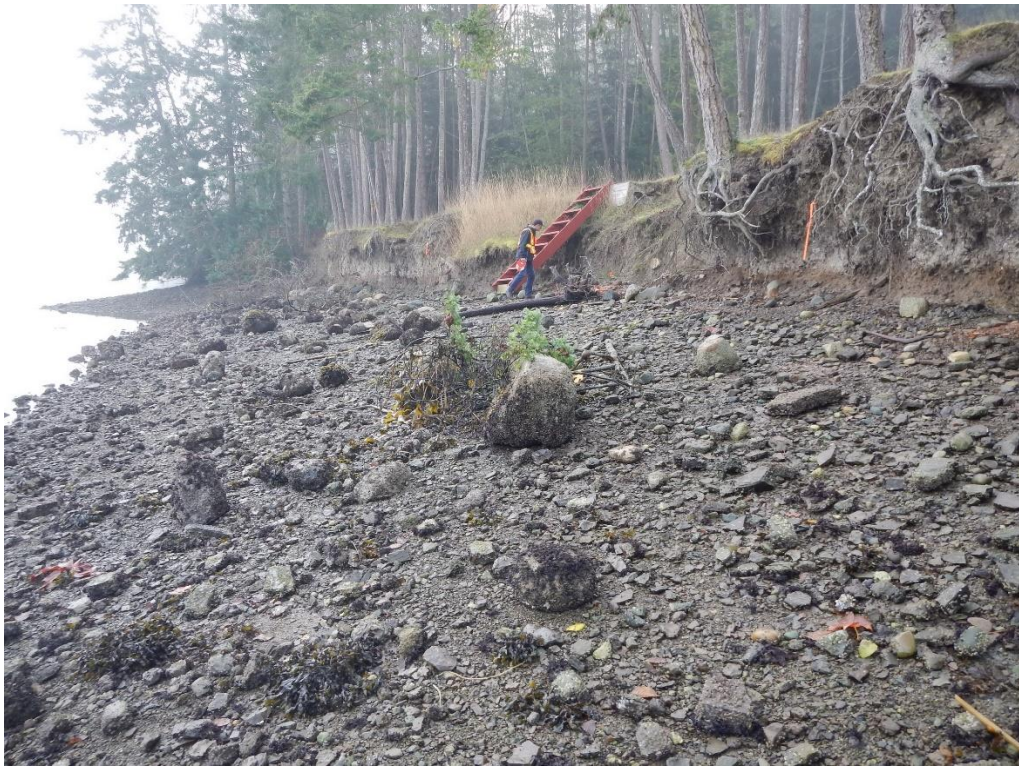
Figure 5. Glacial erratic boulders (>26 cm in diameter) on beach to the west of the Anson Rd property.

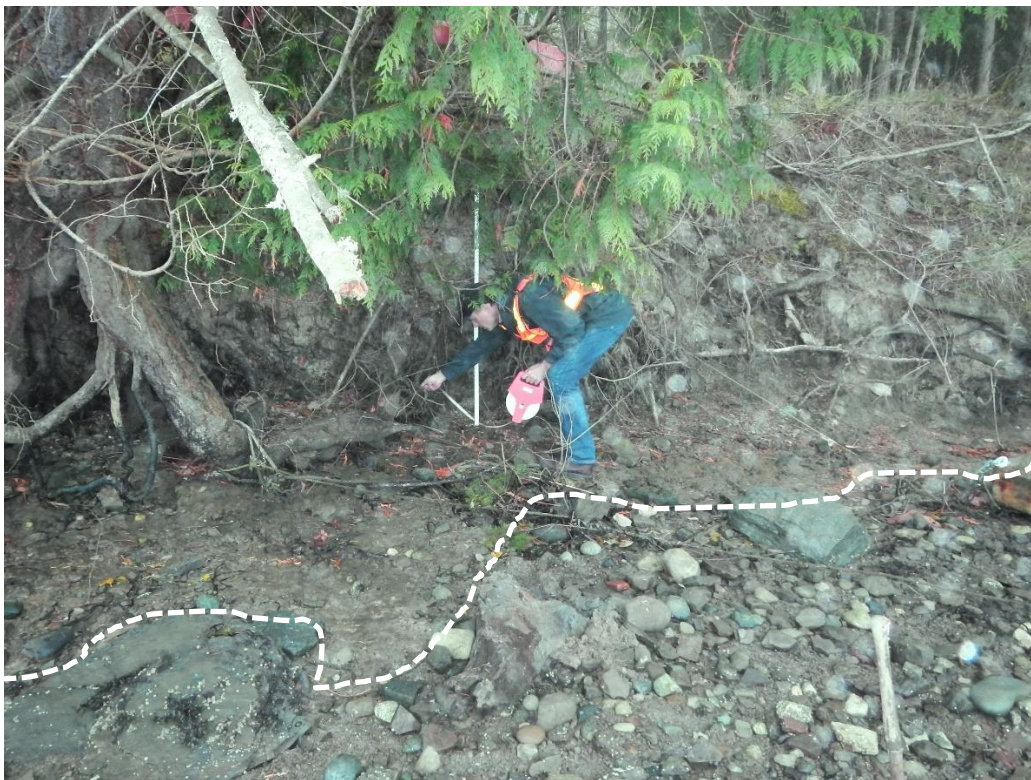
The shoreline is almost straight except for a protuberance or “nose” in the 10 to 40 m area of the survey. The beach is more or less uniform in composition along the shore with a pebble-cobble veneer over a mixture of sand-pebble-cobble (Fig 4). Occasional boulders (glacial erratics) were observed on the beach (Fig. 5). There is a stiff clay layer near the base of the cliff around Sections 25 m to 40 m (Fig. 6) and this stiff glacial-marine clay extends out 1-2m onto the upper beach near the “nose” of the cliff (Fig. 6); the clay layer may be the reason that the nose is there (more resistant to erosion).

Figure 6. A photo of the cliff base near the 35-m mark. The dotted line indicates the approximate seaward limit of the stiff clay outcrop that occurs near the “nose” of the Anson Rd right-of-way.

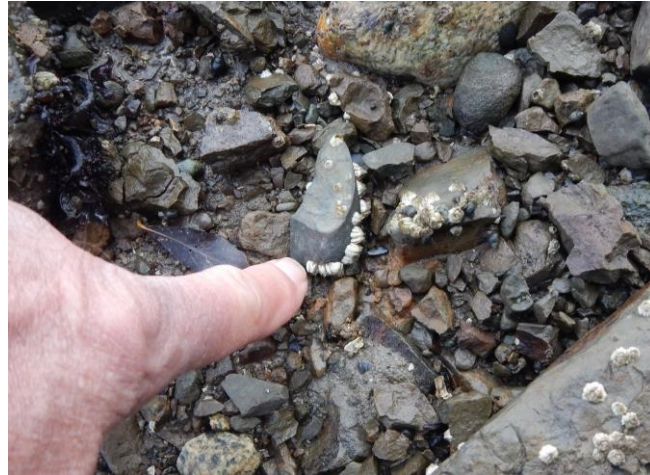
The site is a low exposure site. Maximum wave fetches to the site are <1 km (from east) and the convoluted, narrow channel between Mayne and Curlew Islands prevents larger waves from the Strait of Georgia from reaching the site. Barnacles, which need a stable substrate on which to grow, are present on very small pebbles, suggesting that these pebbles are not rolled around very often (Fig 7).

Figure 7. Photograph of small, 5-cm, pebble with attached barnacles. The very angular nature of the pebble and the attached barnacles suggest that this is a very low energy site and sediments are not reworked very often by wave or tidal currents.

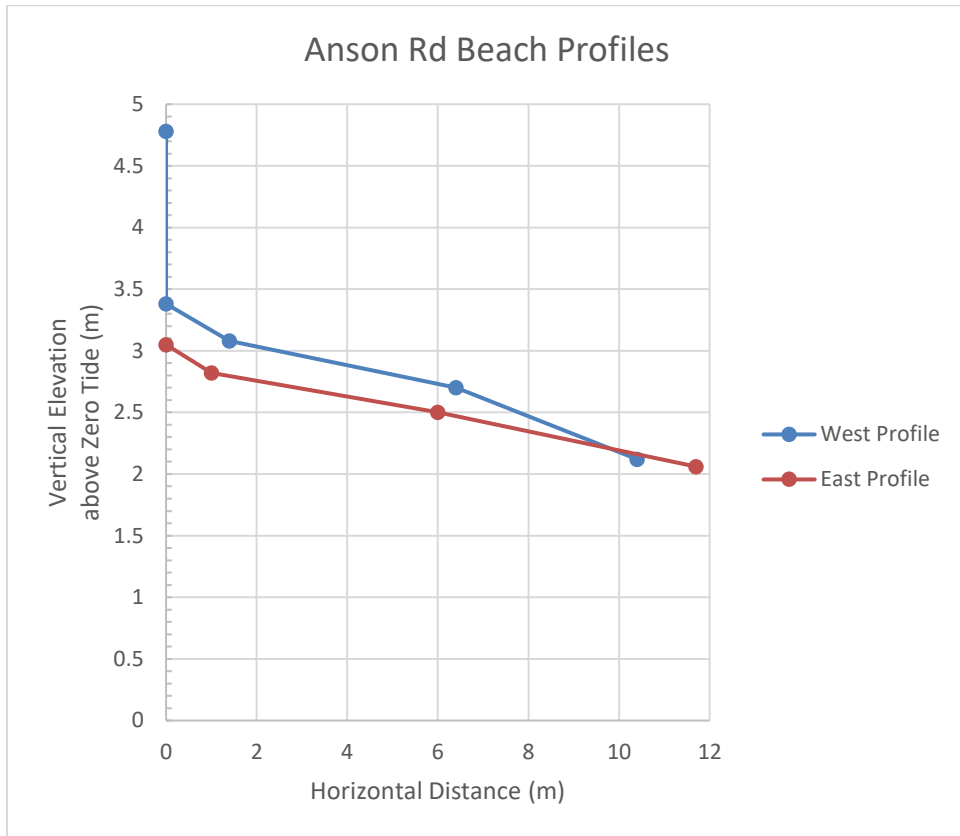
Two beach profiles were surveyed at the site (Fig. 8) to show differences in the beach slope of the “nose” of the property, which is the location of the proposed walkway, and the area to the east of the nose. The slope of the eastern beach is 4.8° and the slope of “nose” beach is 6.6°, so about 2° greater slope on “the nose”.

Figure 8. Across-shore beach profiles showing the beach slopes of the West (at approximately 27-m Section; refer to Fig 1 for location) and East (at approximately the 5-m Section; refer to Fig.1 for location) profiles. The beach is slightly steeper on the “nose” of the property (West Profile) than the adjacent eastern portion of the property. The cliff face at the West Profile is 1.4 m high and is slightly undercut at this location (Fig. B-5).

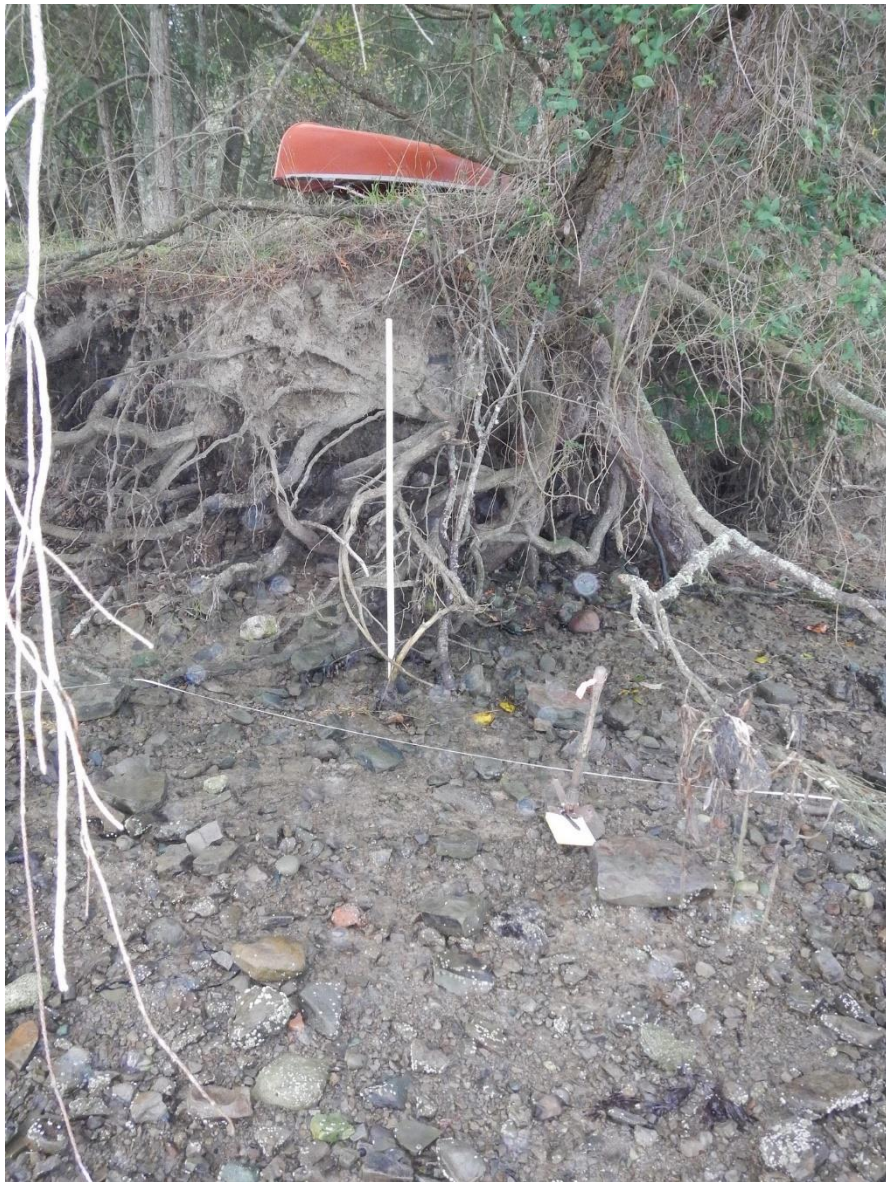
30	1.8	10	“nose” of shoreline w large Douglas Fir and roots protruding from bank; scarp is undercut so there is an overhang; there is a stiff clay layer outcropping on the upper beach (~2m in width); the lower portion of the visible beach is angular to sub-angular pebble-cobble veneer over sandy gravel (Fig. B-5).
40	1.9	11	Poorly-sorted diamicton noted on scarp face with pebbles and cobble within a fine matrix; a large Douglas Fir (~75 cm dia) is protruding from the cliff face; beach is a cobble-pebble veneer over sandy gravel; cobbles are generally well-rounded suggesting a glacial till origin (Fig. B-6).
50	2.5	4.5	The scarp here is cut into mostly fine material with some pebbles, cobbles and boulders visible; trees above the scarp have been de-limbed (lower branches removed); The beach has a coarser veneer than other stations (Fig. B-7) – well rounder cobble-pebble, probably of mostly glacial origin; property boundary marker seen just about the 50m in drone photo (Fig. A-6).

Figure B-5. Section 30-m, “the nose” looking upslope. Note outcropping clay layer near trunk and plate-shaped cobbles on beach.
