BEECHWOOD

January 12, 2021

Updated, January 25, 2021

Re: Lot 1, 375 Village Bay Road, tree assessment of significant trees

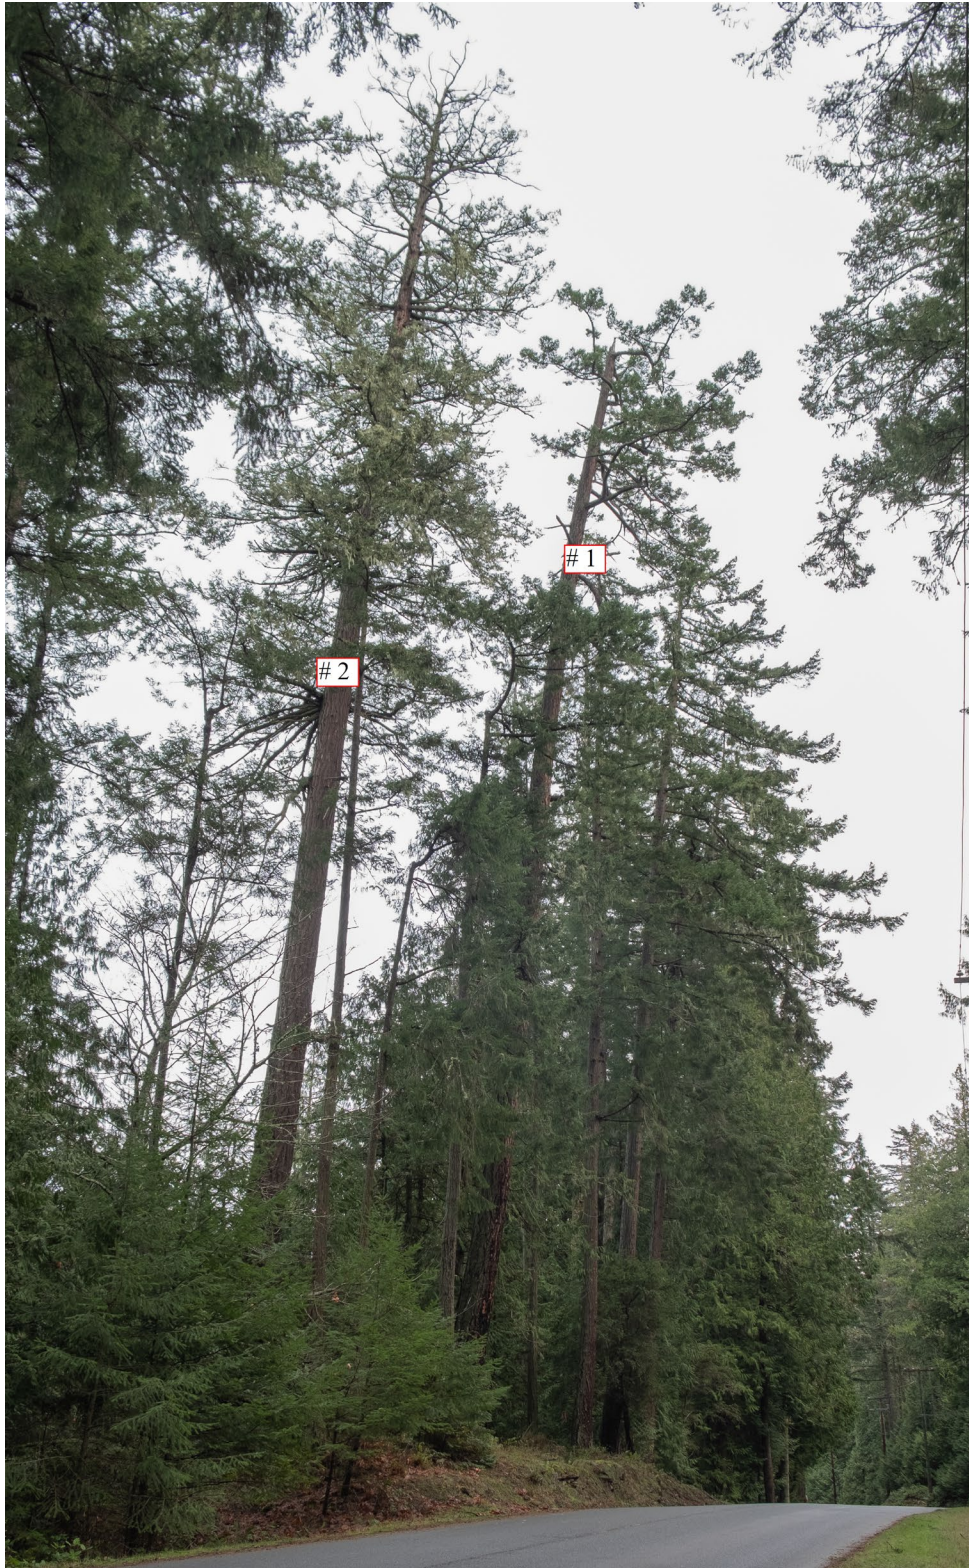
Tree # 1: Douglas fir with a trunk diameter at breast height (DBH) of 142 centimeters and a height of 42 meters. It is located adjacent to the road at the southeast corner of this lot. The tree is in fair health with normal foliage colour, size and density; foliage is limited to the upper canopy. The top of the tree broke off in the past. The tree has a slight lean toward the south southeast; no indications that it shifted recently.

A past forest fire has scarred the bark, on the lower trunk, on the roadside (south). There are horizontal cuts in the bark on the east and west side of the trunk, about 1.5 meters up. It is likely from hardware attached to the trunk in the past. I also found a couple of old scars on the trunk 0.5 meters above ground on the west and south side. I found no visual signs of root rot

I was concerned that the external defects extended into the trunk. To verify or disprove this, I drilled the area with a Rhinntech Resistograph®¹ to determine if internal decay or defects was present in the trunk; none was found. The external defects impact on structural integrity is minor.

Tree # 2: Douglas fir with a DBH of 155 centimeters and a height of 53 meters; it is adjacent to tree number one. It is in poor and declining health. The foliage size is normal; the foliage colour is dull green. The foliage density is sparse, particularly in the upper canopy, where there is little to no live foliage.

I found no visual indication of the trunk or root decay. I drilled the trunk to determine if there is internal decay, none was found. The tree is still structurally sound; the risk of tree failure within the next three years is improbable.

Trees number one and two as seen from the southwest

This tree can be preserved, the risk of tree failure within the next three years is improbable², the most likely parts to fail are branches; this is common on Douglas firs. This is a large tree requiring a very large tree protection zone. I recommend that the TPZ (tree protection zone) extends 15 meters out from the trunk (see map).

If the tree continues to decline, it will likely die. Application of water during the summer months would improve its chances of survival. If the tree dies, it should be removed or turned into a wildlife tree. If the desire is to preserve this tree, the TPZ should extend 18 meters out from the trunk (see map).

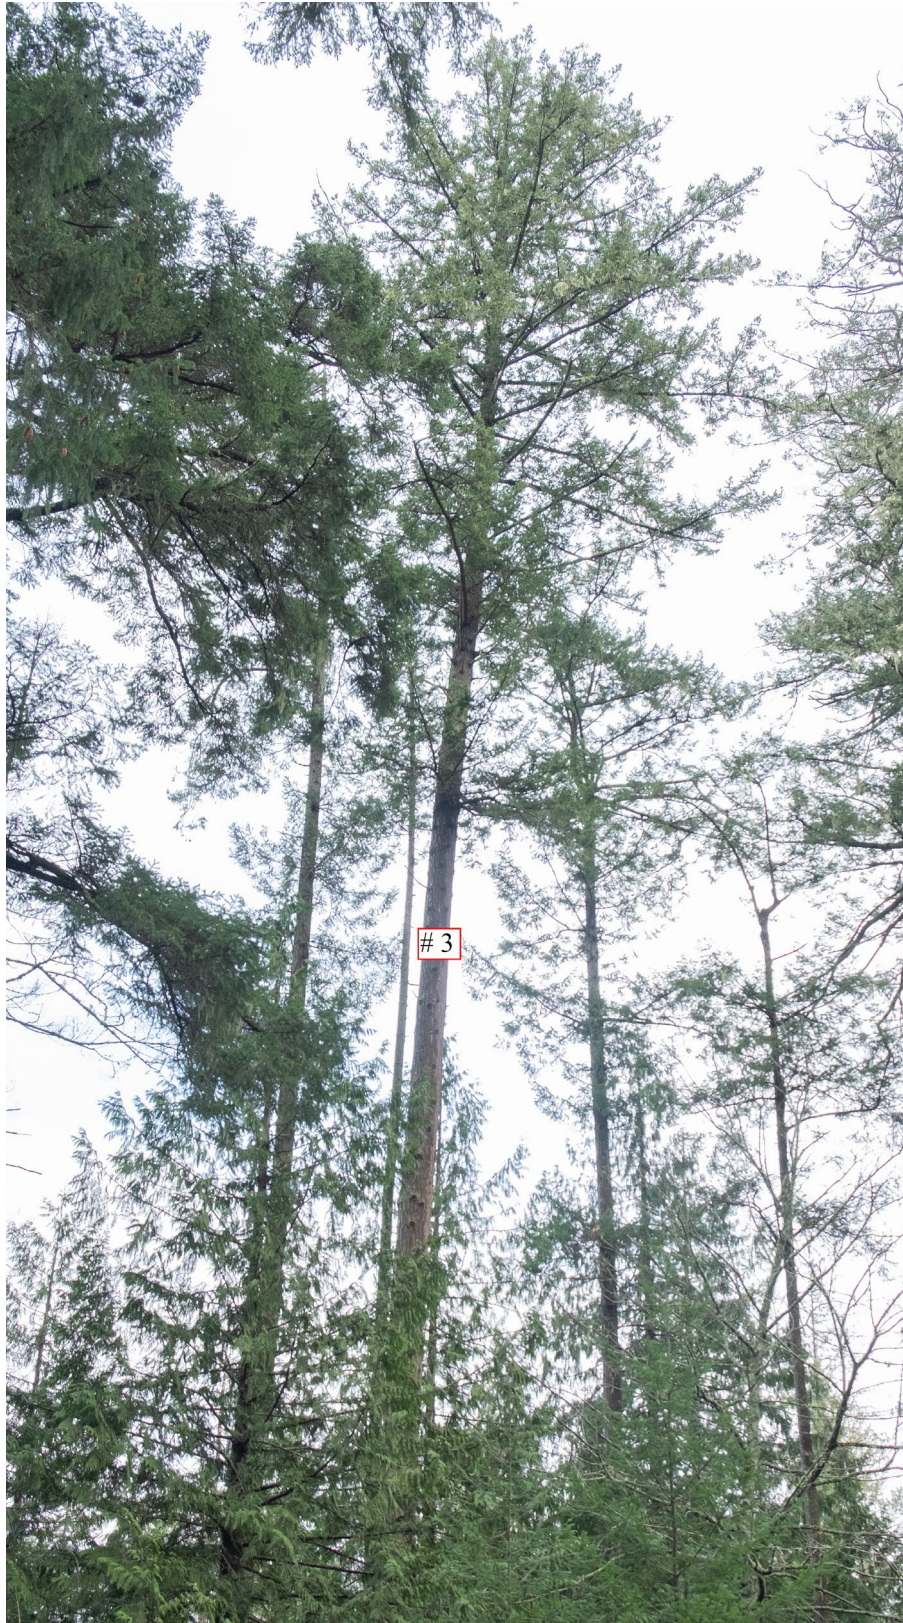
Tree # 3: Douglas fir with a DBH of 105 centimeters and a height of 50 meters. It is situated at the south end of the lot. It is in fair health with normal foliage size; density is a bit sparse, and foliage is a dull green. I found no major defects in this tree.

The tree is structurally sound; the risk of tree failure within the next three years is improbable. To preserve this tree, the TPZ should extend 9 meters out from the trunk (see map).

Tree number three as seen from the south

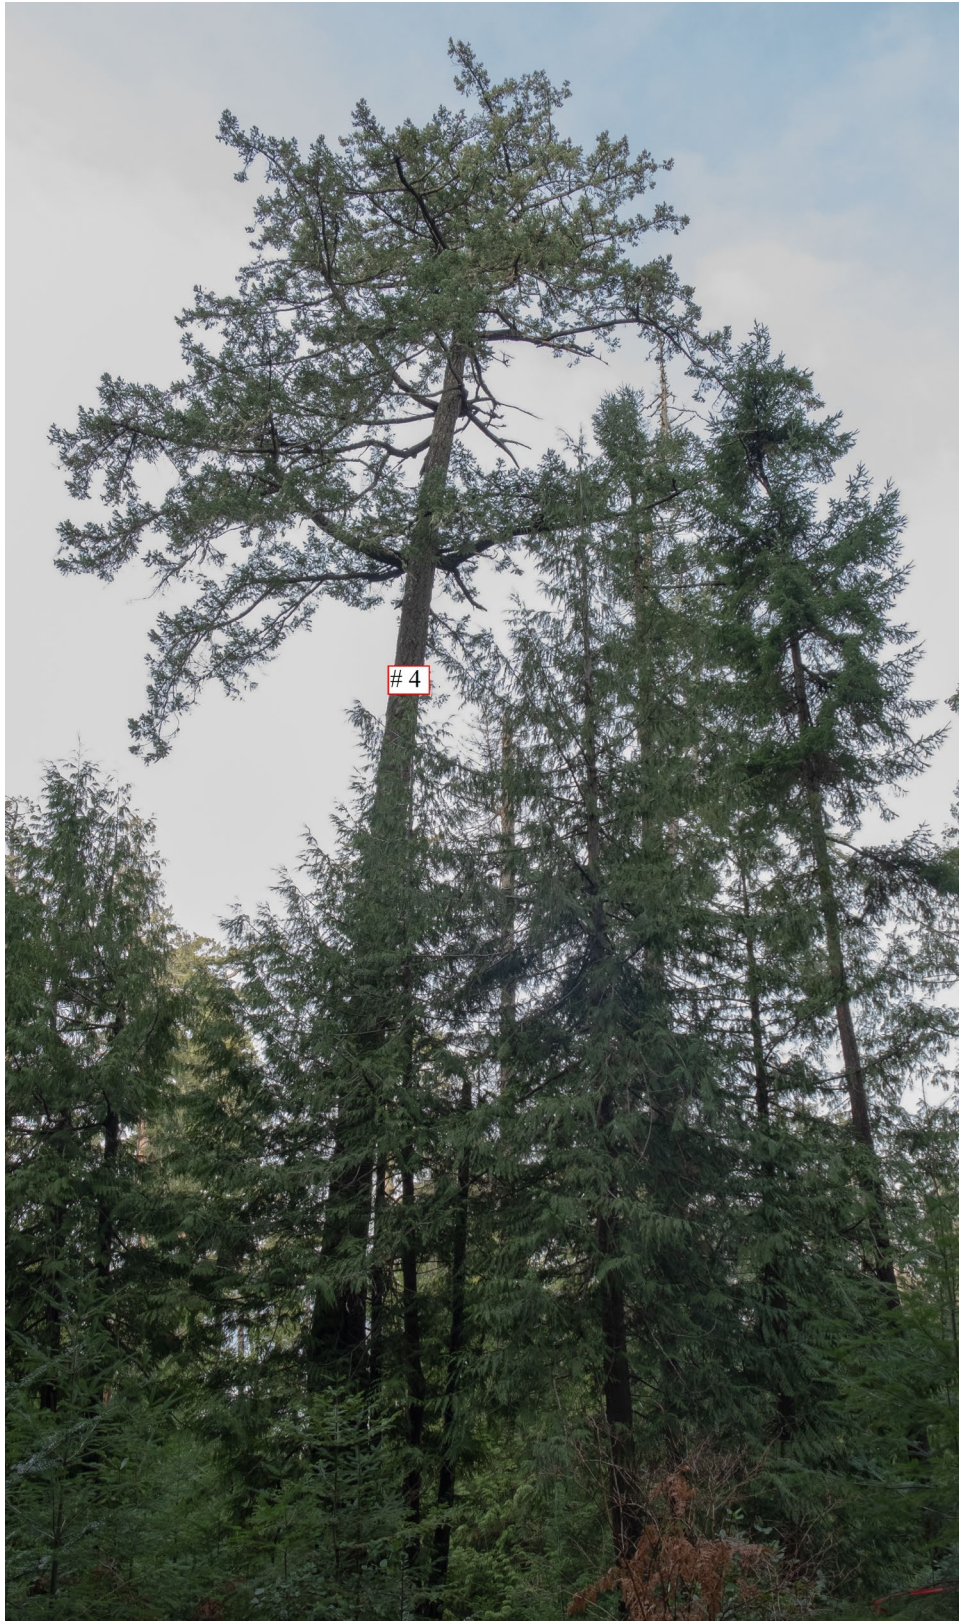
Tree # 4: Douglas fir with a DBH of 128 and a height of 30 meters, situated in from the road on the southwest corner of the lot. It is in fair health with normal foliage size; foliage colour is near normal, and foliage density is slightly sparse. The tree has a slight lean toward the northeast, and the trunk has a bow in the lower trunk and partway up; all minor issues. The canopy has some dead and dying branches throughout.

The lower trunk looks bedraggled; there are fire scars, bulges, swellings and minor sap flow from the trunk. I thoroughly inspected the lower trunk to determine if these surface defects extended into the trunk, possibly affecting this area's structural integrity.

I drilled the lower trunk in three places and drilled the two largest anchoring roots to determine if there is internal decay. I found no internal decay in the places I drilled. The lower tree trunk is structurally sound. The likelihood of tree failure within three years is improbable.

Tree number four as seen from the south

I recommend removing the dead and dying branches to prevent them from falling onto people and property below. To preserve this tree, the TPZ should extend 10 meters out from the trunk (see map). If the other trees in the protection zone will be removed, they should be cut at ground level, leaving the stumps intact. Removal of stumps could make this tree unstable.

Amendment Jan 25, 2021: The TPZ can be oval or offset slightly to provide enough space for the planned road between the tree and the west property line. It is essential to stay at least 7 meters away from the trunk, as closer could increase the risk of tree failure.

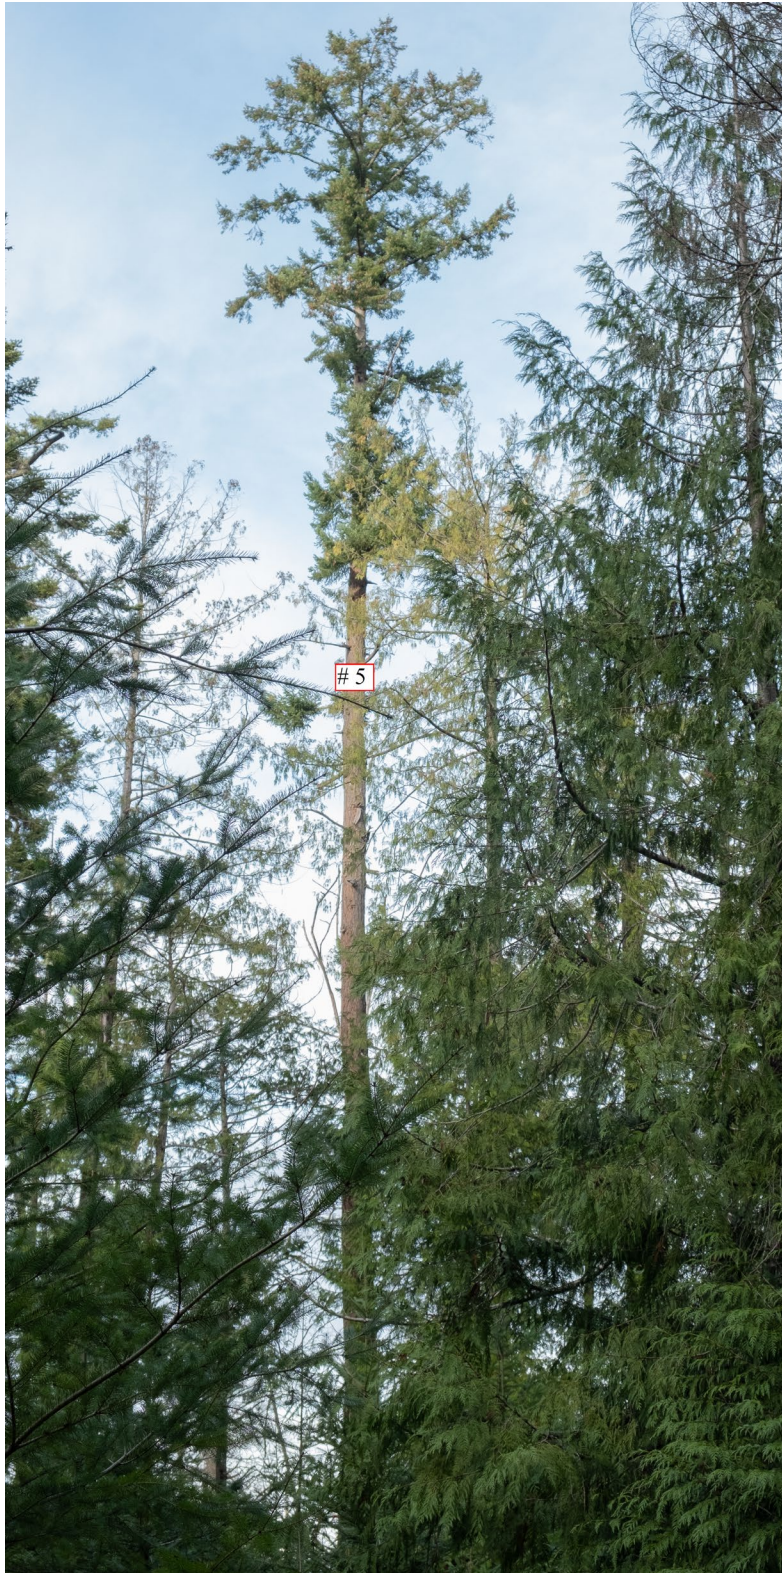
Tree # 5: Douglas fir with a DBH of 103 centimeters and a height of 46 meters. It is in average health with normal foliage colour, density and size. The lower trunk has a moderate bow, and the tree has a slight lean toward the east. I found minor sap flow from the southwest side of the lower trunk. The bow, lean and sap flow are minor issues at this point.

I found no signs of trunk, or root decay. The likelihood of tree failure within three years is improbable. To preserve this tree, the TPZ should extend 8 meters out from the trunk (see map).

Tree number five as seen from the south

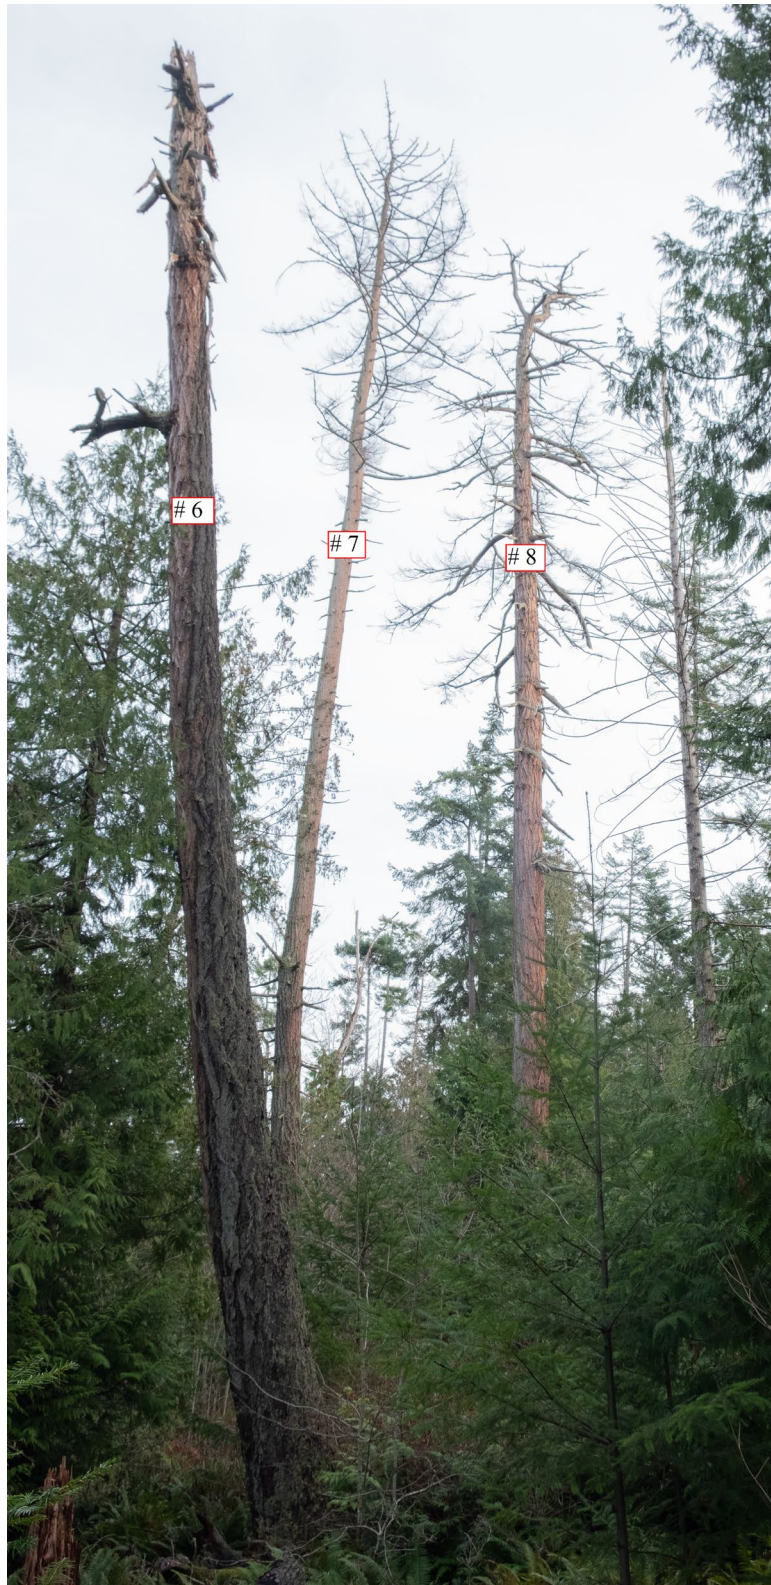
Tree # 6: Dead Douglas fir with a missing top. It has a DBH of 115 centimeters and a height of 24 meters and is situated to the east of tree number five. The trunk has a significant lean toward the north. I found extensive external and internal decay in the trunk and anchoring roots.

This tree can fail (fall over) at any time; when it fails, it will fall in the direction of the lean. It is an excellent wildlife tree that can be left, providing that people do not trespass into the fall zone. Installation of infrastructure or trails to the north of the tree should be at least 30 meters away from the tree.

Tree # 7: Douglas fir that died recently with a DBH of 92 centimeters. It is 41 meters tall and located just to the east of tree number six. The lower trunk has a bow in it. The tree trunk is in the initial stages of decay; the impact on structural integrity is minor at this point.

Tree # 8: Douglas fir that died recently with a DBH of 168 centimeters and a height of 46 meters. It is located to the southeast of tree number seven and 20 meters to the northwest of the new wellhead. The trunk still appears sound; structural integrity is starting to decline due to external decay.

Wildlife trees number six, seven and eight as seen from the east

I recommend topping this tree while it can still be safely climbed to function as a wildlife tree. The proximity of people and property should determine the height of the topping cut. Distance to people and property should be 1.5 times that of the remaining tree trunk. For example, if the closest building is 15 meters away, the tree should be topped at the height of 10 meters.

I recommend topping this tree while it can still be climbed safely to function as a wildlife tree; topping it at the height of 13 meters or less will prevent it from falling onto the new wellhead when it fails.

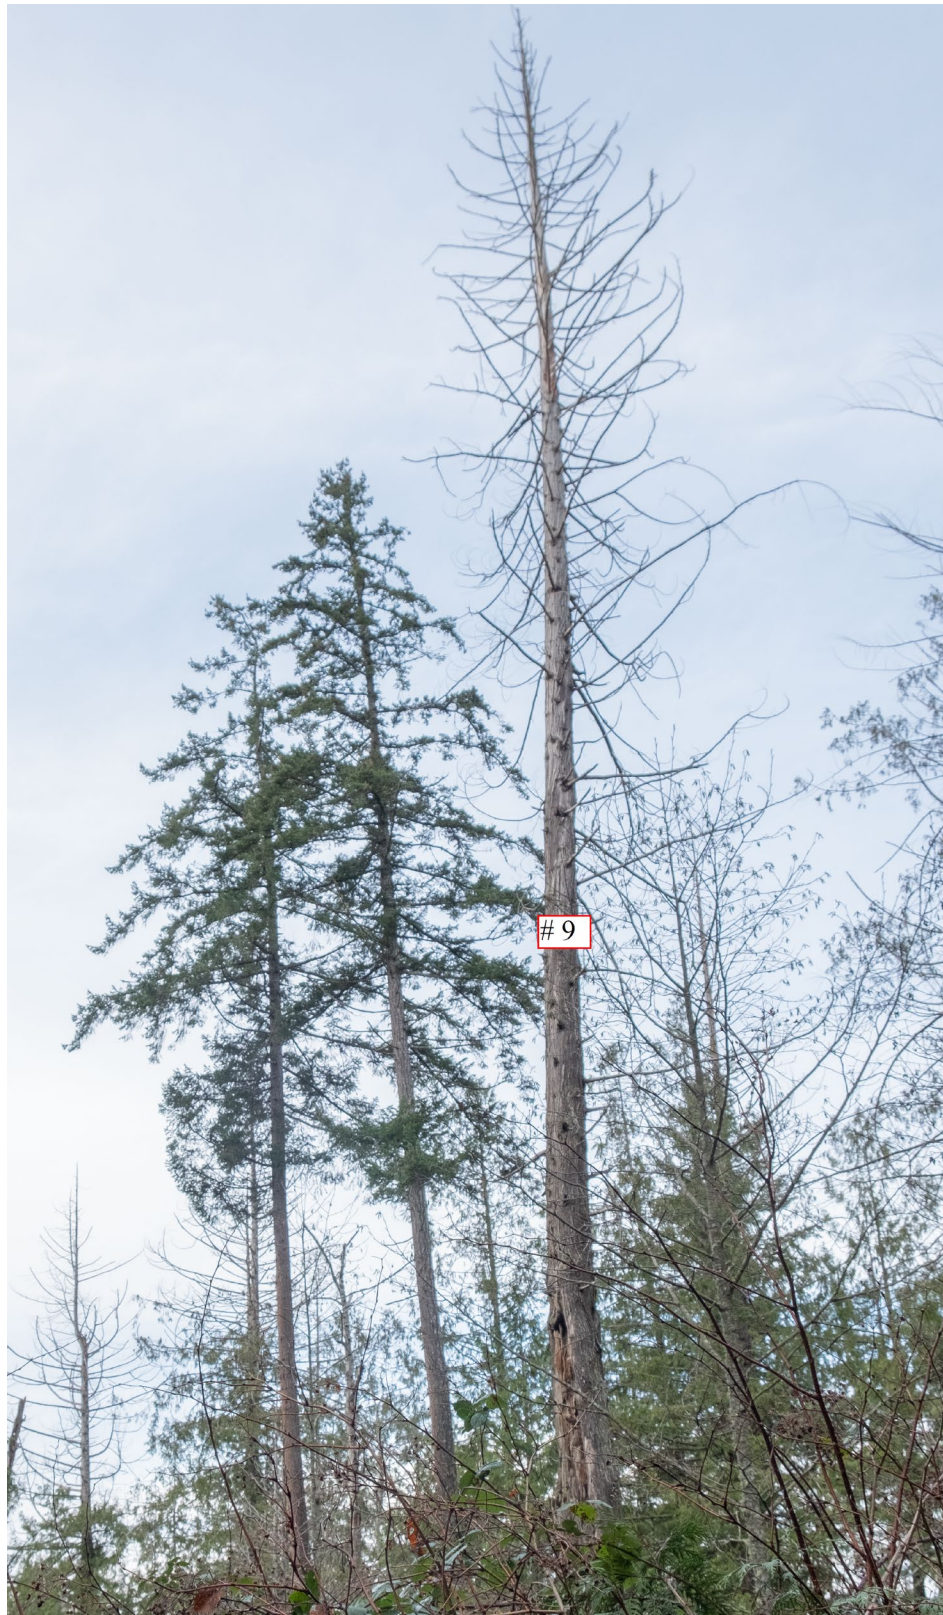
Tree # 9: Dead Western redcedar (*Thuja plicata*) with a DBH of 135 centimeters and a height of 36 meters with a lean toward the northeast. The trunk has a large wound from a past failure a few meters up on the southwest side.

The trunk has extensive internal and external decay and can fail at any time. It will most likely fall toward the northeast. I recommend removing this tree as it can fall onto neighbouring properties; it should be cut at a ground level as it is not safe to climb.

Wildlife tree number nine as seen from the southeast
