File No.: GB-DVP-2022.3 (Pink) X.ref:
GB-BE-2022.10 (Pink)

DATE OF MEETING: April 17, 2025
TO: Gabriola Island Local Trust Committee
FROM: Margot Thomaidis, Planner 2
Northern Team
COPY: Renée Jamurat, Regional Planning Manager
SUBJECT: Development Variance Permit – GB-DVP-2022.3 (Pink)
Applicant: Tom & Jeff Pink (Owners)
Location: 1160 The Strand, Gabriola Island

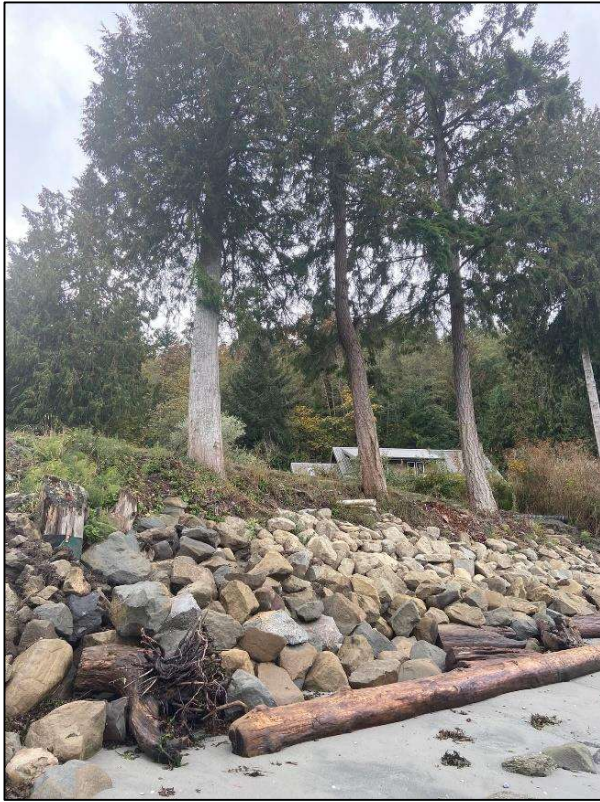
Western portion of revetment at 1160 The Strand

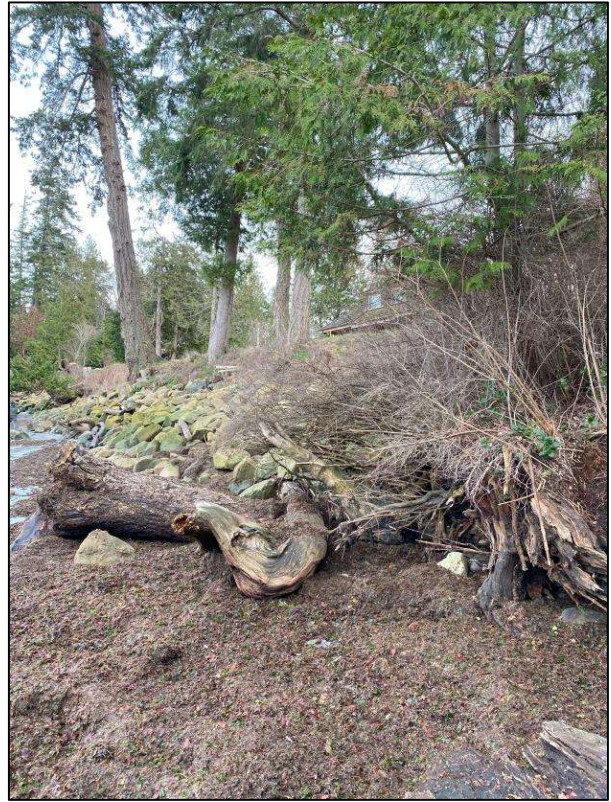
Western edge of seawall at 1160 The Strand

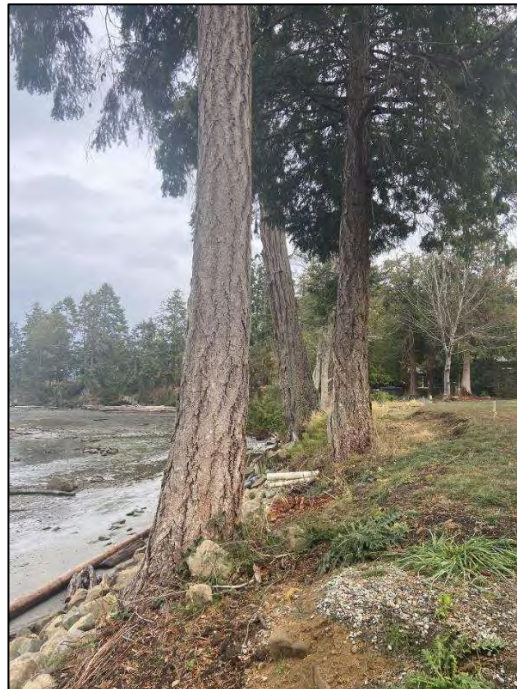
Top of bank at 1160 The Strand

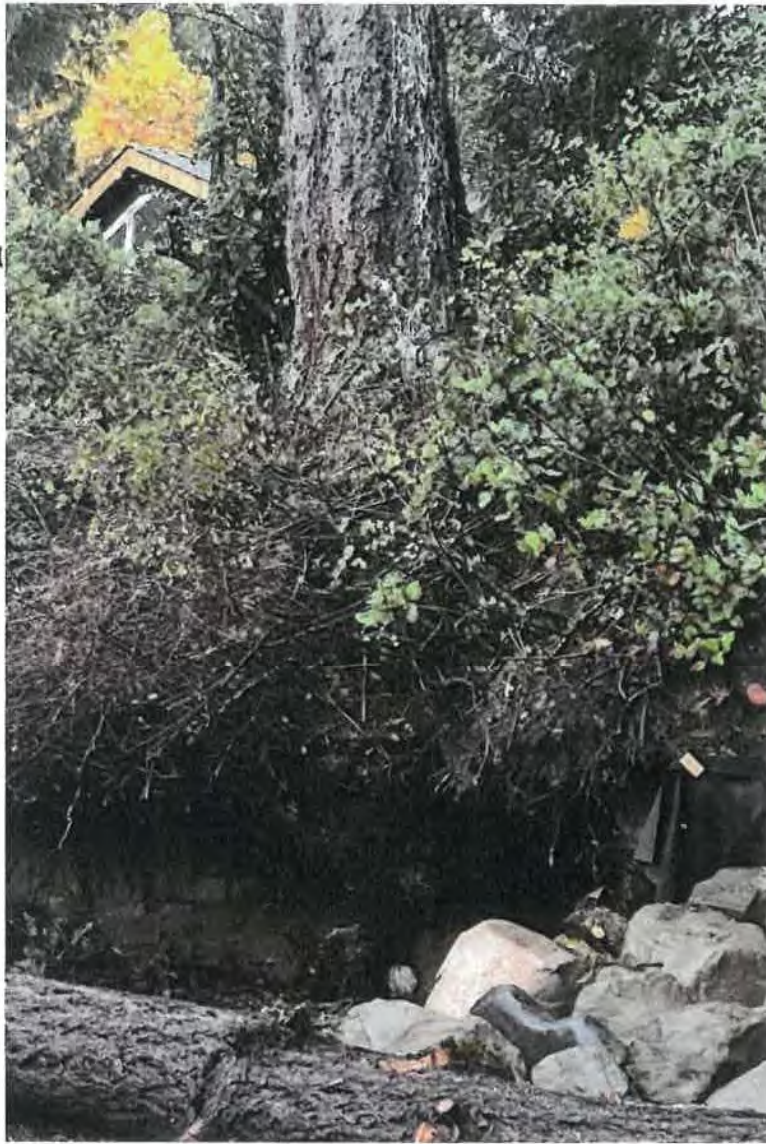
LARGE FIR TREE
ON LOT 4 BANK
HOLLOWED OUT
UNDERNEATH, WHICH
COLLAPSED IN THE
SPRING & HAD TO BE
CUT DOWN.

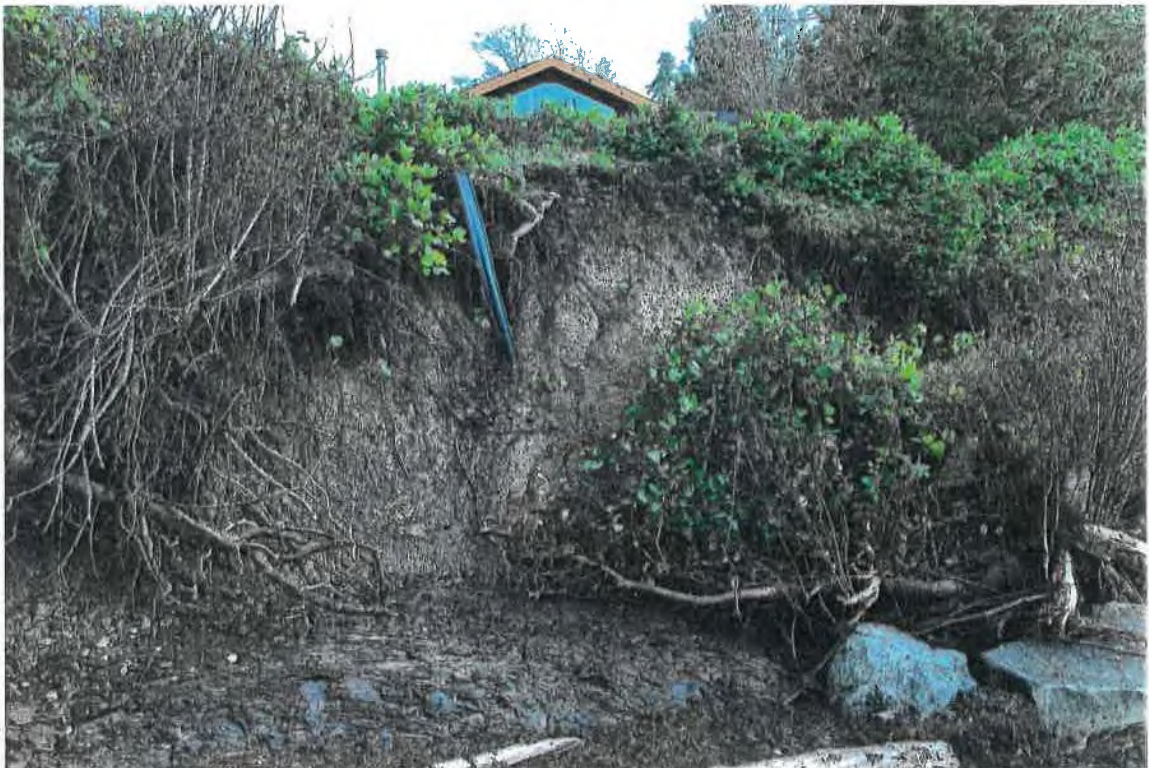
A LARGE SECTION OF
THE BANK ON LOT 4
WHICH COLLAPSED IN
SPRING '22

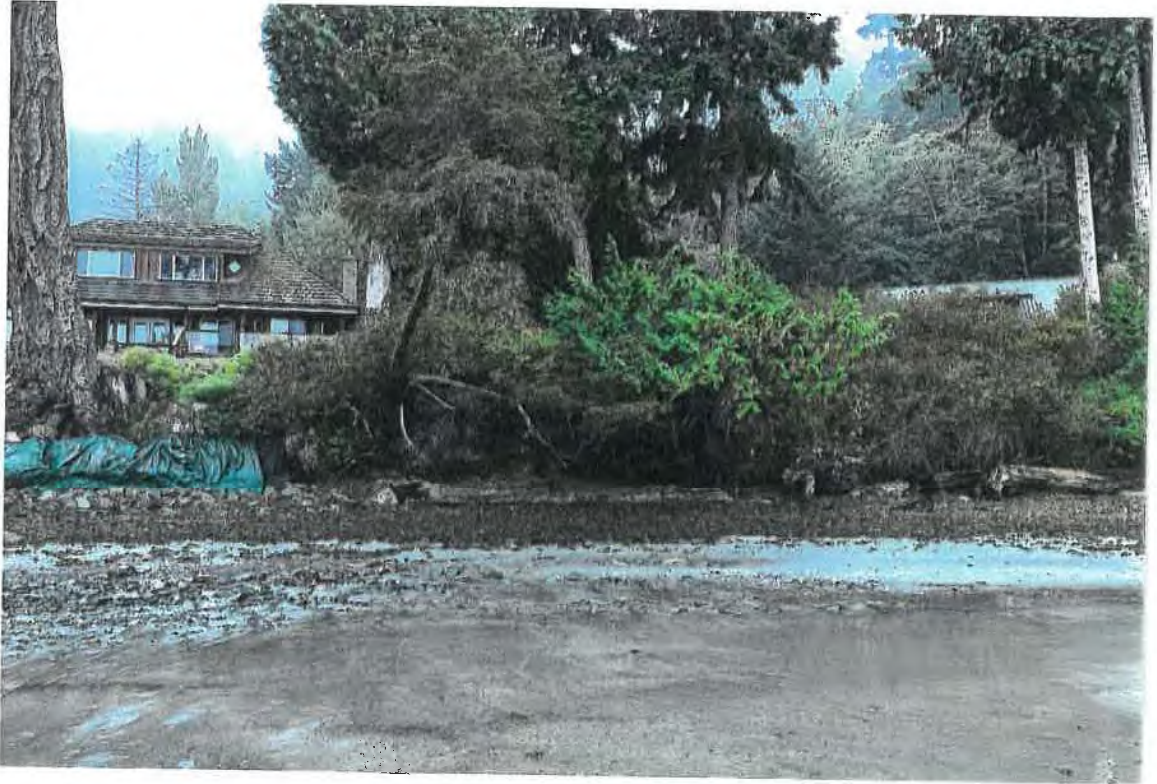
LOWER BANK ON LOT 5 BEING UNDERMINED AS SOFT CLAY AND SOIL IS CARRIED AWAY, EXPOSING ROOTS OF VEGETATION,

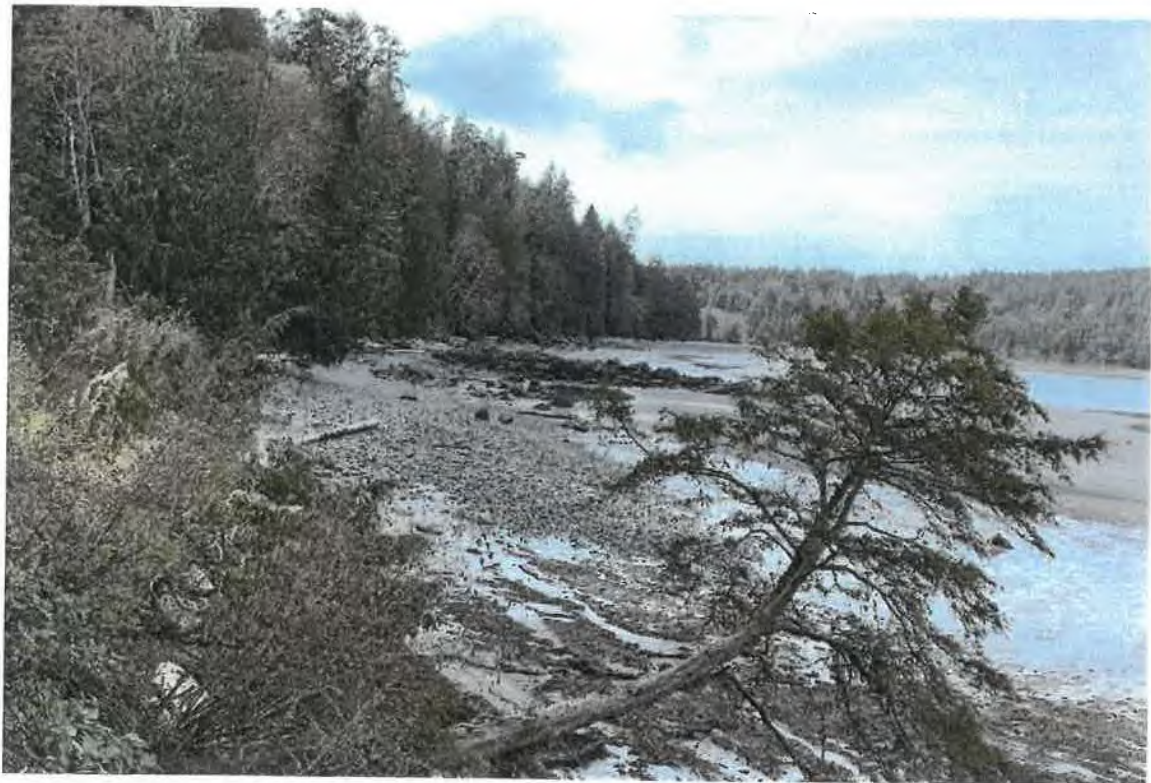
FIR TREE THAT WAS UNDERMINED AND FELL OFF THE BANK ON LOT 5 THIS SPRING '22.

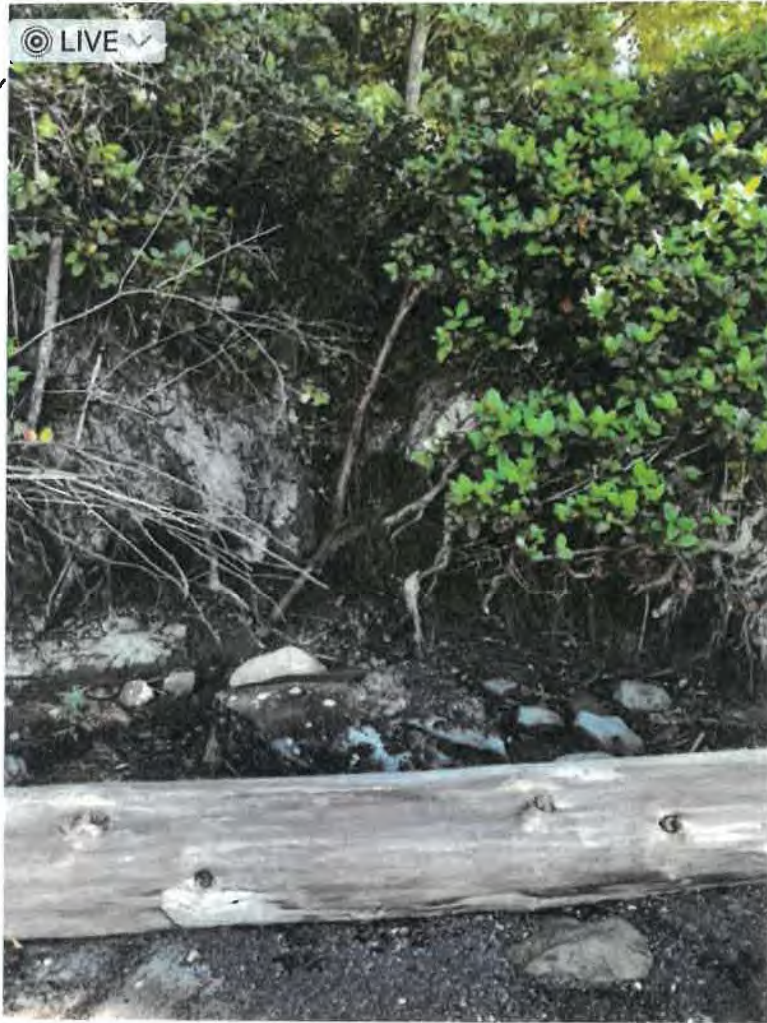
SOFT CLAY & SOIL
BANK BEING QUICKLY
ERODED ON LOT 5

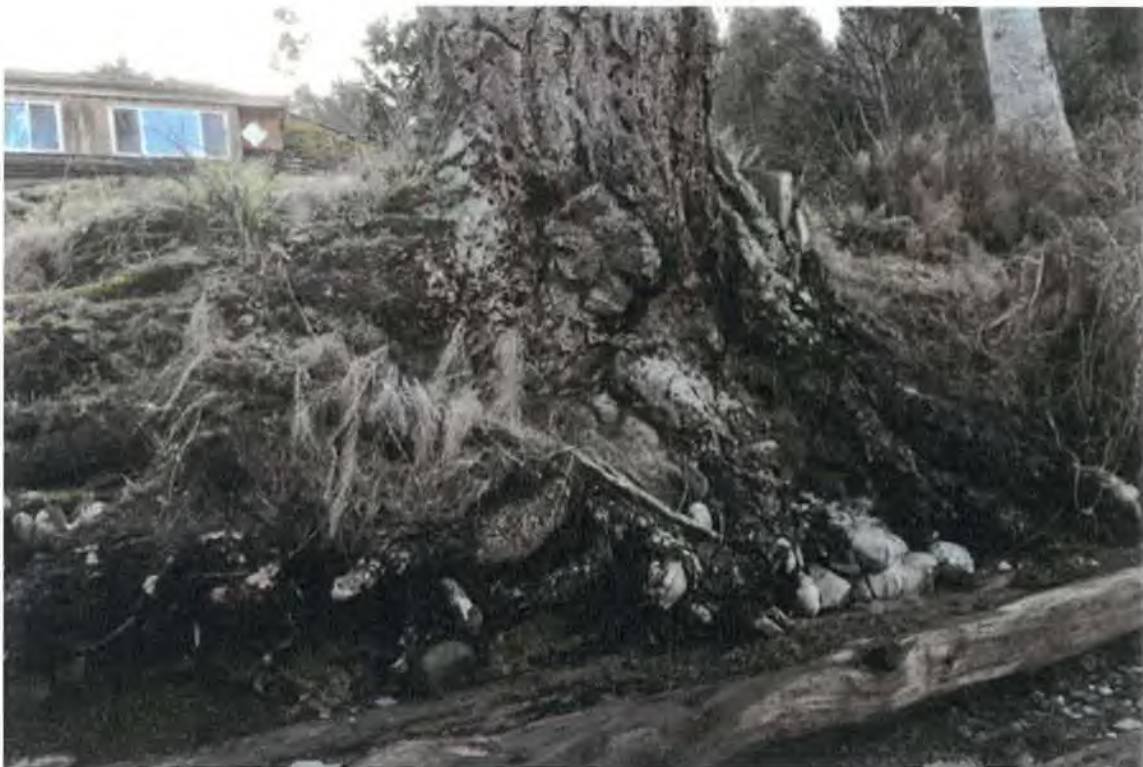
EROSION PROCESS
HOLLOWING OUT
UNDER MASSIVE
OLD GROWTH FIR
TREE ON LOT 5.

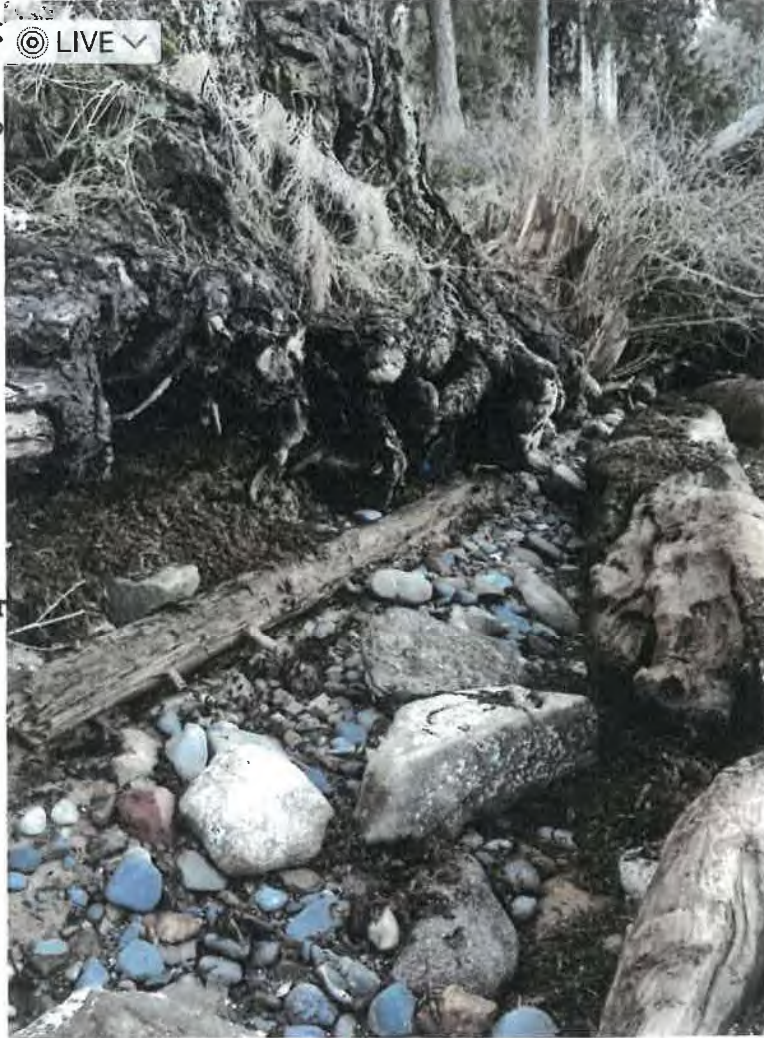
OLD GROWTH DOUGLAS
FIR ESTIMATED TO BE
ALMOST 300 YEARS OLD
BEING SEVERELY
UNDERMINED AND
BATTERED BY WAVE
ACTION AND LOGS.

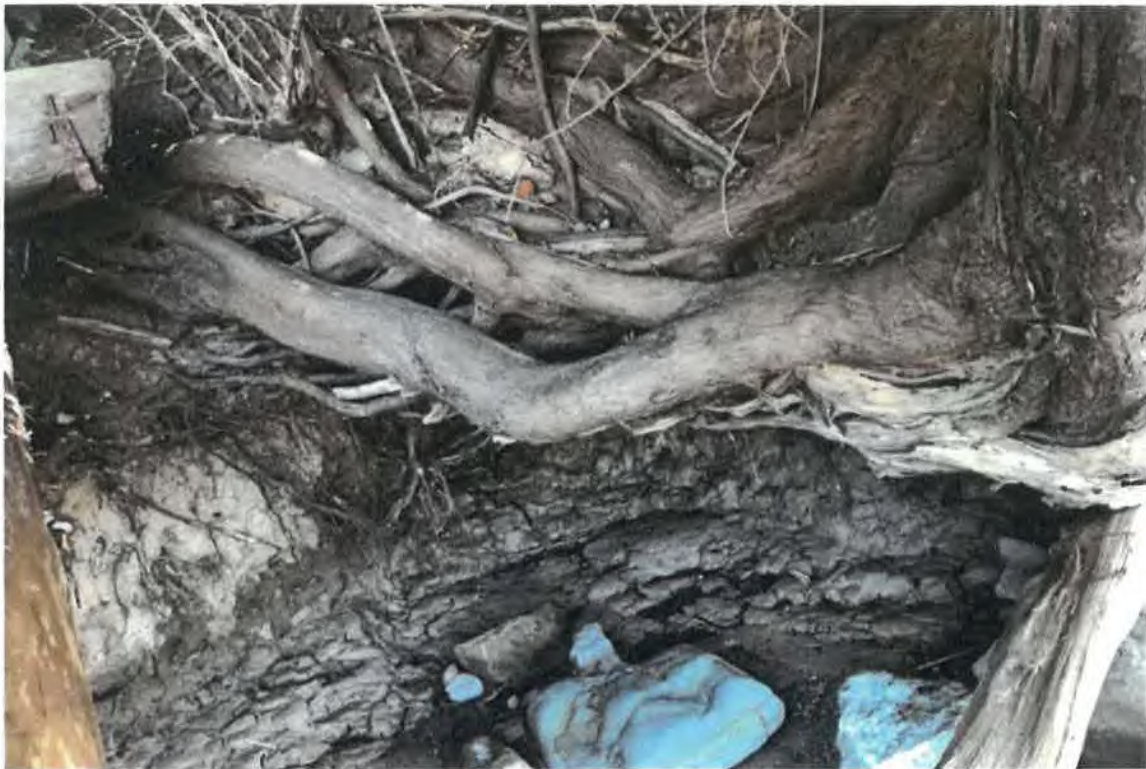
THE CERTAIN NEAR
TERM COLLAPSE OF
THIS MAGNIFICENT
TREE WOULD HAVE
RIPPED OUT A LARGE
PORTION OF OUR FRONT
YARD, EXPOSING THE
SOFT CLAY & SOIL TO
THE SALISH SEA.

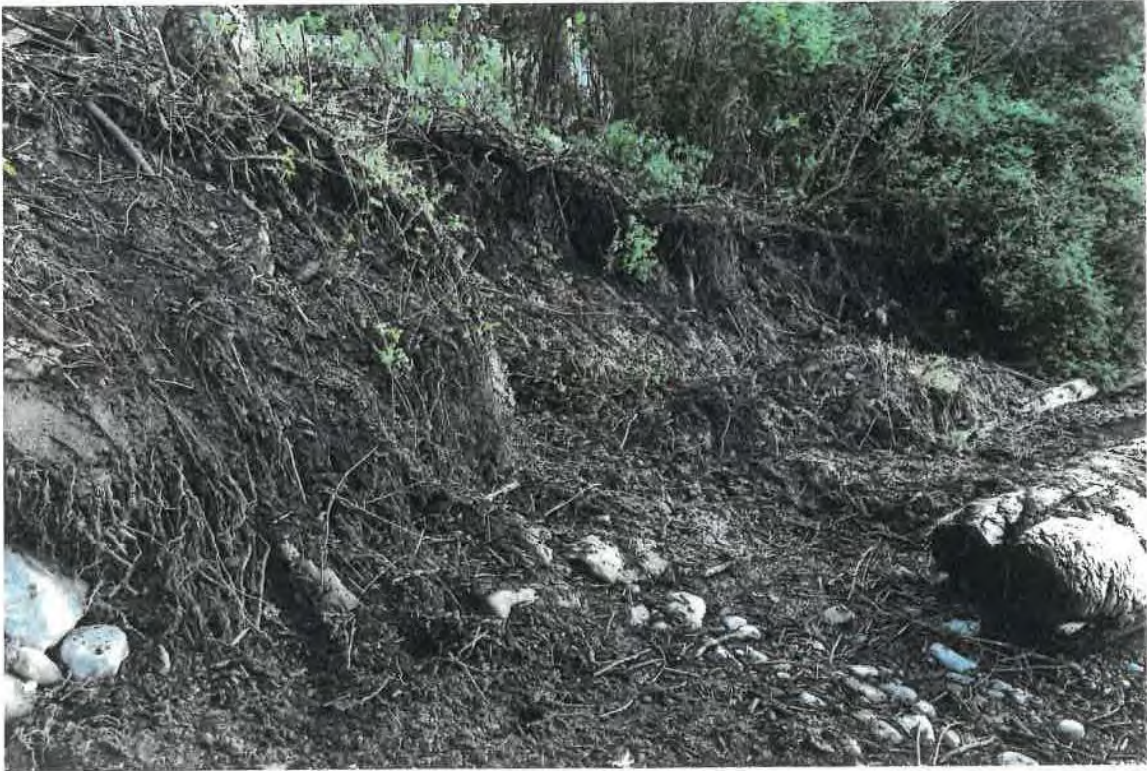
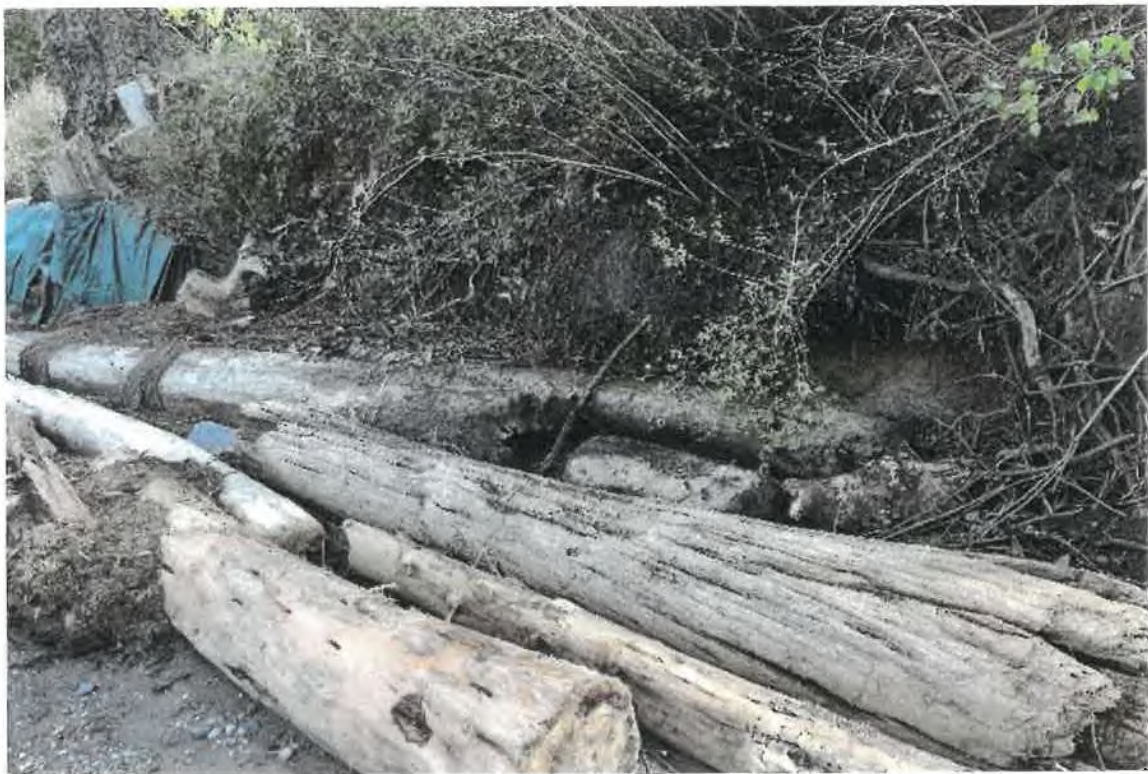
SOFT CLAY AND SOIL BANK SECTIONS ON LOTS THAT WERE BEING ERODED QUICKLY.

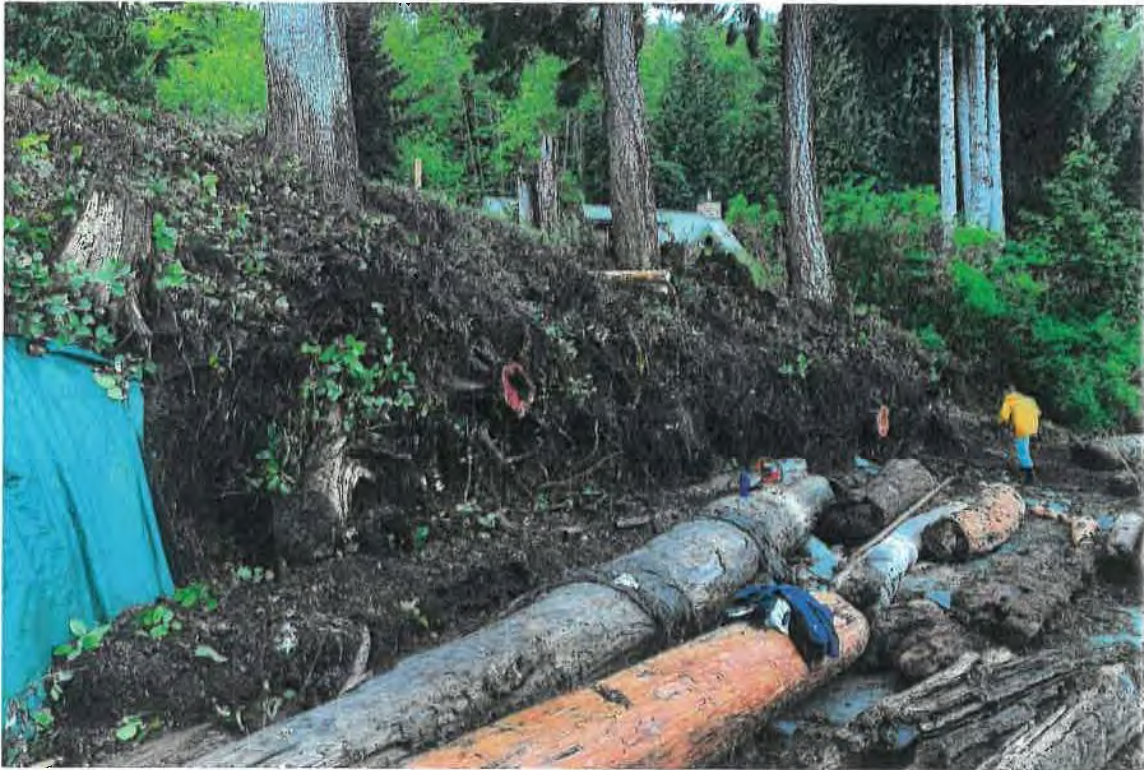
THESE 3 FIR TREES WERE GOING TO TOPPLE OVER THE BANK SOON, THEY HAVE NOW BEEN SAVED, HAD THEY FALLEN, OUR YARD AND THAT OF THE NEIGHBOR ON LOT 6 (HOUSE VISIBLE) WOULD BE IMMEDIATELY THREATENED.

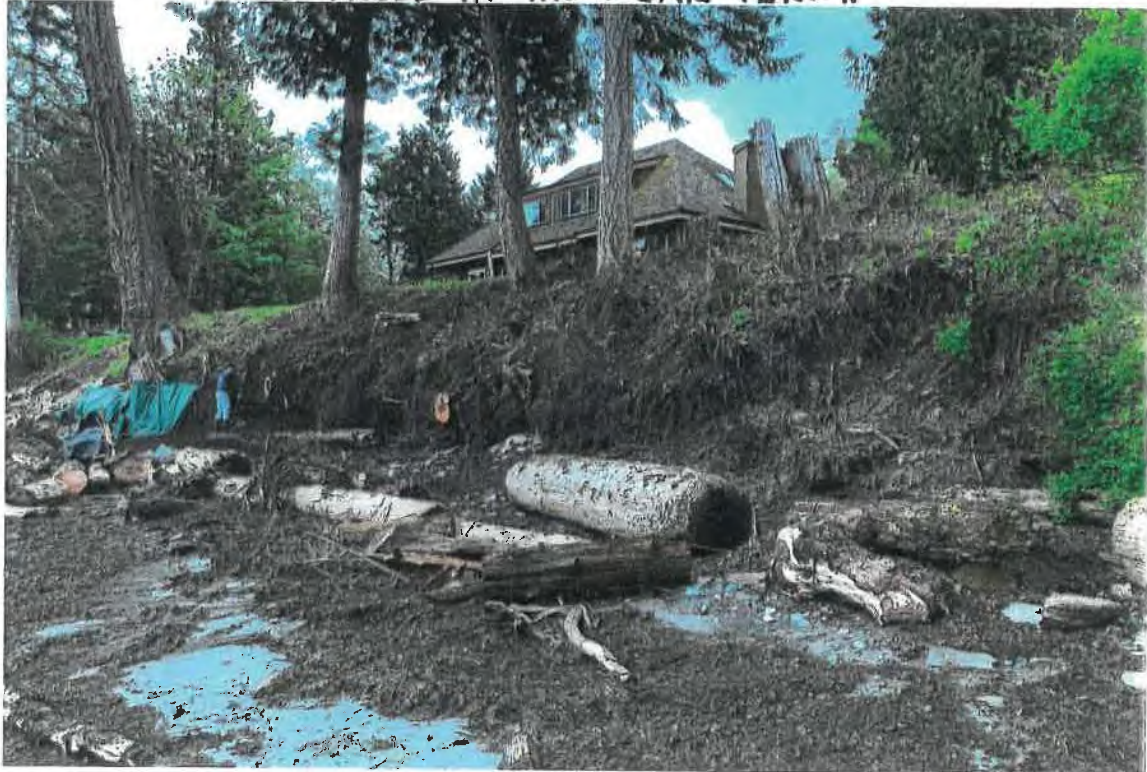
2 HORIZONTAL STUMPS WHICH SLUMPED OVER THE BANK SPRING '22 AND HAD TO BE REMOVED.

3 LARGE FIR TREES BEING HOLLOWED OUT UNDERNEATH BY EROSION. WE WERE GOING TO LOSE THESE TREES IN THE NEAR TERM.

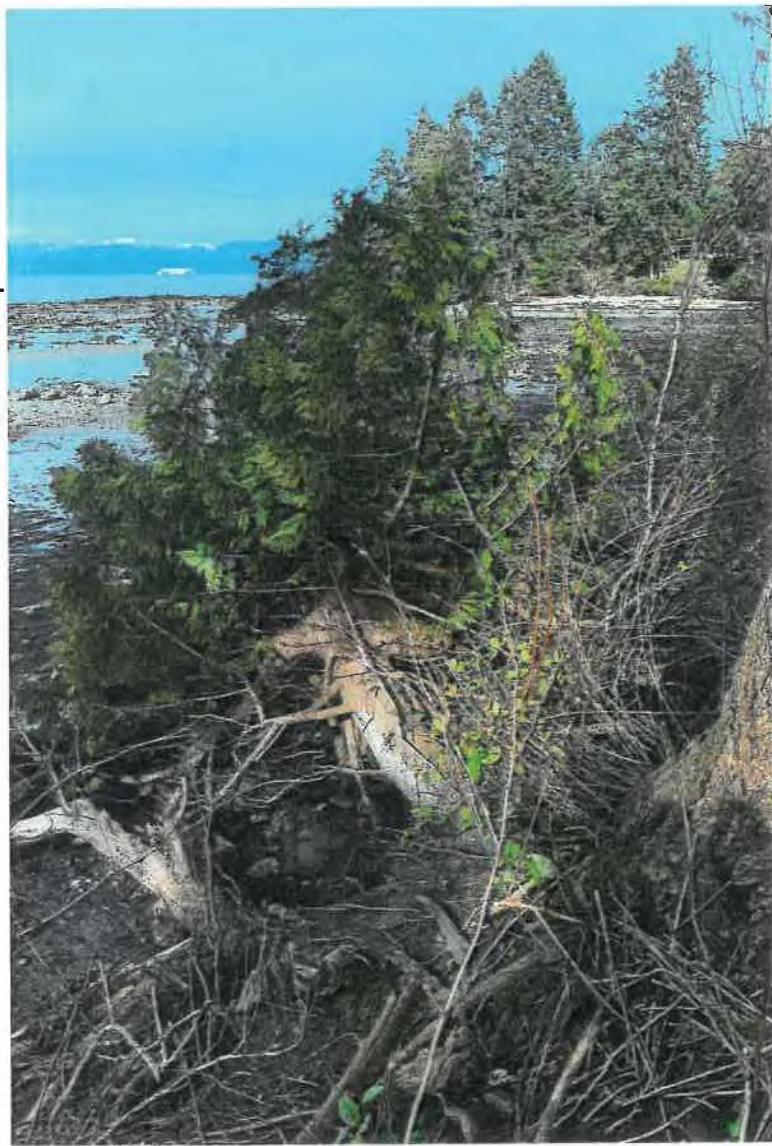
CEDAR TREE THAT
HAD IT'S ROOT
STRUCTURE ERODED
AND FELL OFF THE
BANK IN SPRING '22

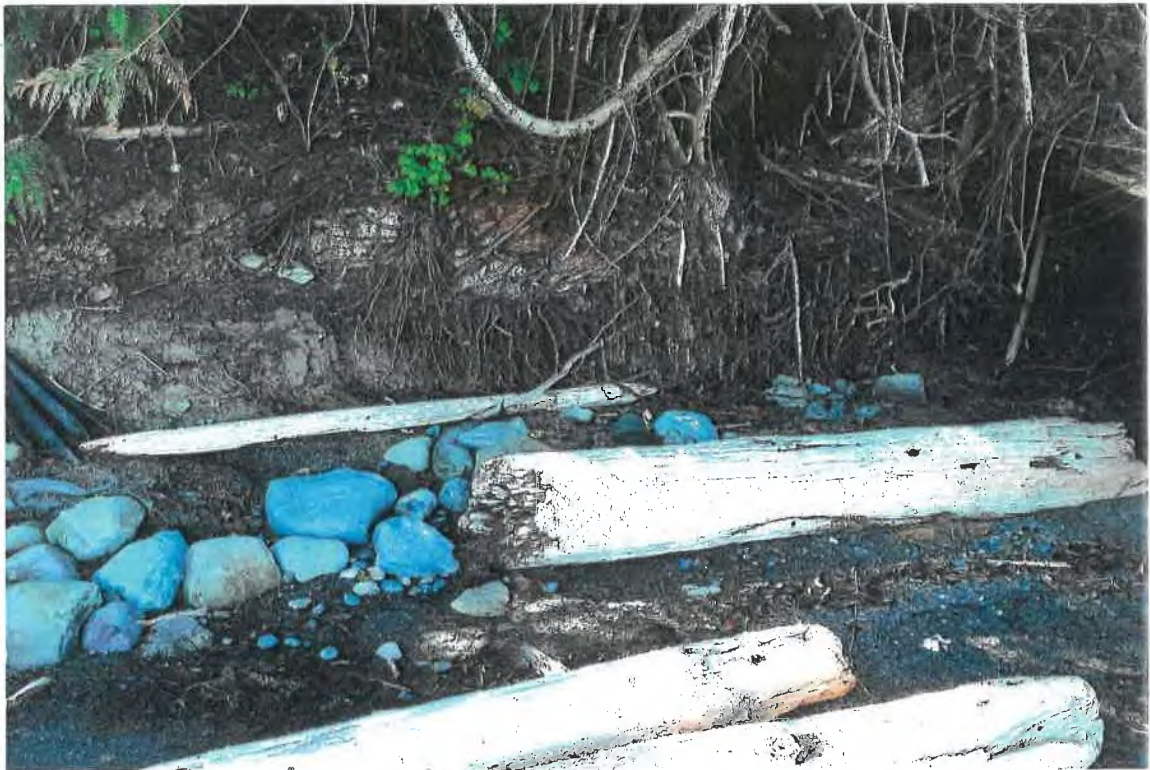
SOFT CLAY AND SOIL ON LOT 5 BANK BEING QUICKLY ERODED
EXPOSING ROOT STRUCTURE OF VEGETATION .

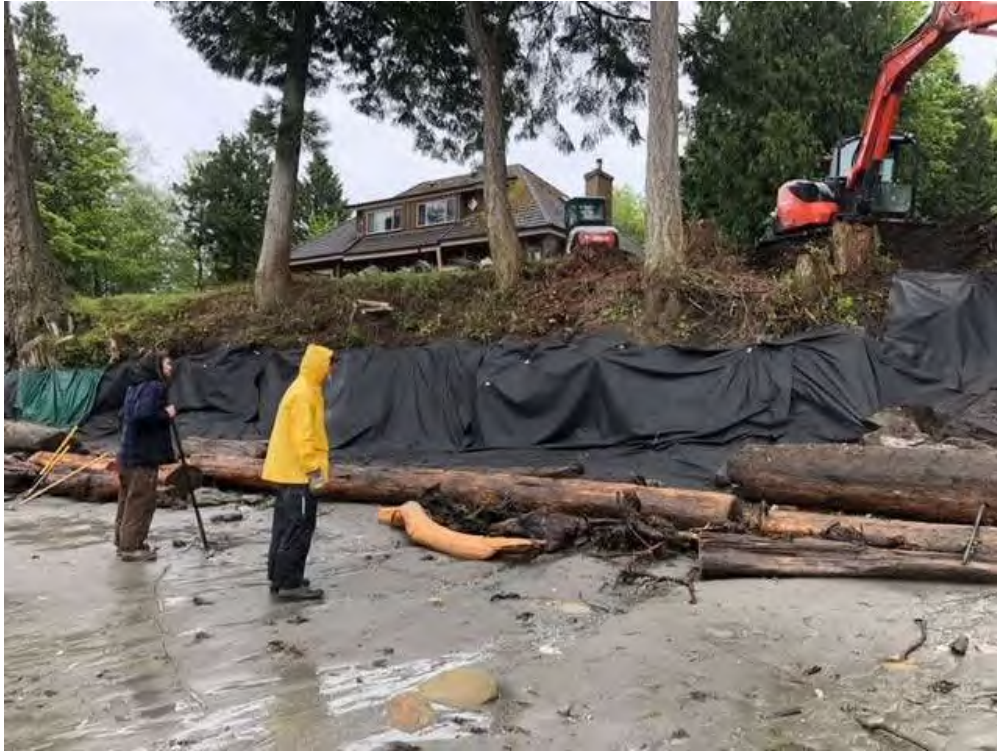
- b. In general, the foreshore can be characterized as a low-bank shoreline with a gently sloping, smooth shallow intertidal zone facing the open waters of the Strait of Georgia / Salish Sea to the north. The total height of the shoreline bank was approximately 5.1m to 5.5m at the time of our assessment. The crest is defined by the rear yard extent of lawn and organic soil cap. Several mature evergreen trees are located at or just below the slope crest. There is no vegetation below the tree extents to the beach below. This area is comprised of a revetment installation consisting of a collection of 500mm to 1000mm sized boulders deposited on a geotextile base that was installed as an emergency measure to protect the property against the significant erosion caused by waves and drifting logs from winter storm activity. Since that time the installation has ceased most of the erosion issues and provided stability to the existing mature trees along the slope crest. See Figures 3.1, 3.2 and 3.3 below.

Figure 3.1 Revetment Installation on Steep Eroded Bank

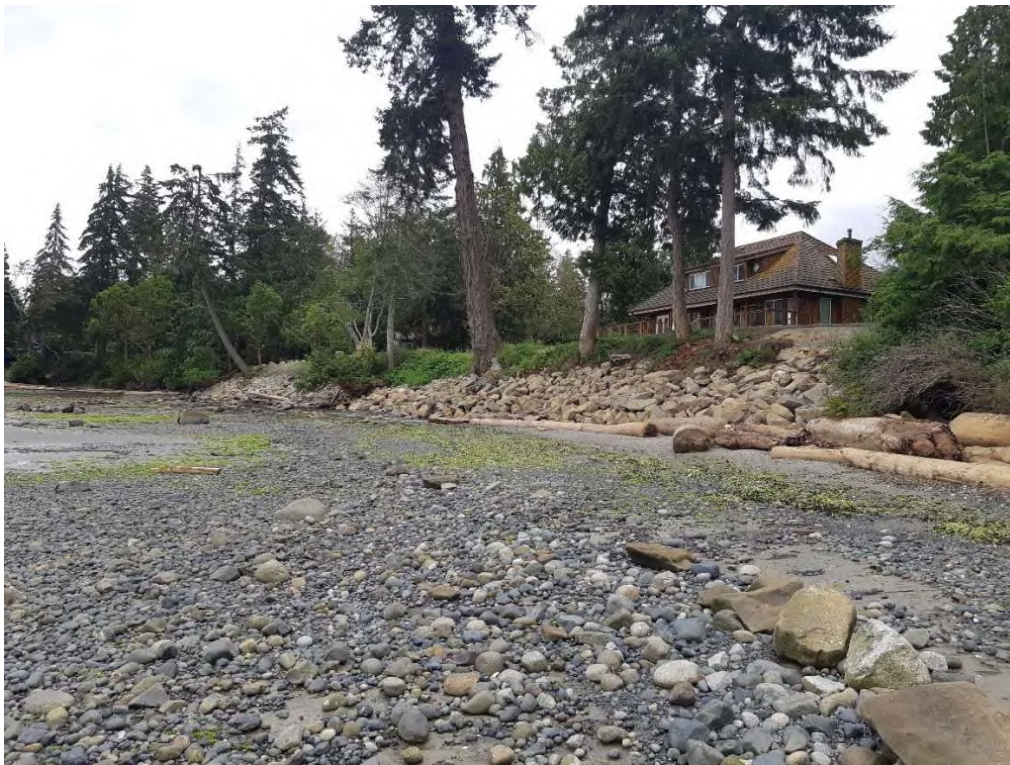
Figure 3.2 Current Shoreline Condition

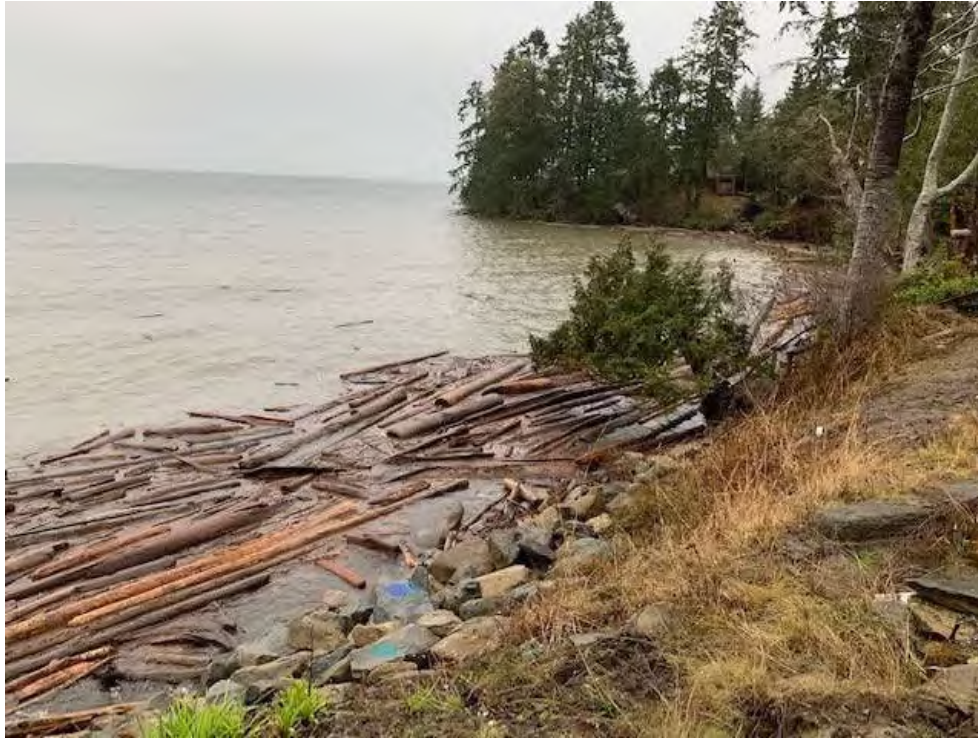
Figure 3.3 Heavy flotsam (Logs) along shoreline

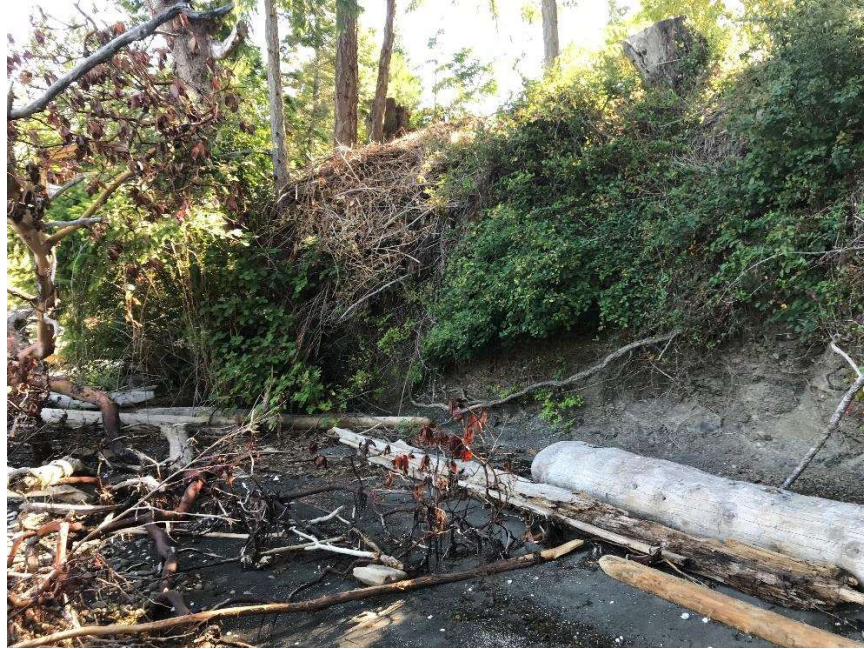
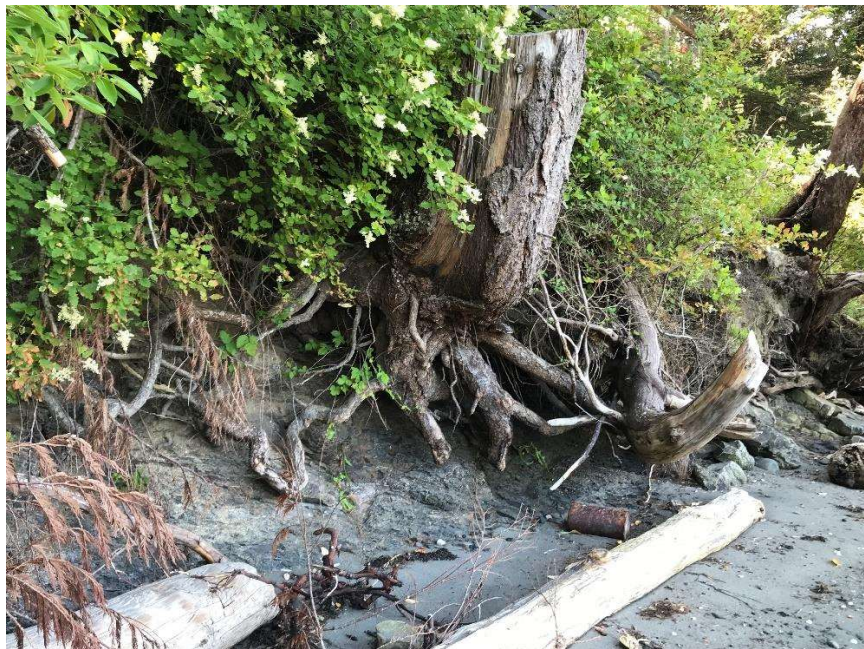
Fig. 2-3: Visible erosion of bank at 1178 The Strand

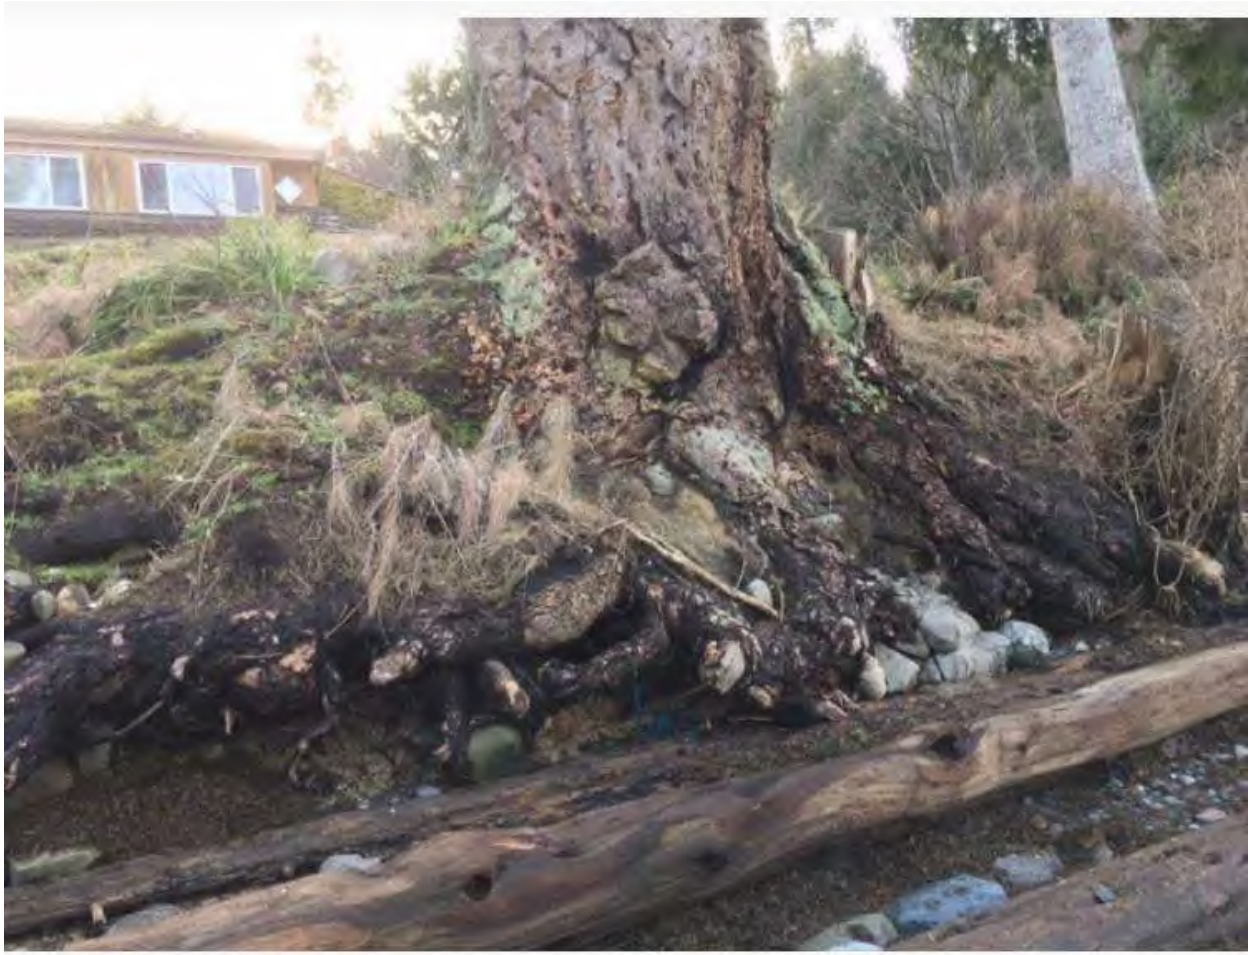
Fig. 4: Exposed roots of D. Fir @ subject property, prior to breakwater installation

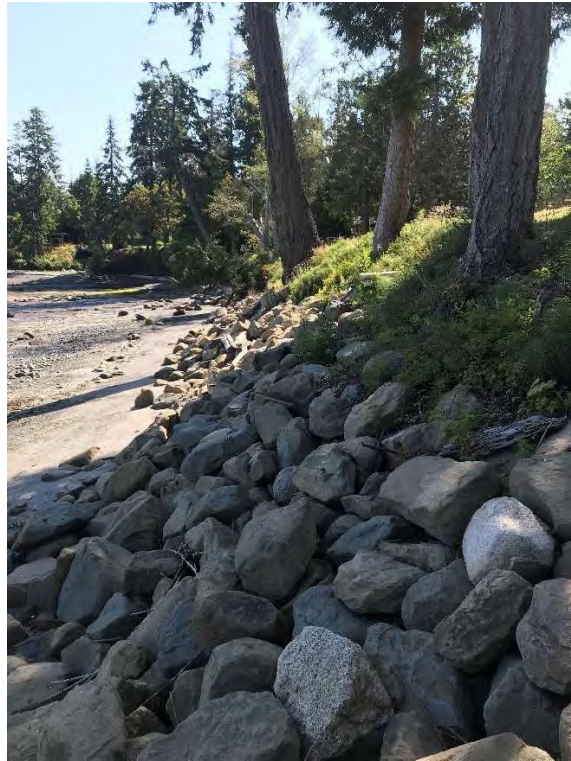
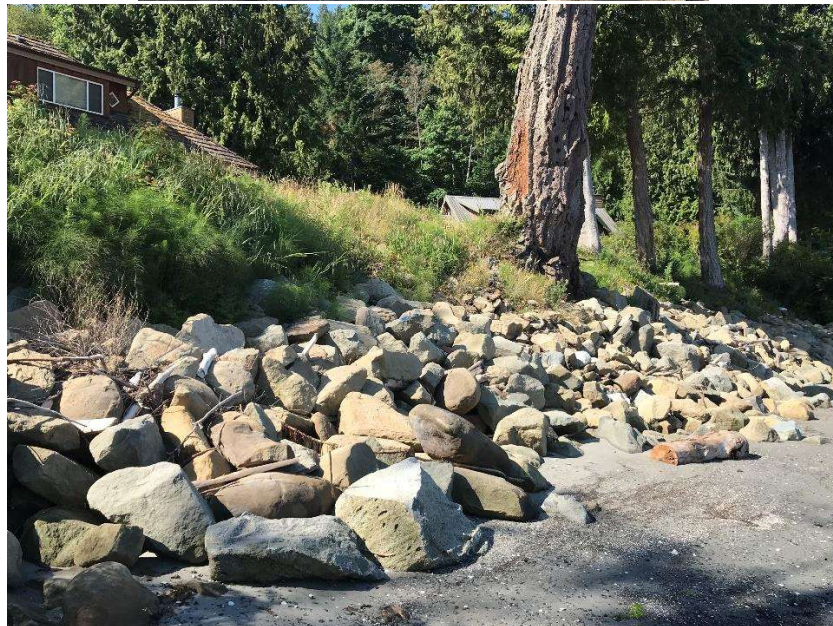
Fig. 5-6: Breakwater supporting lower bank @ subject property

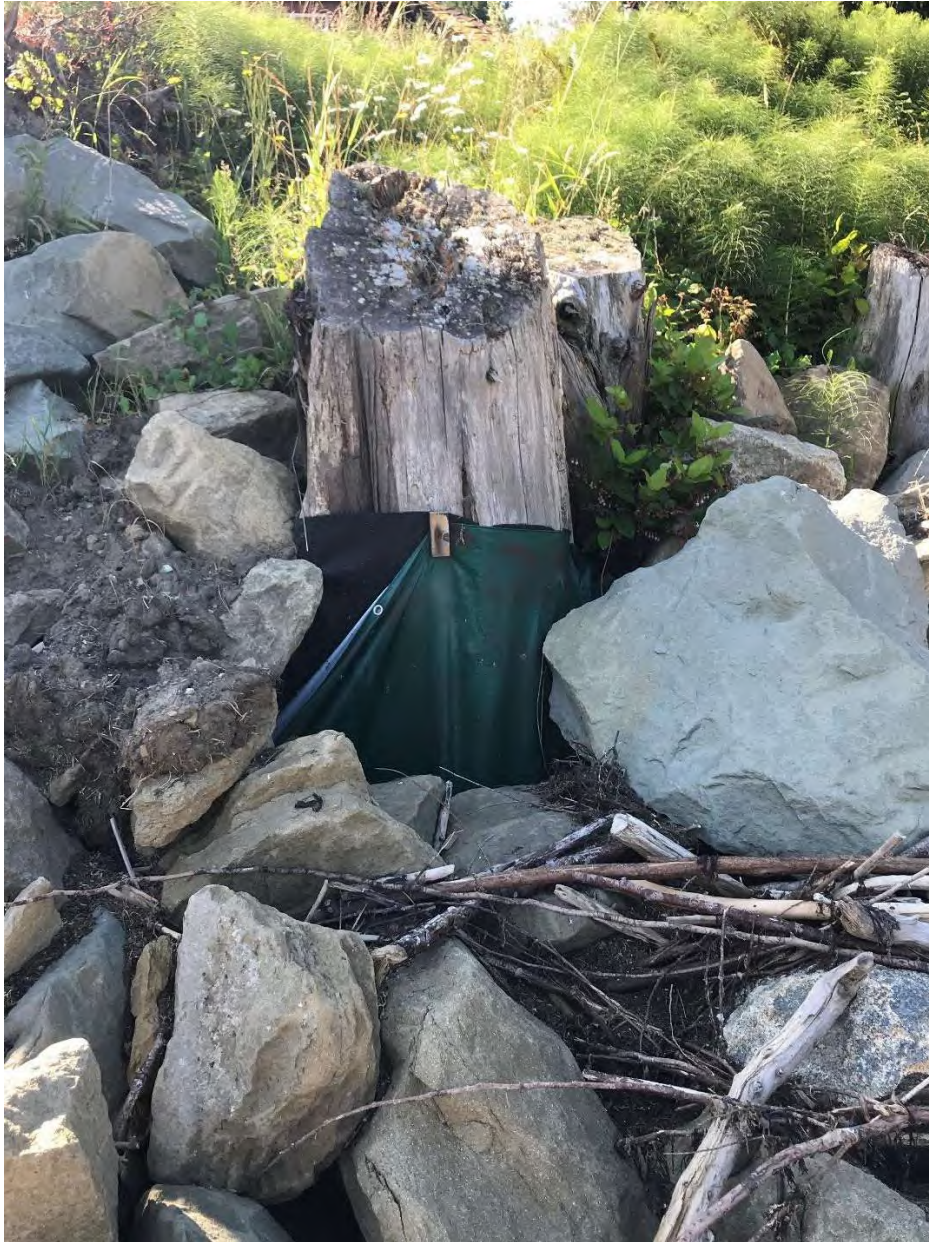
Fig. 7: Evidence of fibre cloth and tarp underlay
