Project No. 2024-056

RE: EELGRASS (*Zostera sp.*) SURVEY OF THE PROPOSED SHINGLE SPIT BOAT LAUNCH

Project
 SHINGLE SPIT BOAT LAUNCH
 IMPROVEMENT PROJECT , HORNBY
 ISLAND

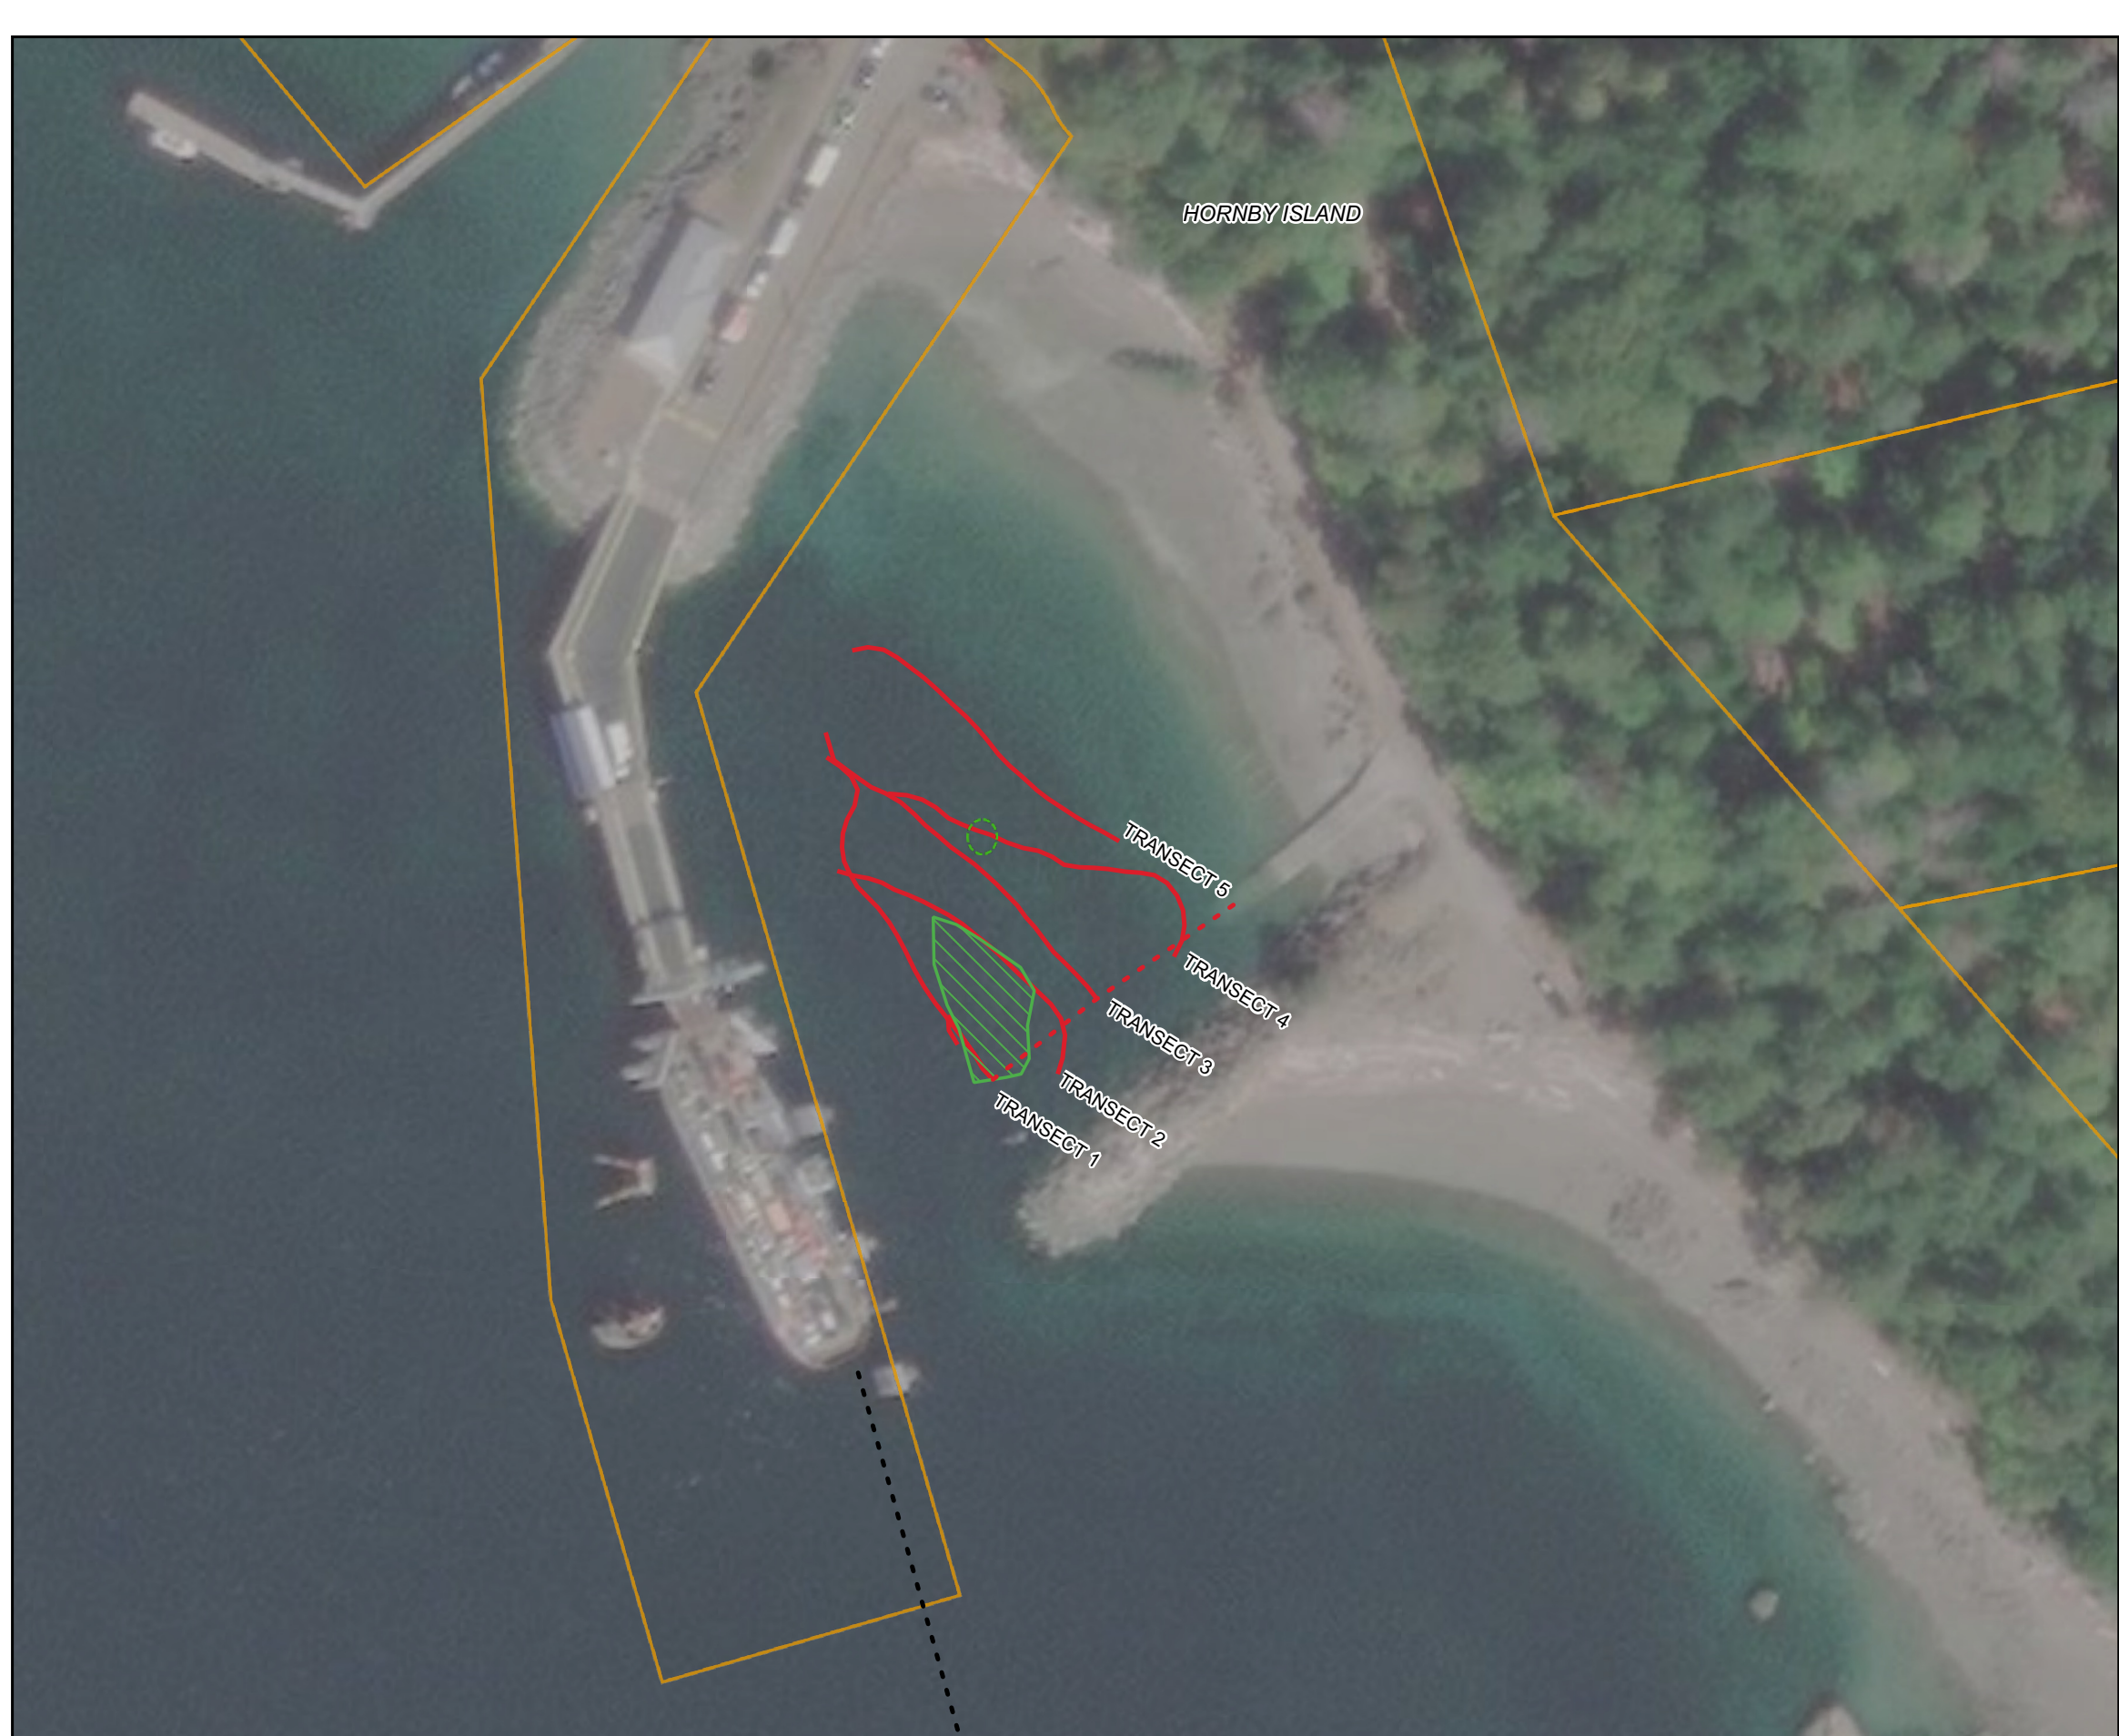
Title
 SITE OVERVIEW

The location of the transects are shown on Figure 1. Note that Transect 6 (shown in a dashed line) is an estimate, as the track function failed to record on the final transect. The aim of this transect was to assess any presence of eelgrass within the project footprint. None was detected.

One continuous bed of eelgrass was detected during the survey, the area of which is estimated to be approximately 200m² and is positioned approximately 22 m straight off from the end of the proposed ramp. There is a wooden piling just beyond the south end of the eelgrass patch that can be used as a good reference when working on the water (Photo 3). Note that the central area of this polygon supports a reasonable density of eelgrass (Photo 4) mixed with a lesser components of sea lettuce (*Ulva lactuca*) and Turkish towel (*Chondracanthus exasperatus*). The eelgrass, as well as other species become much less dense around the edges (Photo 5). All of the eelgrass detection points, including the more sparse, patchy areas surrounding the core area, are within the "Eelgrass - Continuous Bed" polygon indicated on Figure 1, with the exception of one minor additional detection on Transect 4 that was only identified after reviewing the video. This minor detection consists of a handful of individual eelgrass plants in dense sea lettuce (Figure 1). Much of the rest of the substrate consists of shell hash, cobble and a scattering of other seaweed species.

Note that the eelgrass thins considerably within the edges of the delineated polygon, all areas with some presence of eelgrass were included so this should be considered a conservative estimate of the distribution of eelgrass on the site at the time of the survey.

- No anchoring or contact with the bottom should occur within any area that supports eelgrass.
- Prior to anchoring a barge or other vessel involved with construction in the area, a quick pre-construction check of the bottom should be conducted to determine suitable anchoring locations and avoid potential impacts to eelgrass. A similar approach to the spot checks conducted for this survey will be appropriate.
- The CVRD should install signage at the boat ramp informing boaters of the sensitive eelgrass in the area and advising not to anchor within it.

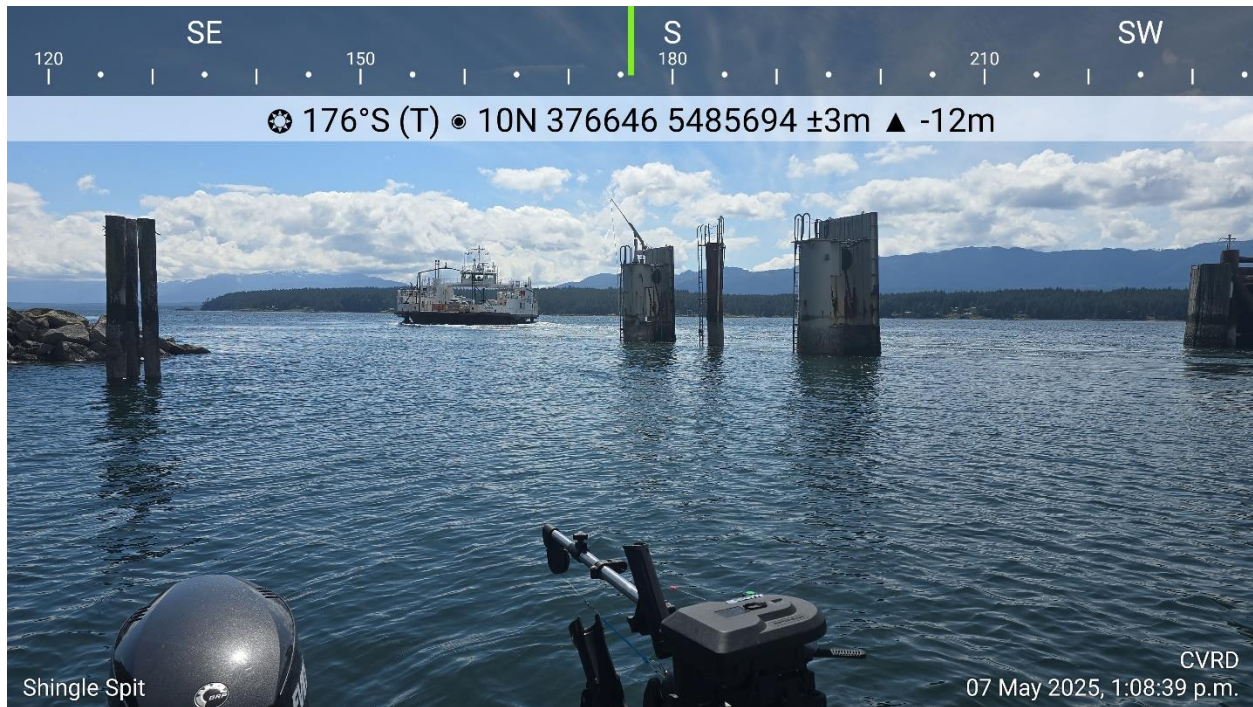
Photo 3. Showing the ferry leaving the dock (at right). The set of three pilings at far left of the photo roughly delineates the southern end of the eelgrass patch and can be used to as a quick reference when working above the water.

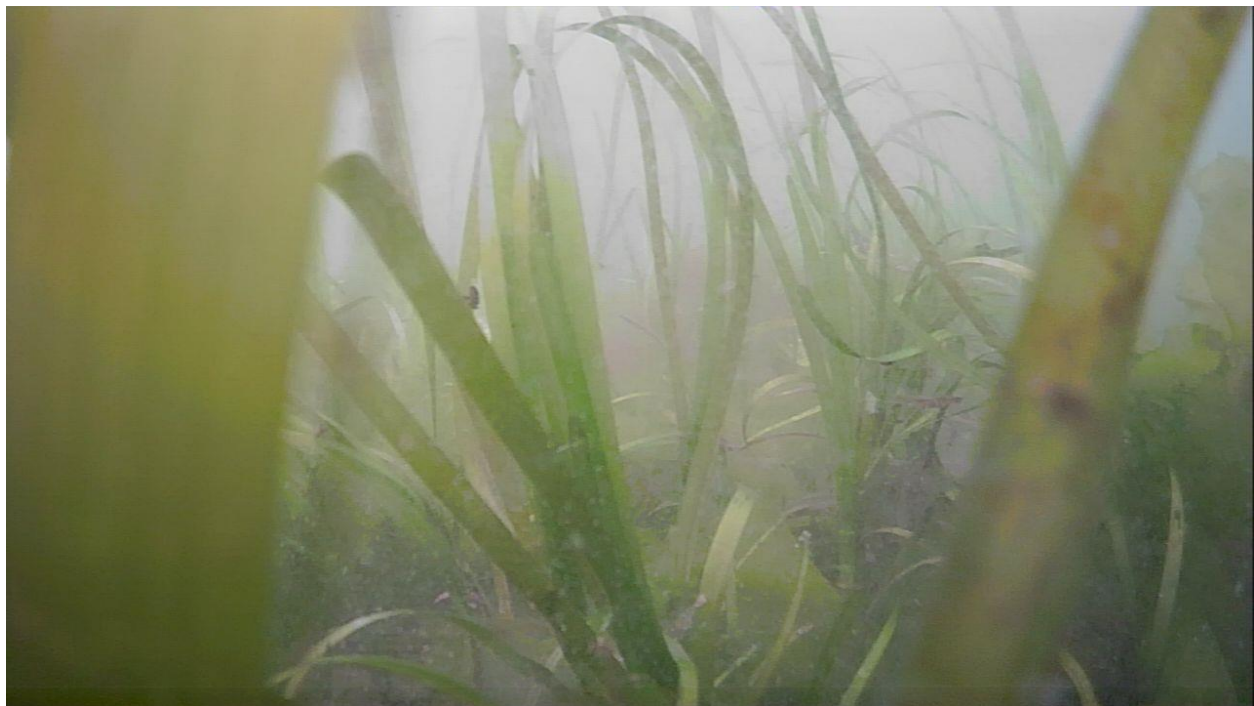
Photo 4. Dense eelgrass near the center of the eelgrass polygon. Photo taken May 7, 2025.

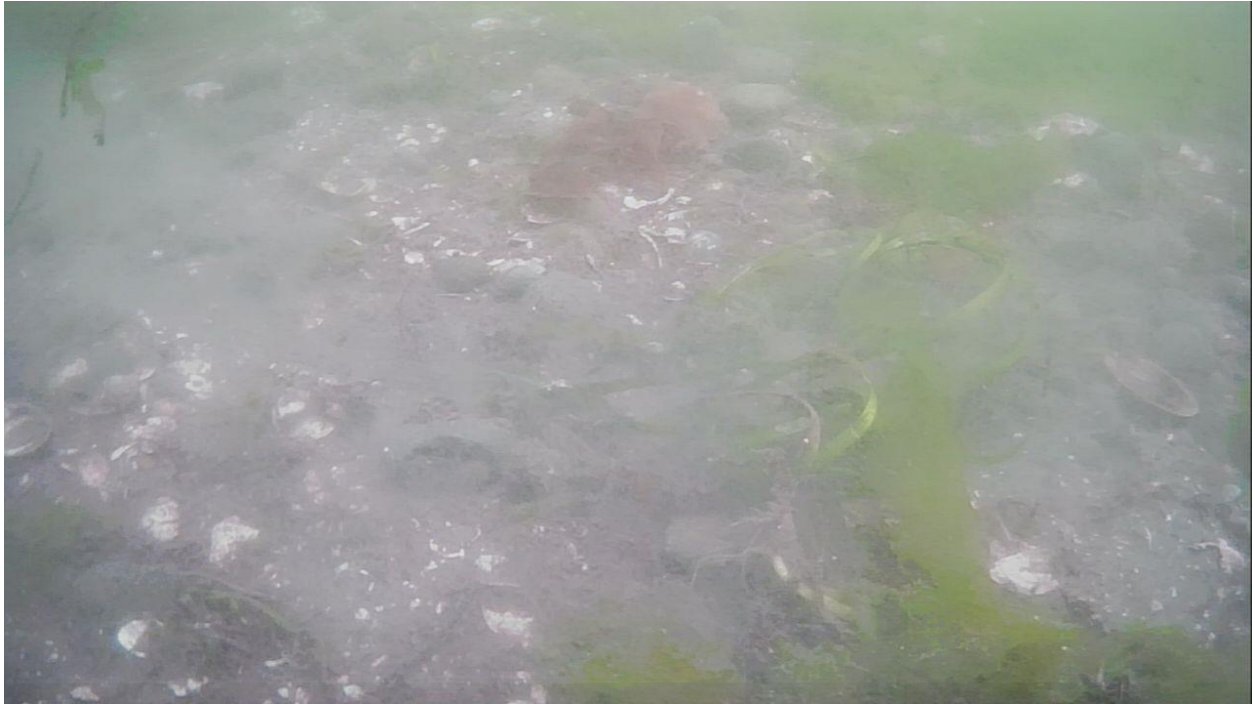
Photo 5. Showing low density of eelgrass at the edge of the polygon, note the muddy substrate, shell hash and trace Turkish towel. Photo taken May 7, 2025.

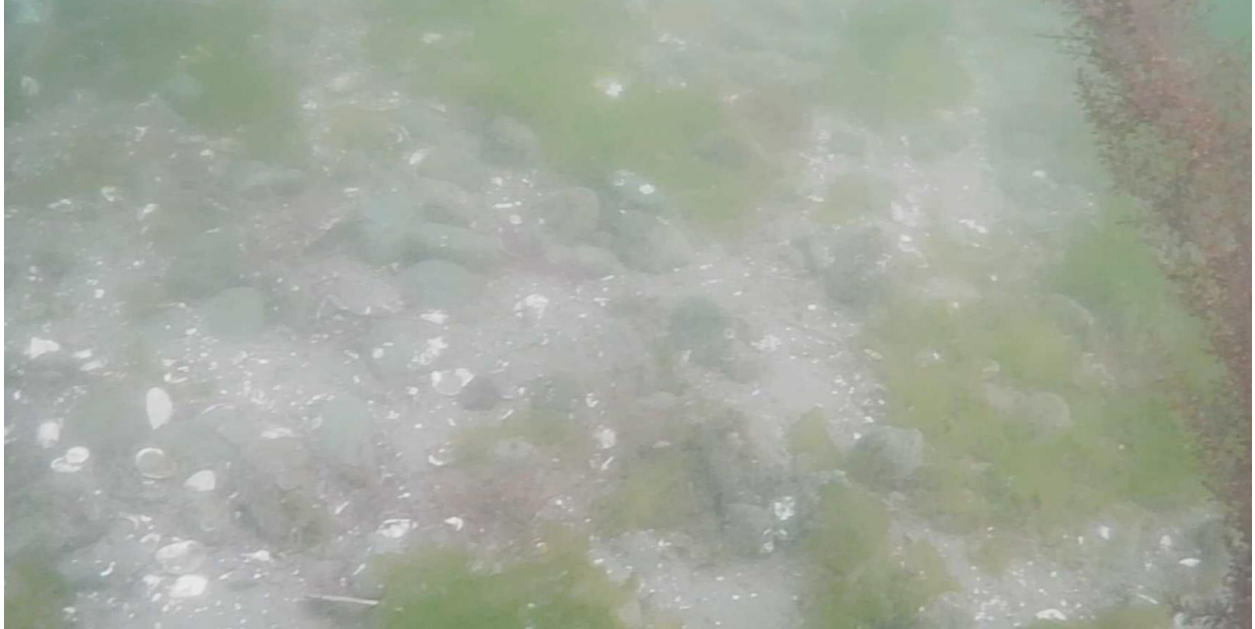
Photo 6. Showing range of ground cover outside of eelgrass polygon – mixed muddy/sandy substrate, shell hash, sea lettuce and what is assumed to be *Plocamium* sp.
