MEMORANDUM

DATE OF MEETING: February 22, 2021
 TO: Mayne Island Local Trust Committee
 FROM: Narissa Chadwick, Southern Team
 COPY: Robert Kojima, Regional Planning Manager
 SUBJECT: MA-RZ-2020.1 Application Update

BEECHWOOD

Re: Lot 1, 375 Village Bay Road, tree assessment of significant trees

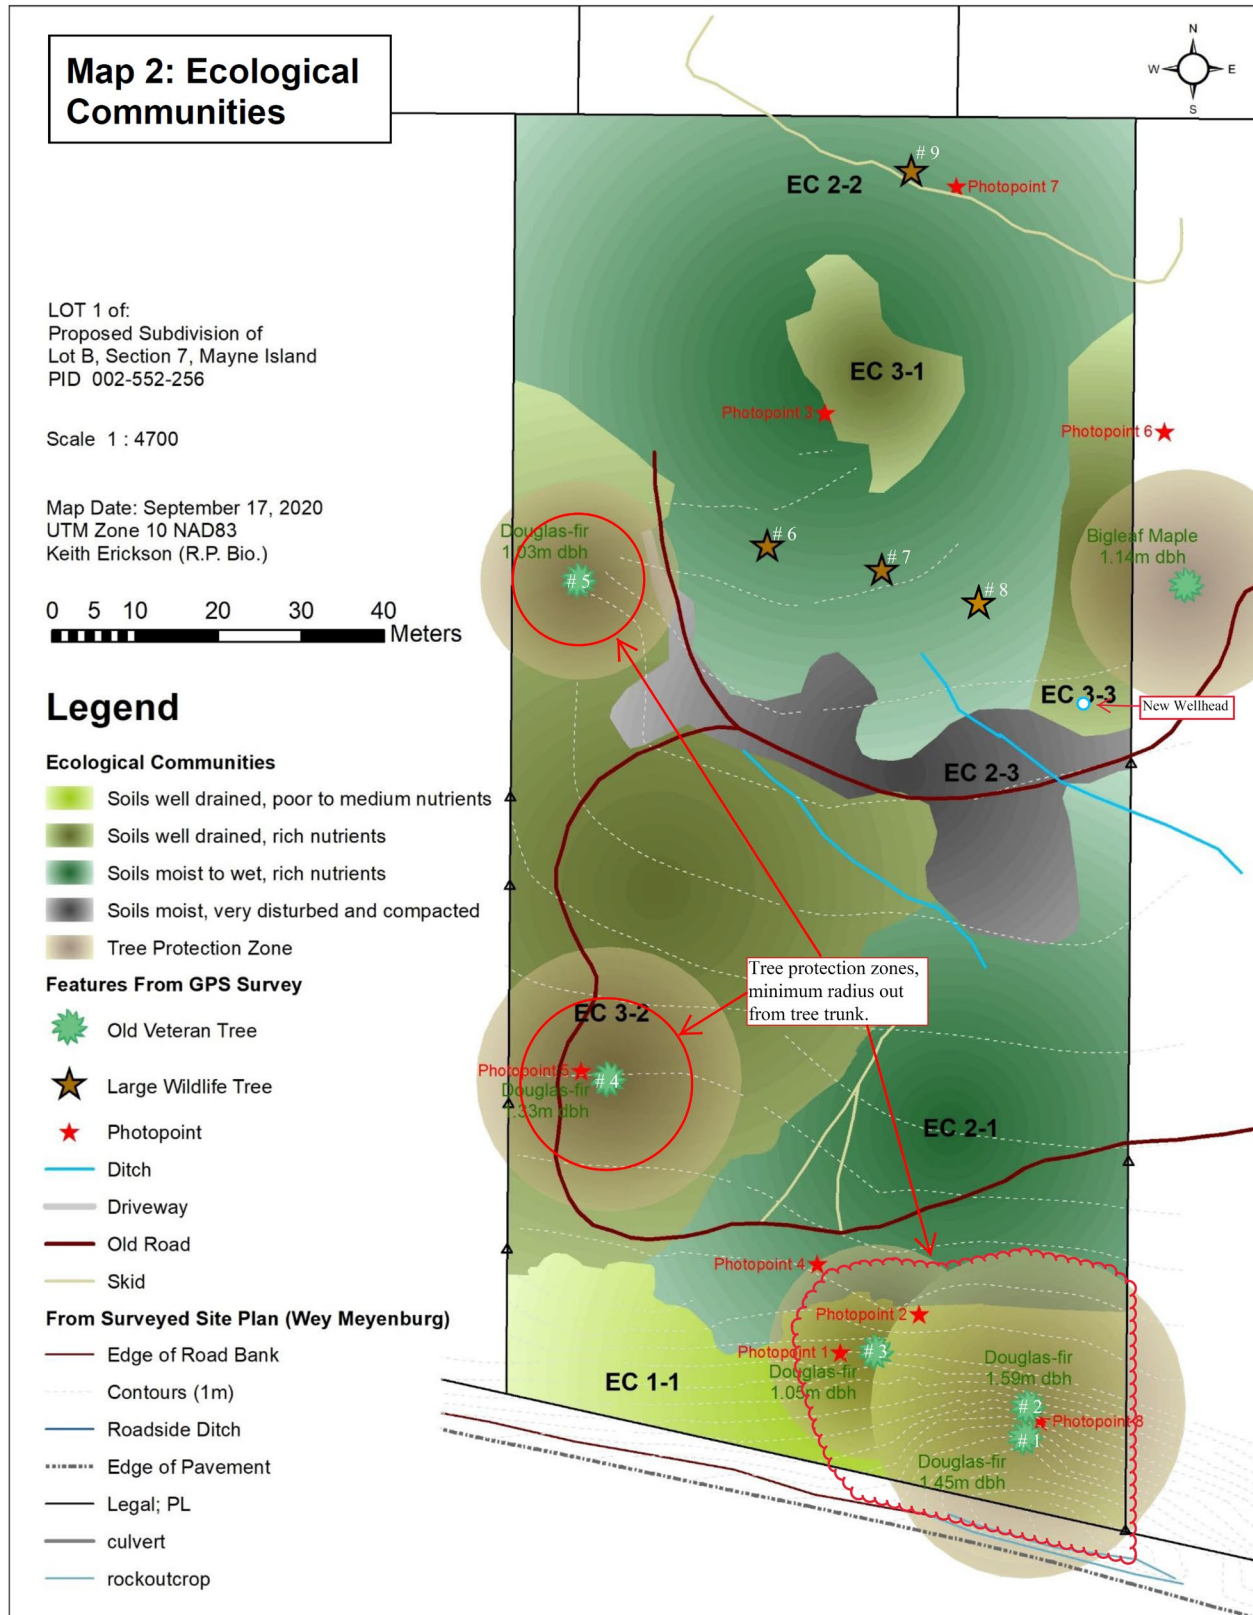
Map with tree locations and tree protection zones

This tree can be preserved, the risk of tree failure within the next three years is improbable², the most likely parts to fail are branches; this is common on Douglas firs. This is a large tree requiring a very large tree protection zone. I recommend that the TPZ (tree protection zone) extends 15 meters out from the trunk (see map).

If the tree continues to decline, it will likely die. Application of water during the summer months would improve its chances of survival. If the tree dies, it should be removed or turned into a wildlife tree. If the desire is to preserve this tree, the TPZ should extend 18 meters out from the trunk (see map).

The tree is structurally sound; the risk of tree failure within the next three years is improbable. To preserve this tree, the TPZ should extend 9 meters out from the trunk (see map).

Amendment Jan 25, 2021: The TPZ can be oval or offset slightly to provide enough space for the planned road between the tree and the west property line. It is essential to stay at least 7 meters away from the trunk, as closer could increase the risk of tree failure.

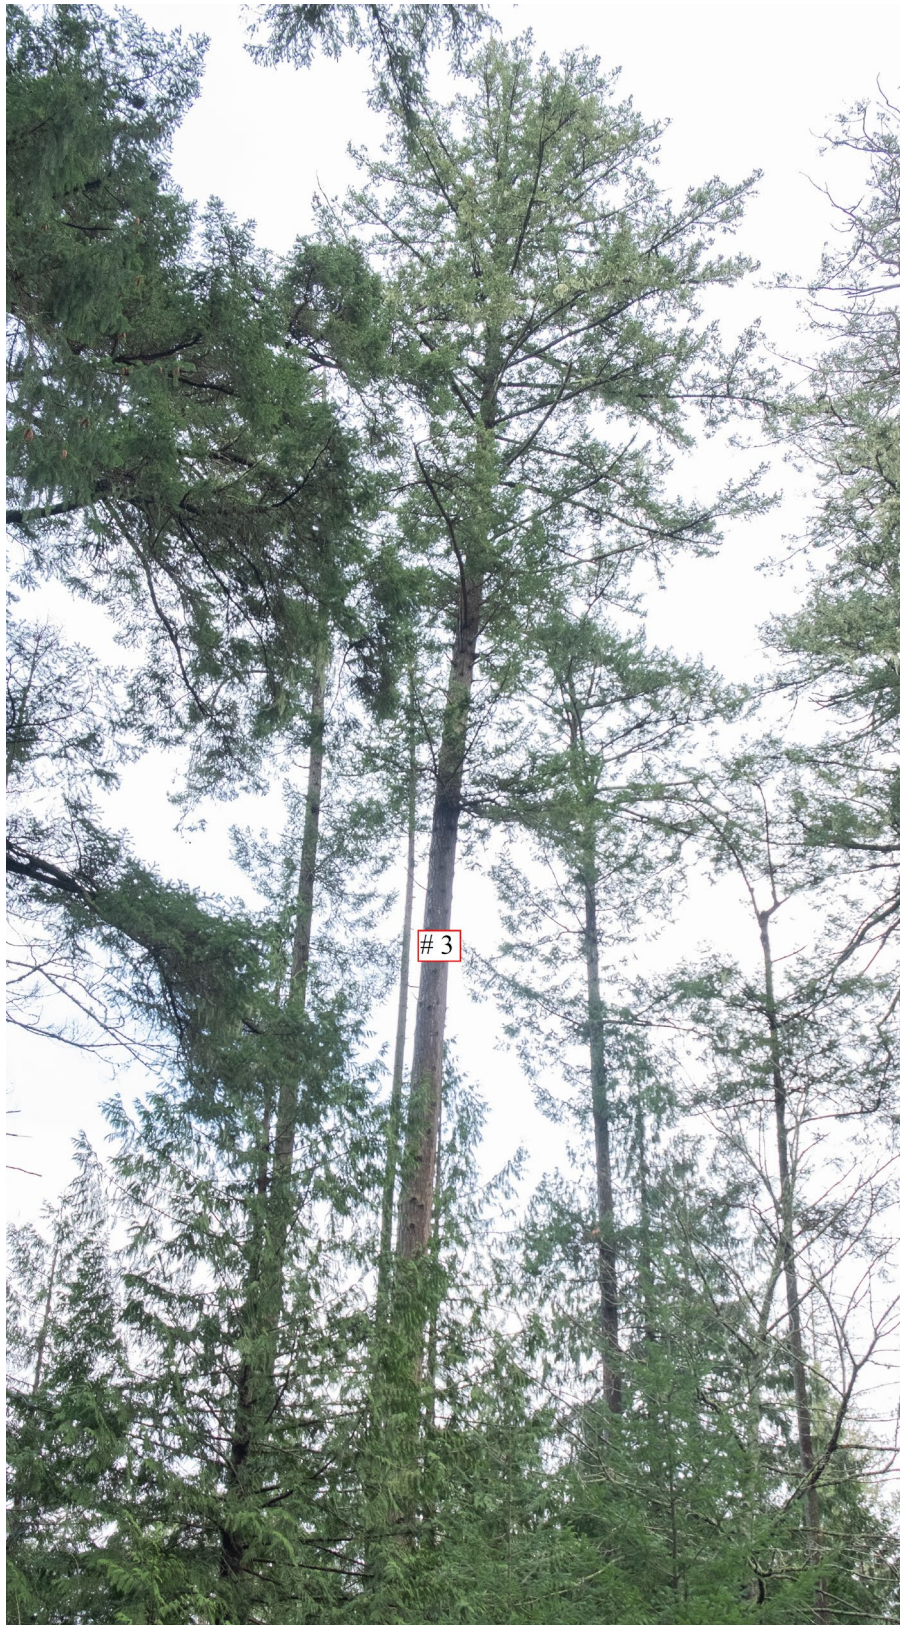
Tree number three as seen from the south

Tree # 3: Douglas fir with a DBH of 105 centimeters and a height of 50 meters. It is situated at the south end of the lot. It is in fair health with normal foliage size; density is a bit sparse, and foliage is a dull green. I found no major defects in this tree.

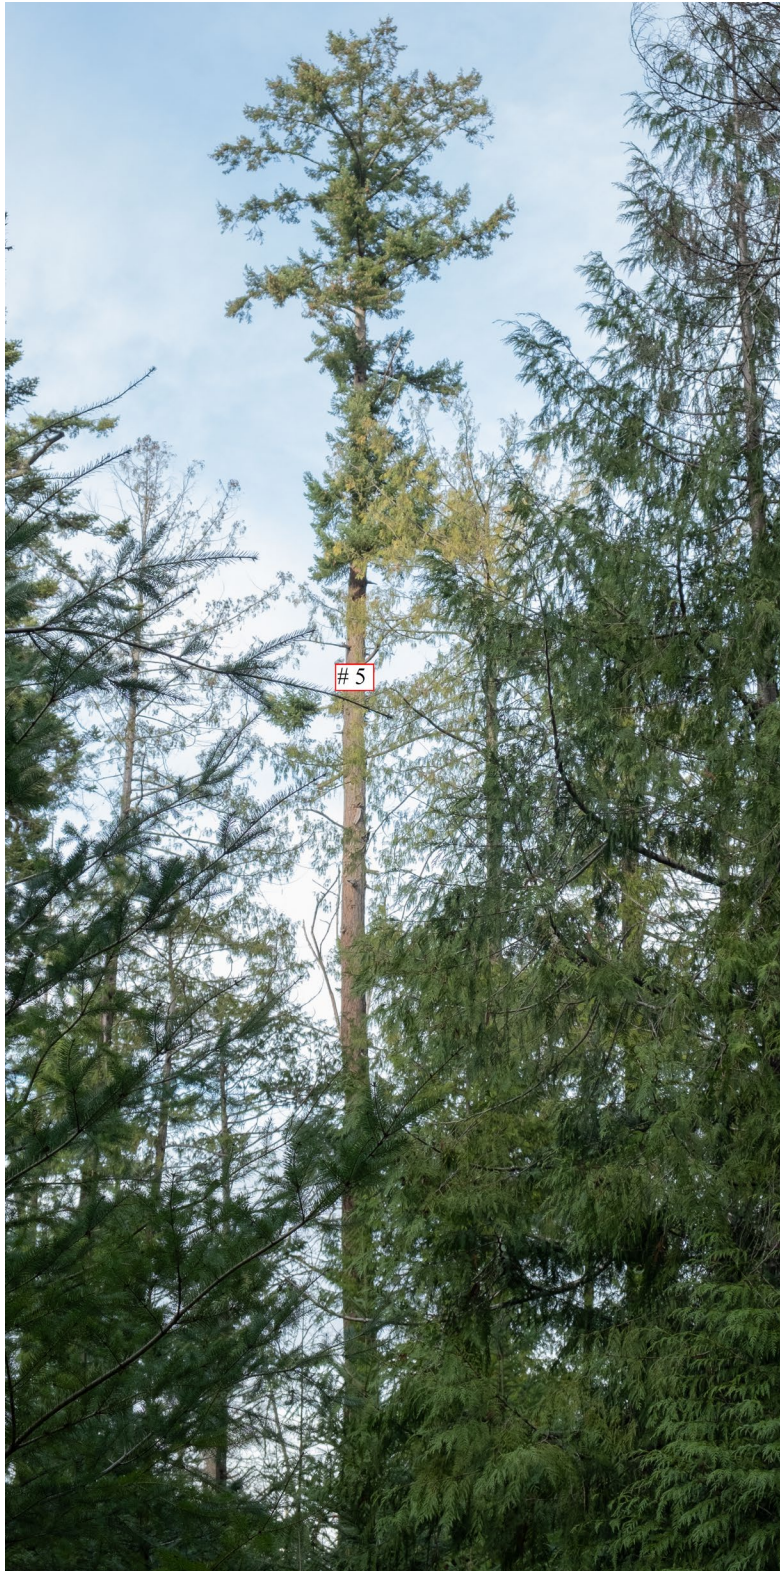
Tree number five as seen from the south

Tree # 5: Douglas fir with a DBH of 103 centimeters and a height of 46 meters. It is in average health with normal foliage colour, density and size. The lower trunk has a moderate bow, and the tree has a slight lean toward the east. I found minor sap flow from the southwest side of the lower trunk. The bow, lean and sap flow are minor issues at this point.

I found no signs of trunk, or root decay. The likelihood of tree failure within three years is improbable. To preserve this tree, the TPZ should extend 8 meters out from the trunk (see map).
