09 November 2020

Mayne Island Housing Society  
274 Mariners Way  
Mayne Island, BC, V0N 2J2

**Re: Site Assessment for the Purpose of a Community Onsite Wastewater System for Subdivision Development and Rezoning – 375 Village Bay Road, Mayne Island, BC**

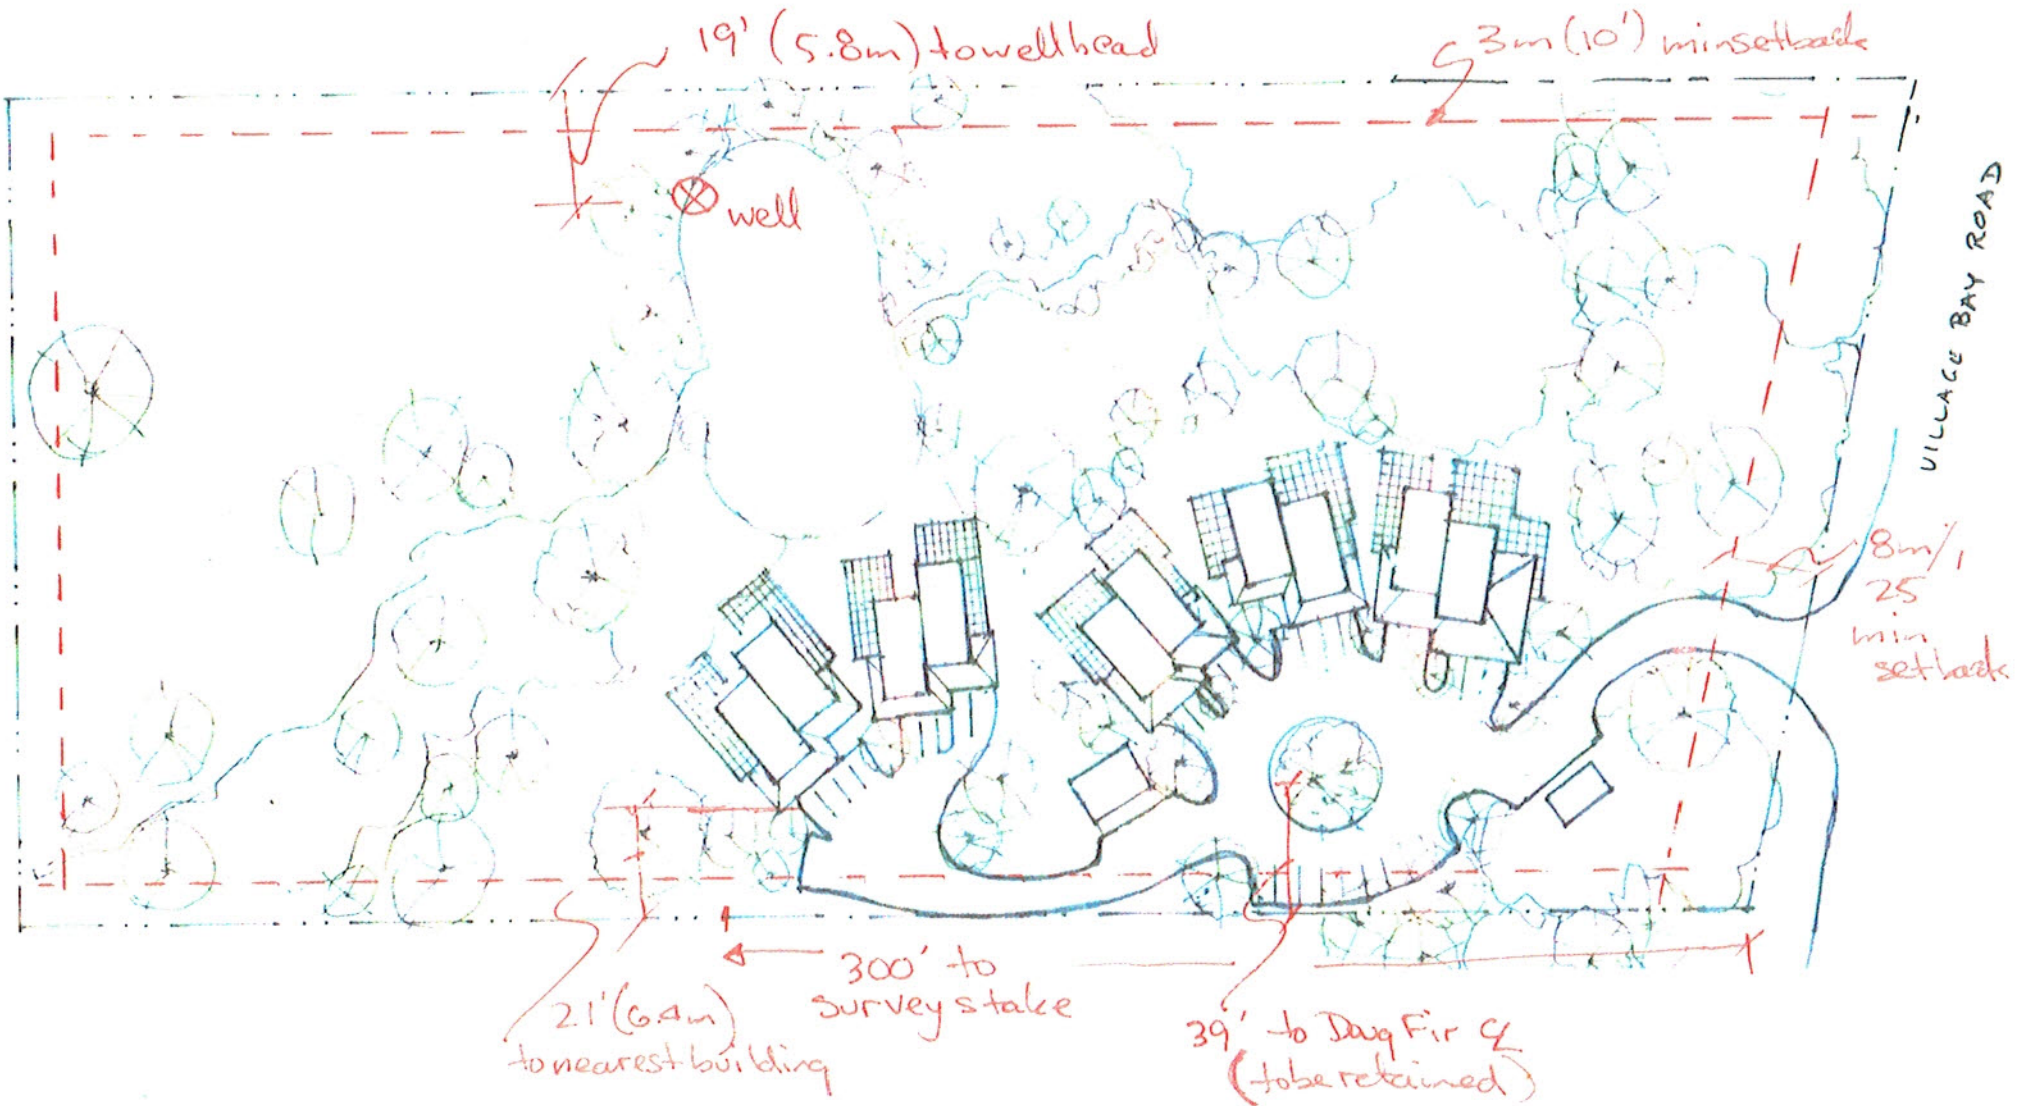
SITE PLAN  
9-11-20

The proposed dispersal field is of a mound construction with an infiltrative area 2 meters wide X 80 meters long. There will be sloped fill on the upgradient side and a longer sloped fill on the down gradient side with a mantel extending a minimum of 7.5 meters. The estimated total area will be approximately 12 meters X 90 meters.
