Crystal Mountain Ecosystem-based Land-use Plan

**Parcel A of DL89 except part in plan 27287
& Lot 9 Plan 31200 DL90
Galiano Island, BC**

**Keith Erickson (R.P.Bio.)
January 2010**

Revised April 2014

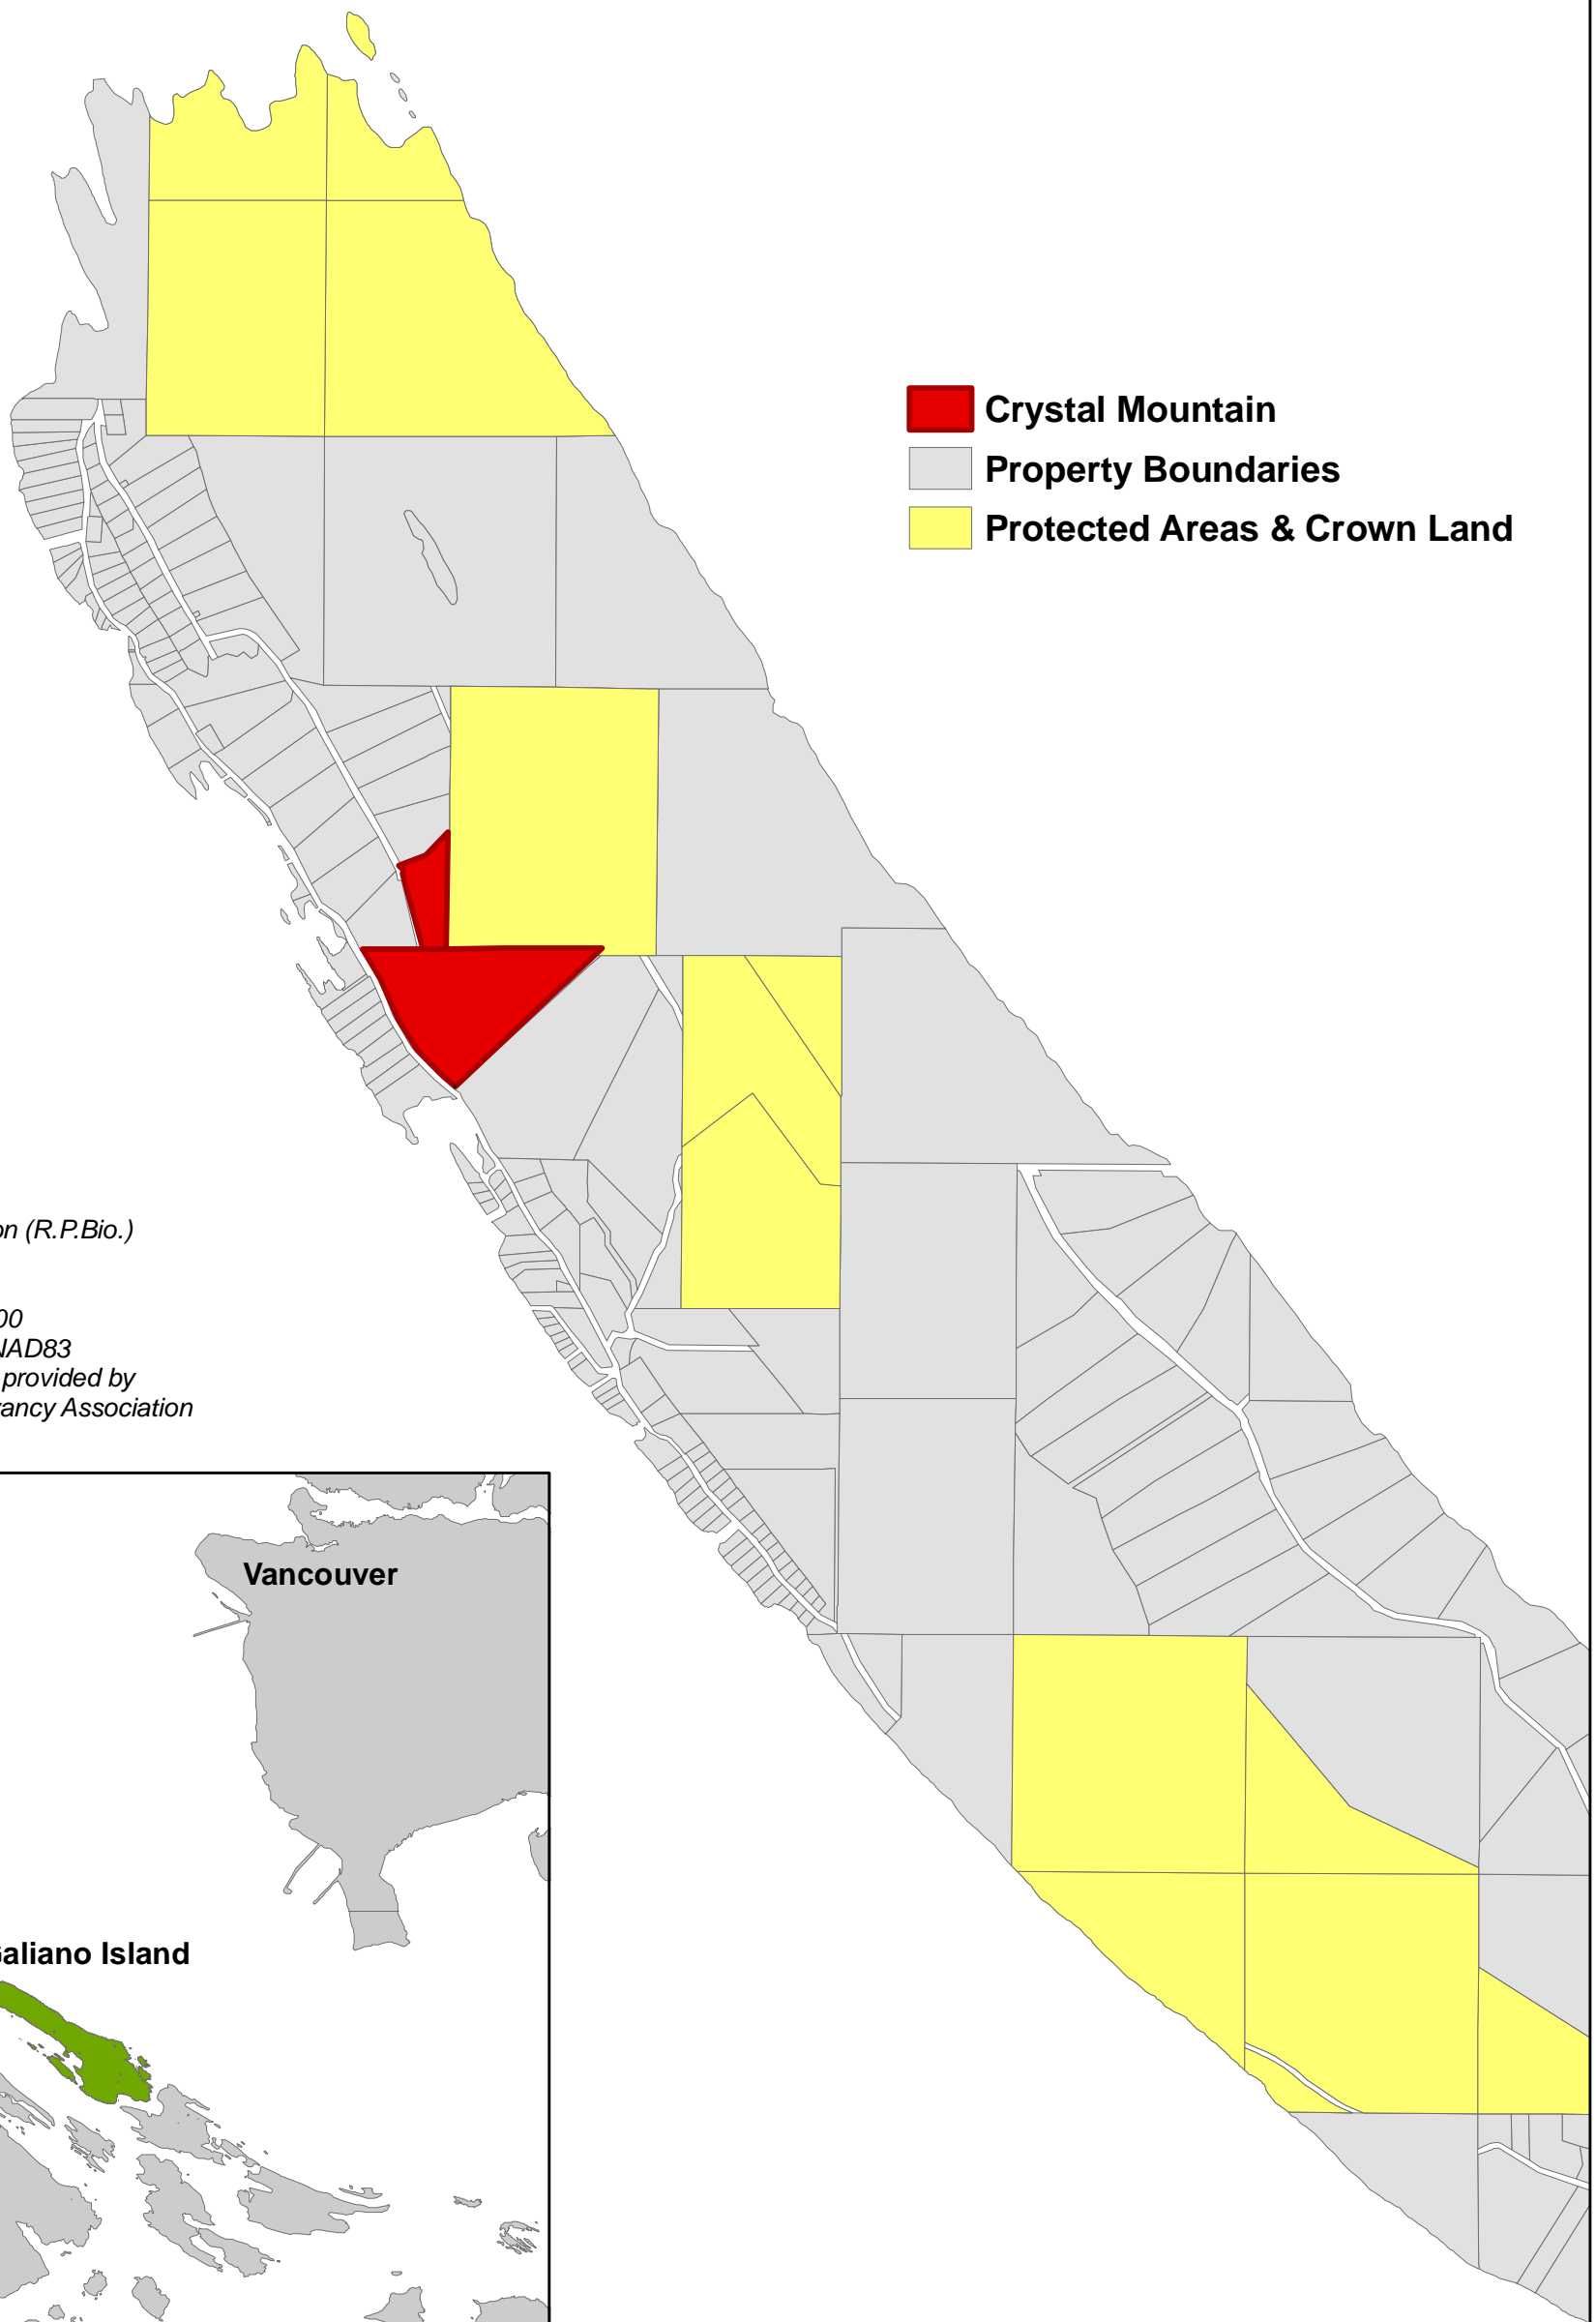
-- Property Location and Surrounding Protected Areas --

Produced by: Keith Erickson (R.P.Bio.)
Map Date: January 2009
Scale: 1 : 25,000
Inset Map Scale: 1 : 600,000
Projection: UTM Zone 10 NAD83
Data: Property boundaries provided by
the Galiano Conservancy Association

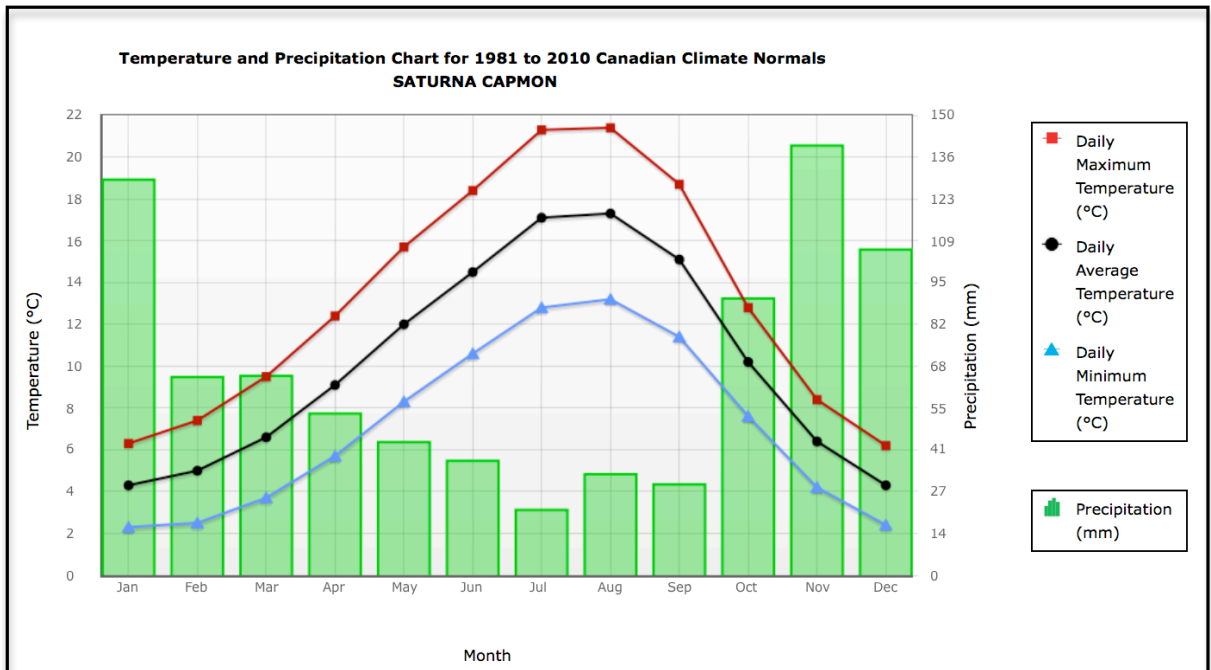
Figure 2. Graph of monthly normal monthly precipitation for Saturna Island Campon station (Climate ID. 1017098). Graph from Government of Canada (2015a).

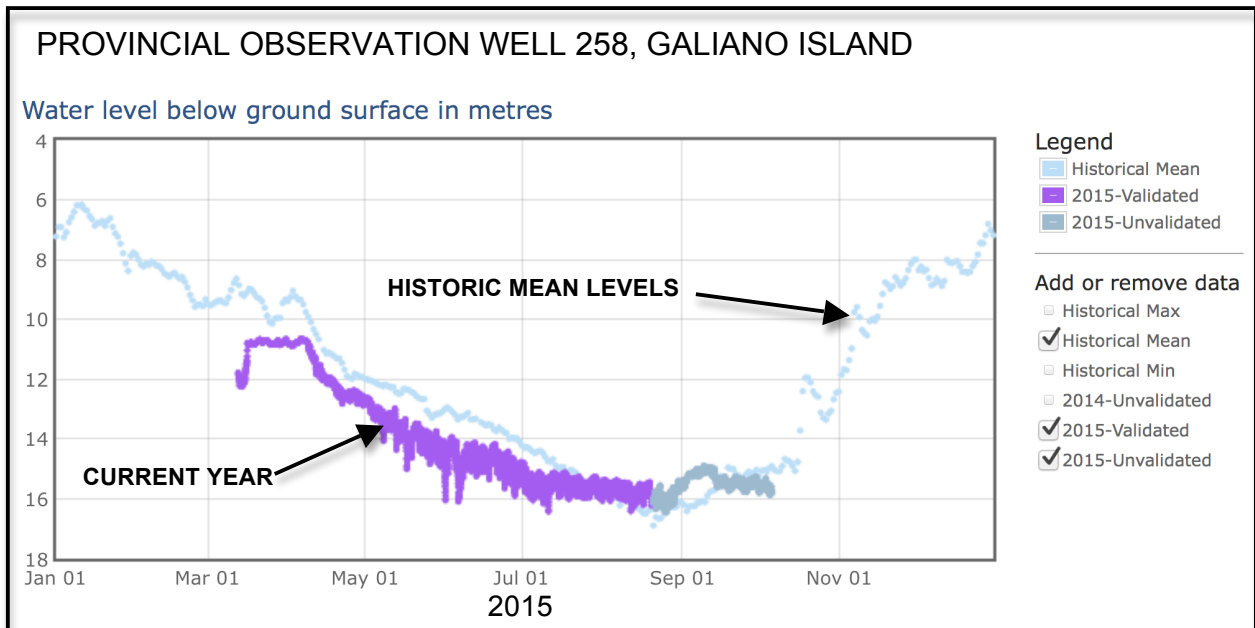
Figure 3. Groundwater level trend in 2015 compared to historic mean data for Observation Well 258. From Ministry of Environment (2015b).

From historic observation well data in the Gulf Islands, groundwater levels in bedrock wells generally rise and fall with the seasons, in response to available precipitation, becoming highest during the late fall and winter months. Water levels then normally decline during the dry summer months reaching seasonal lows in the late fall months (Kohut *et al.*, 1984). Figure 3 shows the groundwater level trend for 2015 falling below historic mean levels from May to September as shown in the graph of provincial observation well 258.

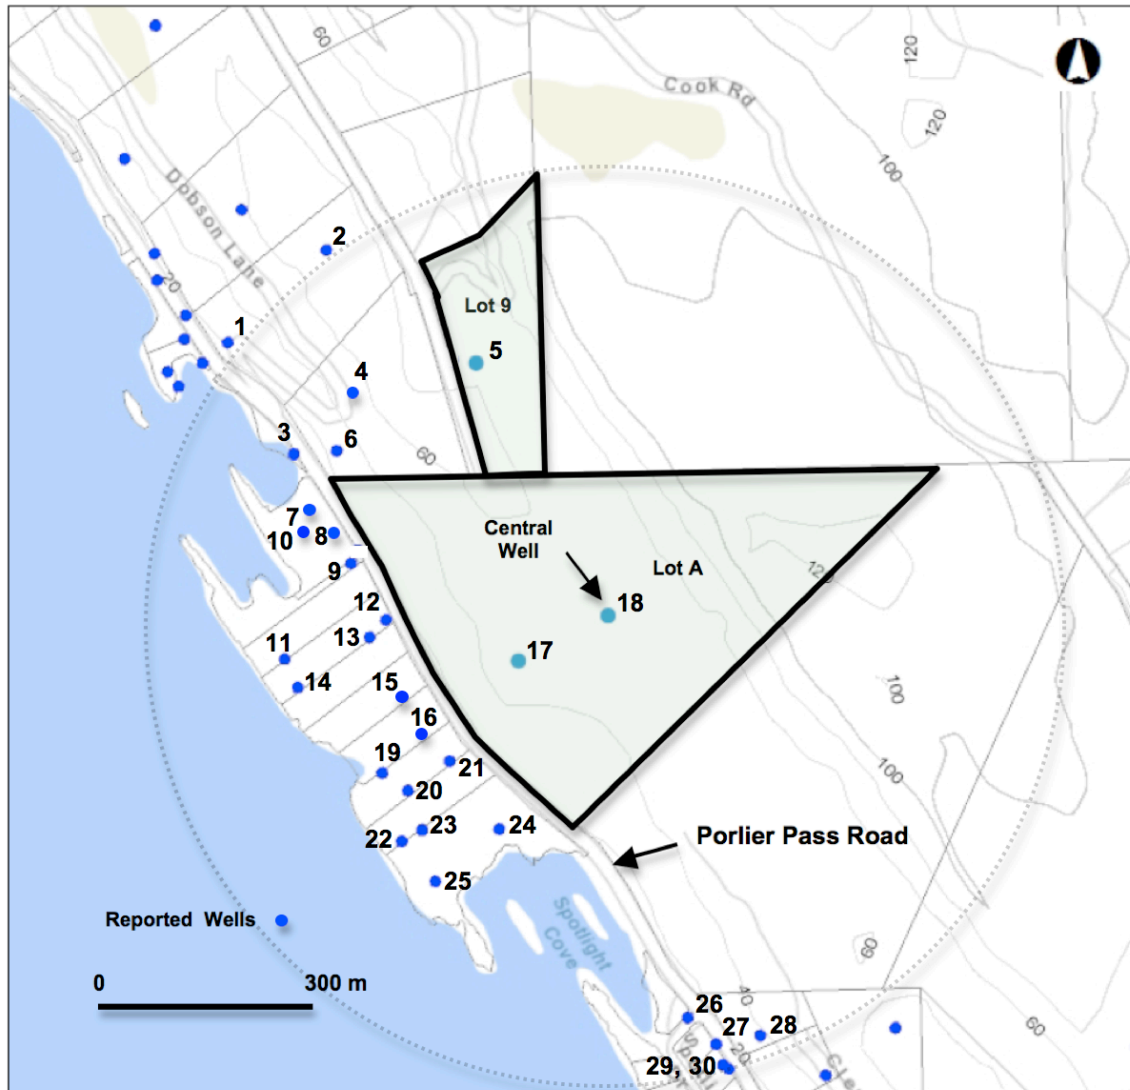
Figure 4. Existing wells and springs within 0.64 km of the central well on Crystal Mountain property.

Figure 4 shows the location of 30 known and reported water wells and springs within 0.64 km. of the central well on the Crystal Mountain property. It should be noted that all well locations have not been verified in the field. Table 2 provides a brief description of the wells within the 0.64 km radius of the central well. Wells currently within the Ministry of Environment's database are identified in Table 2 with a Ministry well tag number (WTN) that is a unique computer generated identification number. In recent years, the Ministry has also provided well identification plate (WID) numbers to well drillers for attaching to the casing of new wells for their identification in the field.

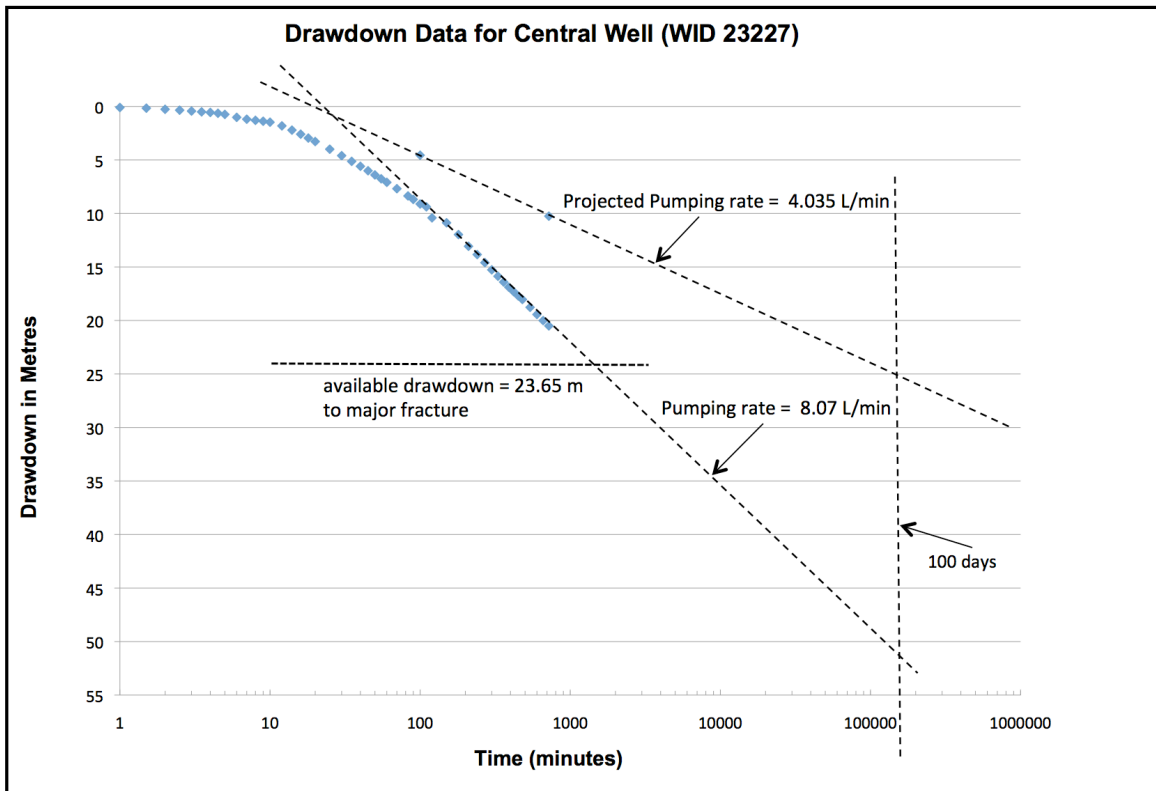
Figure 5. Drawdown in the central well observed during pumping at 8.07 L/min and projected drawdown at a pumping rate of 4.035 L/min.

During the pumping test (Test 2) drawdown in the pumped well (Figure 5) reached a level of 20.505 m below the pre-pumping level of 13.290 m, utilizing 86.7 percent of the available drawdown of 23.65 m to the major water-bearing fracture at a depth of 36.58 m (120 feet). Specific capacity at the end of the test of was 0.3936 L/min per meter. As the drawdown showed no evidence of stabilization at the pumping rate of 8.07 L/min it is evident that the well would not be able to sustain this rate for a period of 100 days without recharge. Reducing the pumping rate by 50% to 4.035 L/min as shown in Figure 5 would result in the drawdown reaching the main water-producing fracture after 100 days of pumping. Applying a 70% safety factor (i.e. utilizing only 70 percent of the

available drawdown in the well) would indicate a potential long-term well yield of 2.826 L/min (4069 L/day). This calculated yield is 43% more than the estimated water supply requirements of 2839 L/day and would amount to a total potential supply of 1.49 million litres/year. Water level in the well recovered to within 95% of the pre-pumping level after 1000 minutes following pump shutdown. The recovery graph (Figure 2, Appendix B) indicates that the well would fully recover within a reasonable time.

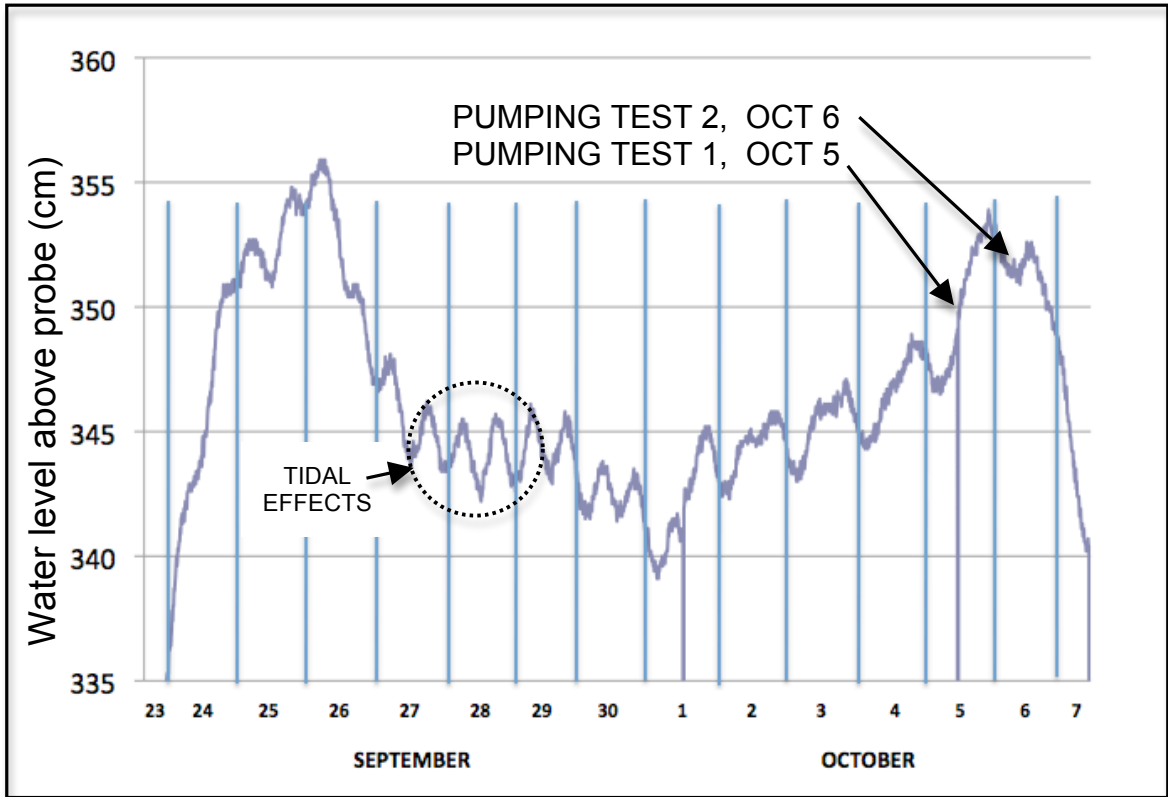
Figure 6. Water levels in observation well site 5, (WTN 56583/WID 23228).

No discernable pumping effects were observed in the two observation wells monitored during the October 5 pumping test as water levels were rising slightly in these wells at the time (Figures 6 and 7). Similarly, well site 17 showed a rising trend during the October 6 pumping test while well site 5 showed a slight declining trend, dropping less than 5 cm during the test. This minor decline was likely due mainly to tidal effects. Both wells show daily water level changes that range from 3 to 7 cm due to tidal effects. During the period September 23 to October 7, the water level in well site 17 showed an overall downward trend falling about 15 cm. During the same period the water level in well site 5 showed an initial rising trend over 3 days, followed by a declining trend for 6 days and then rising again for 5 days before declining again. Total water level variation was about 20 cm. The longer term variations shown at well site 5 suggest some pumping effects of a nearby well, likely down-slope, but these effects are not due to any pumping of the central well. The above data indicates that pumping the central well at a rate of 1.972 L/min (2839 L/day) would have no measureable effect on any of the neighbouring wells or surface water sources in the region.

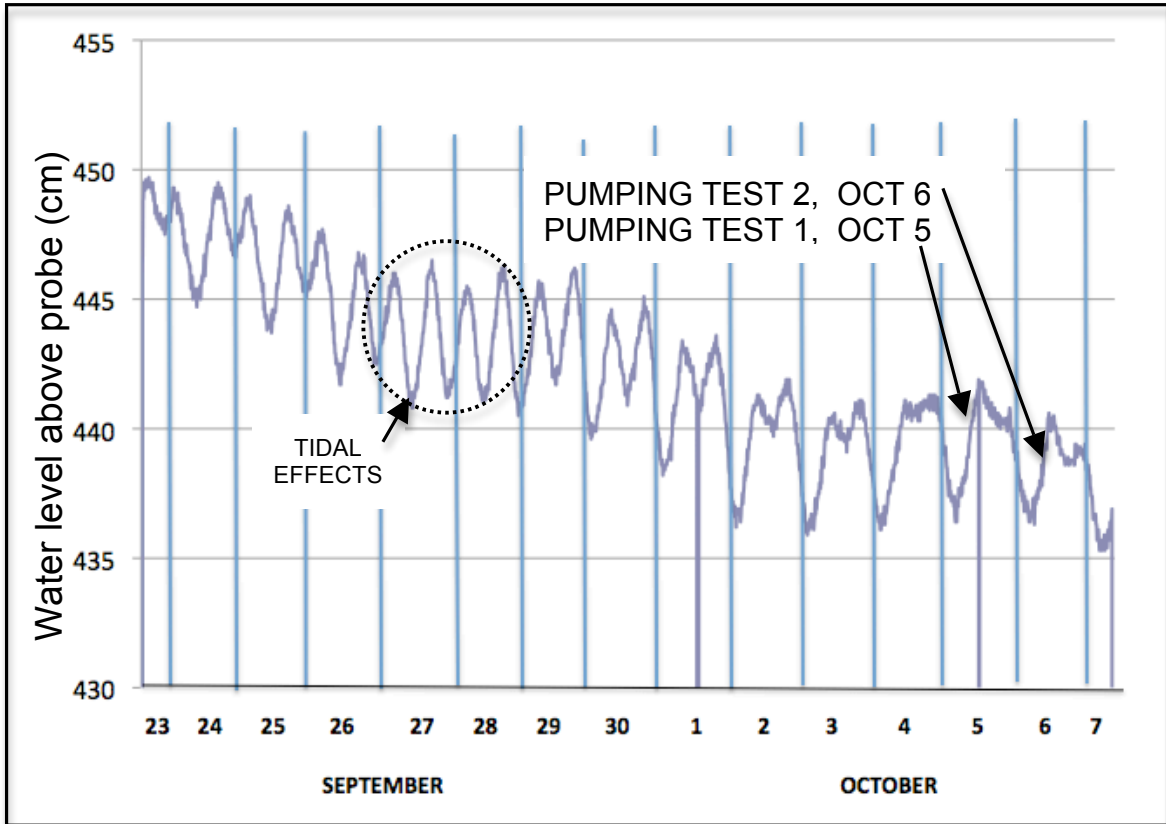
Figure 7. Water levels in observation well site 17, (WID 23229).

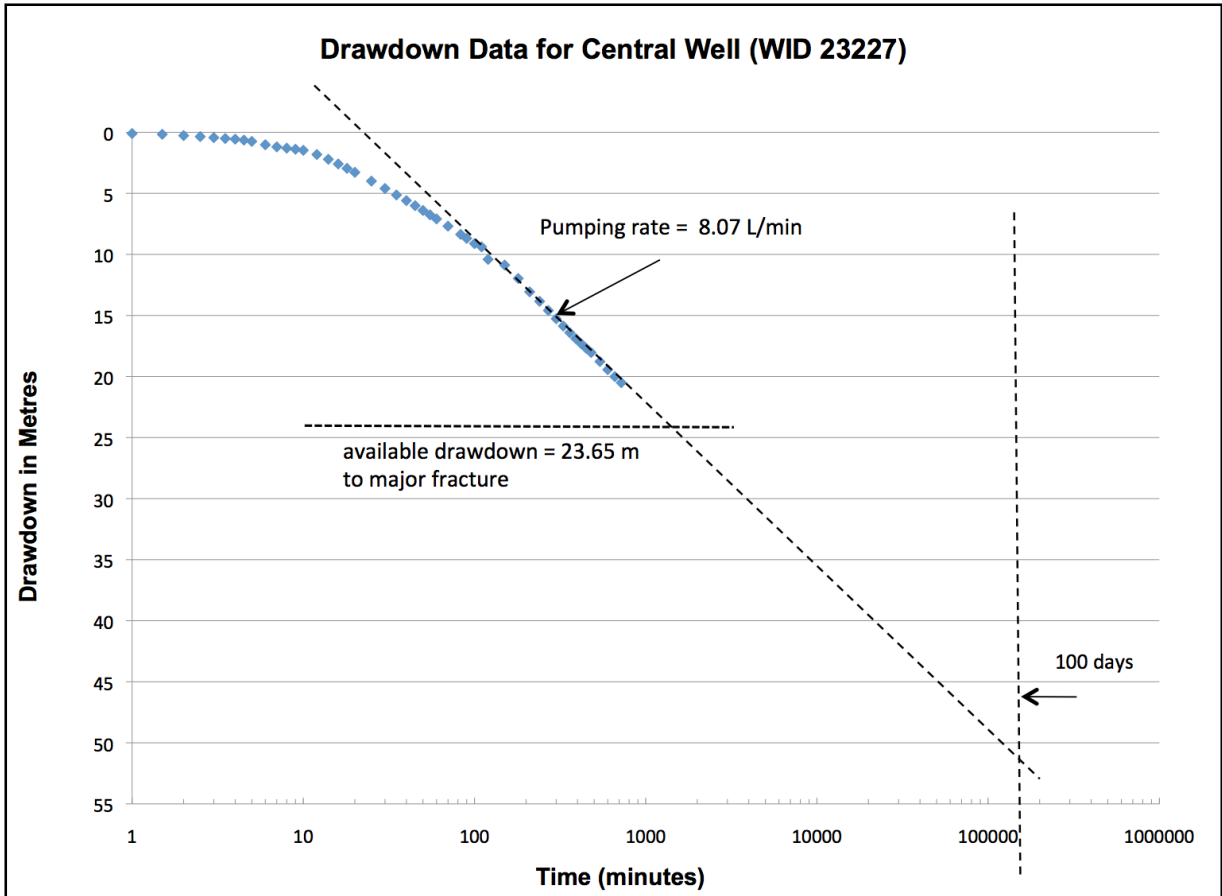
Figure 1. Drawdown graph for central well, pumped October 6, 2015.

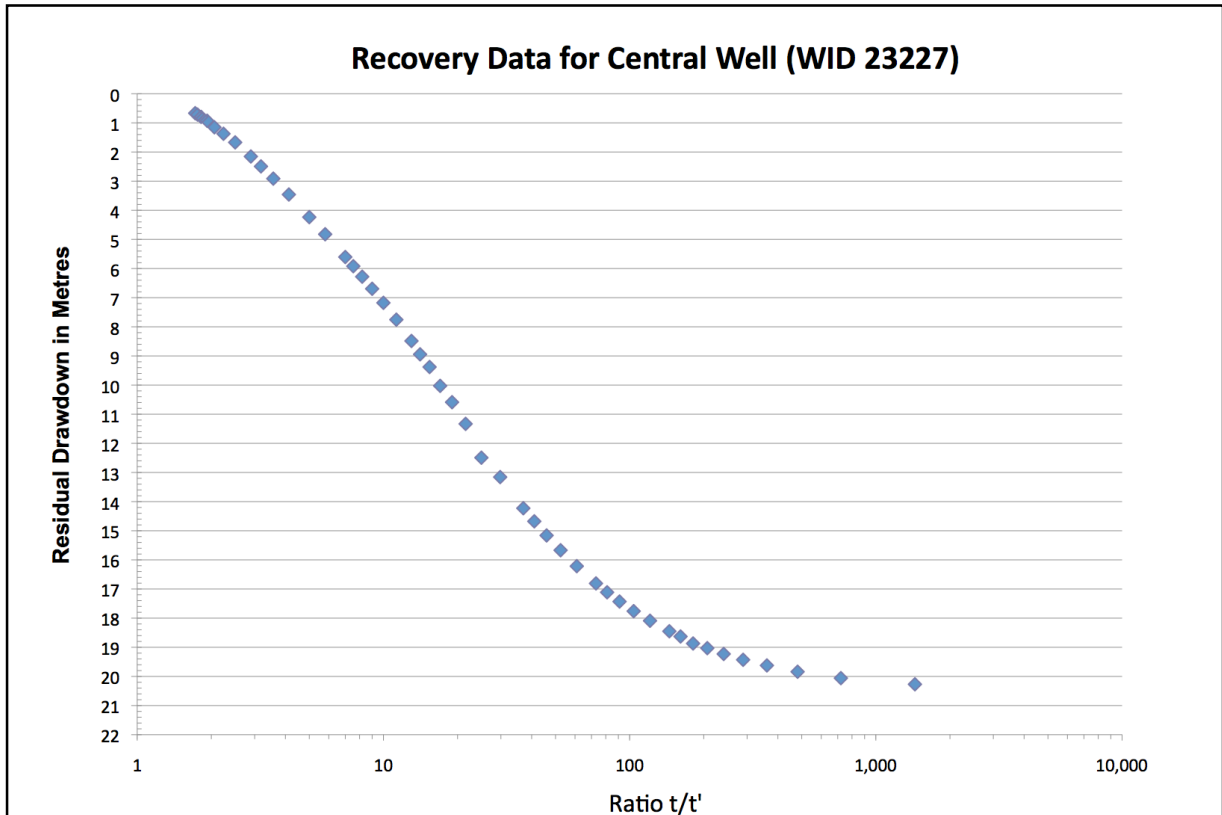
Figure 2. Recovery graph for central well, pumped October 6, 2015.

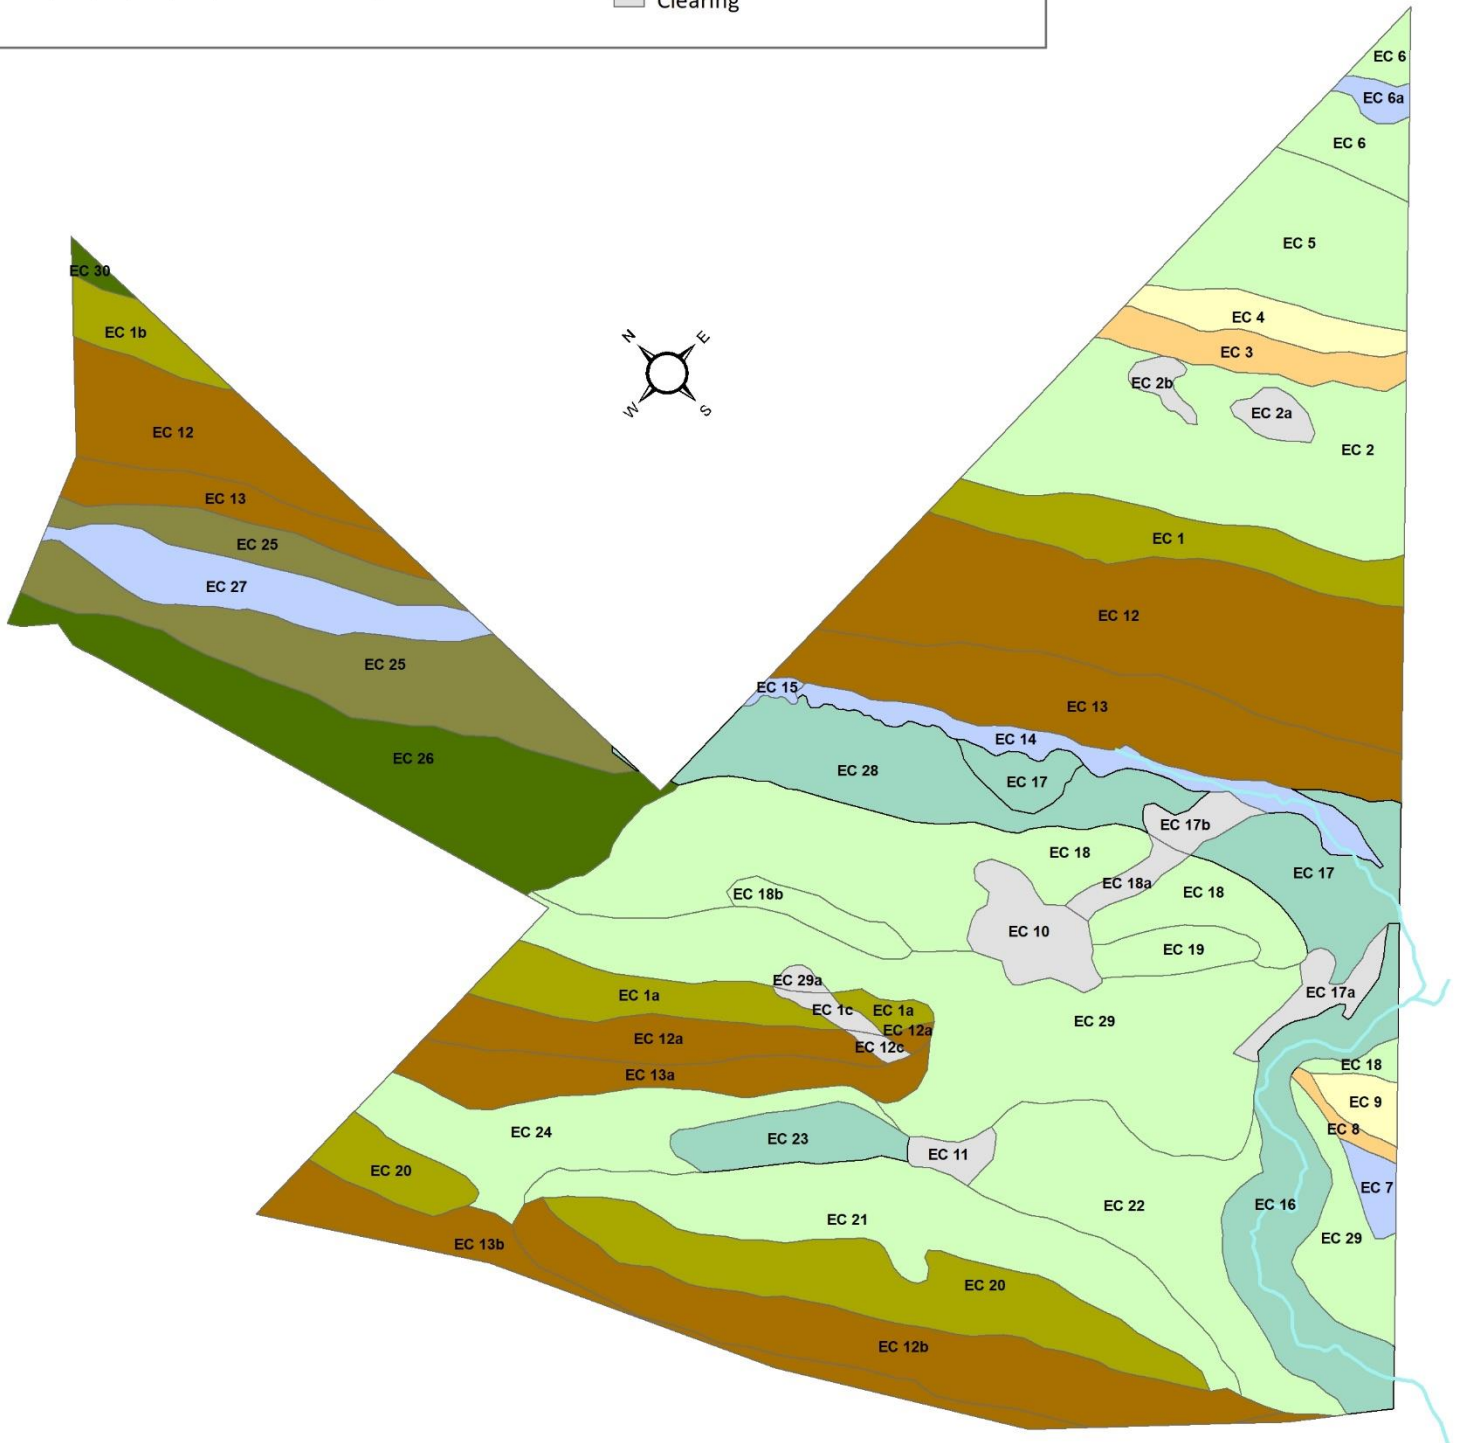
MAP 1

- Creek
- Mature Forest - Moist Soil
- Mature Forest
- Mature Forest - Steep SW Slope
- Mature Forest - Ridge
- Immature Forest - Moist Soil
- Immature Forest
- Immature Forest - Steep SW Slope
- Immature Forest - Ridge
- Wetland
- Clearing

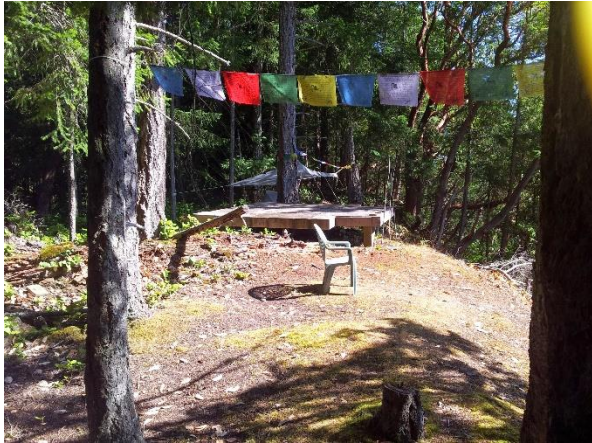
2013 – Platform in active use.

A meditation platform was removed from southwest edge of ridge in Polygon 1 in 2016. This site is now designated for day use meditation which does not require infrastructure.

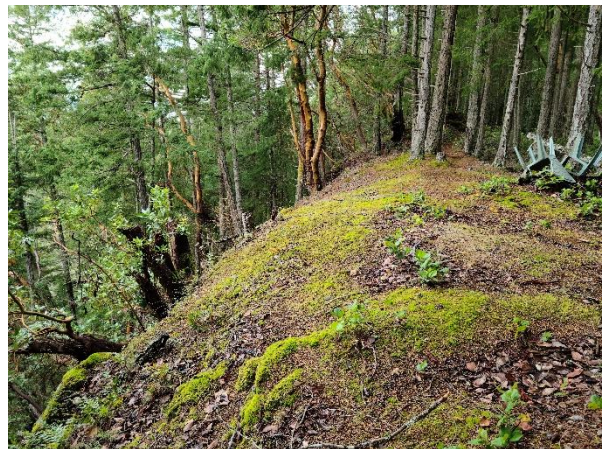
December 2020 – site recovering.

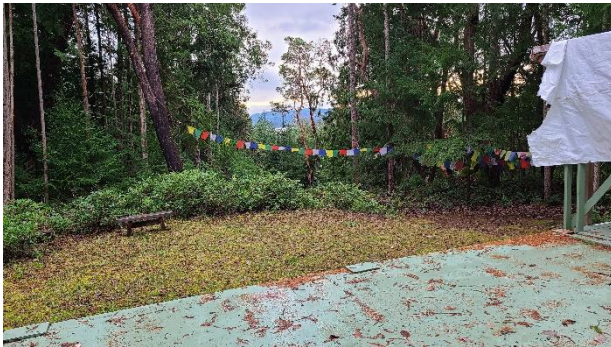
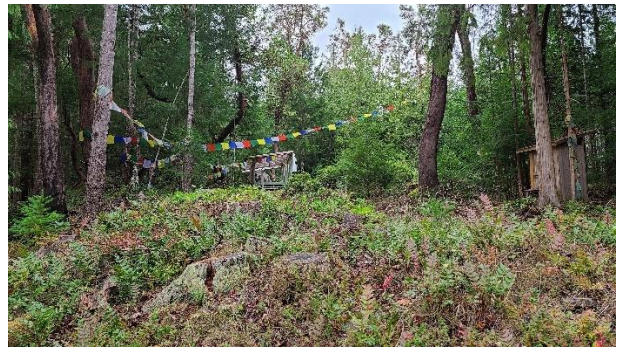
In Polygon 01a, a patch of forest extending south from the meditation platform has been logged to create an unobstructed view to the Trincomali Channel. The cutting extends down through Polygon 12a and into Polygon 29. The platform and clearing are shown on the accompanying map and labeled as Polygons 01c, 12c and 29a.

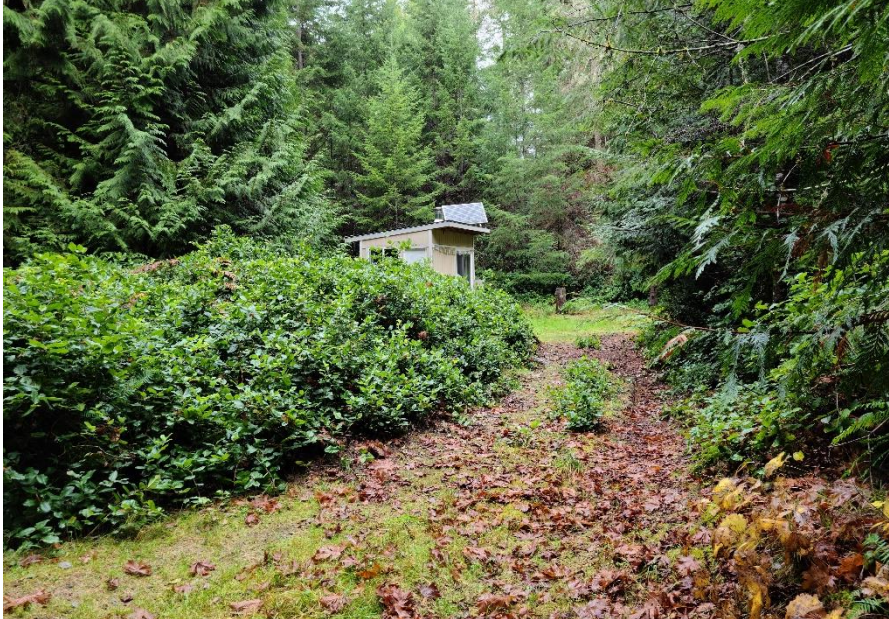
A sleeping hut and related clearing have been established in this polygon. The clearing is shown on the revised Ecological Communities Map and is shown as Polygon 2b. Access to the hut is from the established easement road through EC02.

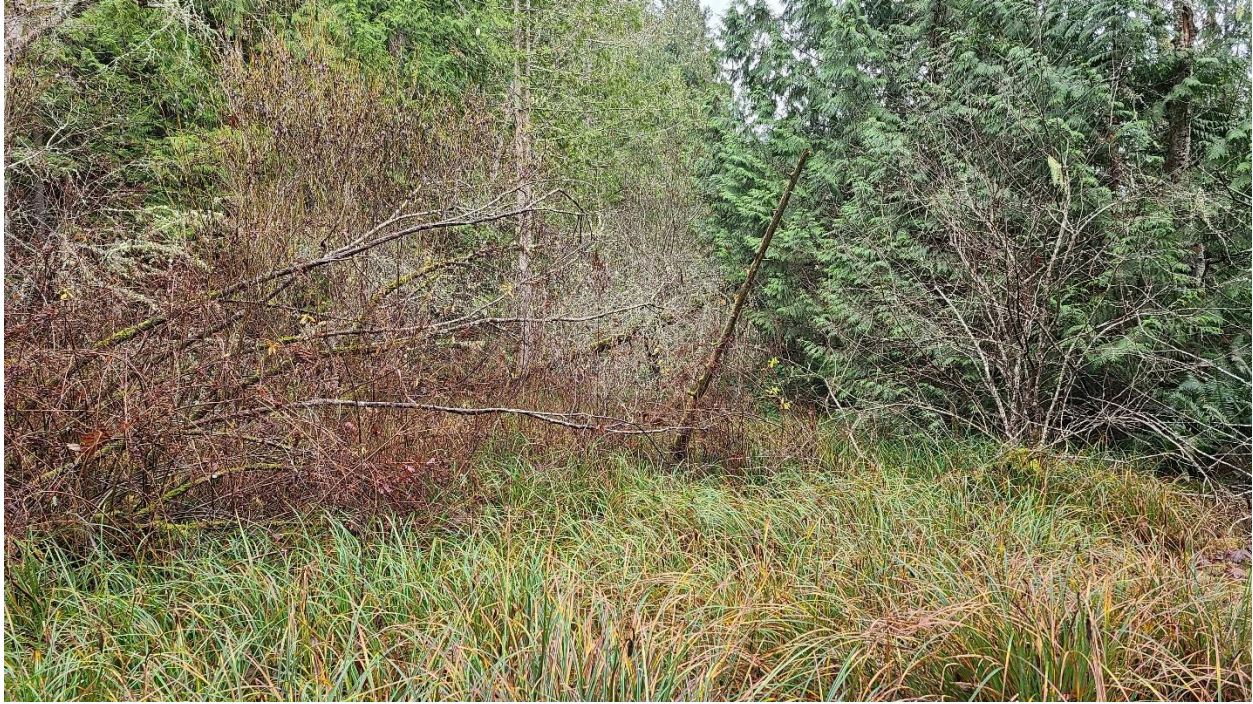
The map label EC15 now refers to a small, previously unmapped wetland that was discovered at the toe of the major cliff line along the norther boundary of Lot A. The wetland is dominated by slough sedge (*Carex obnupta*) mixed with patches of hardhack (*Spirea douglasii*) along with scattered willow (*Salix sitchensis?*), Pacific ninebark (*Physocarpus capitatus*) and black hawthorn (*Crataegus douglasii*) in the shrub layer. The margins of the wetland are lined with red alder, Western redcedar, and grand fir along with a dense sword fern and salal patches characteristic of a CDFmm/06 ecosystem as it transitions into EC28 to the west and EC13 to the east.

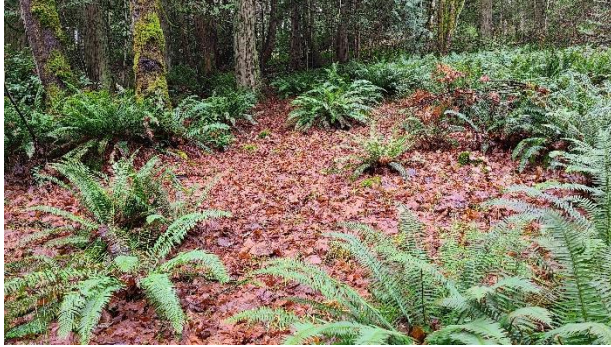
Dec. 2020: Site of former meditation hut.

Meditation huts have been carefully deconstructed and removed. There is 1 outhouse and 1 storage shed remaining in this area. These structures are slated to be removed prior to transfer of the land.

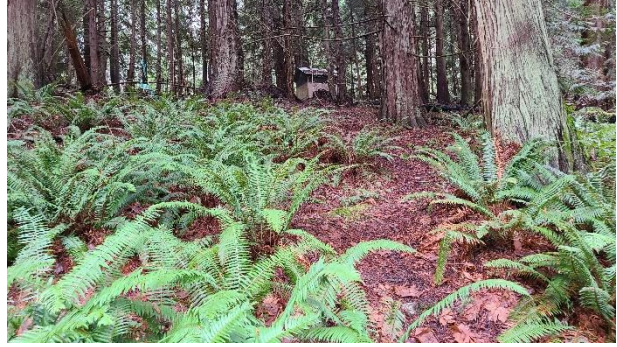
Shed to be removed.

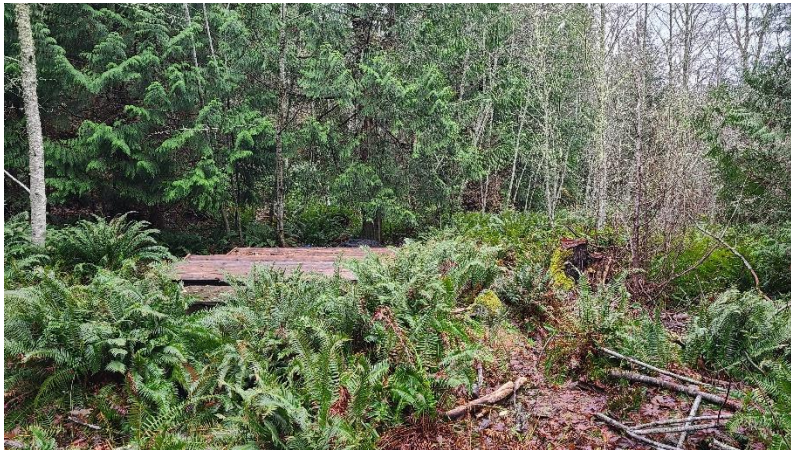
Disassembled platform shown in background. Stump of cut tree just to right of platform.

A small area was cleared of shrubs and a couple of trees were cut to accommodate a tent platform in this polygon. The platform will be removed, and the site will be restored prior to transfer. This area is shown on the updated map.

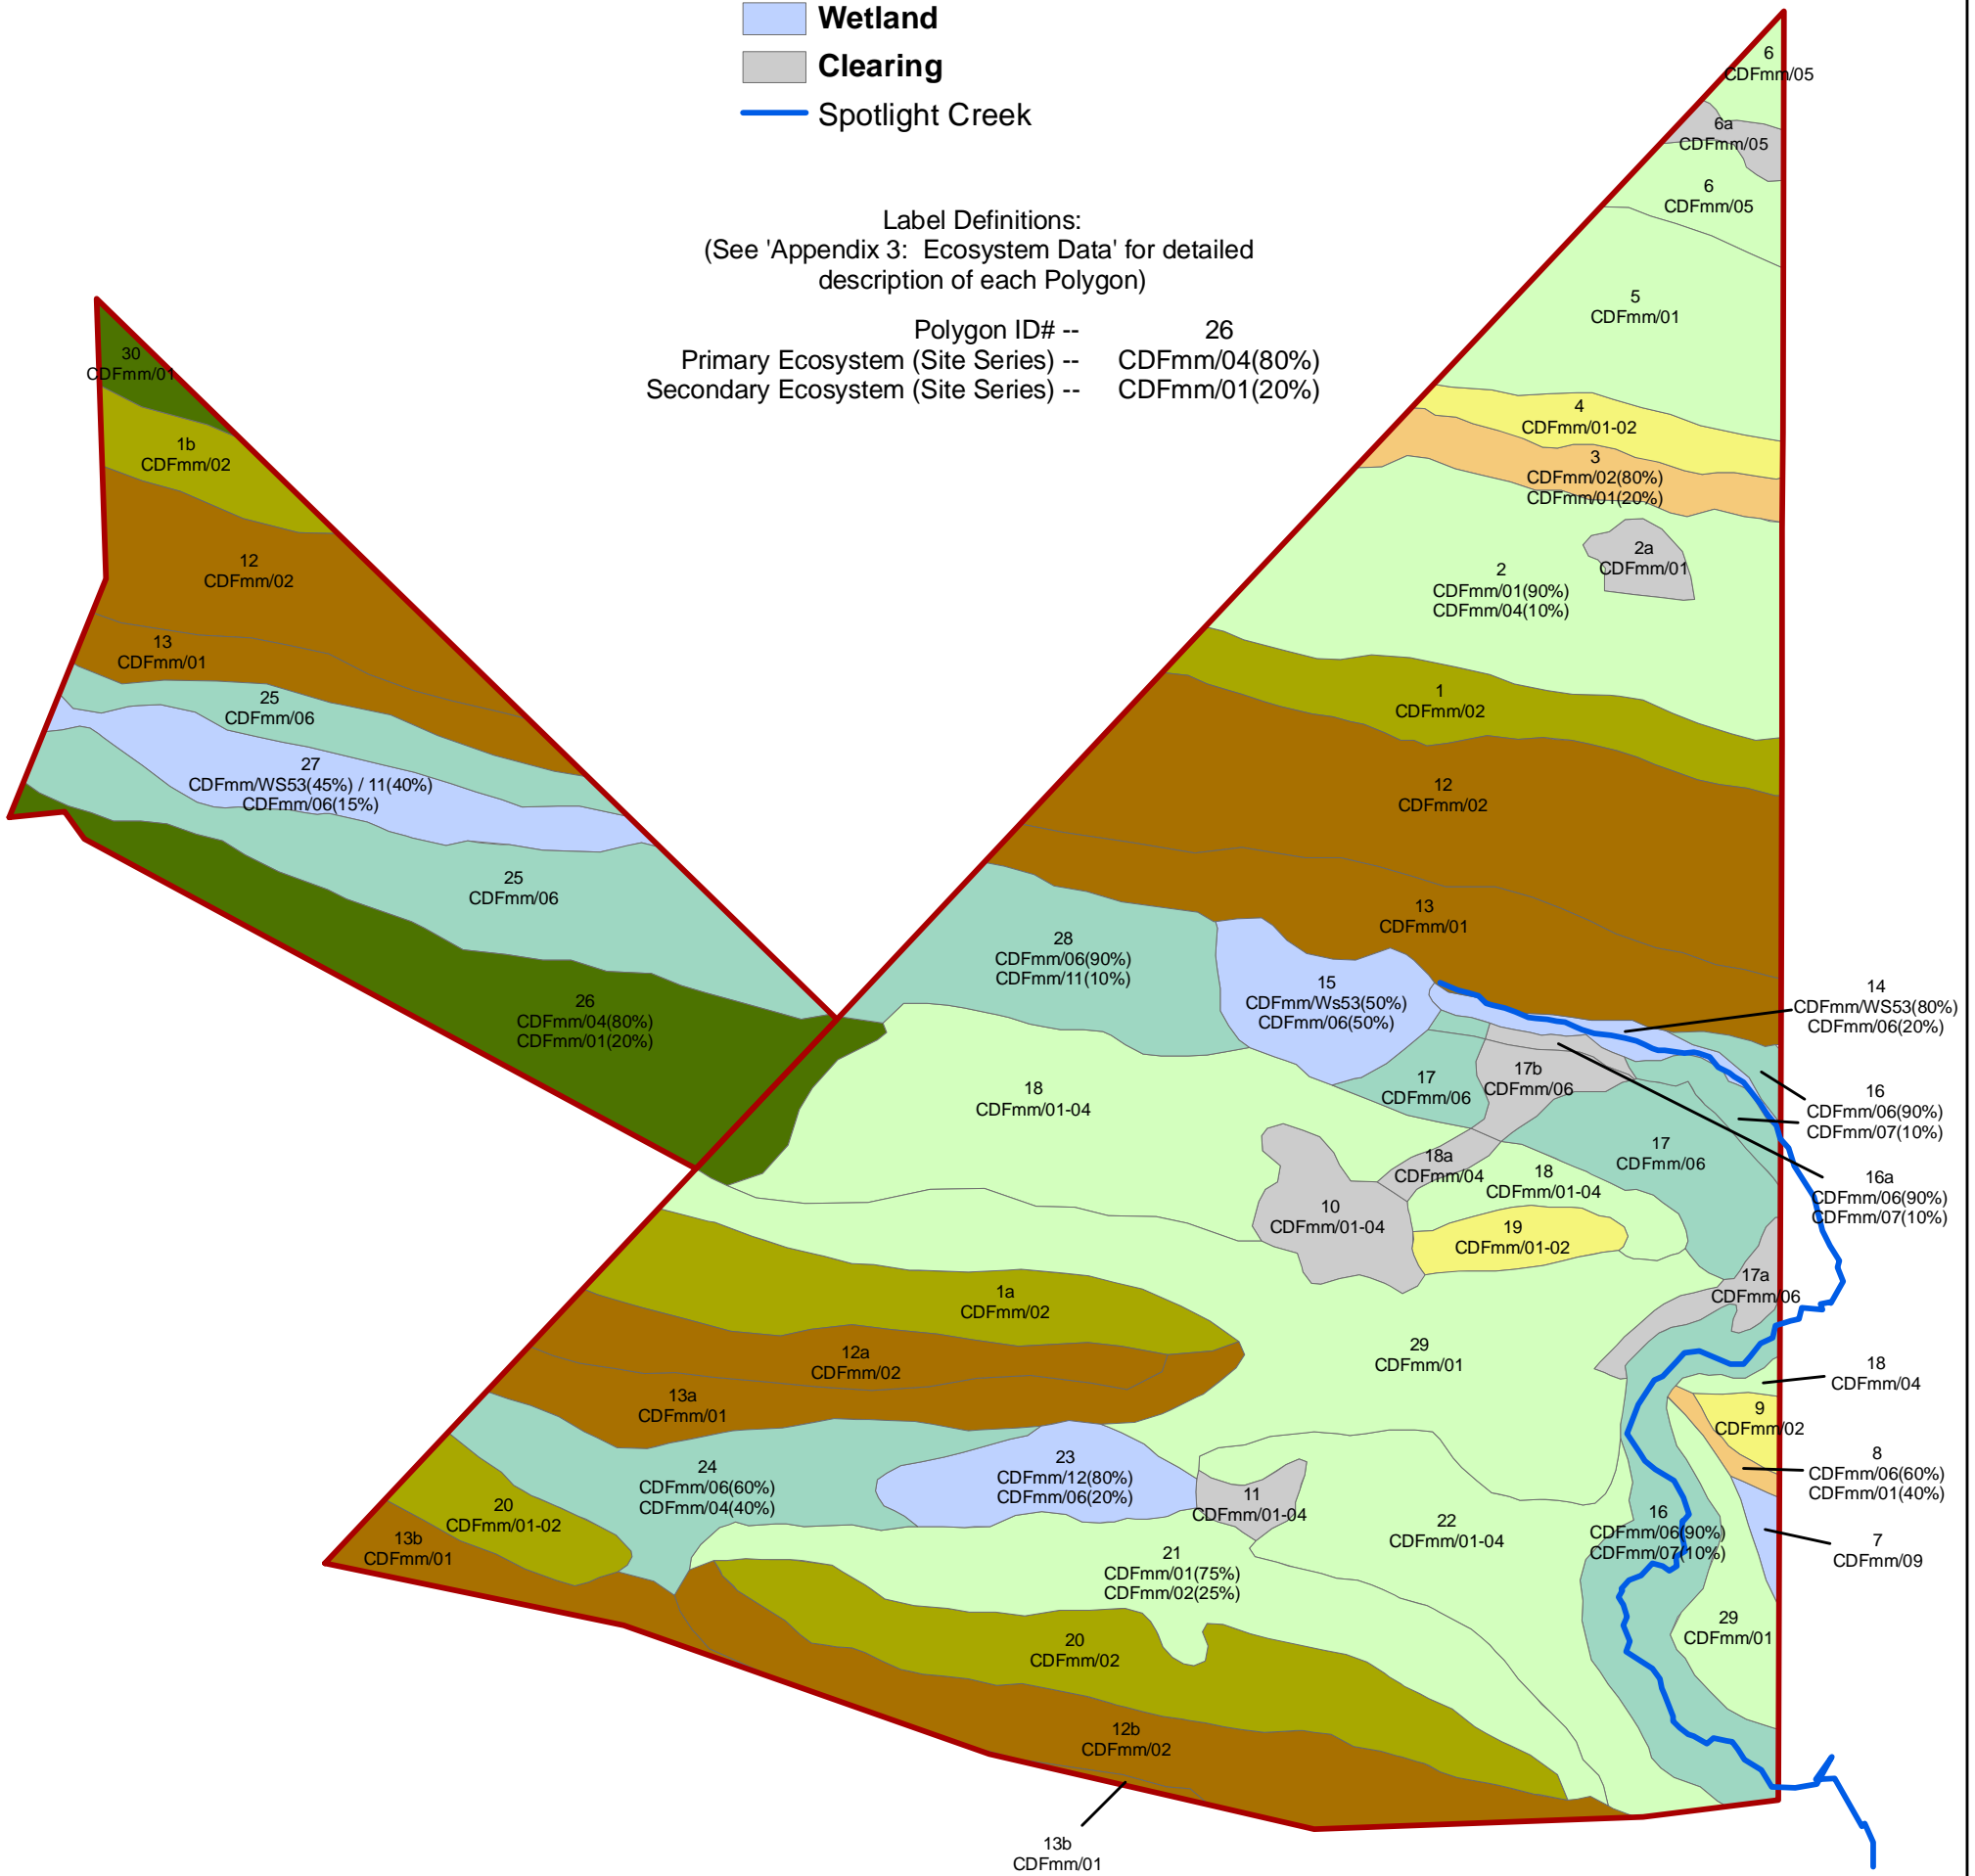
Label Definitions:
(See 'Appendix 3: Ecosystem Data' for detailed description of each Polygon)

Polygon ID# --	26
Primary Ecosystem (Site Series) --	CDFmm/04(80%)
Secondary Ecosystem (Site Series) --	CDFmm/01(20%)

Produced by: Keith Erickson (R.P.Bio.)
 Map Date: December 2009
 Scale: 1 : 2,850
 Projection: UTM Zone 10 NAD83
 Rotation: 46.5 degrees W of N
