Re: Installation of Groundwater Monitoring Well at Concrete Plant, 4415 Bedwell Harbour Road, Pender Island

As requested, Hy-Geo Consulting has prepared the following report on the recent installation of a groundwater monitoring well located down gradient from the concrete batch plant. The installation of a monitoring well was a requirement for property under the Temporary Use Permit, NP-TUP-2023.5 (Grimmer) issued by the North Pender Island Local Trust Committee (2023).

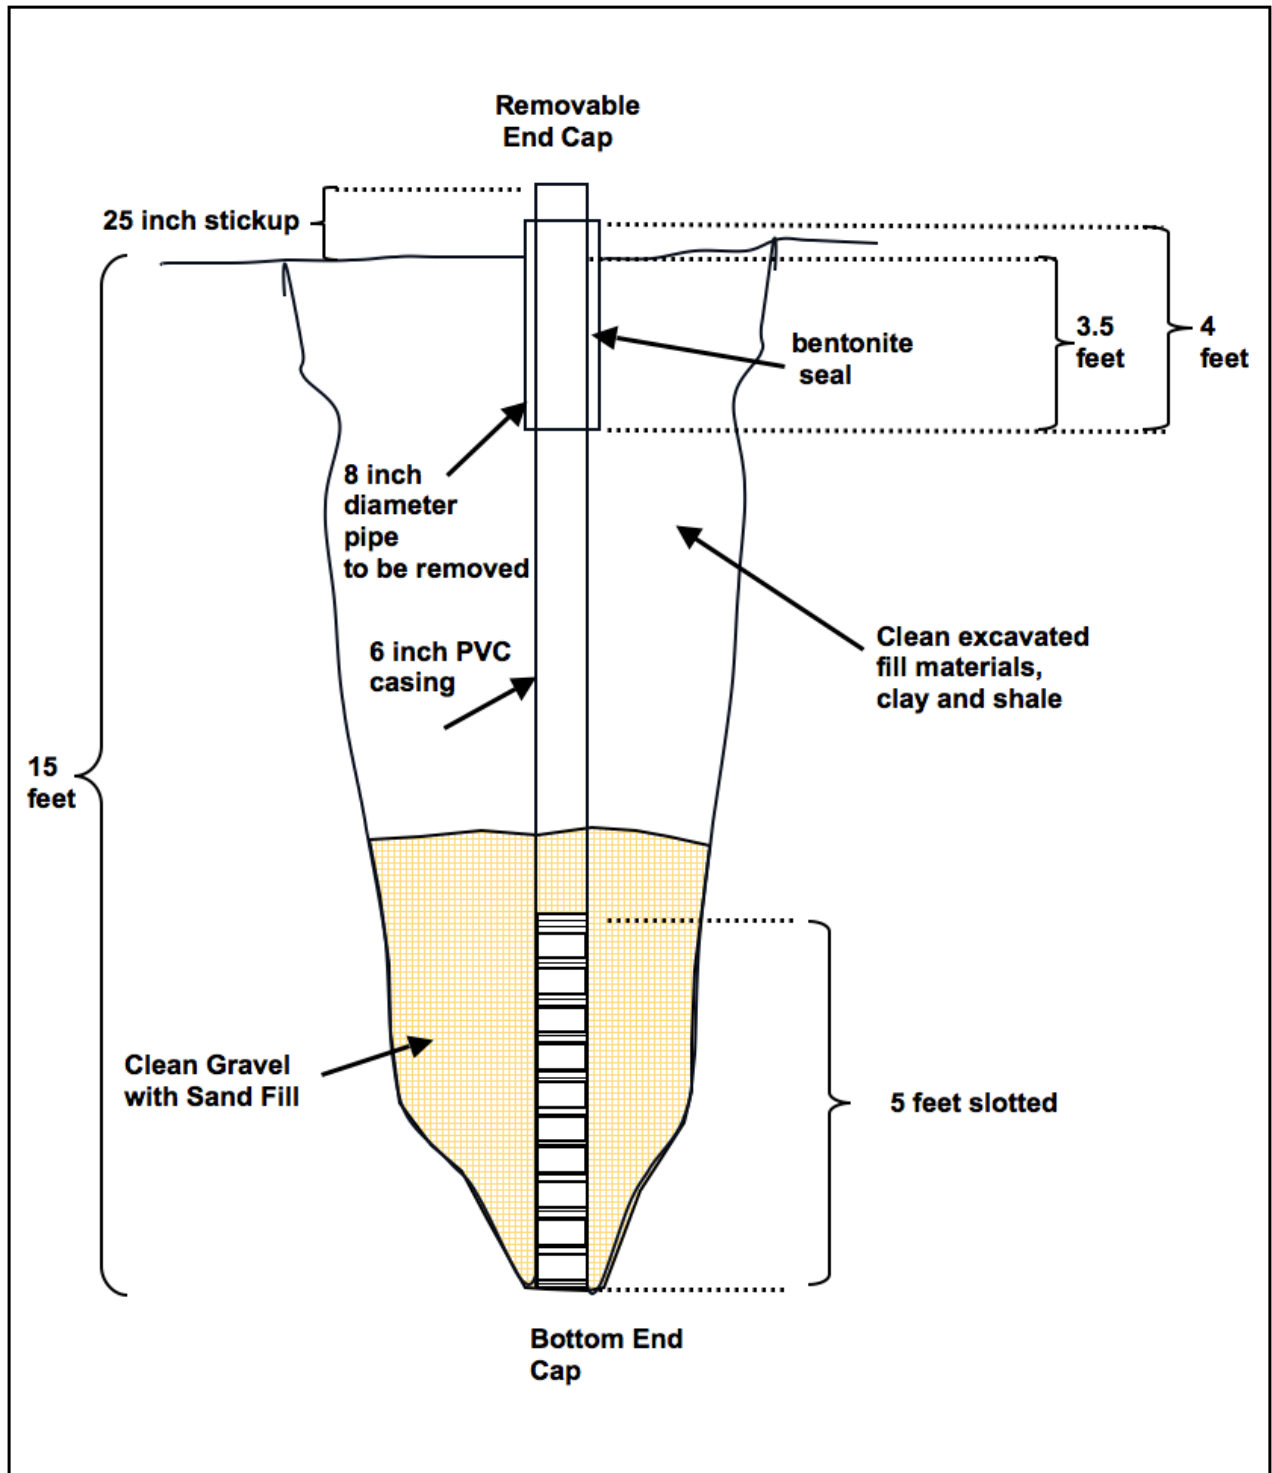
Figure 2. Schematic of monitor well installation, not to scale.

then backfilled in stages with more of the excavated materials while the 8 inch diameter casing was being pulled back until the excavation was completely filled leaving the monitor well casing sticking up 25 inches above the ground surface. Figure 2 shows the design of the monitor well as completed prior to pulling the temporary surface casing. Photo 8, Appendix A, shows the temporary surface casing being removed and Photo 9, Appendix A shows the completed monitor well with 25 inch stick-up.

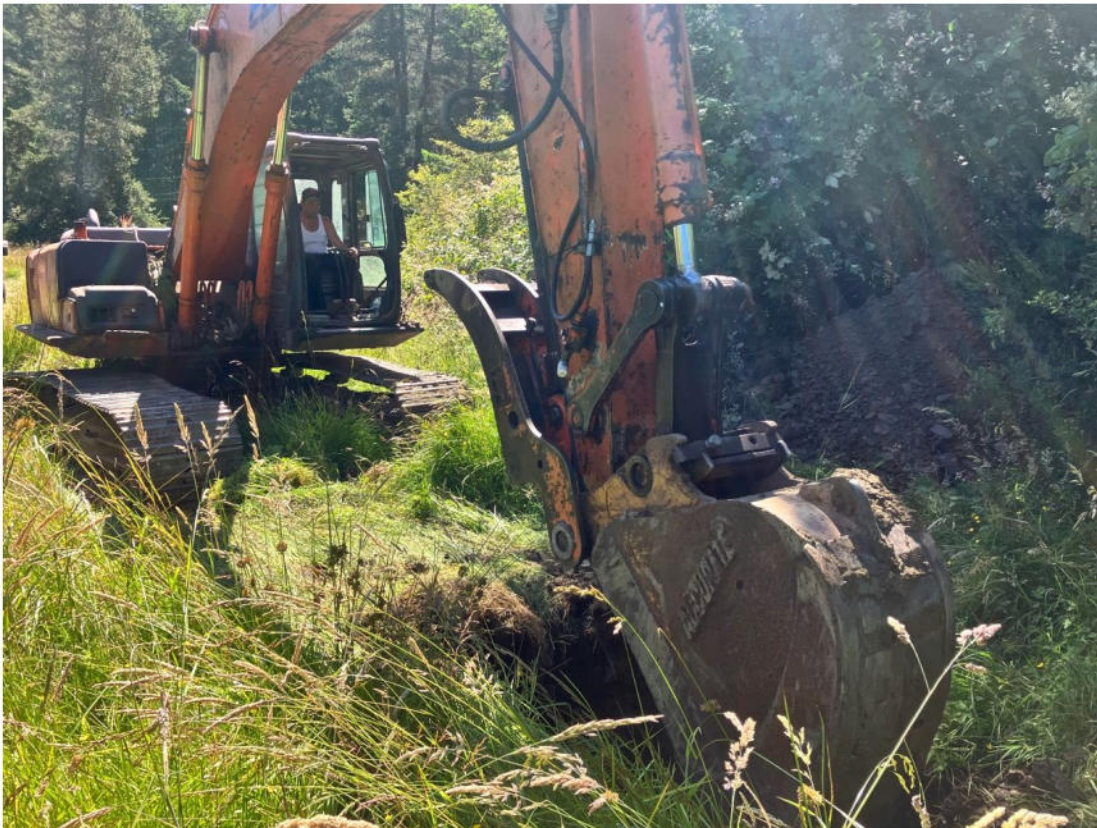
Photo 1. Excavator employed to install monitor well, June 30, 2025.

The monitoring well was constructed by Gulf Excavating Ltd., to a depth of 15 feet (4.6 m) utilizing an excavator (Photo 1, Appendix A). The excavation encountered 1 foot of organic topsoil underlain by 2 feet of buff stiff clay followed by 12 feet of grey clay and shale (Photos 2 and 3, Appendix A). Groundwater was observed below a depth of 11 feet (3.4 m) on some of the fracture surfaces in the shale. After completing the excavation to a depth of 15 feet (4.6 m), a 20 foot (6.1 m) length of 6 inch diameter PVC thermoplastic casing with the bottom 5 feet (1.5 m) slotted was set in the excavation (Photo 4, Appendix A). Water as observed coming at the bottom of the excavation (Photo 5, Appendix A). Clean gravel with sand (Photo 6, Appendix A), was backfilled around the slotted portion of the casing to within 8 feet of the ground surface and the remainder of the excavation was initially filled in with the excavated materials to within 3.5 feet (1.1 m) of the ground surface. A temporary 8 inch diameter surface casing 4 feet (1.2 m) in length was then set over the 6 inch diameter well casing and the annular space between the casings filled with medium-sized bentonite pellets (Photo 7, Appendix A). The area around the 8 inch diameter casing was

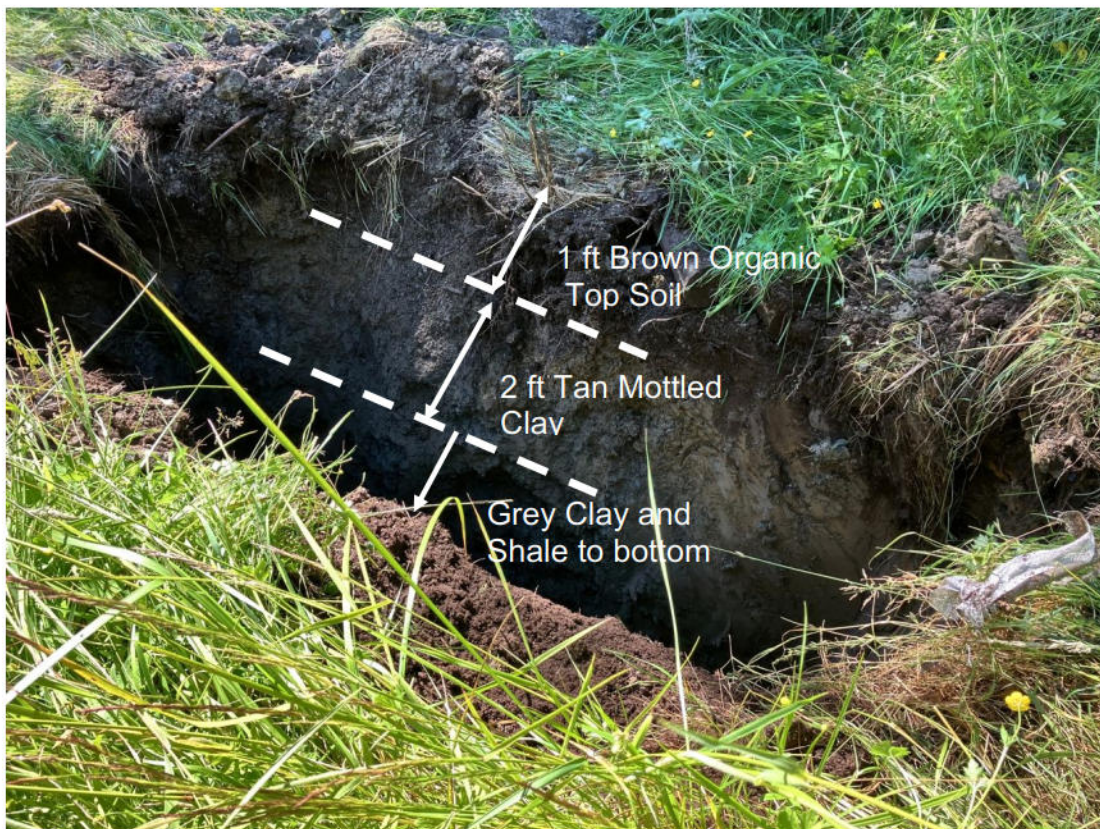
Photo 2. Exposed upper portion of soils in excavation for monitor well, June 30, 2025.

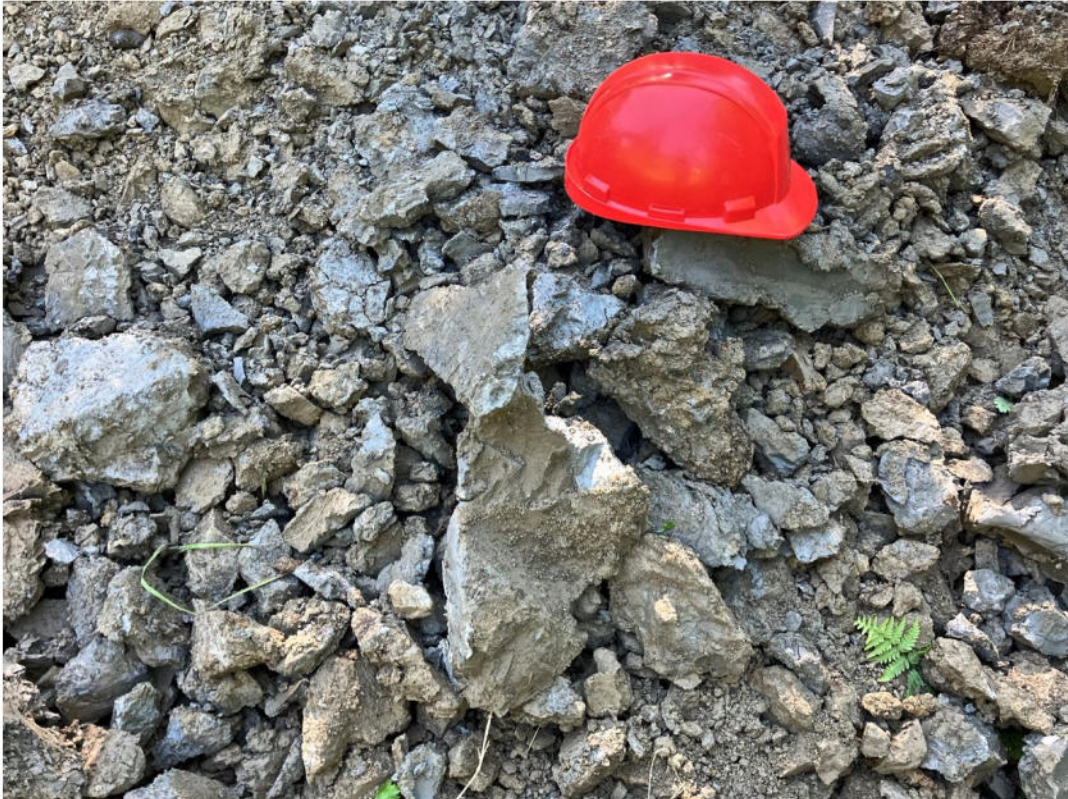
Photo 3. Excavated material comprised of soft grey clay and alternating harder layers of grey mudstone and shale, June 30, 2025.

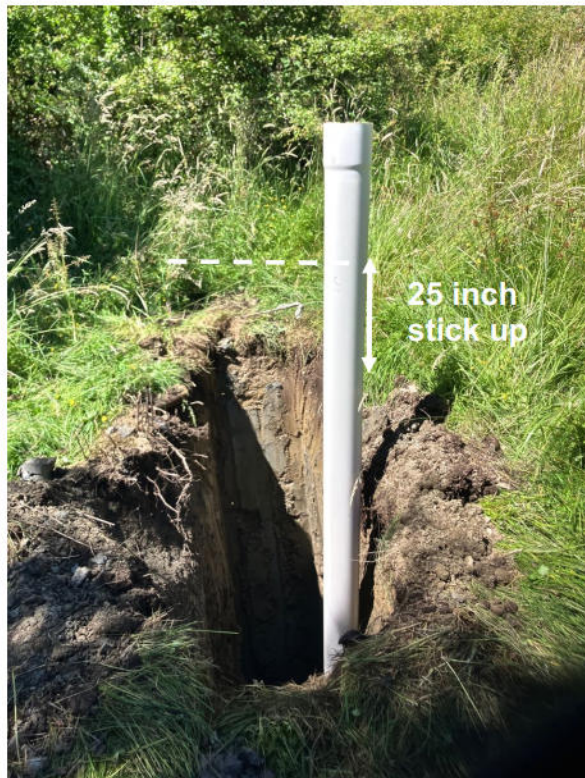
Photo 4. 6 inch diameter PVC well casing set in excavation to depth of 15 feet (4.6 m), June 30, 2025. Casing was subsequently cut to provide a 25 inch (63.5 cm) stick up above ground level.

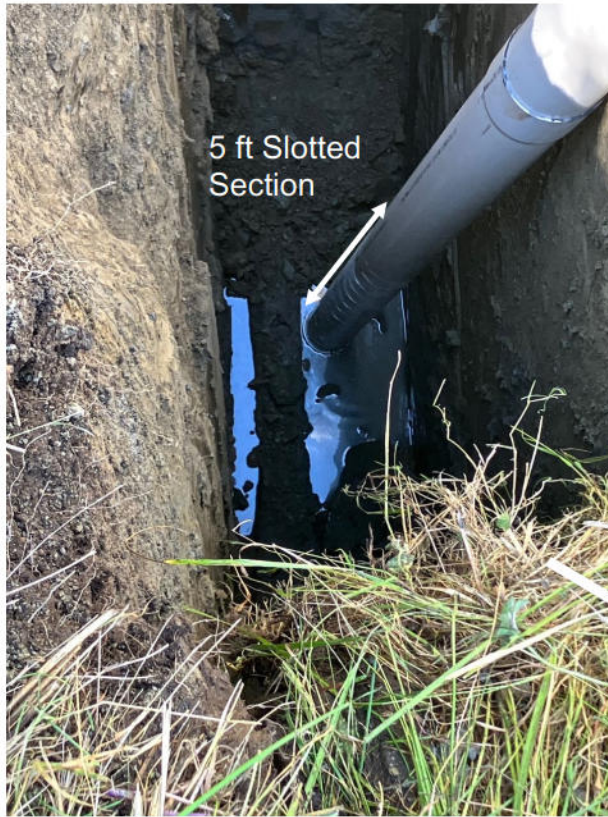
Photo 5. Monitor well casing set in excavation. Note water in bottom of excavation, June 30, 2025.

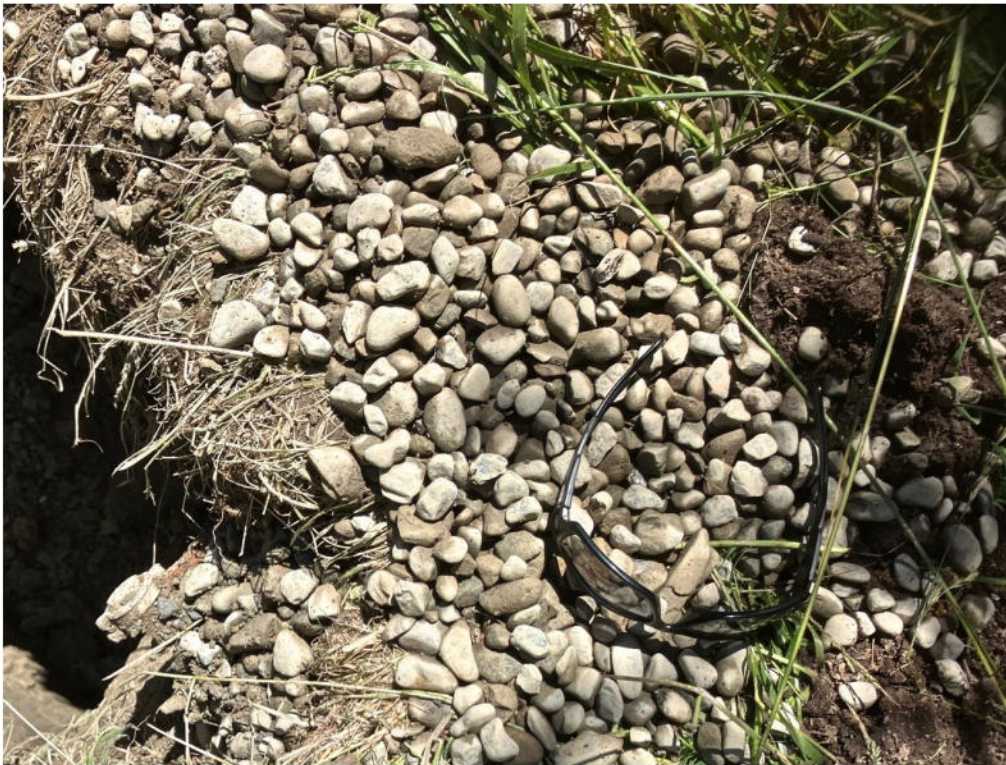
Photo 6. Gravel with sand material for backfill around slotted section of well casing, June 30, 2025.

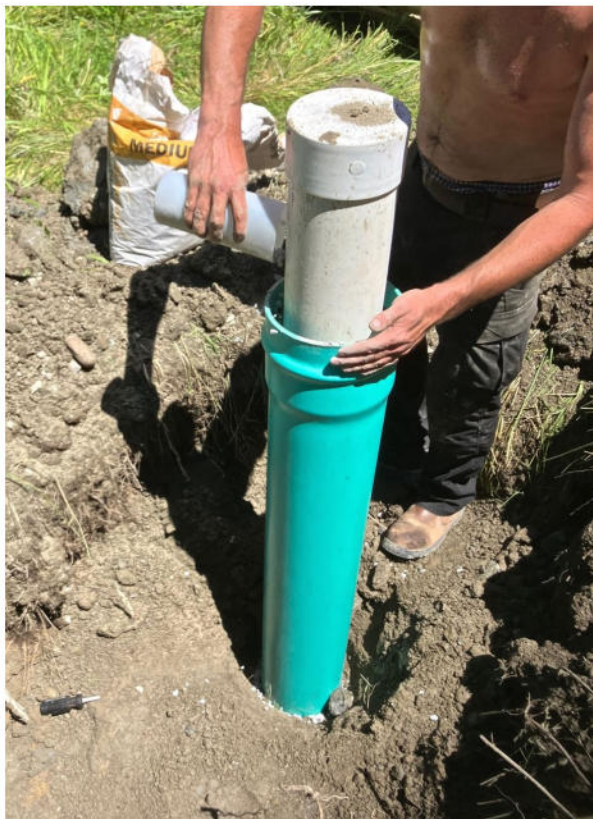
Photo 7. Pouring bentonite pellets between 6 inch diameter well casing and temporary 8 inch diameter surface casing, June 30, 2025.

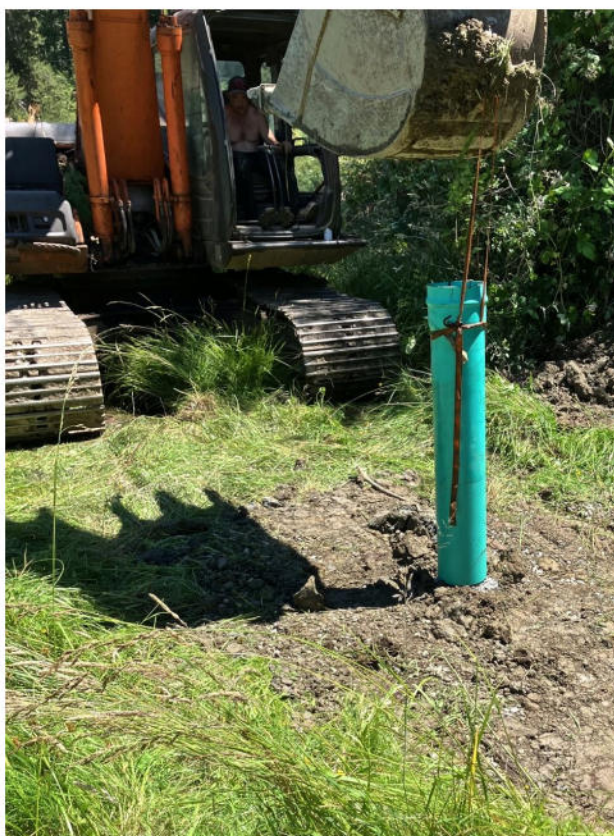
Photo 8. Pulling out 8 inch temporary surface casing, June 30, 2025.

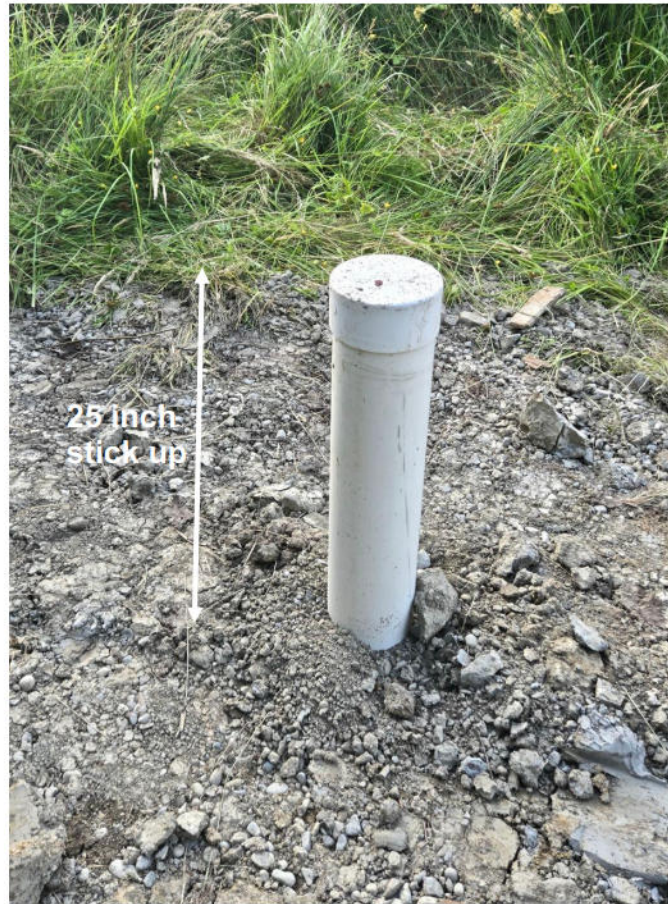
Photo 9. Completed 6 inch diameter monitoring well, June 30, 2025.

1. As the monitor well was completed with PVC thermoplastic casing it would be important to protect the casing from future damage by installing a larger diameter steel casing with a lockable well cap over the plastic casing. This would be in compliance with Section 34 Protection of thermoplastic casings under the *Groundwater Protection Regulation*. Care should be taken not to excavate the bentonite seal around the plastic casing when installing the steel casing. The stick-up of the plastic casing could also be reduced to 12 inches if necessary.
2. Prior to any groundwater sampling of the monitor well it would be prudent to bail several well volumes from the well before sampling.
