DATE OF MEETING: November 21, 2025  
TO: North Pender Island Local Trust Committee  
FROM: Southern Team  
COPY: Robert Kojima, Regional Planning Manager  
SUBJECT: Rezoning Application – Contractor and aggregate storage/sales yard  
Applicant: Braedon Bigham - Big Digem Contracting  
Location: 3334 Port Washington Road, Pender Island

**ENVIRONMENTAL IMPACT ASSESSMENT  
REZONING APPLICATION  
3334 PORT WASHINGTON ROAD, PENDER ISLAND, BC**

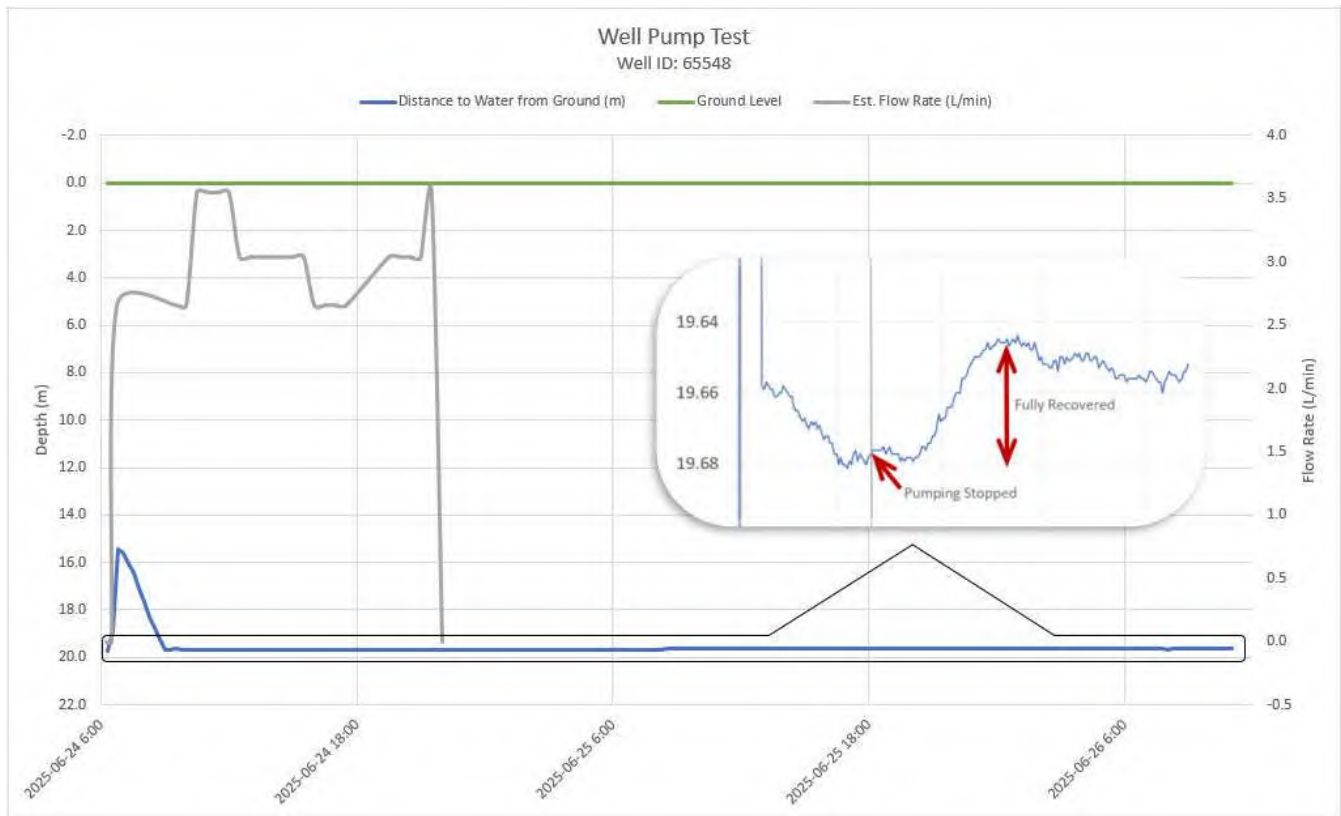
Figure 1: Pump Test and Well Drawdown

Figure 1 demonstrates the results of the pump test at a flow rate of 3.0 L/min. The water rose shortly after the test started and was quickly drawn back down to the initial level within about the first two hours of pumping. An initial spike in the data may be indicative of a plugged screen, which was released with the draw of water through pumping.

As seen in Figure 1, the water level rose nearly 4 cm within 12 hours after the pumping had stopped, fully recovering within a period no longer than the duration of the pumping test. The pump test did not show any signs of negative effects. The well was monitored for 36 hours after the completion of the pump test which generally remained above the initial water level observed prior to the pump test. The theoretical well yield is therefore greater than the 3.0 L/min at which it was tested.

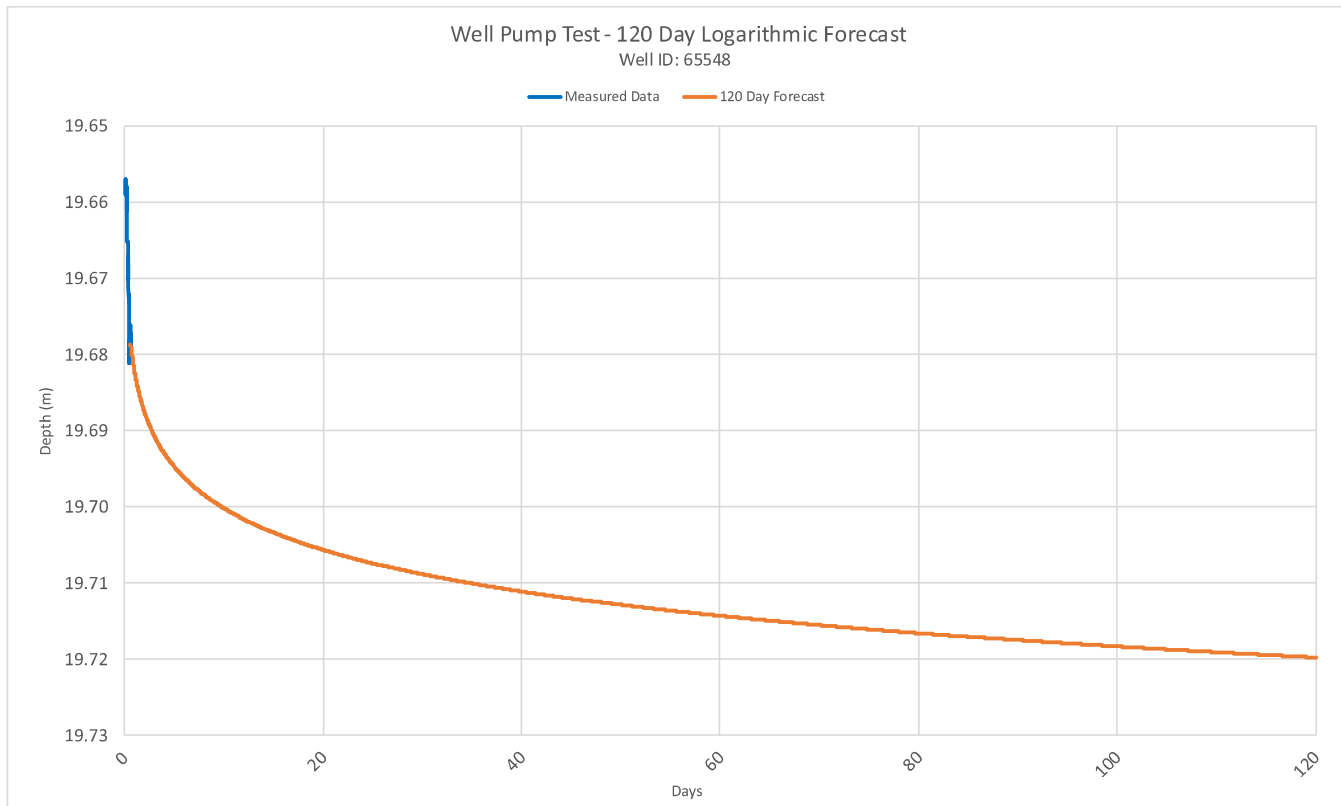
Figure 2: Pump Test 120 Day Projection

Based on the rate of drawdown during the pump test, a 120-day projection can be extrapolated by forecasting the data obtained by the water data logger. By obtaining a logarithmic trendline equation for the data obtained by the data logger, the equation was used to project the trend over 120 days. Figure 2 shows the forecasted water drawdown through 24 hours per day, at 3.0 L/min.

With the well drilled to a depth of 74.7 m, the water drawdown over the 120-day projection does not indicate any concern, as the expected drawdown will bring the water level down to 19.72 m below grade, for a total drop of approximately 0.06 m.

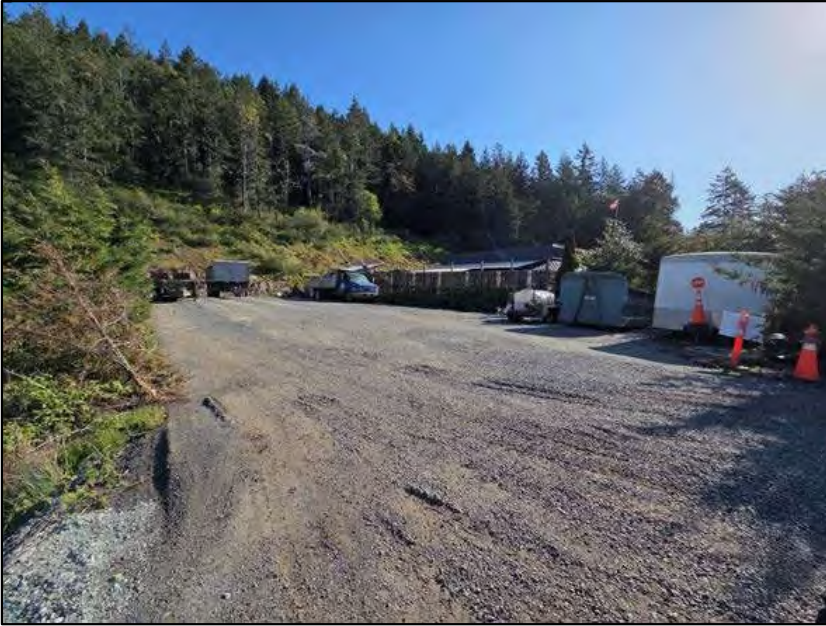
Photo 1: East side of industrial area used to store vehicles.

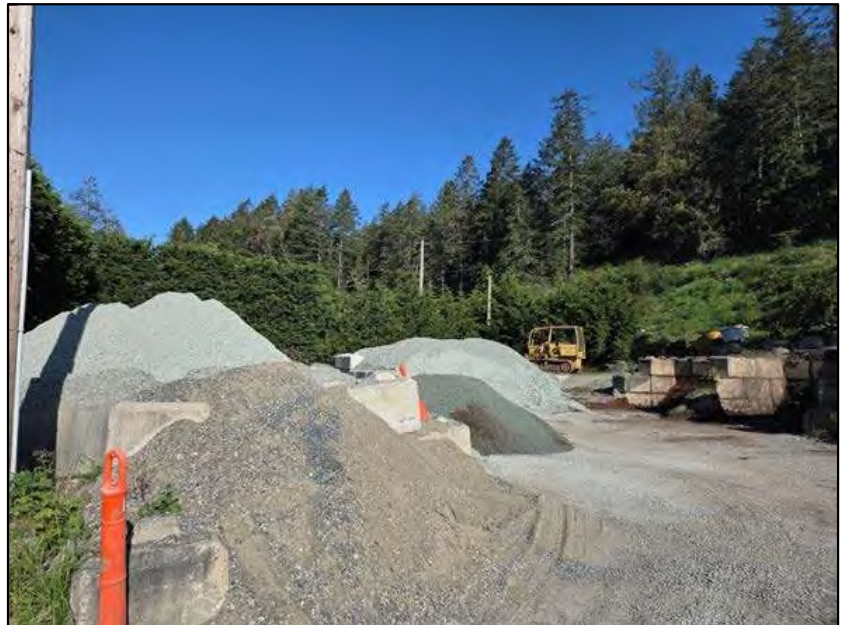
Photo 2: West side of industrial area used as Big Digem work yard. Photo shows piles of aggregates.

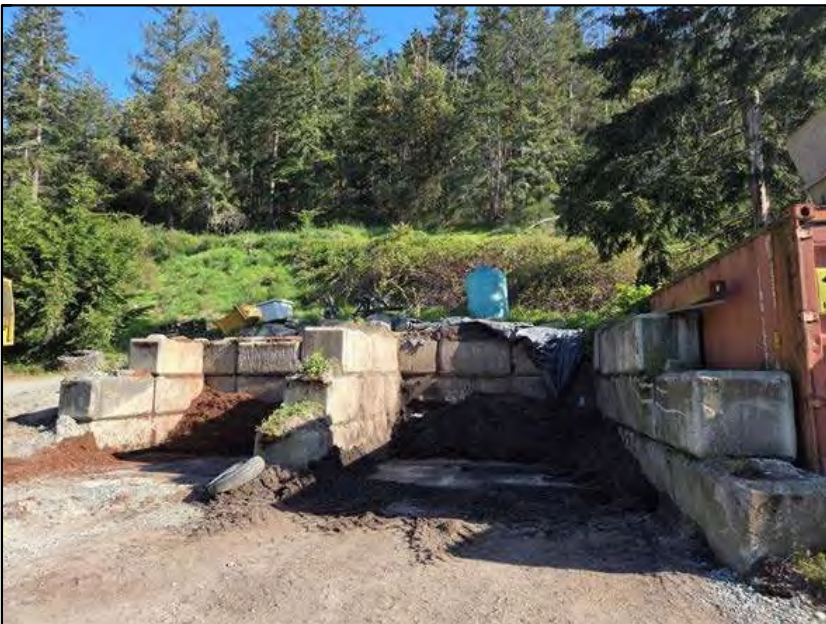
Photo 3: Soils are contained in lock block bins.

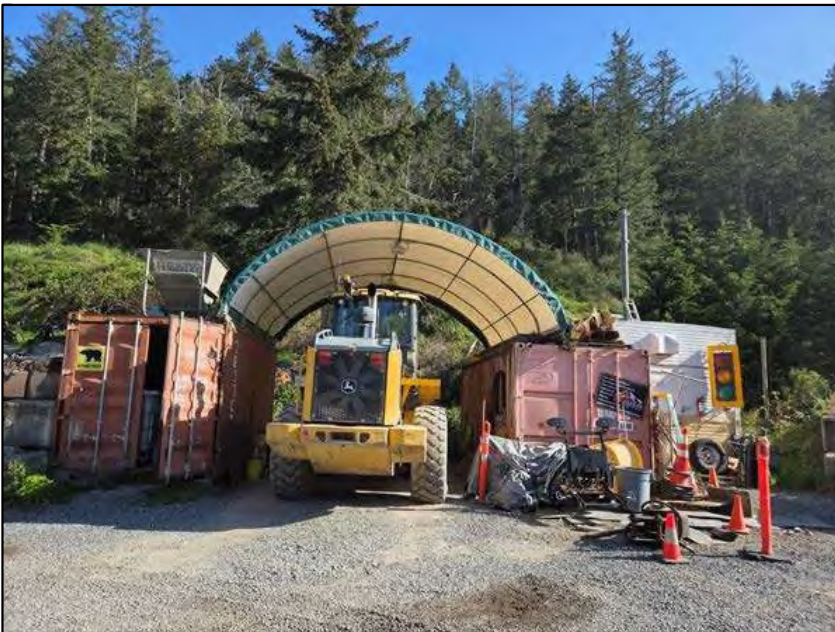
Photo 4: Showing two sea cans. New workshop planned to replace them.

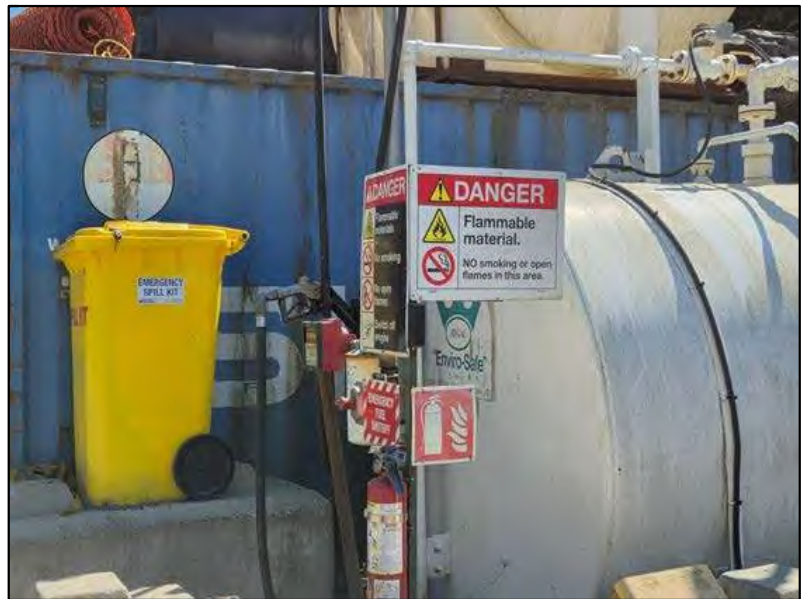
Photo 5: Diesel storage in double walled container with full sized spill kit next to it.

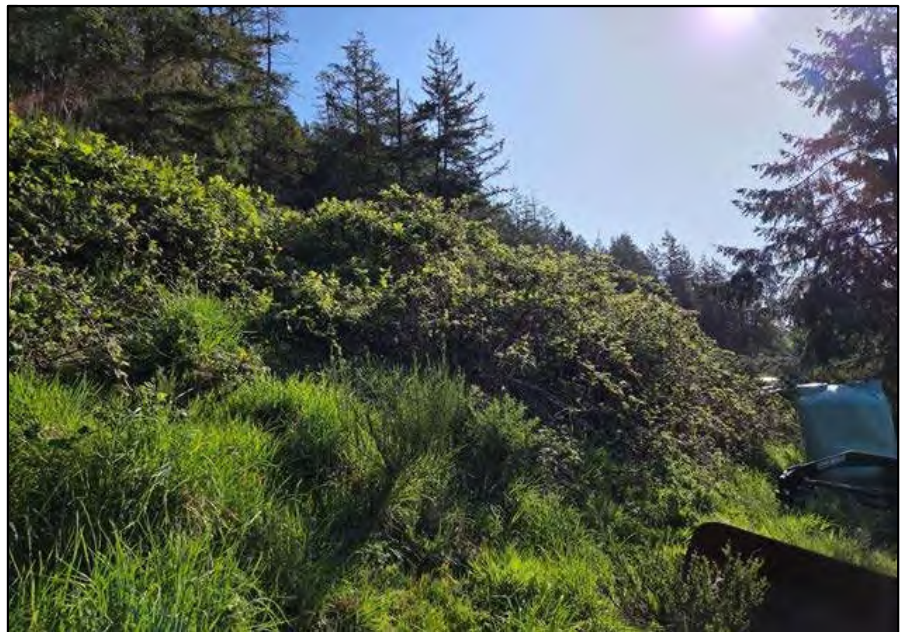
Photo 8: Cleared slope has been overgrown with Himalayan blackberry and Scotch broom – invasive species.
