SUBJECT: Development Variance Permit to reduce setback from the natural boundary of the sea  
Applicant: Serena Klaver  
Location: 434 Baker Road, SSI (PID: 009-555-781)

# ENVIRONMENTAL ASSESSMENT V2.0

431 BAKER ROAD SALT SPRING ISLAND

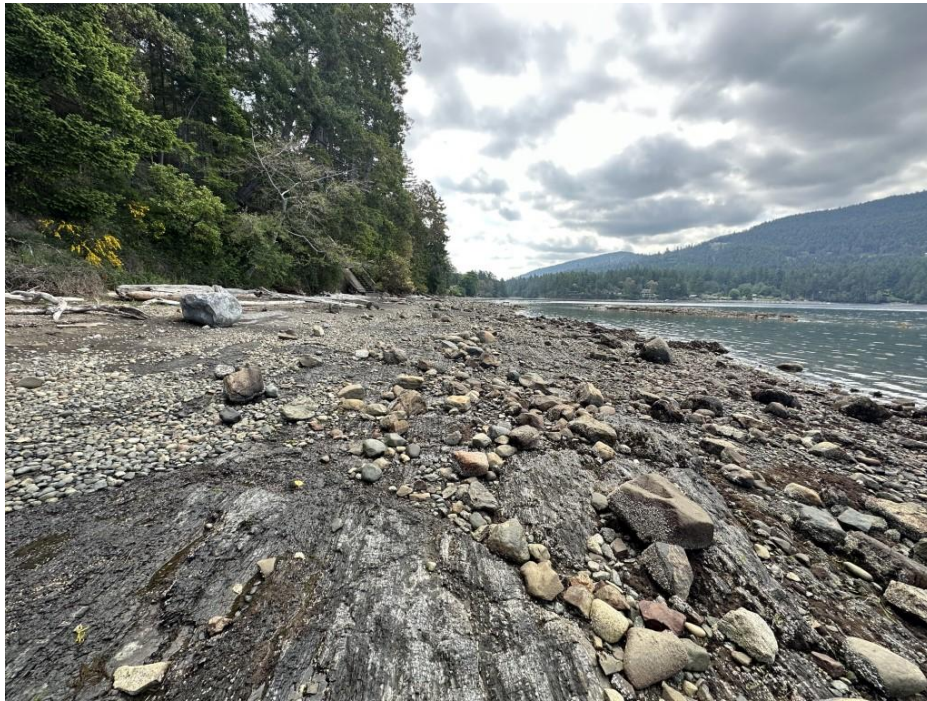
**Photo 1. Close-up of foreshore ground, looking southeast. May 30, 2023.**

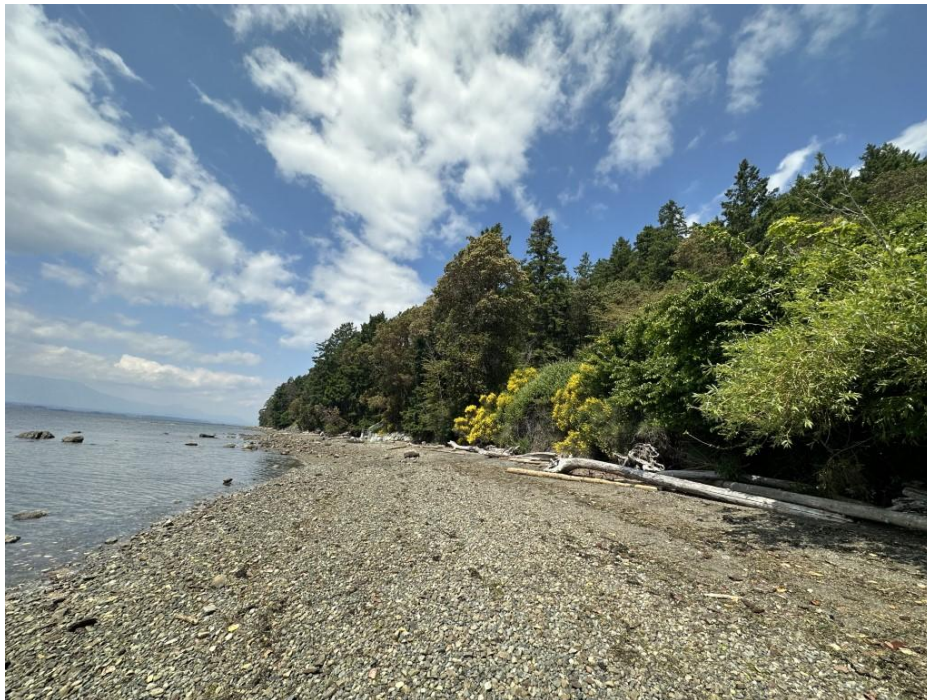
**Photo 2. West view of the foreshore environment. May 30, 2023**

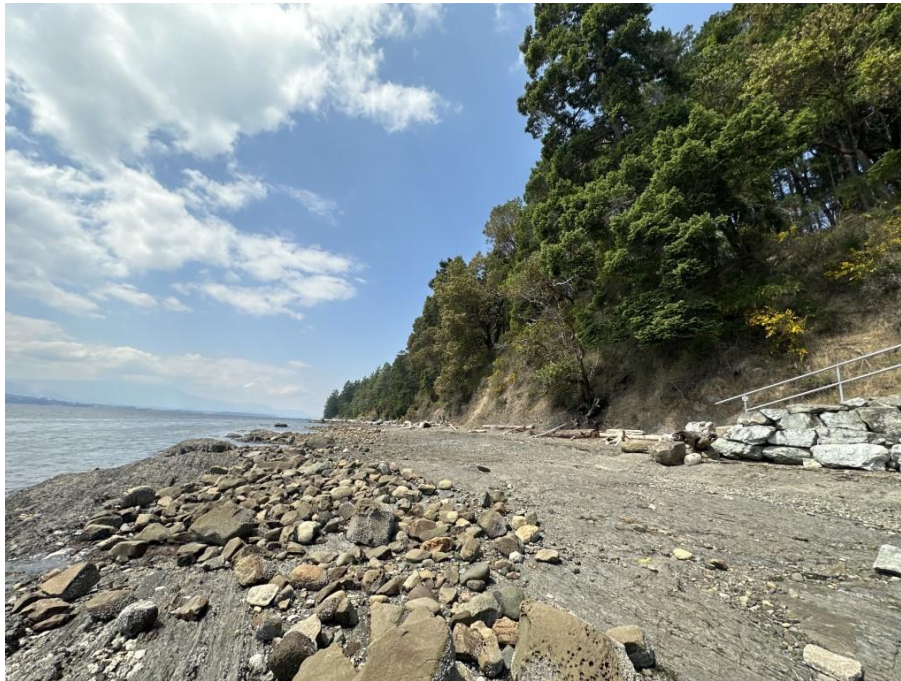
**Photo 3. Foreshore environment in front of Subject Property looking west**

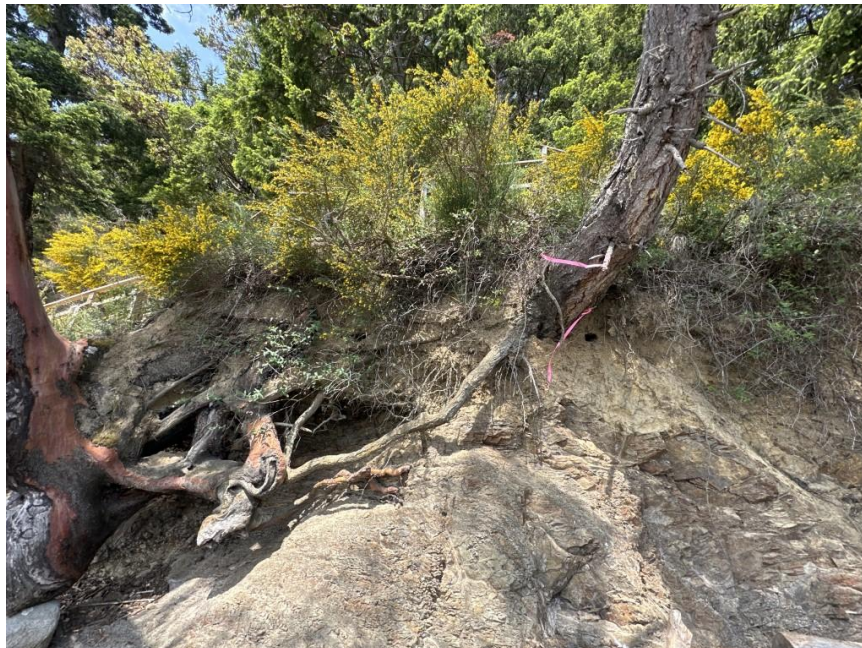
**Photo 4: Eroding bank with extensive patch of invasive Scotch Brome**

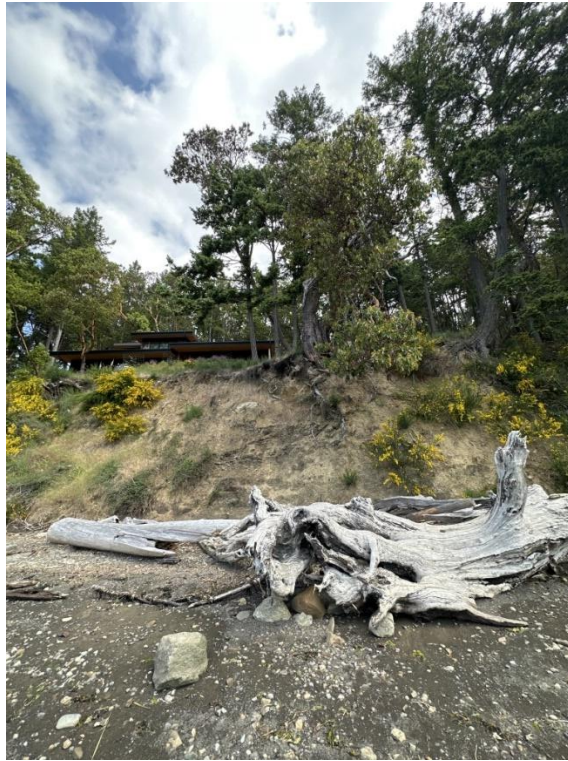
**Photo 5: View of eroding beach with residence in background.**

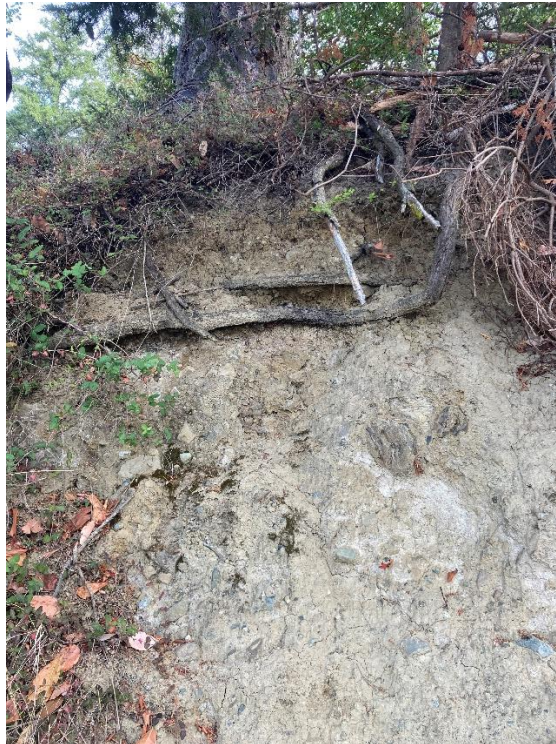
**Photo 6: Eroding bank conditions around the PNB at the Subject Property**

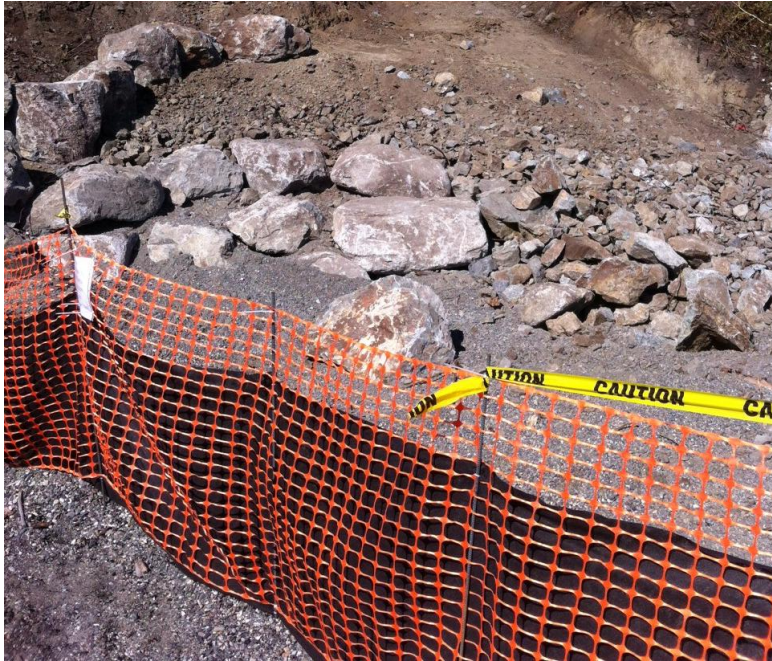
**Photo 3. Example erosion control to protect marine environment during work.**

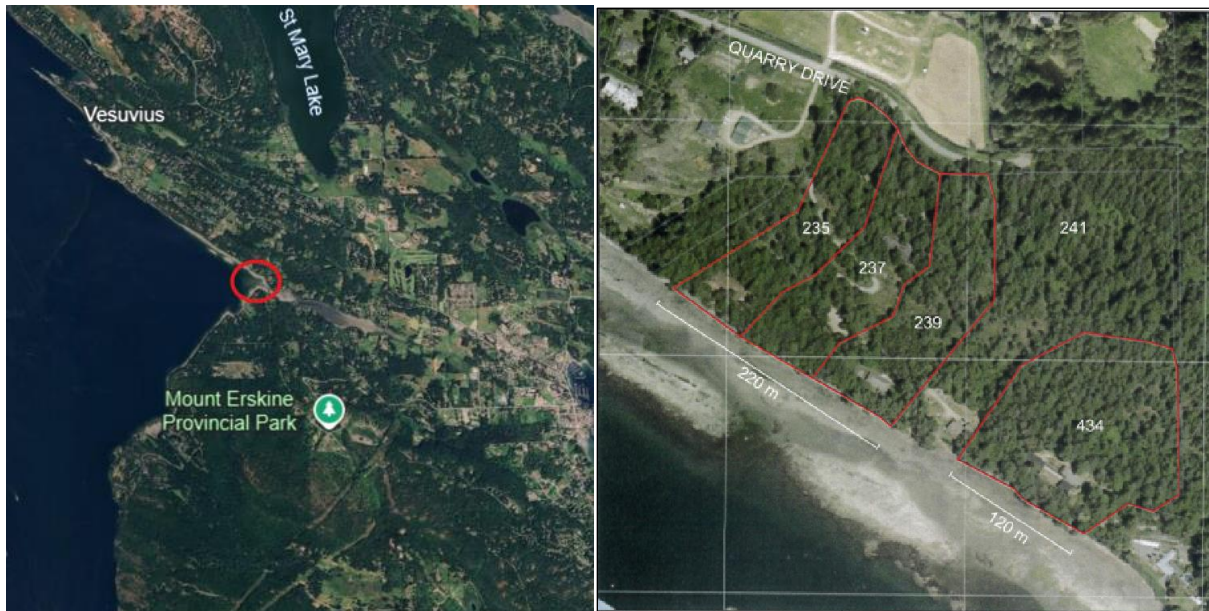
**Figure 1:** Site location plan showing each property and the extent of their shorelines.
