# STAFF REPORT

File No.: PL-RZ-2025-0072 (Welsh

**SUBJECT:** Rezoning Application – Nature-Based Shoreline Protection Proposal

Location: 83 and 84 Blue Heron Rd. and Adjacent Marine Area, Thetis Island

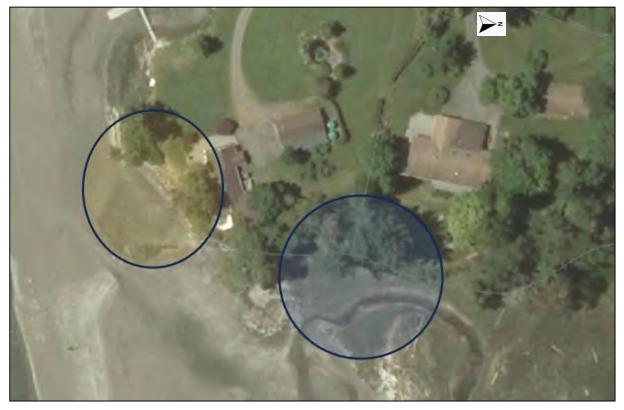
Figure 2 – Sites of Erosion

Source: Marine Shoreline Assessment Report, prepared February 2024, Page 27 (FAEC)

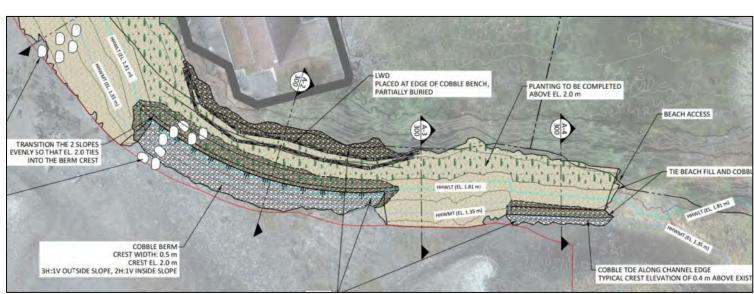
Figure 3 - Proposed Nature Based Erosion Protection Design

Source: Northwest Hydraulic Consultants Ltd. – Thetis Island Nature Based Erosion Protection Design Basis Final Report, Rev.0, prepared October 22, 2024.

The NHC – Nature Based Shoreline Protection design to be installed into the foreshore and at the 'natural boundary' intends to support the failing bank while protecting beach habitat and infrastructure, including buildings. This design has been enhanced by FAEC and their associates by augmenting NHC's 'inert materials design' with Green Shores principles using living material to re-connect the shoreline to the upland properties.

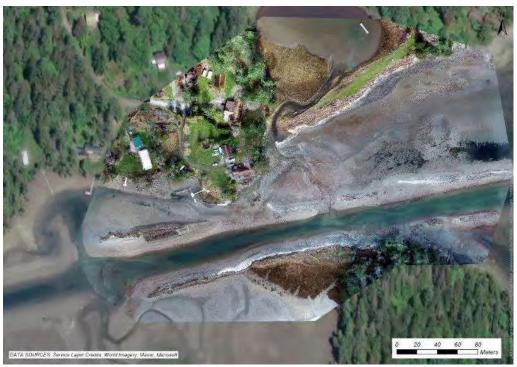
Figure 2.1 Drone orthoimagery captured by NHC on March 12, 2024 in the vicinity of the project location.

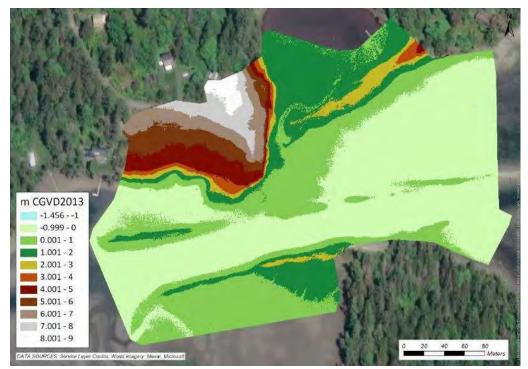
Figure 2.2 Drone survey elevations captured by NHC on March 12, 2024 in the vicinity of the project location.

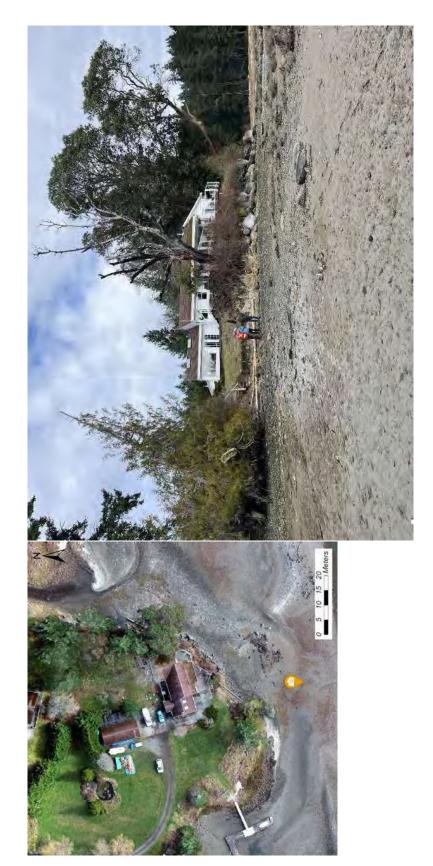
Photo 2.1 The property viewed from the lower intertidal, looking to the north.

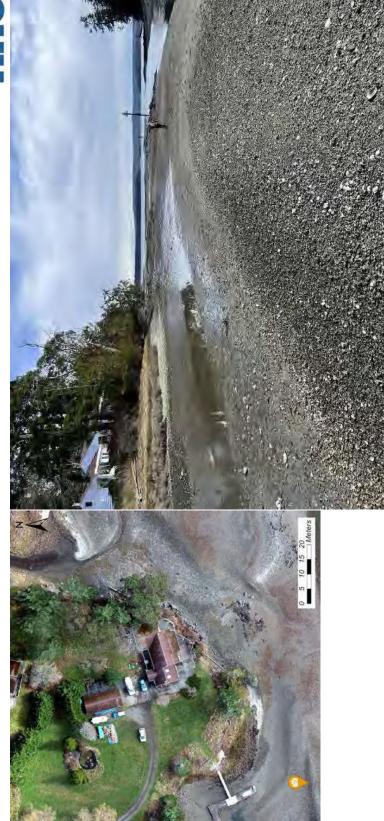
Photo 2.2 Lower intertidal to the south of the property, looking to the east towards Clam Bay. The Cut is located to the south of the property.

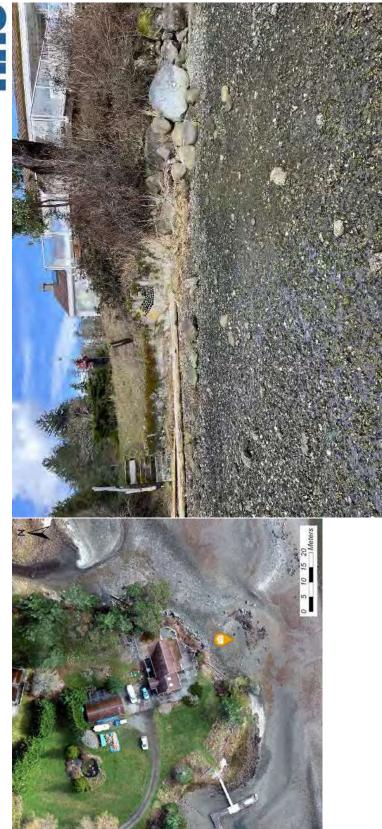
Photo 2.4 Southern shoreline of the property consisting of low concrete seawall and large rocks scattered along the upper beach. Beach access is from concrete stairs on the left, looking towards the north.

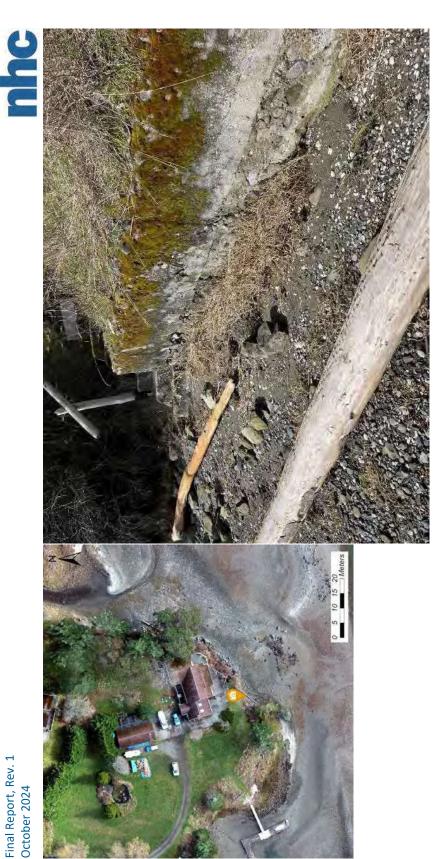
Photo 2.5 Low concrete seawall and concrete stairs.

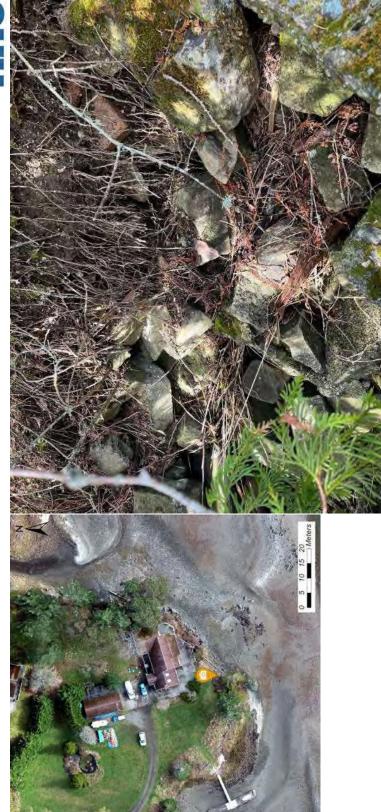
Photo 2.6 Small rocks beneath vegetation on west extents of shoreline.

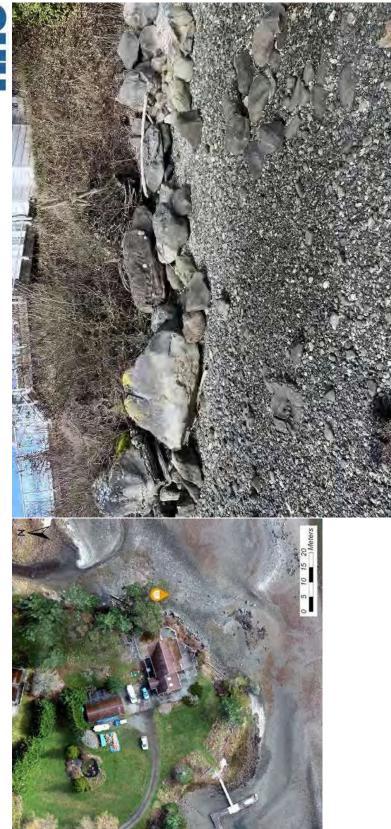
Photo 2.7 Large rocks along the upper beach, looking to the northwest. The upper beach consists of gravel and cobble.

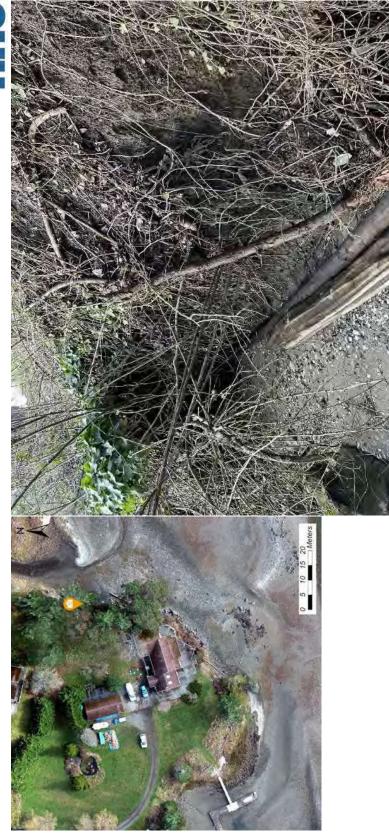
Photo 2.10 Erosion of the low coastal bluff. The bluff consists of fine silty sand material based on visual observations.

- Erosion of the bank was observed from approximately Photo 2.8 to Photo 2.10. The base of the bluff is being undercut by wave action during high water level events. The bluff appears to be composed of silty sand material, based on visual observations.

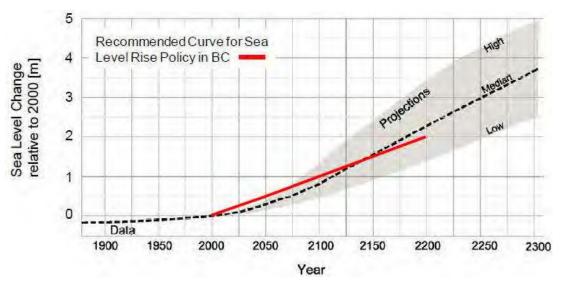
Figure 3.1 Sea level change projection (BC Ministry of Environment, 2011).

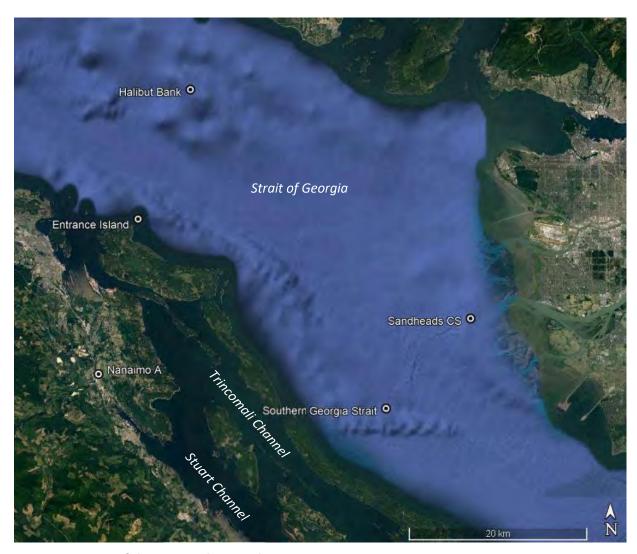
Figure 3.2 Map of the surrounding wind stations.

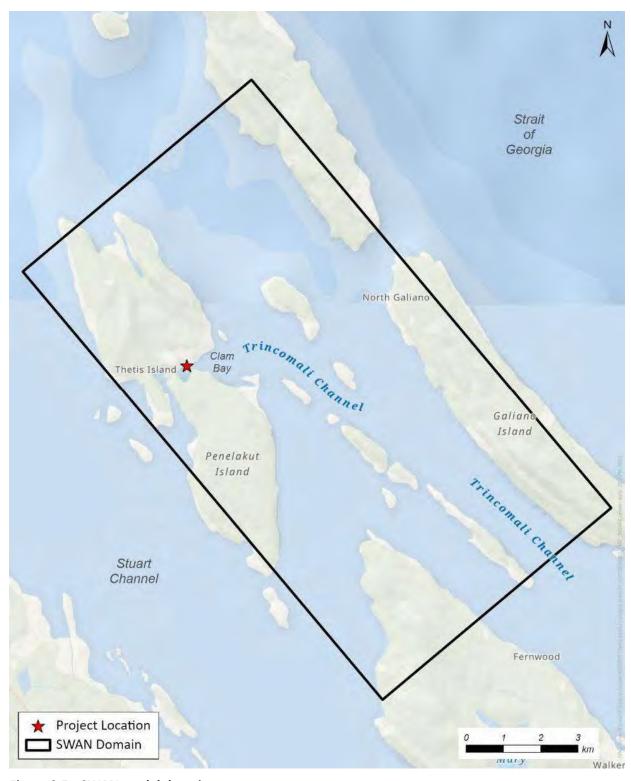
Figure 3.5 SWAN model domain.

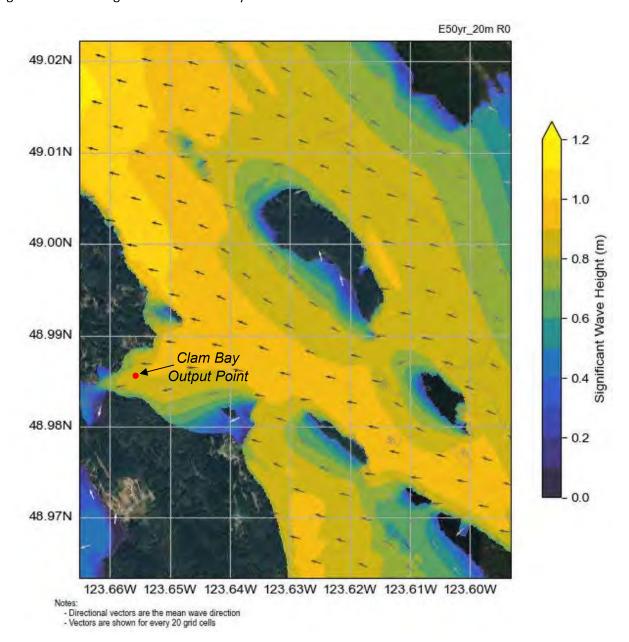
Figure 3.6 SWAN model results for 2% AEP wind event from the east in Clam Bay and Trincomali Channel.

The SWAN model results for the 2% AEP waves in the Clam Bay from the east are shown in Figure 3.6. Significant wave height (Hs) distributions are shown by coloured shading, and wave direction and relative heights are shown by vectors. The easterly event is shown because they resulted in the highest significant wave height values at Clam Bay.

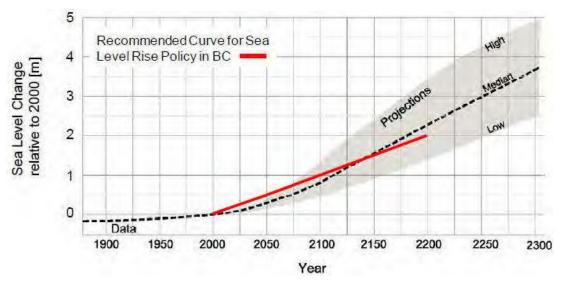
Figure 2.1 Sea level change projection (BC Ministry of Environment, 2011).

In addition to global SLR, isostatic rebound, tectonic uplift, and/or sediment consolidation may influence the local relative sea level rise (RSLR). The total vertical land movement near 83 and 84 Blue Heron Rd is estimated at -0.7 mm/year based on the national-scale crustal velocity model published by Natural Resources Canada (2022).

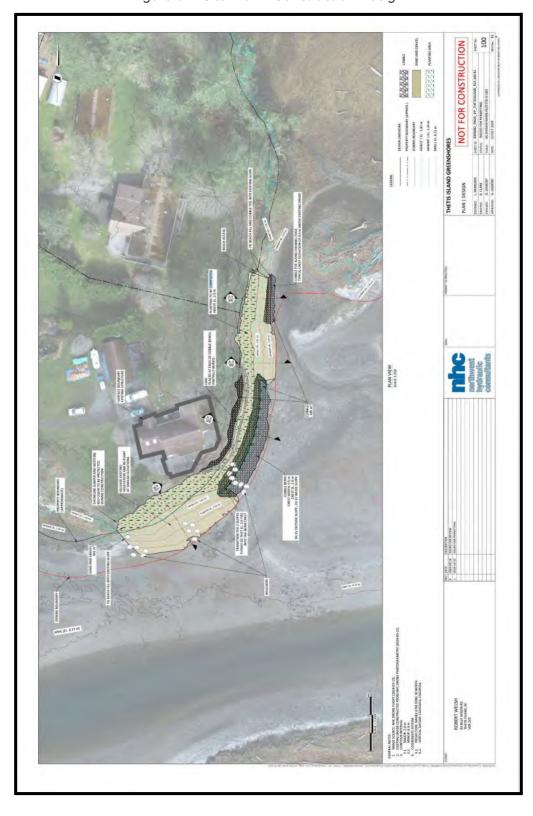
Figure 5. - Site Plan - Construction Design

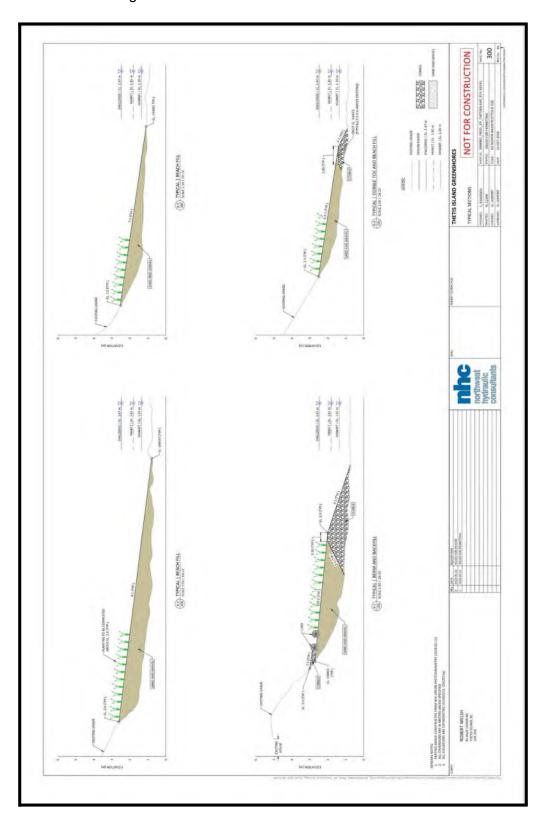
Figure 6. - Site Plan - Construction Profile Views

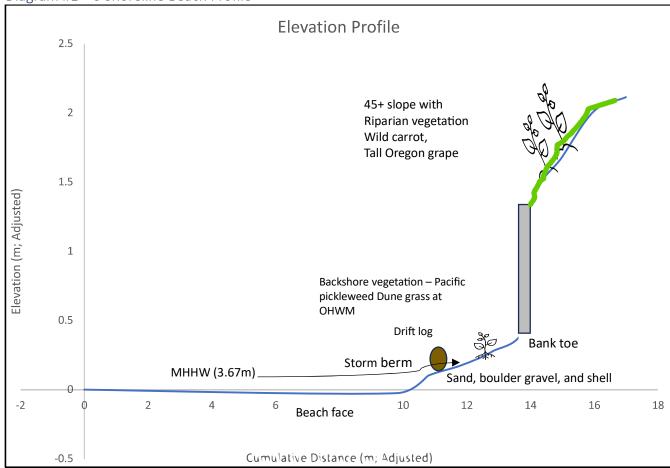
Diagram #1 – S Shoreline Beach Profile

Graph: Beach Profile of S Shoreline on Lot 83. created using the Welsh GSH Project Submittal xls Binder. MHHW - (Mean Higher High Water).

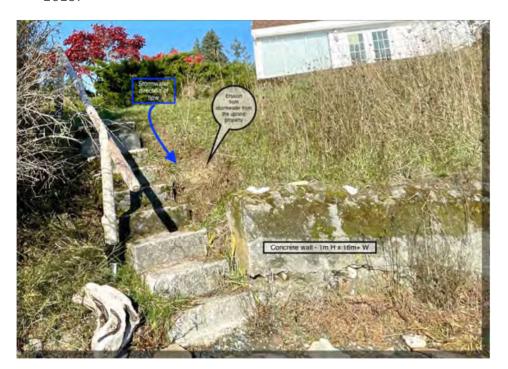
Photo #16. Stormwater direction of flow, evidence of water rills and erosion, concrete wall cracked along bottom of wall. Photo - D. Fenton. Aug 22, 2023.

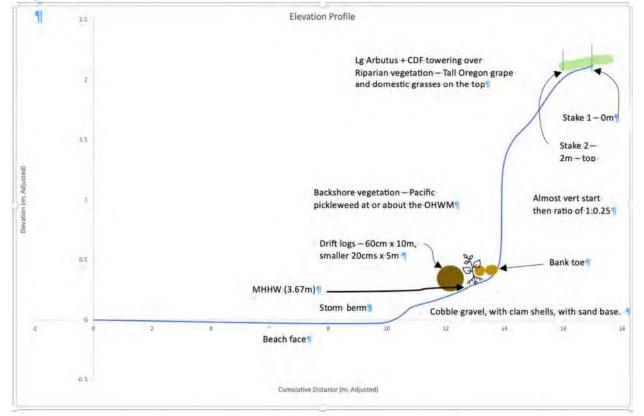
Diagram 1. - Beach Profile E Shoreline of lot 83/84.
