# STAFF REPORT

File No.: GB-DVP-2022.4 (Woodside)

SUBJECT: Development Variance Permit – PL-GB-DVP-2022.4 (Woodside)

Location: 1170 The Strand, Gabriola Island

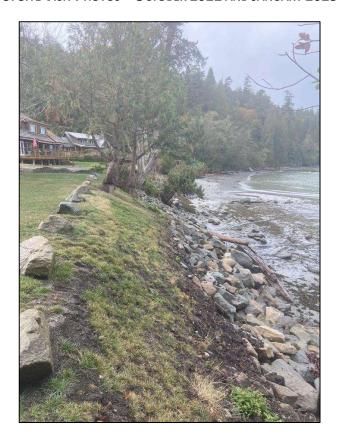
Top of bank and revetment at 1170 The Strand, facing west

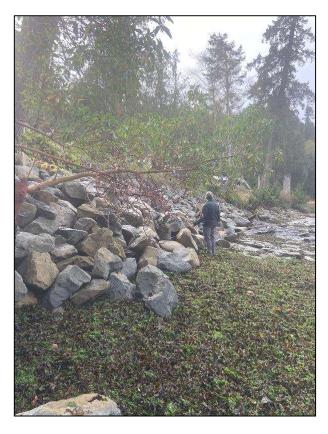
Revetment and foreshore at 1170 The Strand, facing west

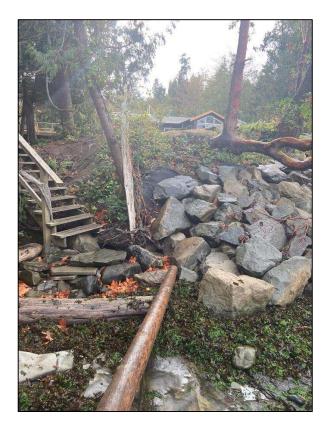
Eastern edge of revetment at 1170 The Strand

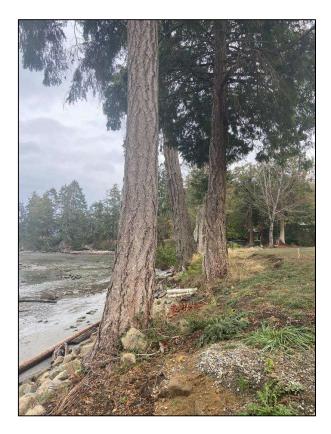
Top of bank at 1160 The Strand facing east

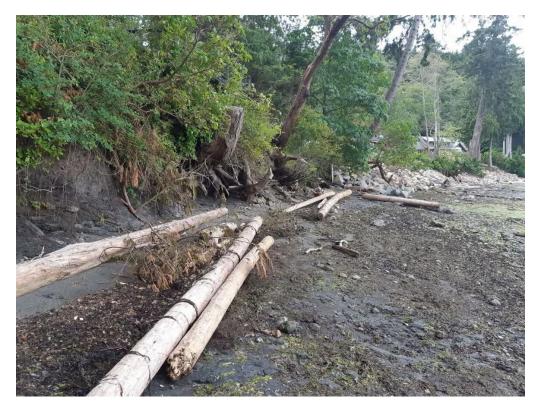
Figure 3.1 Typical Steep Eroded Bank

b. In general, the foreshore can be characterized as a low-bank shoreline with a gently sloping, smooth shallow intertidal zone facing the open waters of the Strait of Georgia / Salish Sea to the north. The total height of the shoreline bank was approximately 4.36m to 5.72m at the time of our assessment. The crest is defined by the rear yard extent of lawn and organic soil cap. Several mature evergreen trees are located at or just below the slope crest. There is no vegetation below the tree extents to the beach below. This area is comprised of a revetment installation consisting of a collection of 500mm to 1000mm sized boulders deposited on a geotextile base that was installed as an emergency measure to protect the property against the significant erosion caused by waves and drifting logs from winter storm activity. Since that time the installation has ceased most of the erosion issues and provided stability to the existing mature trees along the slope crest. See Figures 3.1, 3.2 and 3.3 below.

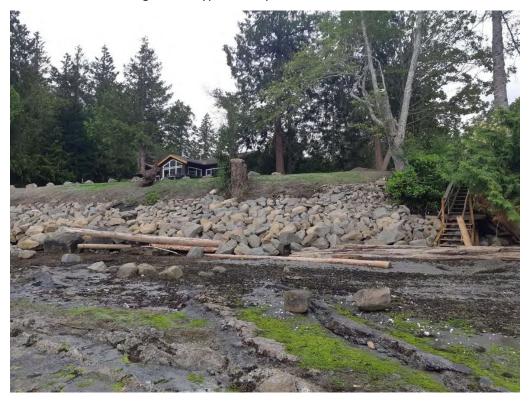
Figure 3.2 Current Shoreline Condition

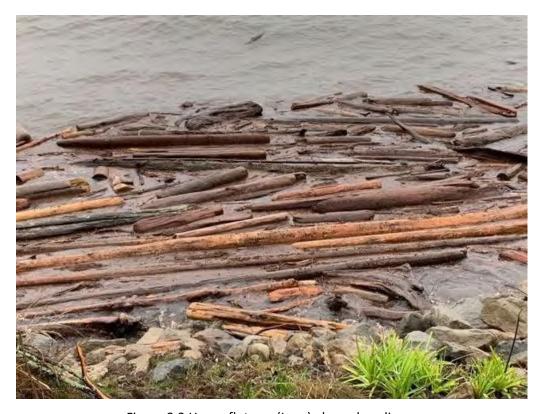
Figure 3.3 Heavy flotsam (Logs) along shoreline

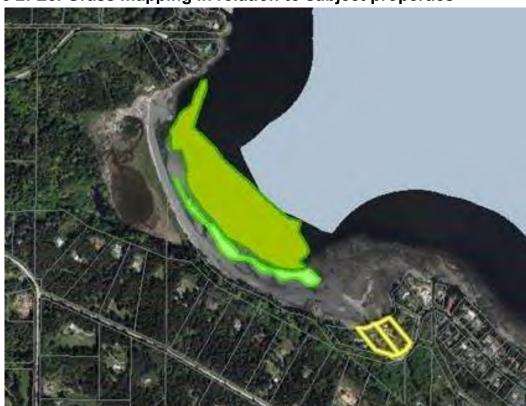
Figure 2: Eel Grass mapping in relation to subject properties

There are marine grasses in the area but not near the structure. Eel grass is located approximately 170-220m offshore from the subject properties in the lower intertidal area (Figure 2). The beach slope is gentle with the steepest portion at the wrack line where it drops away for 5-10 m (0.5m) and then to a relativity flat to the sub-tidal areas approximately 200m away. The upper beach area has a cobble/gravel substrate with small sand deposits that tend to move around with seasonal weather patterns. The lower beach is mostly gravel with sand flats at the outer tide line set on sandstone base. The eel-grass bed is extensive following the foreshore in a broad band (as recorded by CMNBC.ca). It is located approximately 200m from the foreshore and continuing into the deeper waters.
