GEOTECHNICAL ASSESSMENT

Proposed Commercial Development 750 Tin Can Alley, Gabriola Island, BC

File No.: F9892.01 Revision No.: 00 Prepared by: Tennes Hamre, GIT

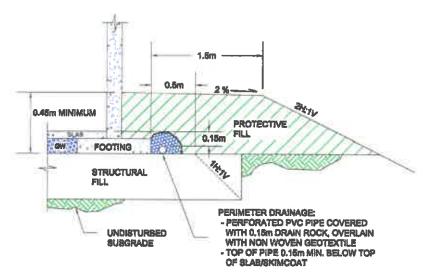
Figure 4.2 - Typical Section, Structural Fill

- d. Structural fills under foundations, roadways, and pavements should include the zone defined by a plane extending down and outward a minimum 0.5m from the outer edge of the foundation at an angle of 45 degrees from horizontal to ensure adequate subjacent support. This support zone is shown below in Figure 4.2.

- a. Where fill is required to raise areas that will support buildings, slabs, or pavements, structural fill should be used. The Geotechnical Engineer should first approve the exposed subgrade in fill areas, to confirm the removal of all unsuitable materials.

- b. Structural fill should be inorganic sand and gravel. If structural fill placement is to be carried out in the wet season, material with a fines content limited to 5% passing the 75µm sieve should be used, as such a material will not be overly sensitive to moisture, allowing compaction during rainy periods of weather.

- Structural fill should be compacted to a minimum of 95% of Modified Proctor maximum dry density (ASTM D1557) in foundation and floor slab areas, as well as in paved roadway and parking areas.

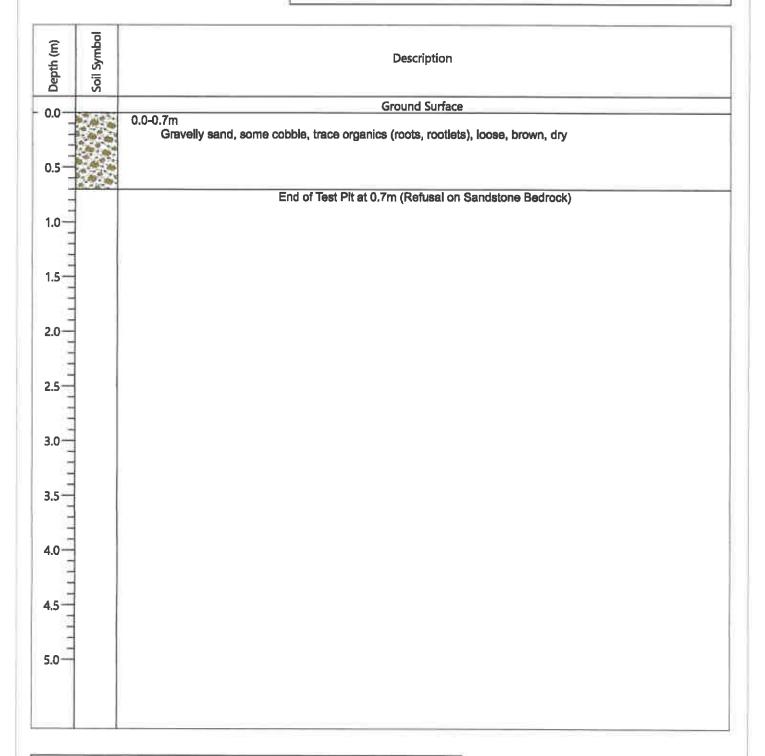
TP21-01

Logged By: Tennes Hamre, GIT Reviewed By: Chrls M. Hudec P.Eng. Digging Method: CAT 308C Excavator Date: July 22, 2021

- b. The main strata are discussed in general below. Detailed descriptions of the subsurface conditions are provided on the attached TP logs (TP 21-01 to TP 21-05).

- c. Loose to compact, brown gravel and sand, or gravelly sand, with trace percentages of cobbles were encountered in each of the TPs from 0.0m to 1.2m.

- d. Sandstone bedrock or inferred sandstone bedrock was encountered in each of the TPs at depths from 0.7m to 1.2m with a mean depth of 0.86m.
- e. Depths are referenced to the existing ground surface at the time of our field investigation. Soil classification terminology is based on the Modified Unified classification system. The relative proportions of the major and minor soil constituents are indicated by the use of appropriate Group Names as provided in ASTM D2488-93 and/or D2487 Figures 1a, 1b, and 2. Other descriptive terms generally follow conventions of the Canadian Foundation Engineering Manual.

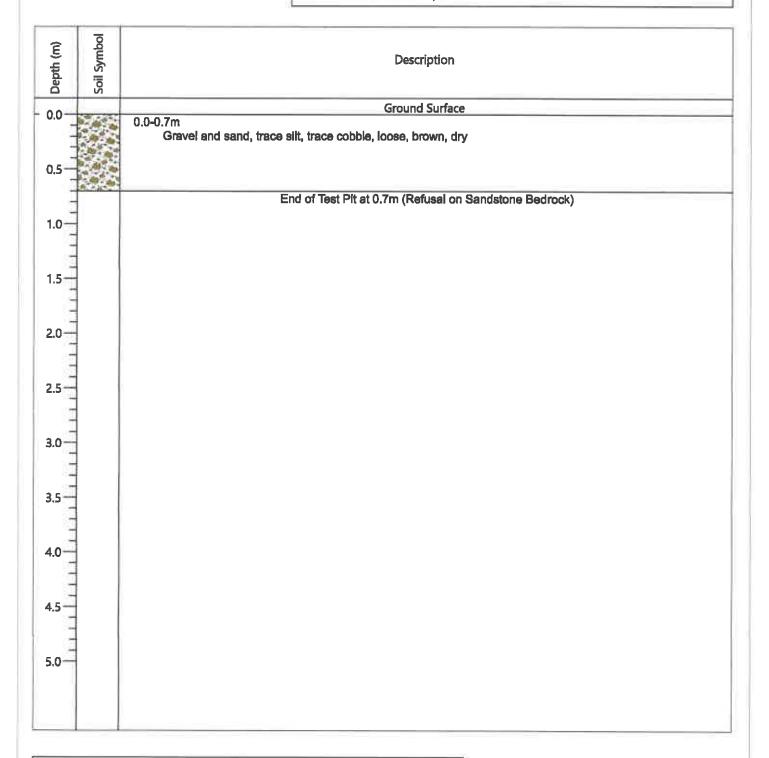
TP21-02

Logged By: Tennes Hamre, GIT Reviewed By: Chris M. Hudec P.Eng. Digging Method: CAT 308C Excavator Date: July 22, 2021

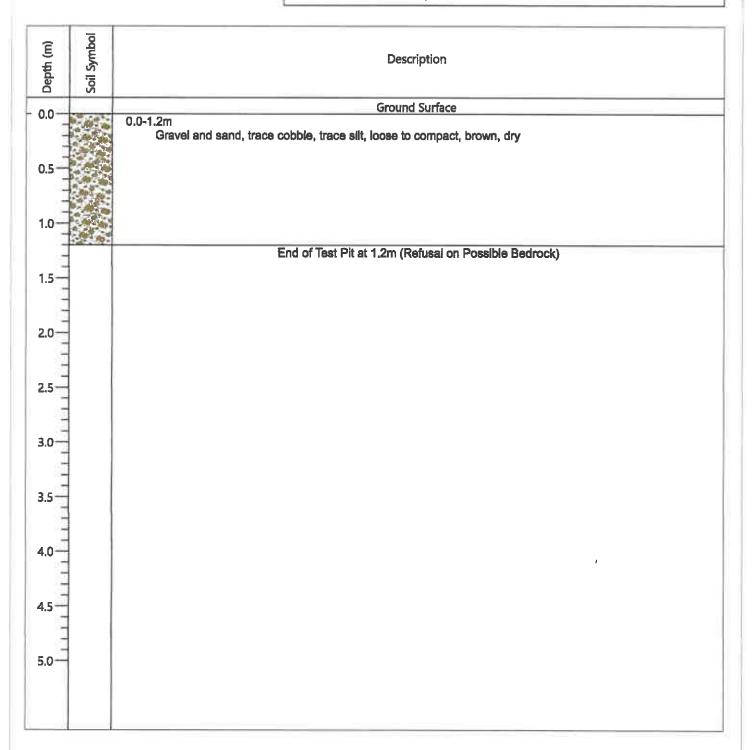
TP21-03

Logged By: Tennes Hamre, GIT Revlewed By: Chrls M. Hudec P.Eng. Digging Method: CAT 308C Excavator Date: July 22, 2021 Page 1 of 1

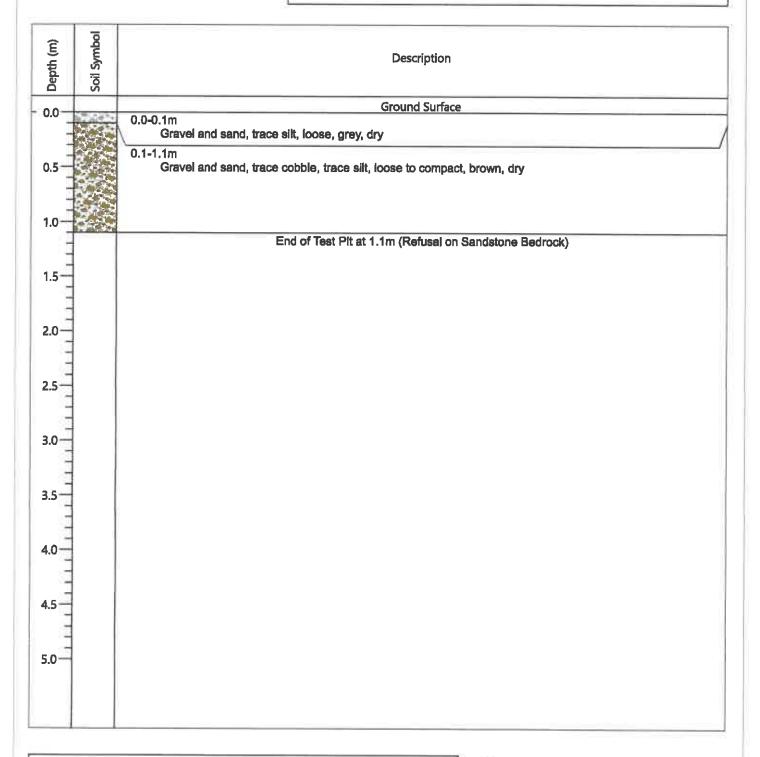
TP21-04

Digging Method; CAT 308C Excavator

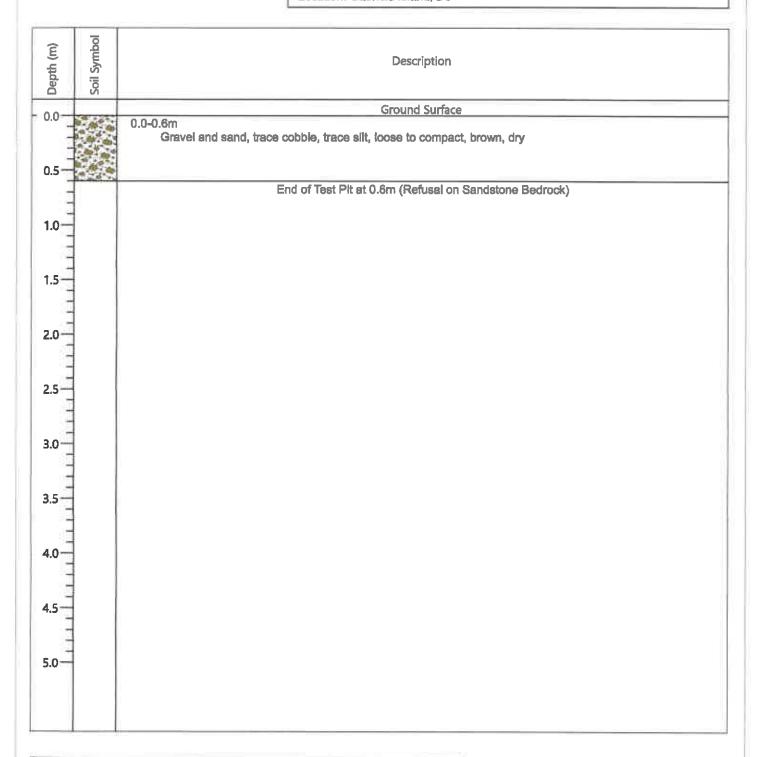
TP21-05

Logged By: Tennes Hamre, GIT Reviewed By: Chris M. Hudec P.Eng. Digging Method: CAT 308C Excavator Date: July 22, 2021 Page 1 of 1 1900 Boxwood Road Nanalmo, British Columbia, V9S 5Y2
