PRELIMINARY REPORT

Gabriola Island Berth Replacement and Upland Redevelopment Environmental Impact Assessment

Project No. 104134-01

January 14, 2020

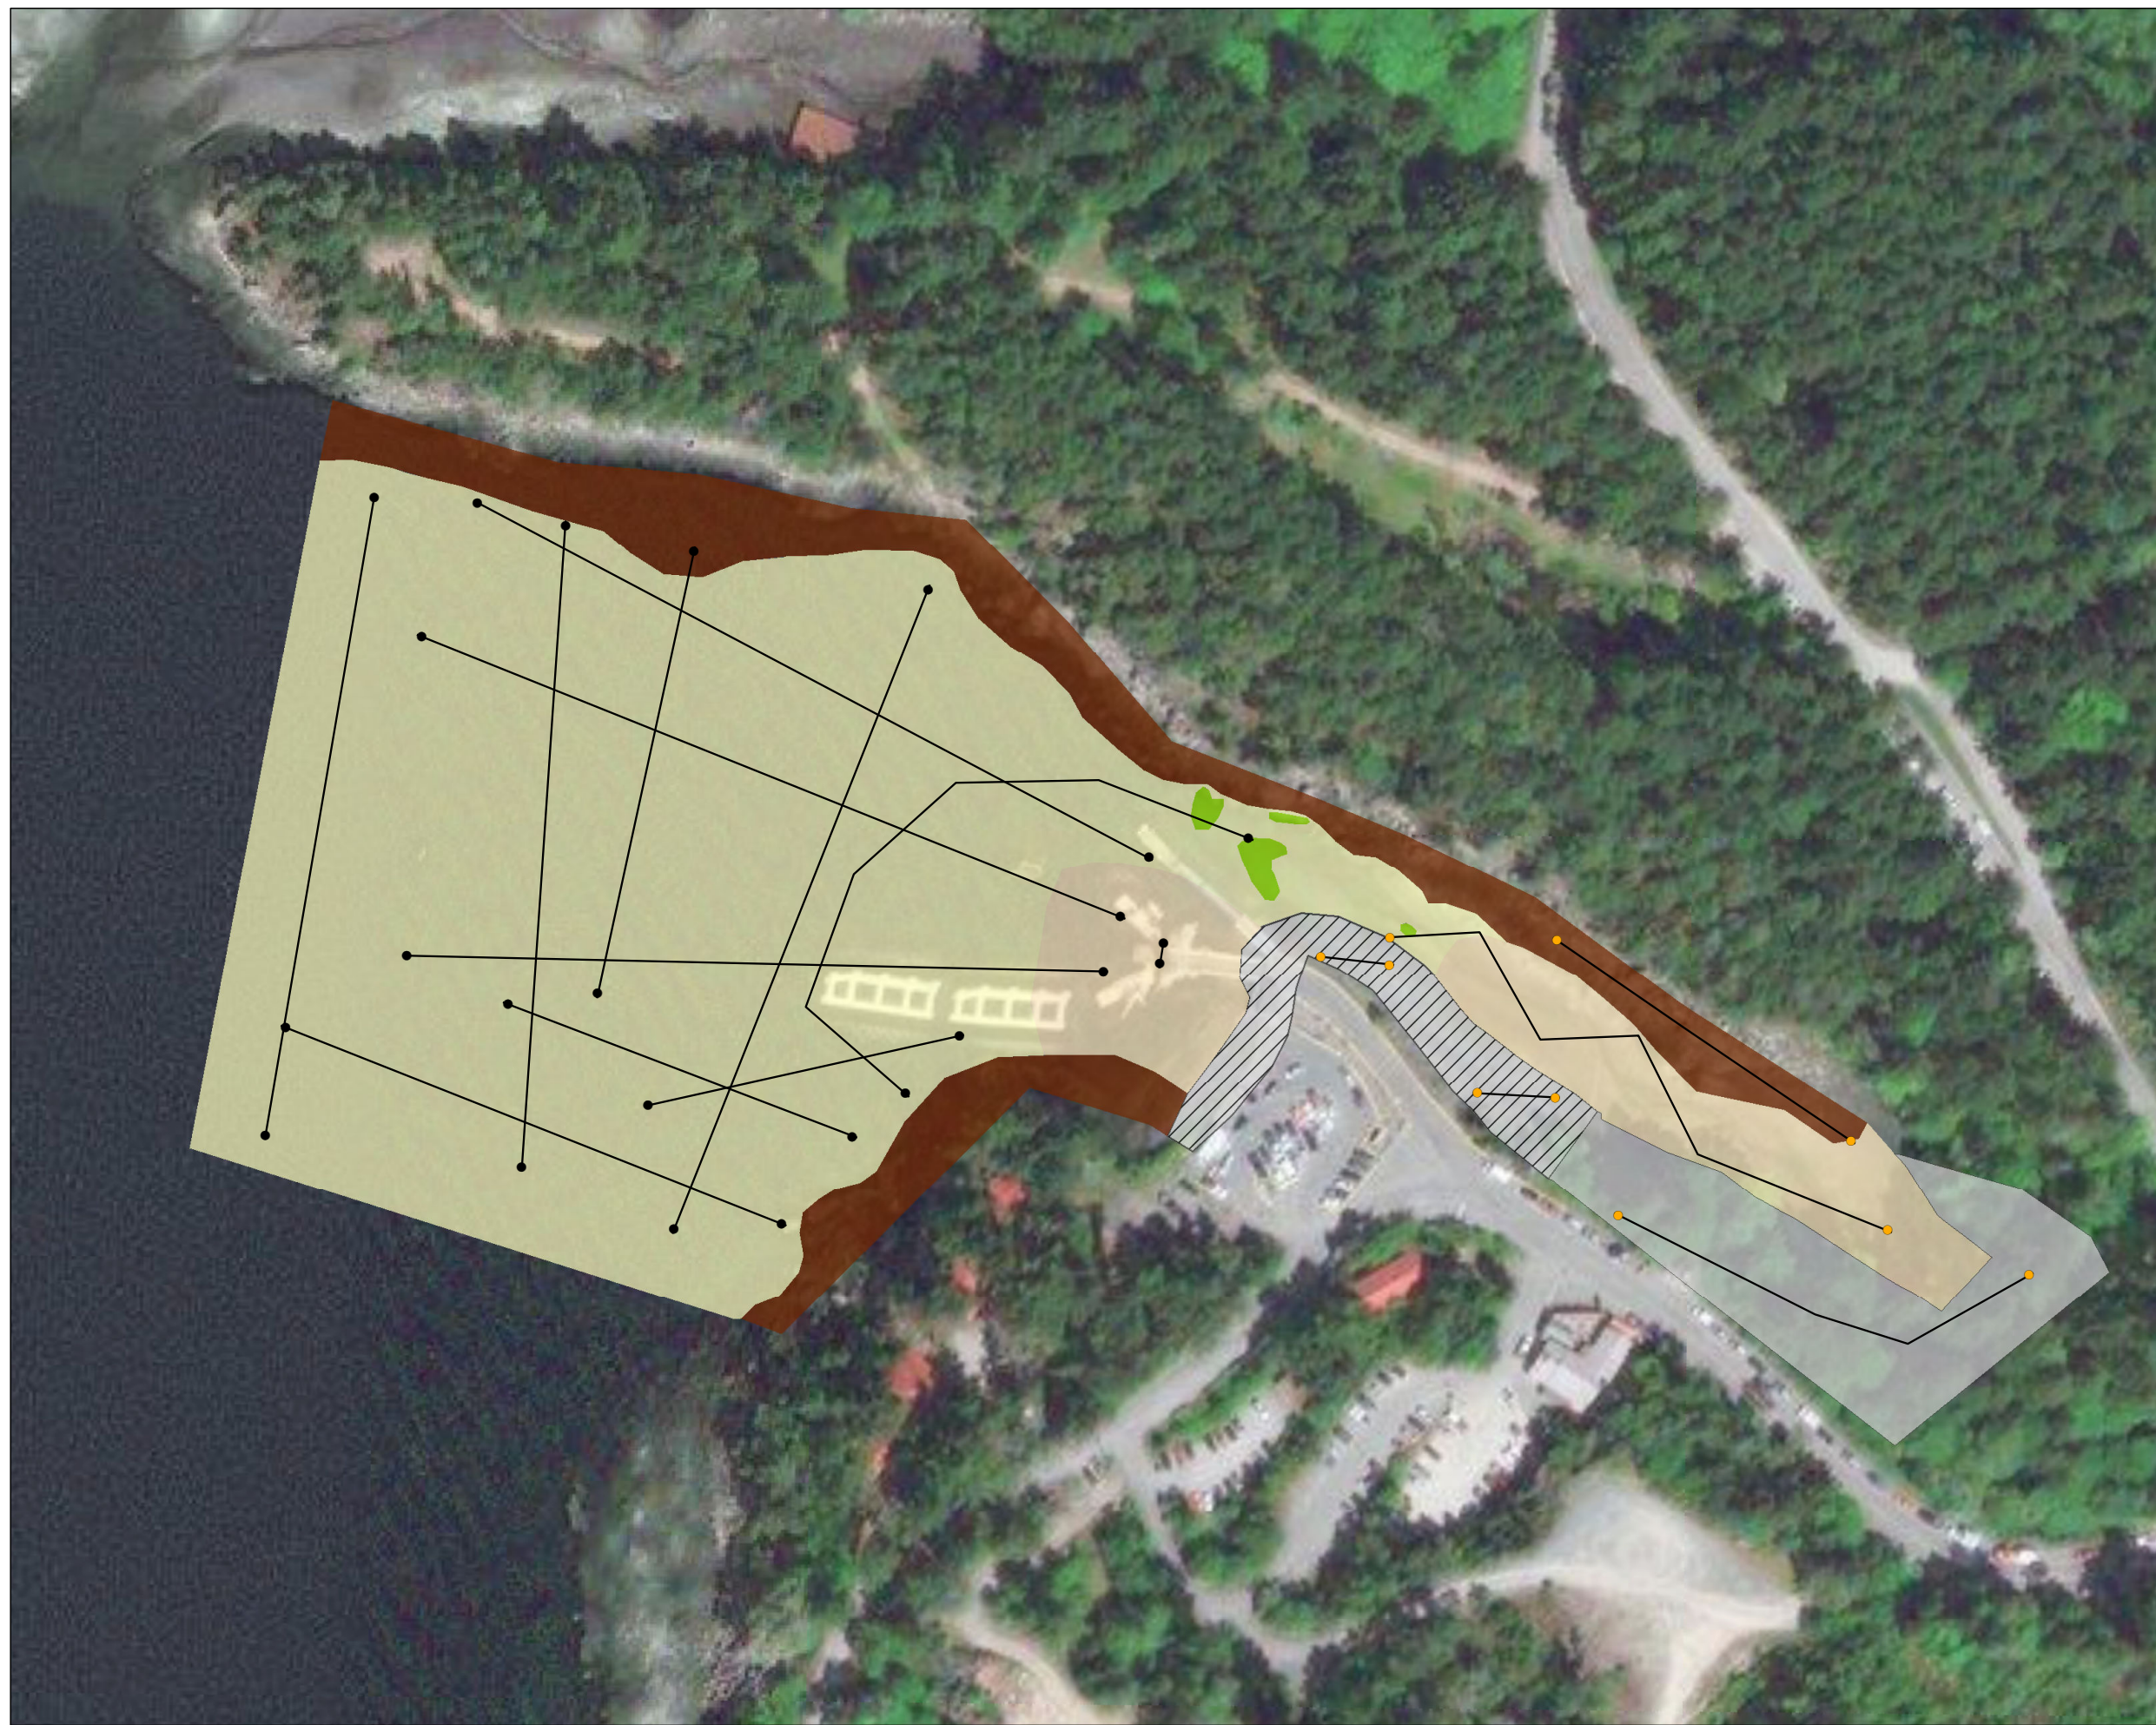
Transect Locations and Habitat Map

- Transect by foot
- Underwater Video Transect
- Habitat Types**
- Boulders and bedrock
- Eelgrass
- Fines (sand, silt, mud)
- Gravels and fines
- Riprap
- Upland

A narrow strip of vegetation is present along the top of the riprap slope immediately south of the berth and continuing along the south bank of the inlet (**Figure 2, Photo 2A**). The vegetation was dominated by weedy, non-native species typical of a disturbed area, including Himalayan blackberry (*Rubus armeniacus*), wild carrot (*Daucus carota*), orchard-grass (*Dactylis glomerata*), and hairy cat's-ear (*Hypochaeris radicata*).

At the east extent of the riprap bordering the inlet, vegetation transitions into coastal upland forest (**Figure 2; Photo 3A, 3B**). Species composition changes from opportunistic, weedy species along the road, to predominantly native species in the less disturbed area. An unnamed tributary flows through a small gully at the southeast end of the Project Site and enters the inlet. Multiple barriers to fish migration are present in the tributary (e.g., depth, large woody debris).

The north extent of the intertidal area comprised sandstone bedrock and boulders (**Figure 2; Photo 4C**). Dominant species colonizing this habitat were rockweed, sea moss, and sea lettuce (*Ulva* sp.), with smaller patches of blue mussels, Turkish washcloth (*Mastocarpus papillatus*), and nori (*Porphyra* sp.). Dense polycultures of American glasswort (*Salicornia pacifica*) were observed along the north shore of the inlet on the bedrock shelf (**Photo 4D**).

The majority of the subtidal area in the Project Site comprised predominately fine substrates (**Figure 2**). In the shallow subtidal area north of the berth, three patches of eelgrass were identified at the mouth of the inlet, comprising an area of approximately 163 m² (**Figure 2; Photo 5C, D**). A small (<20) school of shiner perch (*Cymatogaster aggregata*) were observed in the eelgrass. The soft, fine substrates are preferred habitat for crab species. Burrows were evident at the Site but only two Dungeness crabs (*Metacarcinus magister*) were observed during the subtidal survey (**Photo 5D**). An unidentified flatfish was also observed. Water jellies (*Aequoreus* sp.) and moon jellies (*Aurelia labiata*) were abundant in the subtidal water column during the subtidal survey.

Bedrock and boulder habitat armouring the shorelines in the Project Site (**Figure 2**) supported occasional small patches of feather stars (*Florometra serratissima*) (**Photo 5E**). Overall, organismal diversity in the subtidal area was low.

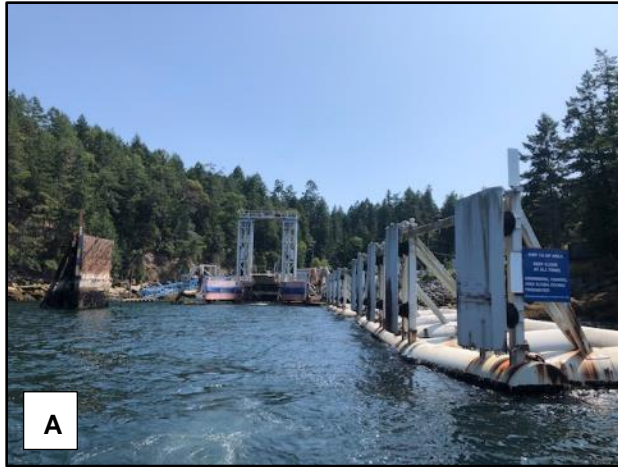
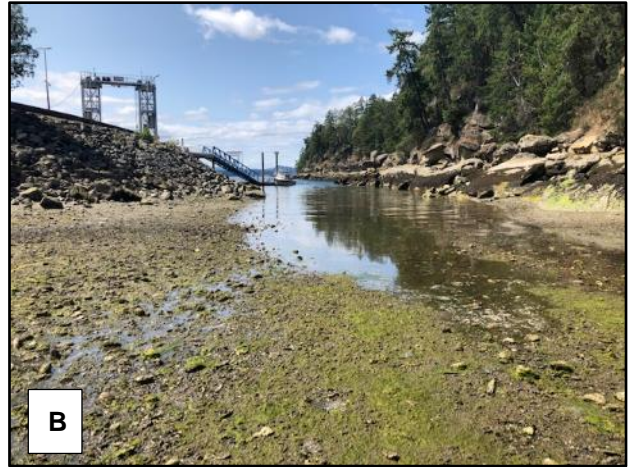
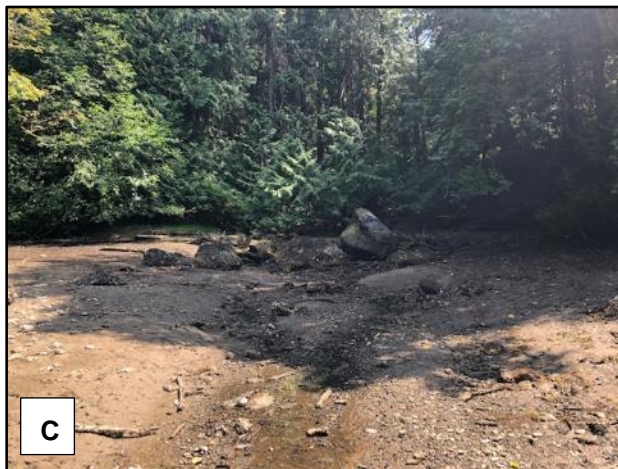
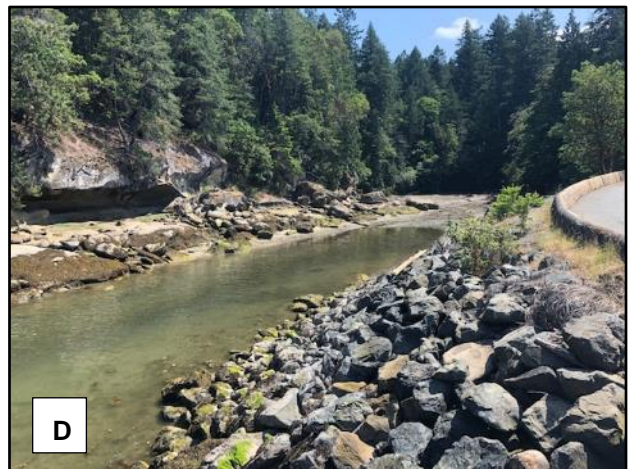
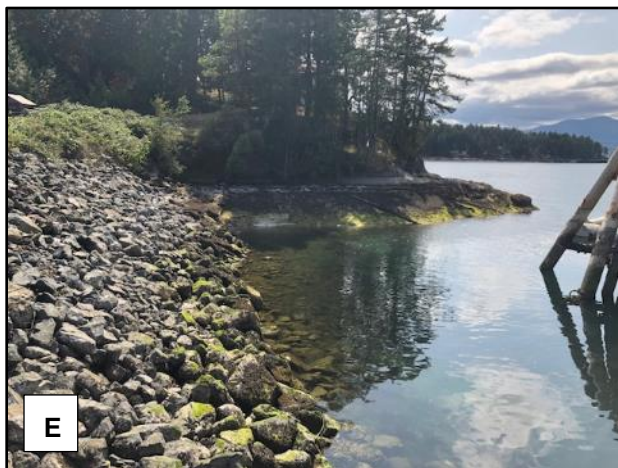
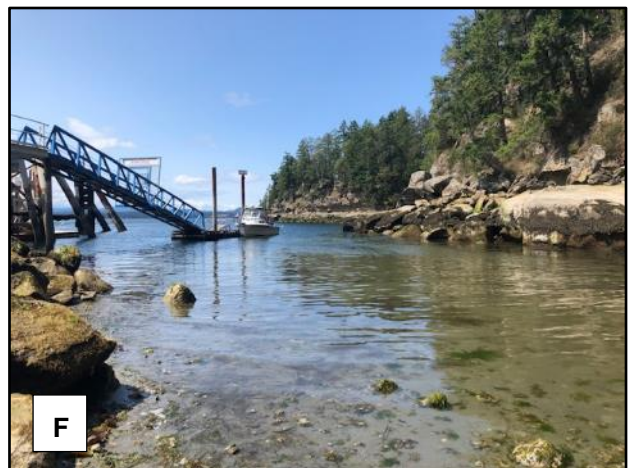
Photo 1 The Project Site looking (A) east at existing berth infrastructure, (B) west from the inlet towards the berth, (C) east (upstream) where unnamed tributary enters the inlet, (D) east from berth towards inlet, (E) south from the berth along riprap, and (F) west from the inlet towards the emergency services dock.

The Project Site comprises upland, intertidal, and subtidal habitat at the Gabriola Island Ferry Terminal (**Photo 1A**). The terminal is located in Descanso Bay, adjacent to an inlet that extends northwest-southeast along North Road (**Figure 1; Photo 1B**). An unnamed tributary enters the bay at the head of the intertidal inlet (**Photo 1C**). The tributary is unmapped on iMapBC and has no records of fish presence (iMapBC 2019). An armoured riprap bank stabilizes the south slope along the inlet and extends south of the berth near the terminal parking area (**Photo 1D and Photo 1E**). A dock is located north of the berth for emergency service access to the island (**Photo 1F**).

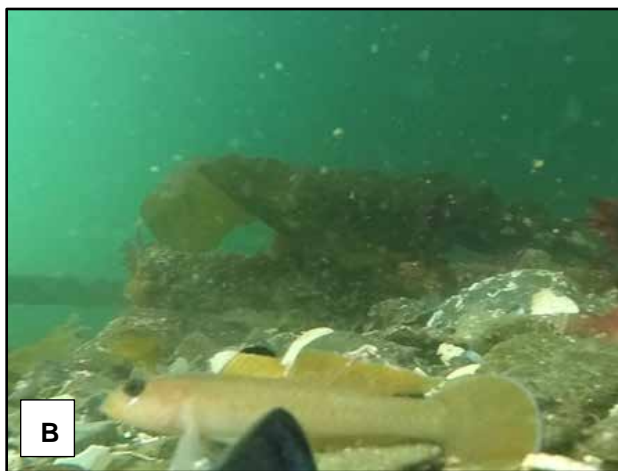
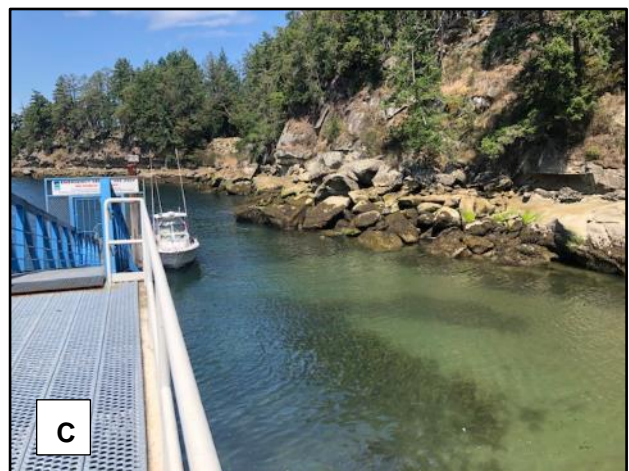
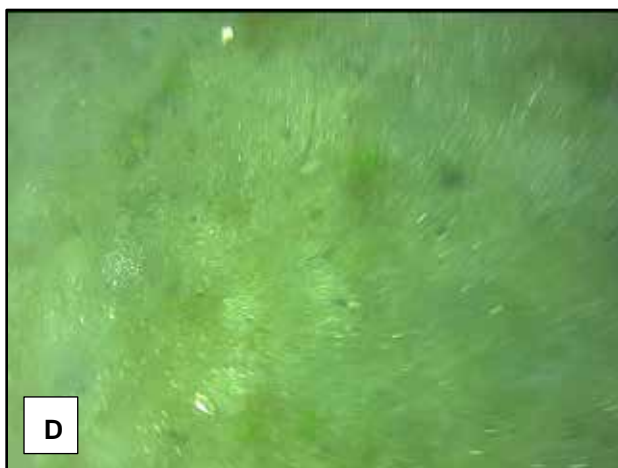
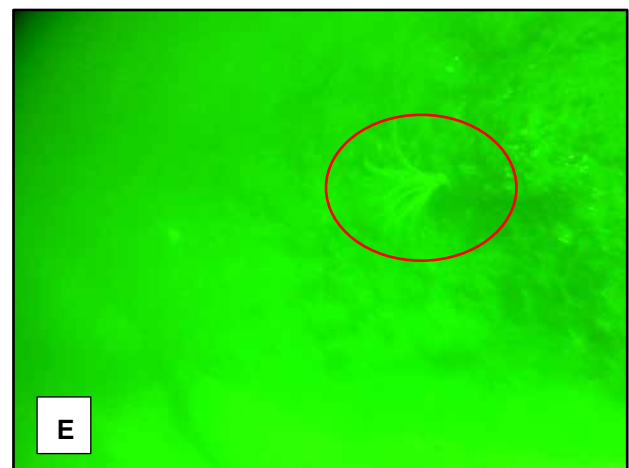
Photo 5 (A) gravel and fines beneath berth infrastructure, (B) blackeye goby beneath berth infrastructure, (C) patches of shallow subtidal eelgrass, (D) soft substrate in subtidal zone, and (E) feather star on hard substrate in subtidal zone.
