File No.: PL-DVP-2024-0299 (Apps)

DATE OF MEETING: April 17, 2025
TO: Gabriola Island Local Trust Committee
FROM: Stephen Baugh, Island Planner
Northern Team
COPY: Renée Jamurat, Regional Planning Manager
SUBJECT: Development Variance Permit – PL-DVP-2024-0299 (Apps)
Applicant: Michael Apps
Location: 1140 The Strand, Gabriola Island

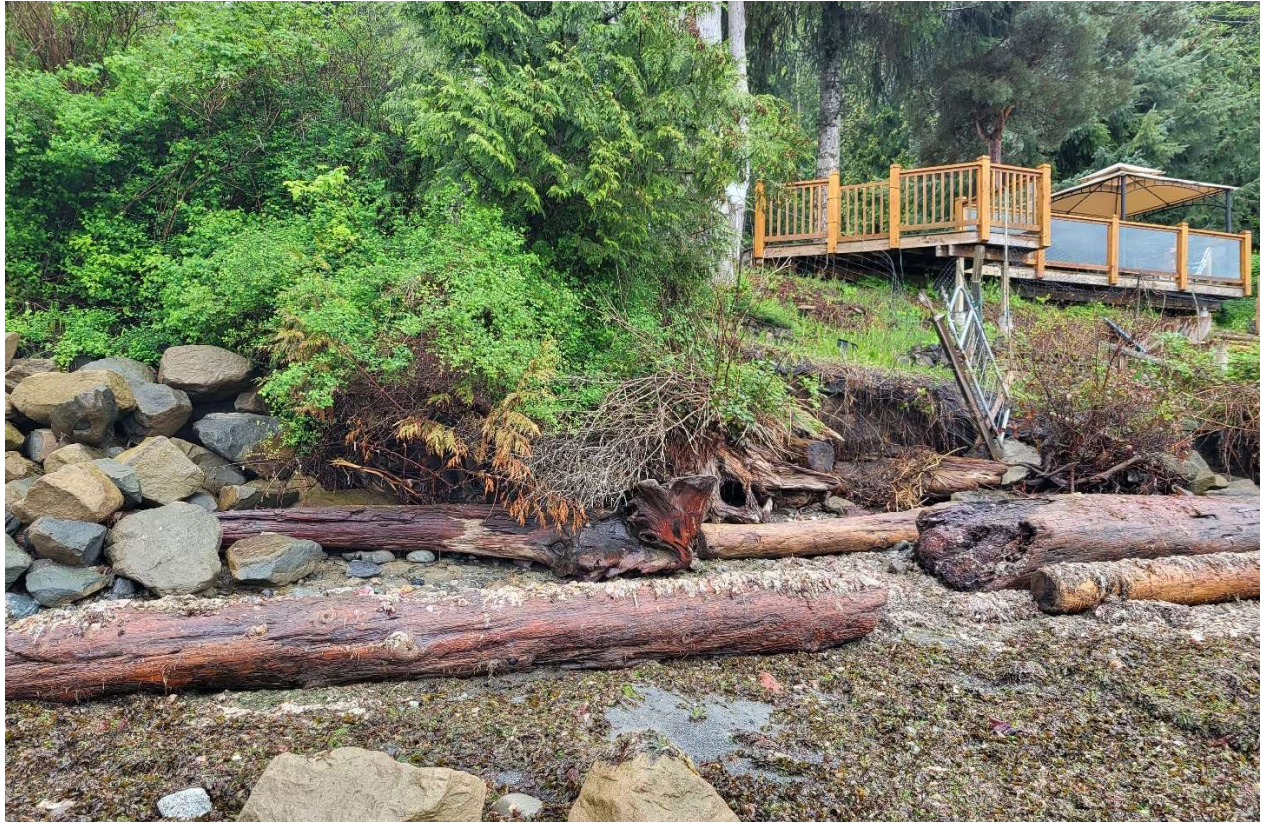
- b. In general, the foreshore can be characterized as a low-bank shoreline with a gently sloping intertidal zone facing the open waters of the Strait of Georgia / Salish Sea to the north. The total height of the shoreline bank ranged from approximately 2.4m to 5.9m at the time of our assessment. The crest is defined by the rear yard extent of lawn and organic soil cap with a detached wooden deck and fencing which transitions to a naturally forested area further to the west along the foreshore. Widely spaced coniferous trees exist at or near the slope crest. The present natural boundary is defined by an approximately 1.5m tall, near-vertical soil exposure located at the toe of the foreshore slope. See photos below.

Photo 1: Western foreshore conditions where they meet neighboring revetment.

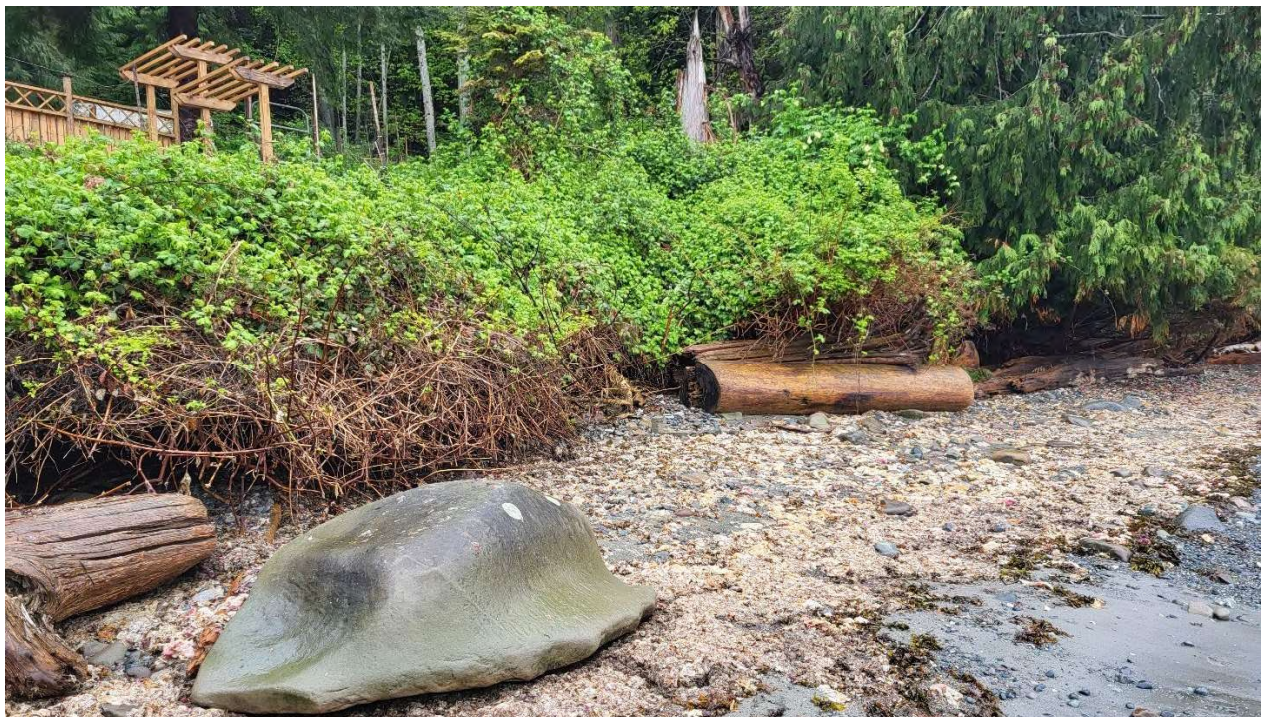
Photo 2: Conditions at the central foreshore area.

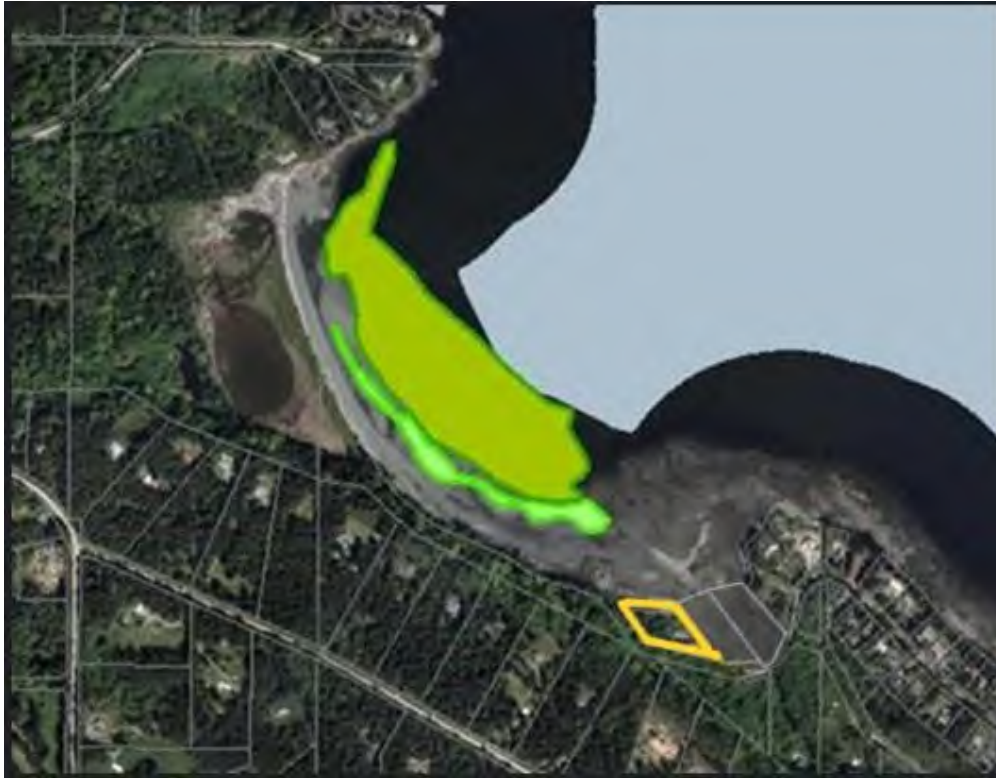
Figure 2: Eel Grass mapping in relation to subject property

There are marine grasses in the area but not near the structure. Eel grass is located approximately 170-220m offshore from the subject properties in the lower intertidal area (Figure 2). The beach slope is gentle with the steepest portion at the wrack line where it drops away for 5-10 m (0.5m) and then to a relatively flat to the sub-tidal areas approximately 200m away. The upper beach area has a cobble/gravel substrate with small sand deposits that tend to move around with seasonal weather patterns. The lower beach is mostly gravel with sand flats at the outer tide line set on sandstone base. The eel-grass bed is extensive following the foreshore in a broad band (as recorded by CMNBC.ca). It is located approximately 200m from the foreshore and continuing into the deeper waters.

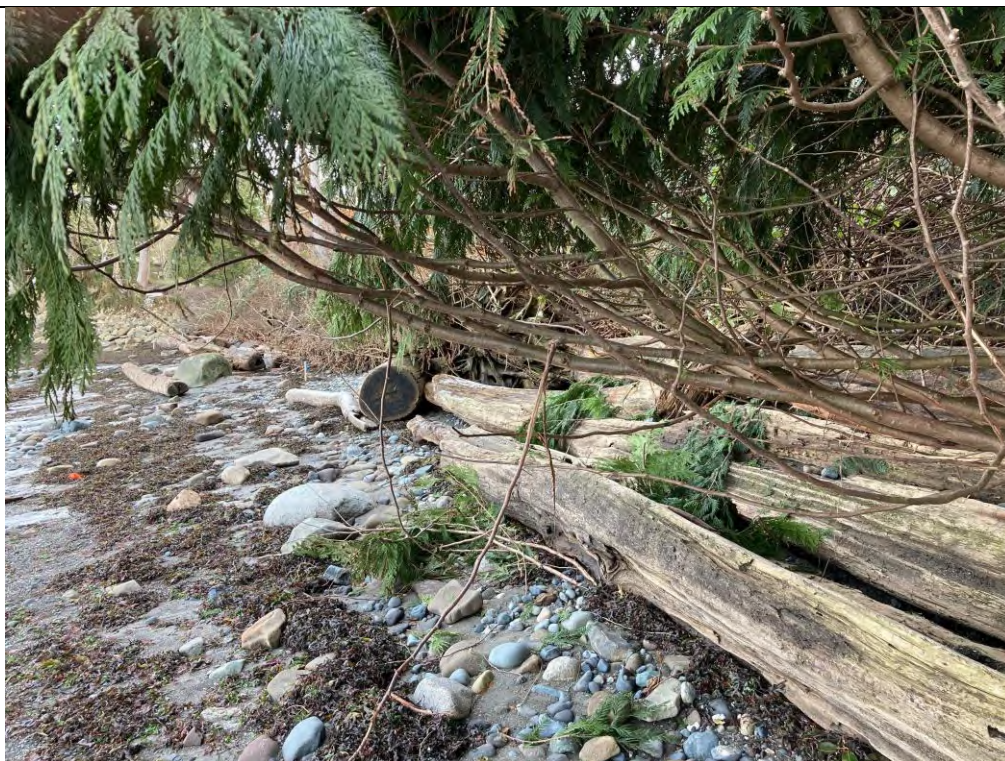
1.) Shore looking east along property line

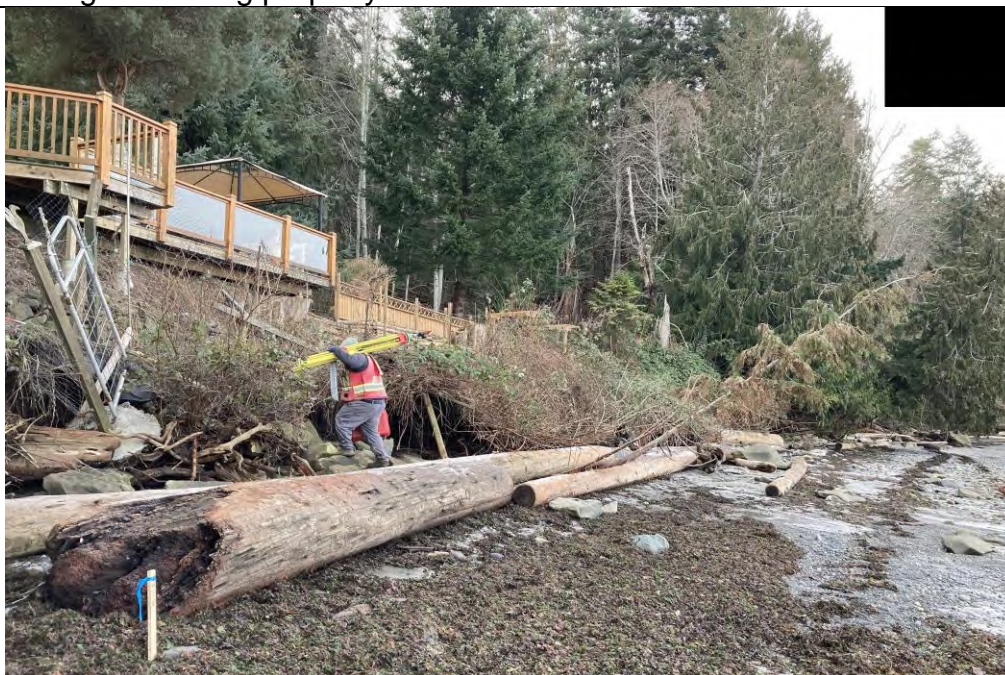
2.) Looking west from NE corner at eroding bank

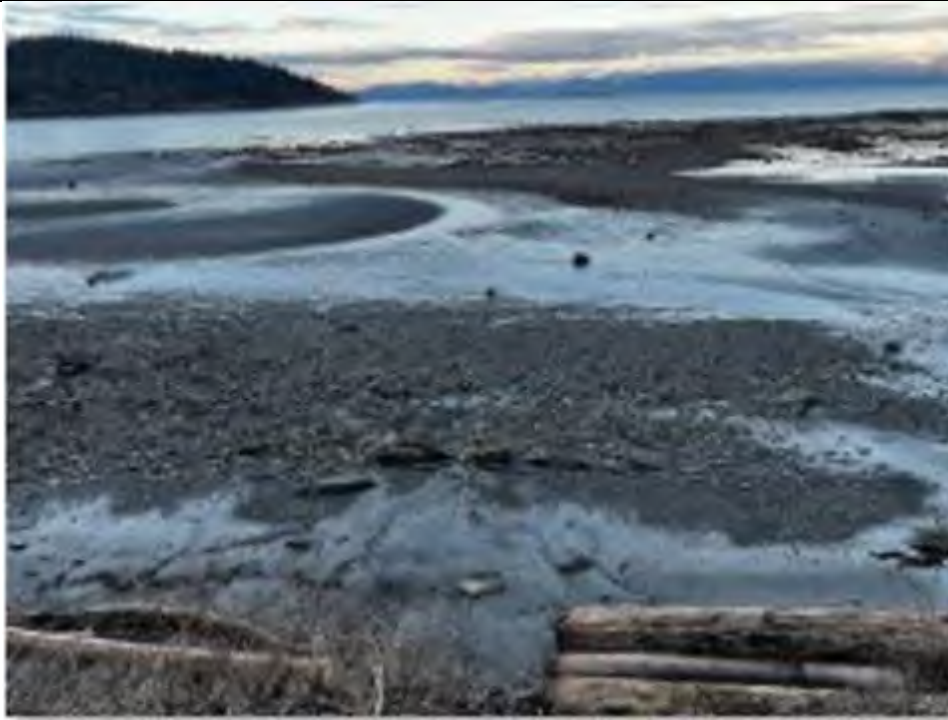
3.) Looking north toward the Salish Sea at beach characteristics
