File No.: PLDVP20240299 (Apps)

DATE OF MEETING: April 23, 2026
TO: Gabriola Island Local Trust Committee
FROM: Stephen Baugh, Island Planner
Northern Team
COPY: Renée Jamurat, Regional Planning Manager
SUBJECT: Development Variance Permit – PLDVP20240299 (Apps)
Applicant: Michael Apps
Location: 1140 The Strand, Gabriola Island

GEOTECHNICAL REPORT

Environmental Impact Assessment,
1140 The Strand
Gabriola Island, BC

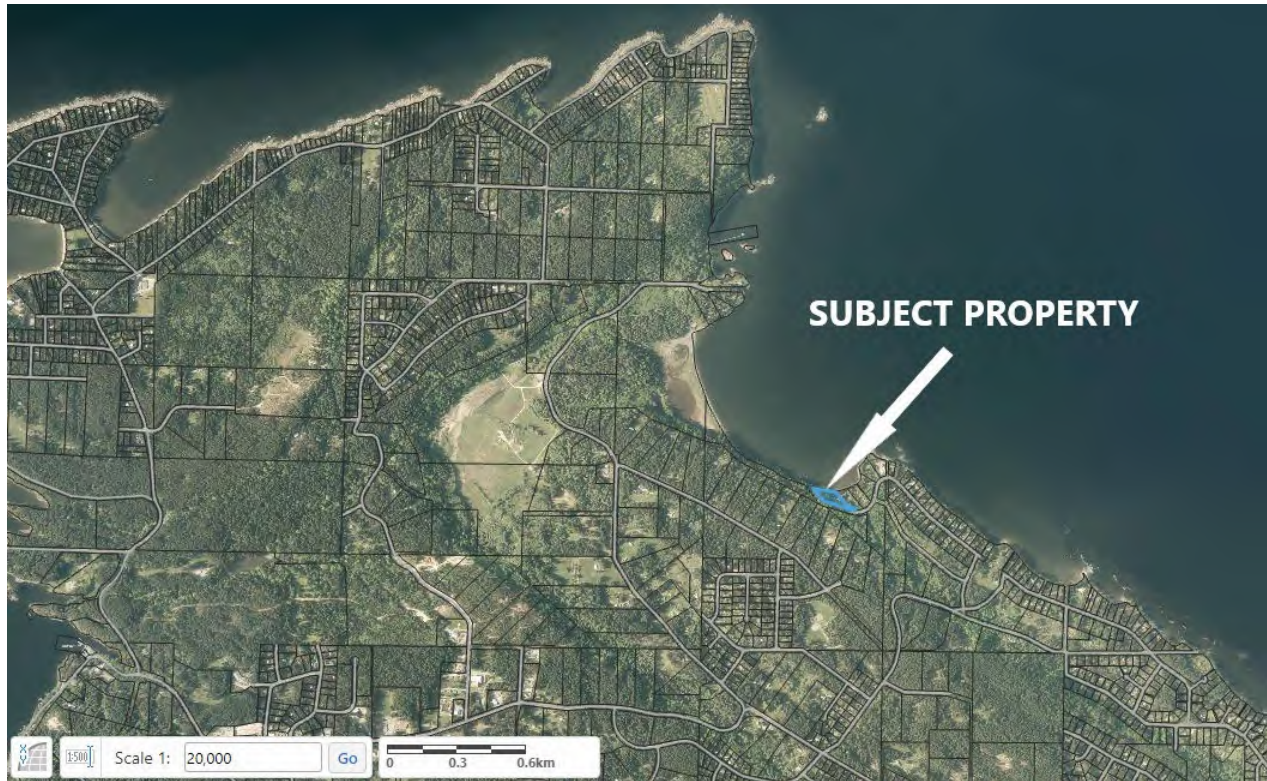
Figure 3.1– Location Plan of Subject Property²

- a. The property is currently developed with an existing single-family residence, existing carriage house, and established landscaping/lawn areas. The subject site is located along the northern shore of Gabriola Island.

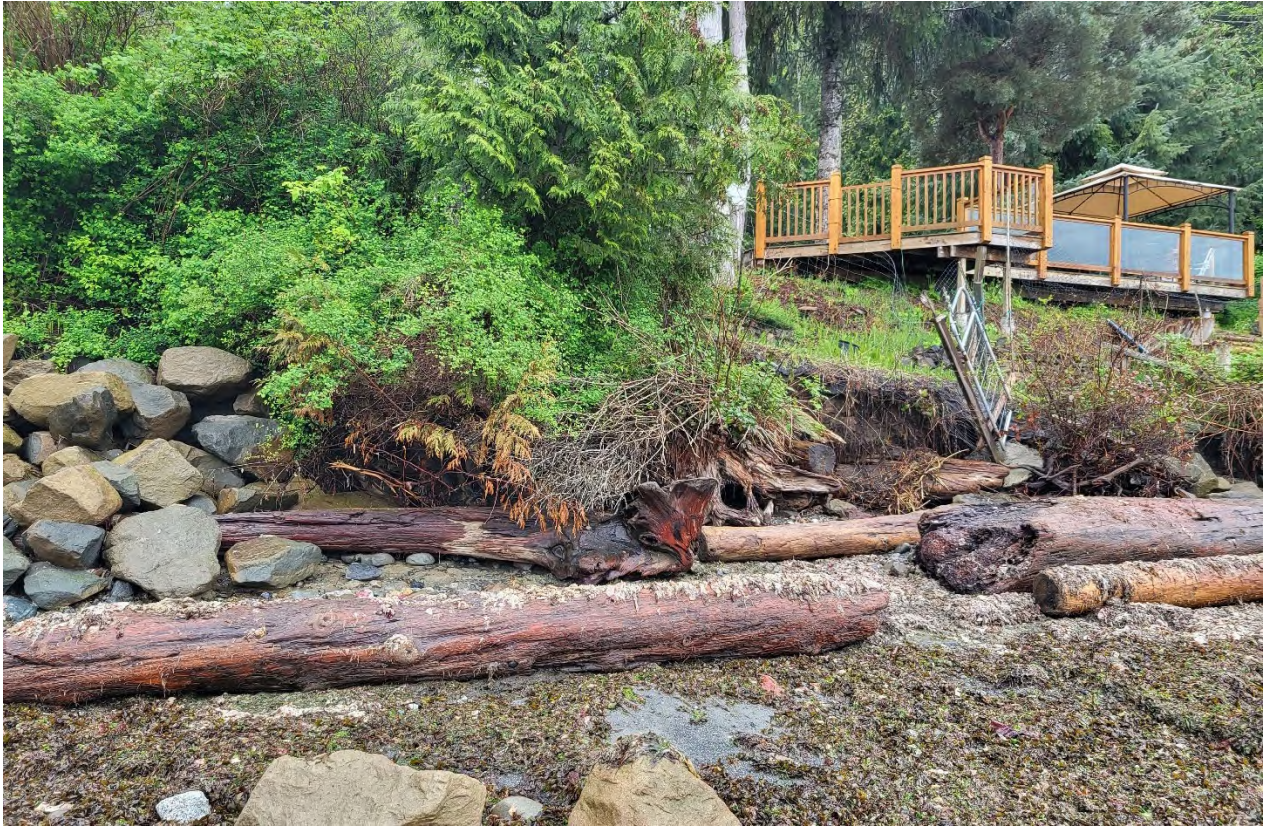
Photo 1: Western foreshore conditions where they meet neighboring revetment.

- b. In general, the foreshore can be characterized as a low-bank shoreline with a gently sloping intertidal zone facing the open waters of the Strait of Georgia / Salish Sea to the north. The total height of the shoreline bank ranged from approximately 2.4m to 5.9m at the time of our assessment. The crest is defined by the rear yard extent of lawn and organic soil cap with a detached wooden deck and fencing which transitions to a naturally forested area further to the west along the foreshore. Widely spaced coniferous trees exist at or near the slope crest. The present natural boundary is defined by an approximately 1.5m tall, near-vertical soil exposure located at the toe of the foreshore slope. See photos below.

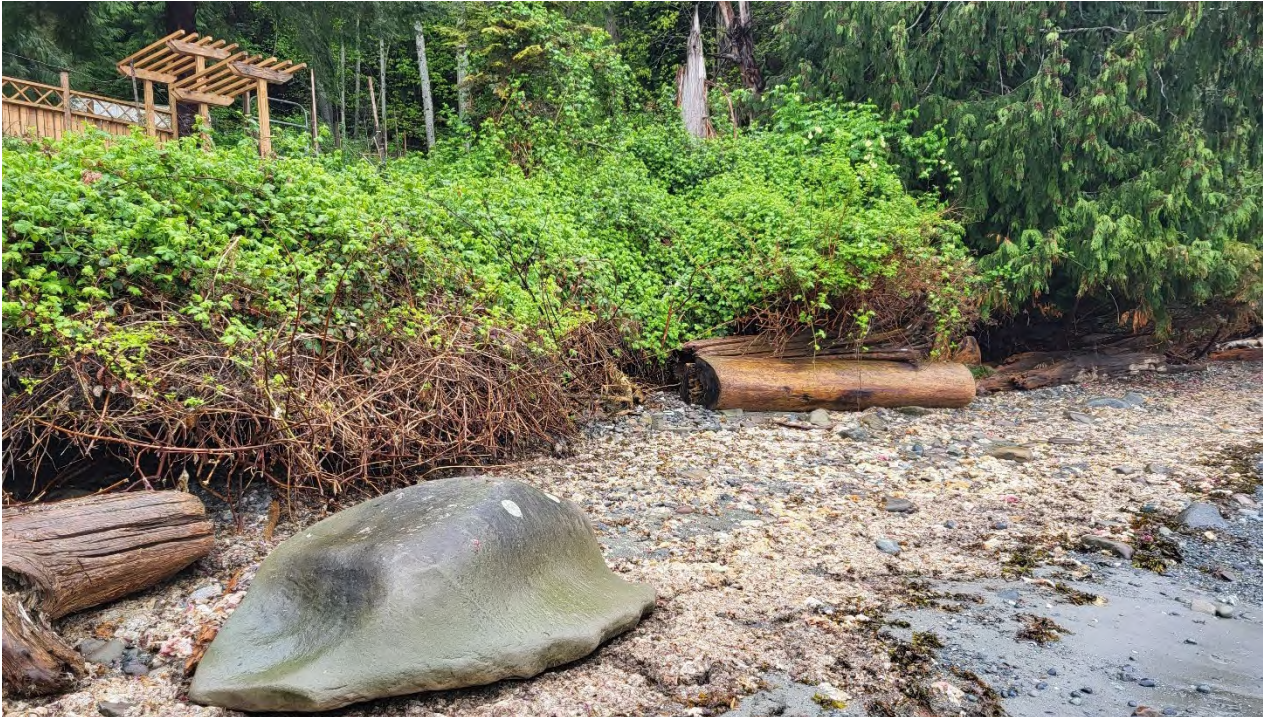
Photo 2: Conditions at the central foreshore area.

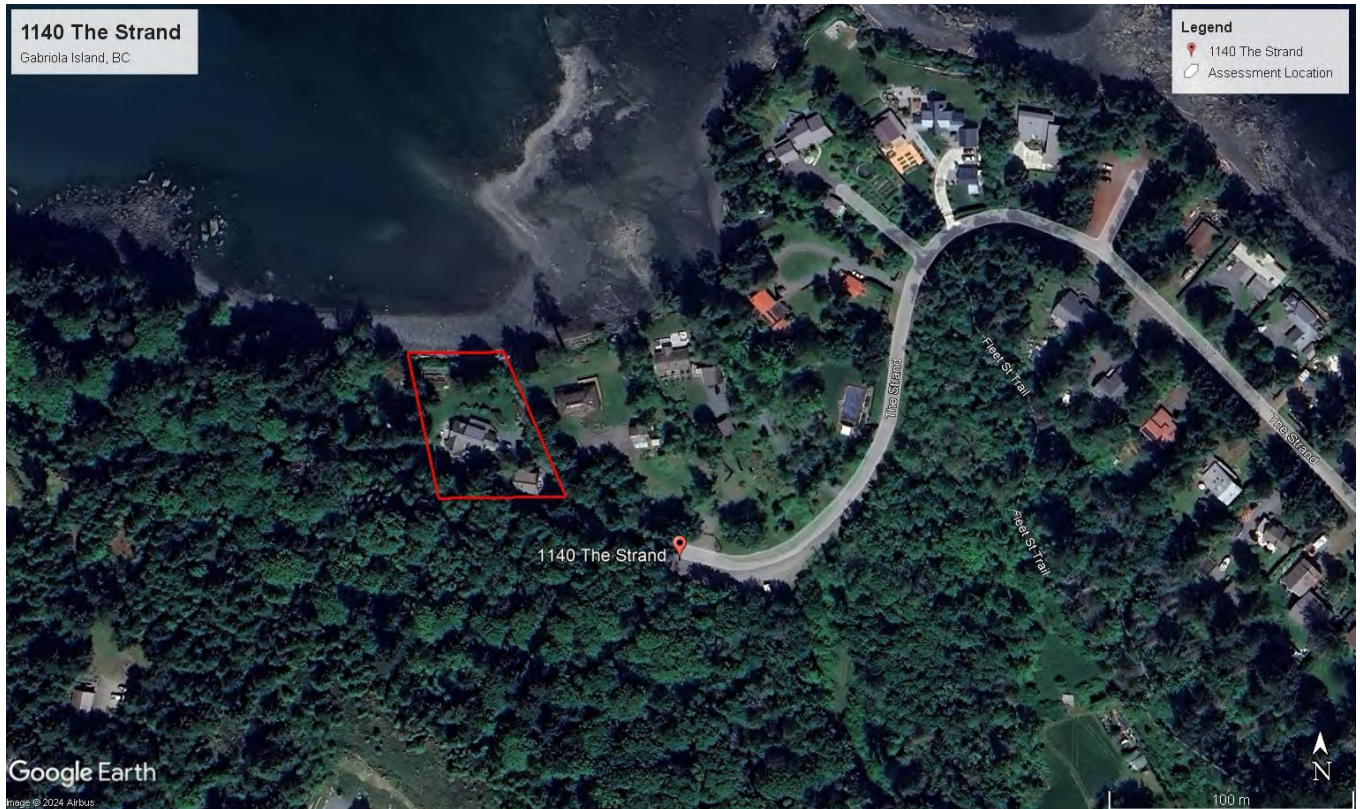
Figure 1.) Site Location

Location: The property is located at 1140 The Strand on in the eastern corner of Lock Bay Gabriola Island (Fig.1) The adjoining properties to the east each have a residential dwelling with revetments previously constructed. The western property is parkland. The property encompasses approximately 95m of lineal foreshore.

The subject property is located in the southeast corner of Lock Bay which has significant southeast exposure to wind and as well as wave/log action during winter storm events (Figure 1).

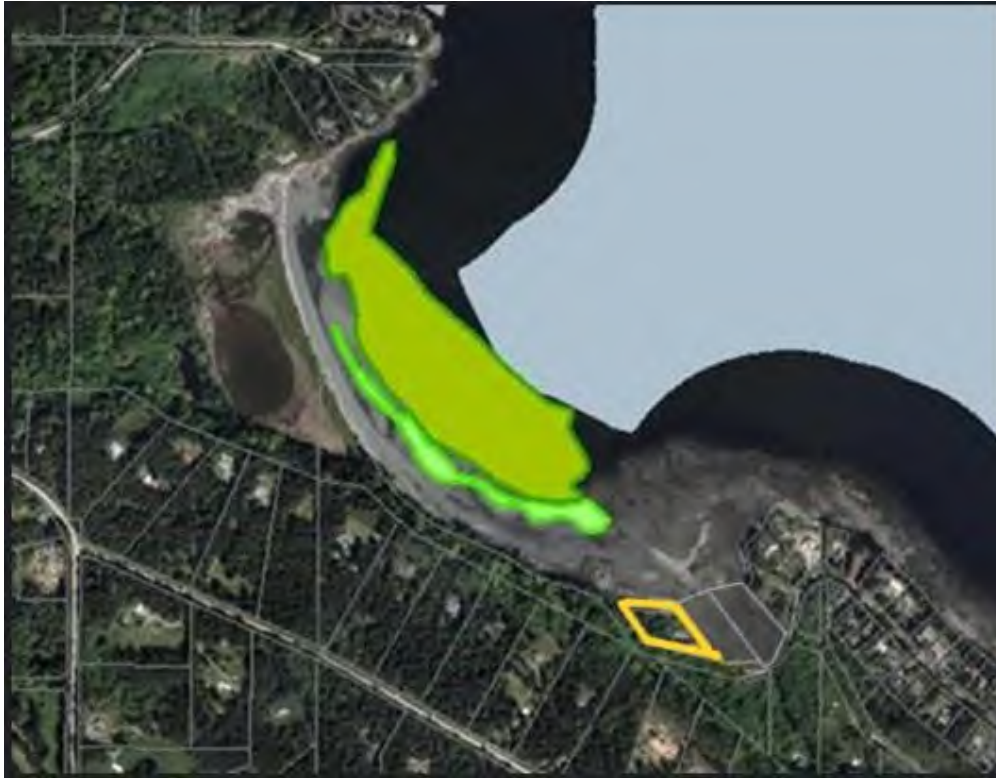
Figure 2: Eel Grass mapping in relation to subject property

There are marine grasses in the area but not near the structure. Eel grass is located approximately 170-220m offshore from the subject properties in the lower intertidal area (Figure 2). The beach slope is gentle with the steepest portion at the wrack line where it drops away for 5-10 m (0.5m) and then to a relatively flat to the sub-tidal areas approximately 200m away. The upper beach area has a cobble/gravel substrate with small sand deposits that tend to move around with seasonal weather patterns. The lower beach is mostly gravel with sand flats at the outer tide line set on sandstone base. The eel-grass bed is extensive following the foreshore in a broad band (as recorded by CMNBC.ca). It is located approximately 200m from the foreshore and continuing into the deeper waters.

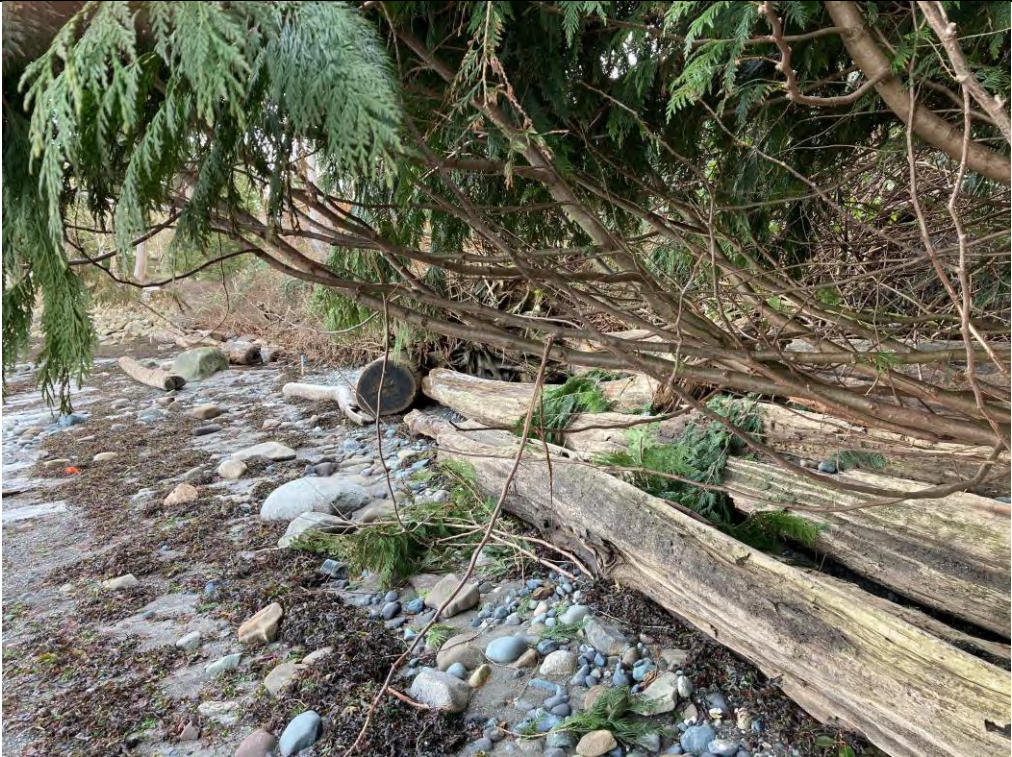
1.) Shore looking east along property line

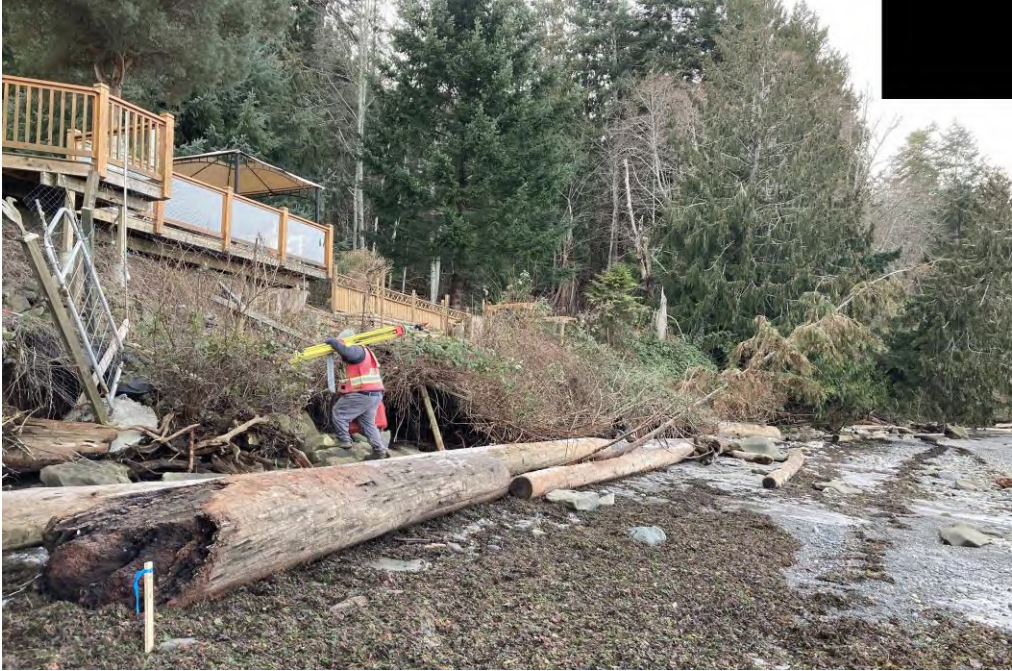
2.) Looking west from NE corner at eroding bank

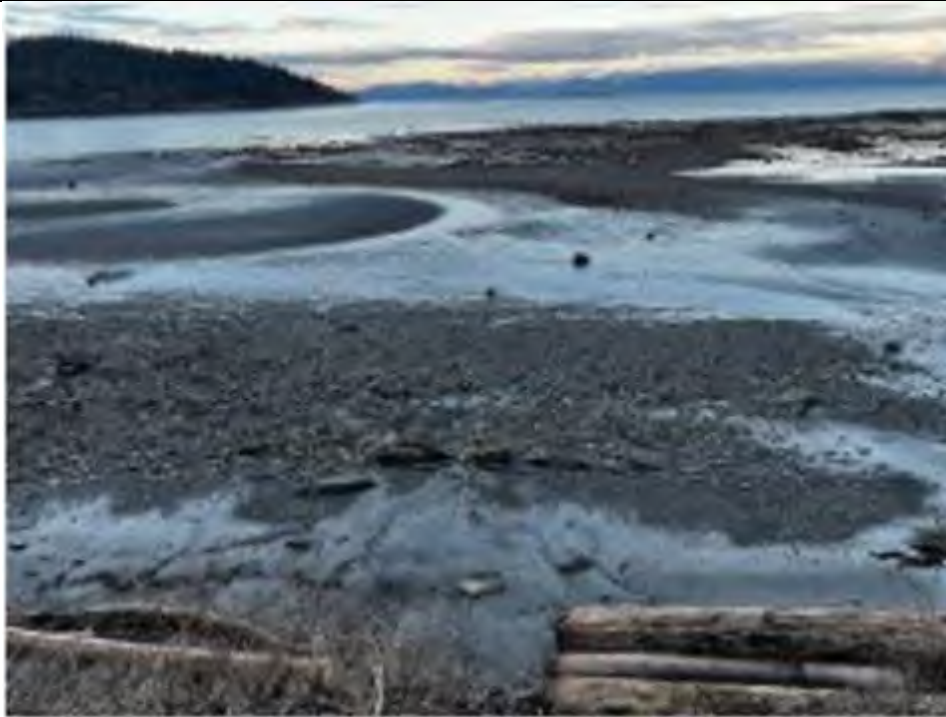
3.) Looking north toward the Salish Sea at beach characteristics
