# SHINGLE SPIT BOAT LAUNCH REPLACEMENT: Biophysical Assessment and Environmental Management Plan

**October 7, 2024**

**CALIDRIS  
Ecological  
SERVICES**  
wildlife - ecology - restoration

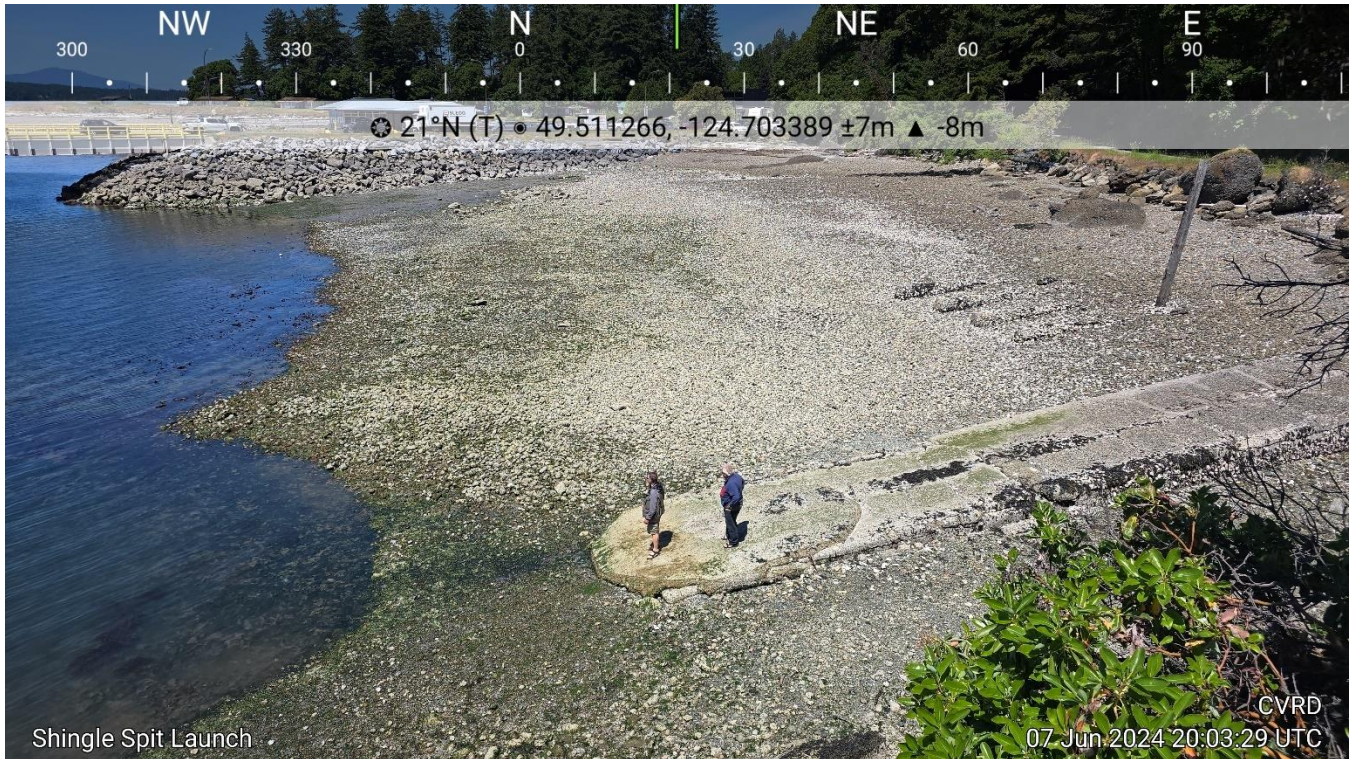
The existing launch is in degraded condition (Appendix D: Photo 1 -2). There are large cracks in the surface concrete and the edges and end of the concrete have been eroded. Undermining of the concrete surface is also evident. Further, the current launch does not allow for safe launching at lower tides. It was estimated that at least a two-meter tide is required to launch small craft safely on the existing infrastructure.

**Photo 1.** Showing the current condition of the boat launch as viewed from the adjacent breakwater. Note the BC ferries dock in the background. The new launch will extend seven meters from the end of the existing dock into the shallow area visible at bottom left of photo. The people in the photo were hoping to launch a small boat at the time of the assessment but the tide was too low to allow for a safe launch.

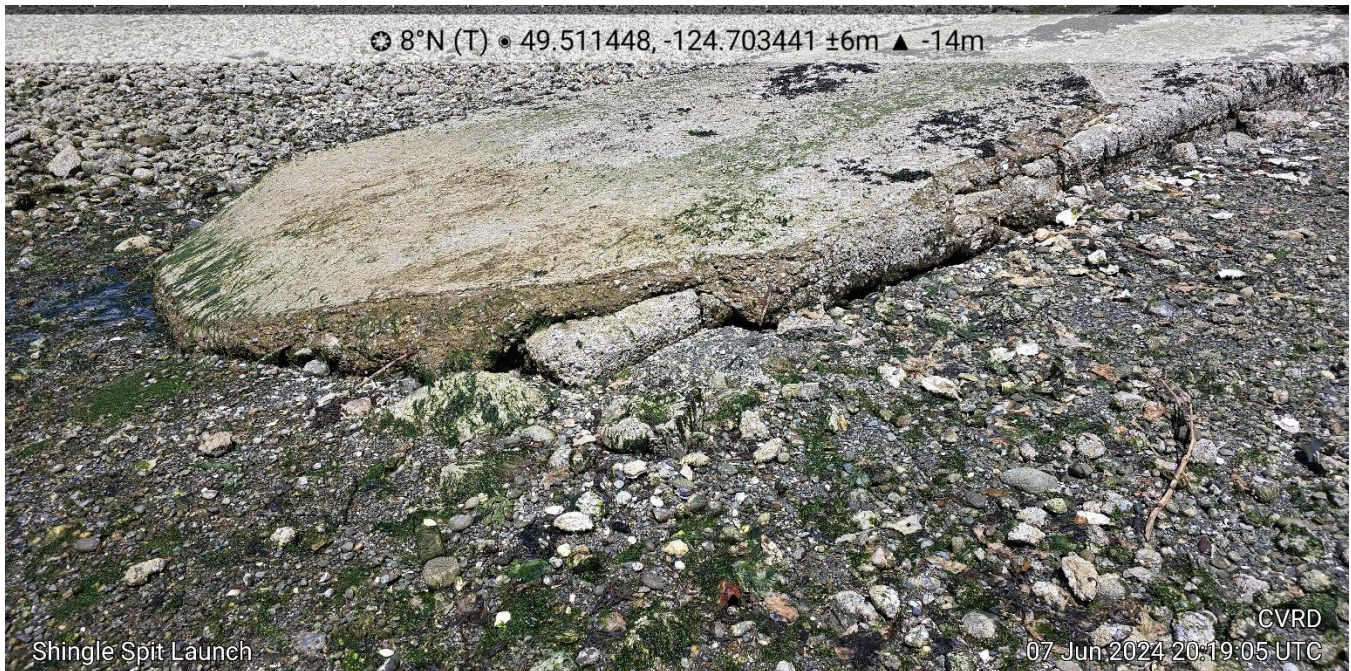
**Photo 2.** Showing the current condition of the boat launch, note eroded end of the launch.

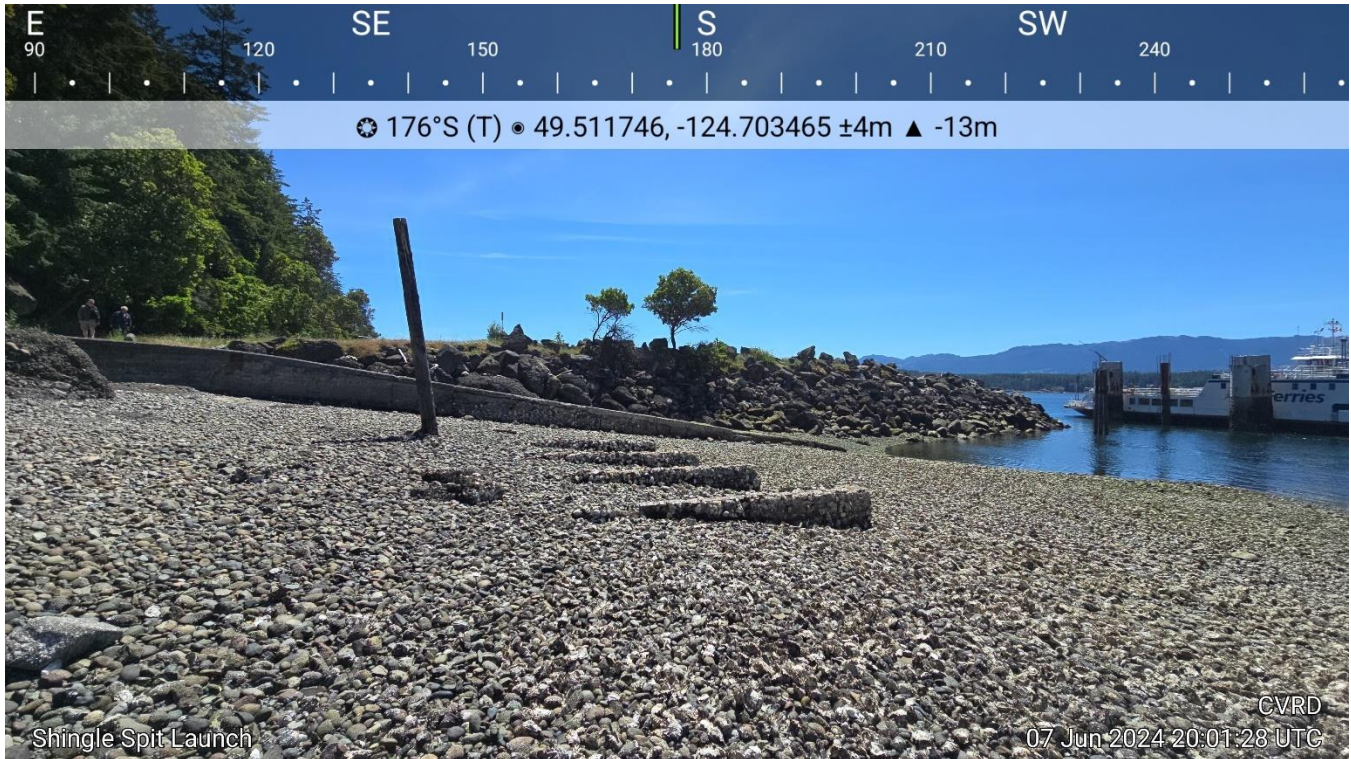
The launch is positioned within the BC Ferries breakwater on the eastern shore of Hornby Island. The area has seen a considerable amount of industrial activity. The existing boat launch and ferry terminal have been in place for at least 20 years according to imagery from Google Earth™. There are remnants of old structures on the beach including old concrete footings the purpose of which are not known (Appendix D: Photo 3).

**Photo 3.** Showing habitat conditions adjacent to the boat launch. Note old infrastructure, cobble substrate and abundant oyster shells.

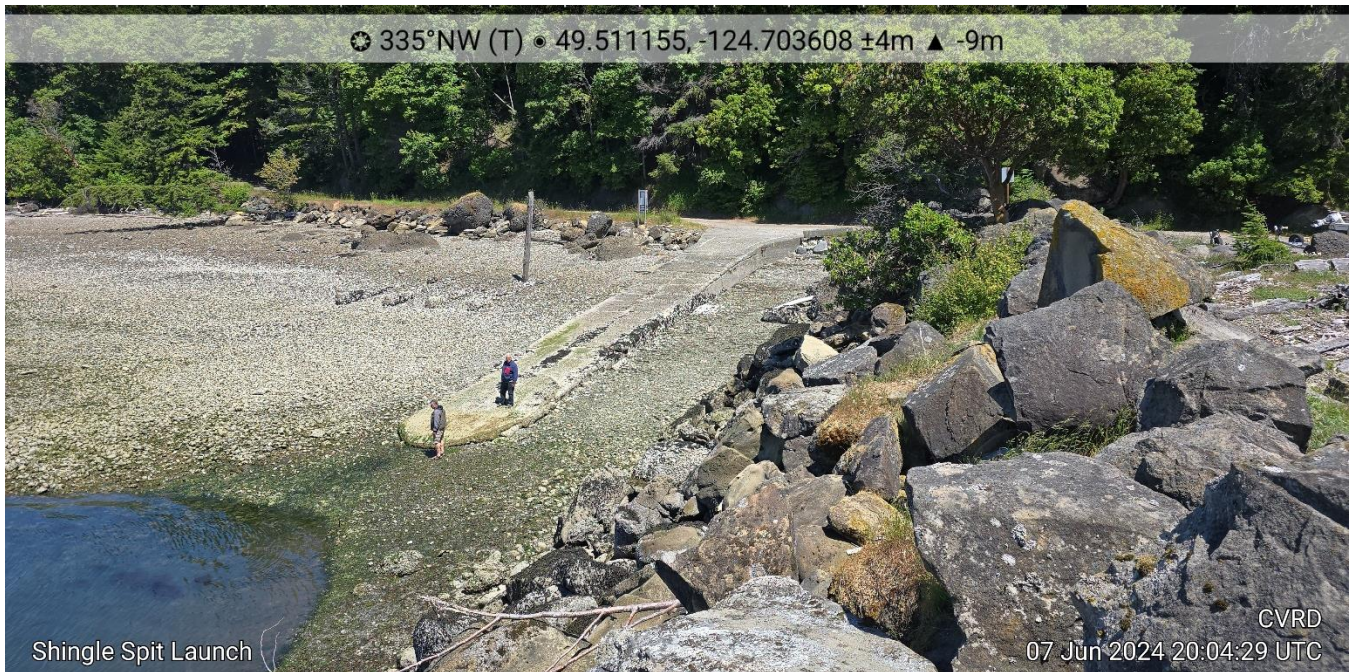
**Photo 4.** Showing habitat conditions adjacent to the boat launch as viewed from the end of the breakwater. Note a few shrubs and deciduous species on the breakwater and near the top of the launch.

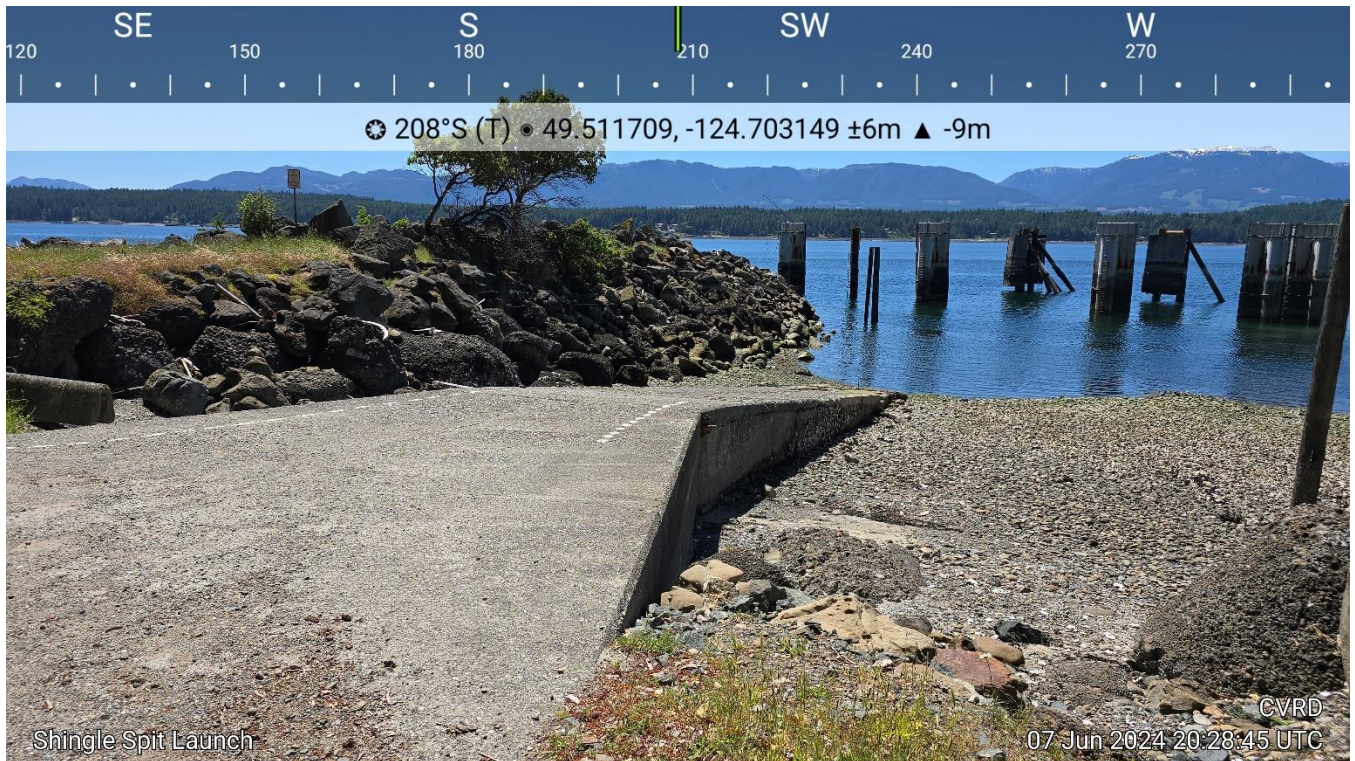
Photo 5. Showing position of the launch in relation to the breakwater and BC Ferry Dock (background, at right).

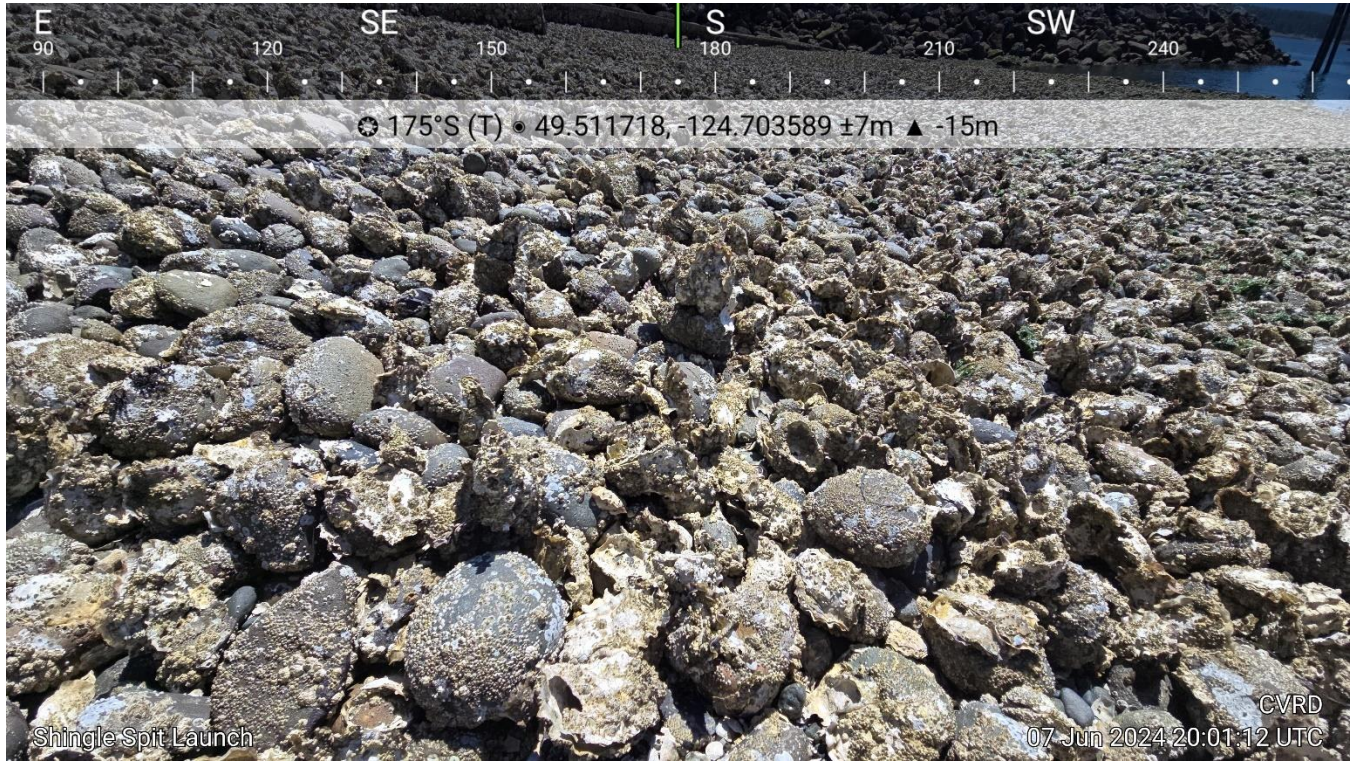
Pacific oyster (*Crassostrea gigas*) was abundant amongst the cobble substrate (Appendix D: Photo 5) as were acorn barnacles (*Chthamatus dalli*). Shore crabs (*Hemigrapsus sp.*) were abundant within the cobble substrate across the beach area. The remains of red rock crab (*Cancer productus*) were also observed.

Photo 6. Showing abundant Pacific oyster among the cobble substrate that dominates the foreshore and intertidal area around the launch.

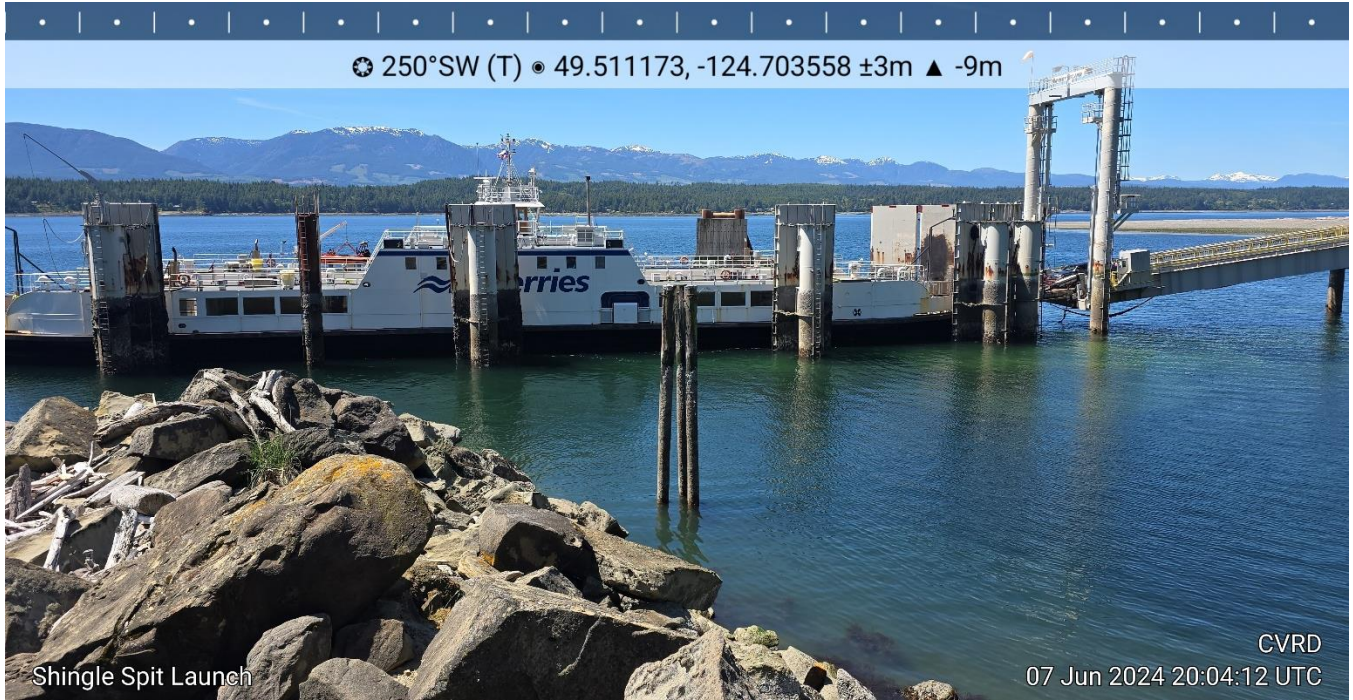
**Photo 7.** Showing the BC Ferry at dock directly in front of where the new launch is going to be placed, as viewed from the breakwater (foreground, at left).

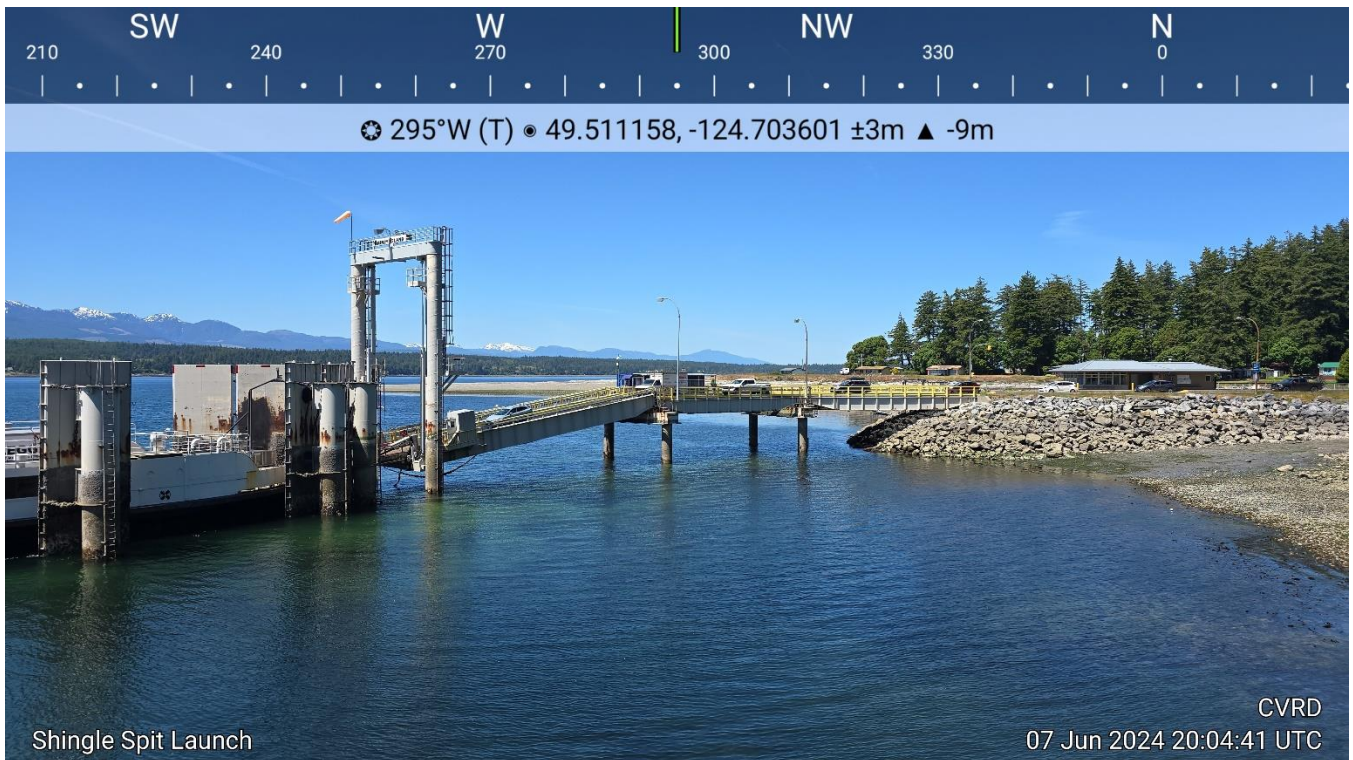
**Photo 8.** Showing the BC Ferry at dock wrapping around the launch, as viewed from the breakwater. The launch is outside of the frame at far right of photo.

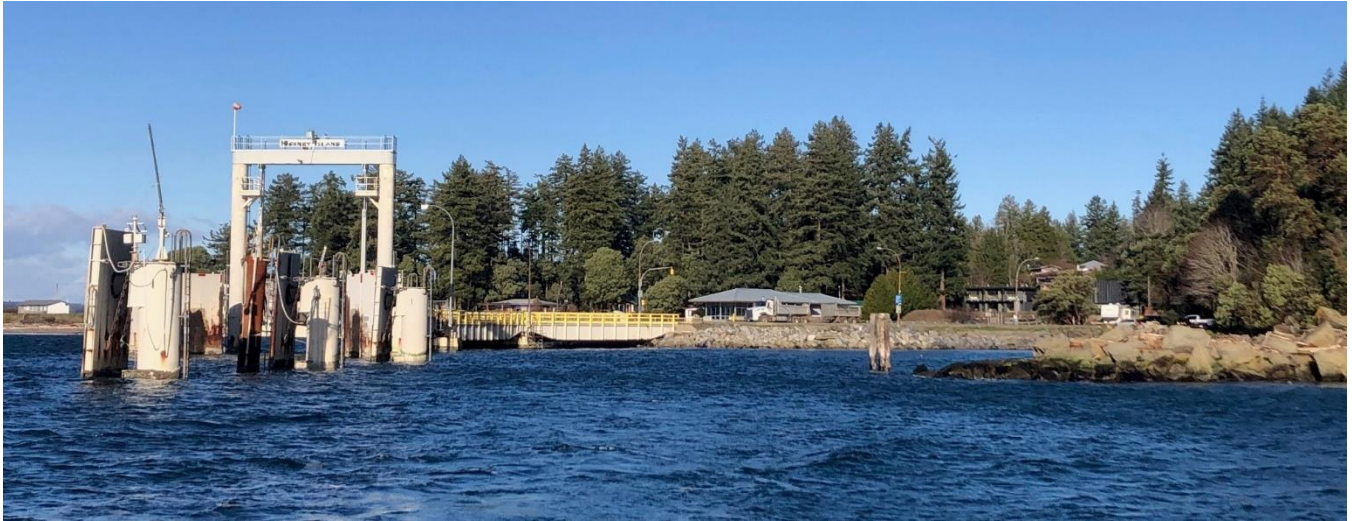
**Photo 9.** Showing the BC Ferry at dock and breakwater at high tide on January 11, 2024. Photo provided by MCCOI Marine and taken during the bathymetry surveys for informing the engineering plan.

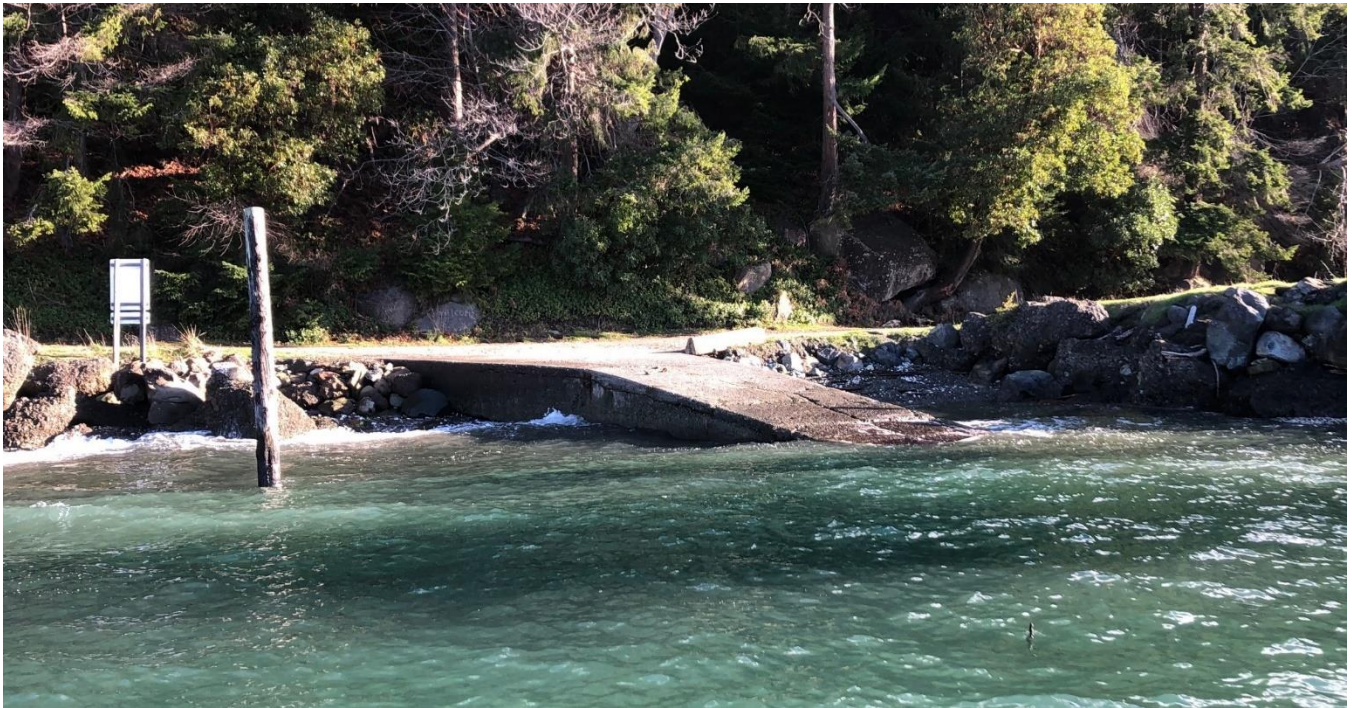
**Photo 10.** Showing the launch at high tide on January 11, 2024. Photo provided by MCCOI Marine and taken during the bathymetry surveys for informing the engineering plan.

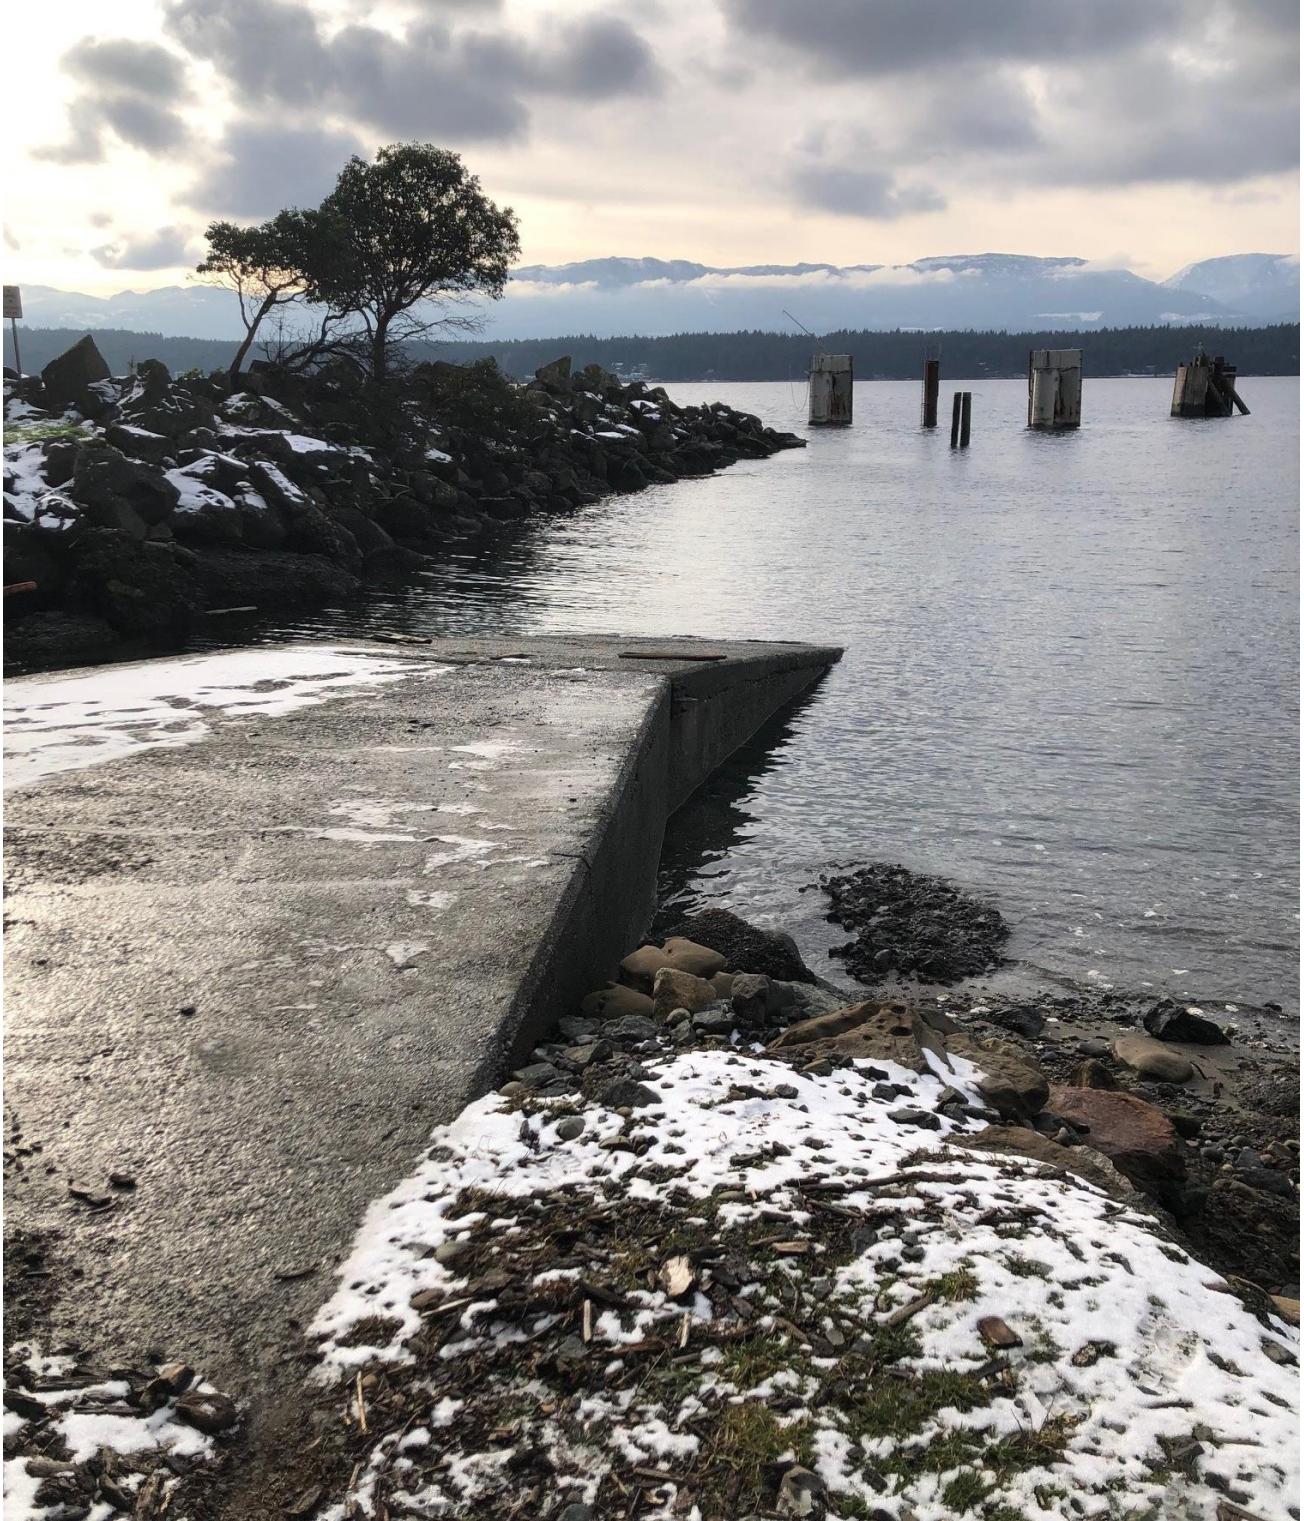
**Photo 11.** Showing the launch at high tide on January 12, 2024. Photo provided by MCCOI Marine and taken during the bathymetry surveys for informing the engineering plan.
