**HORNBY ISLAND RIPARIAN AREA  
REGULATION STREAM IDENTIFICATION –  
BEULAH CREEK AND THREE UN-NAMED  
WATERSHEDS**

**Trystan Willmott, B.Sc. A.Sc.T. and  
Justin Lange, B.Sc., R.P.Bio., A.Sc.T.  
MADRONE ENVIRONMENTAL SERVICES LTD.  
1081 Canada Avenue, Duncan, BC, V9L 1V2**

**January 21, 2014**

Dossier 13.0315

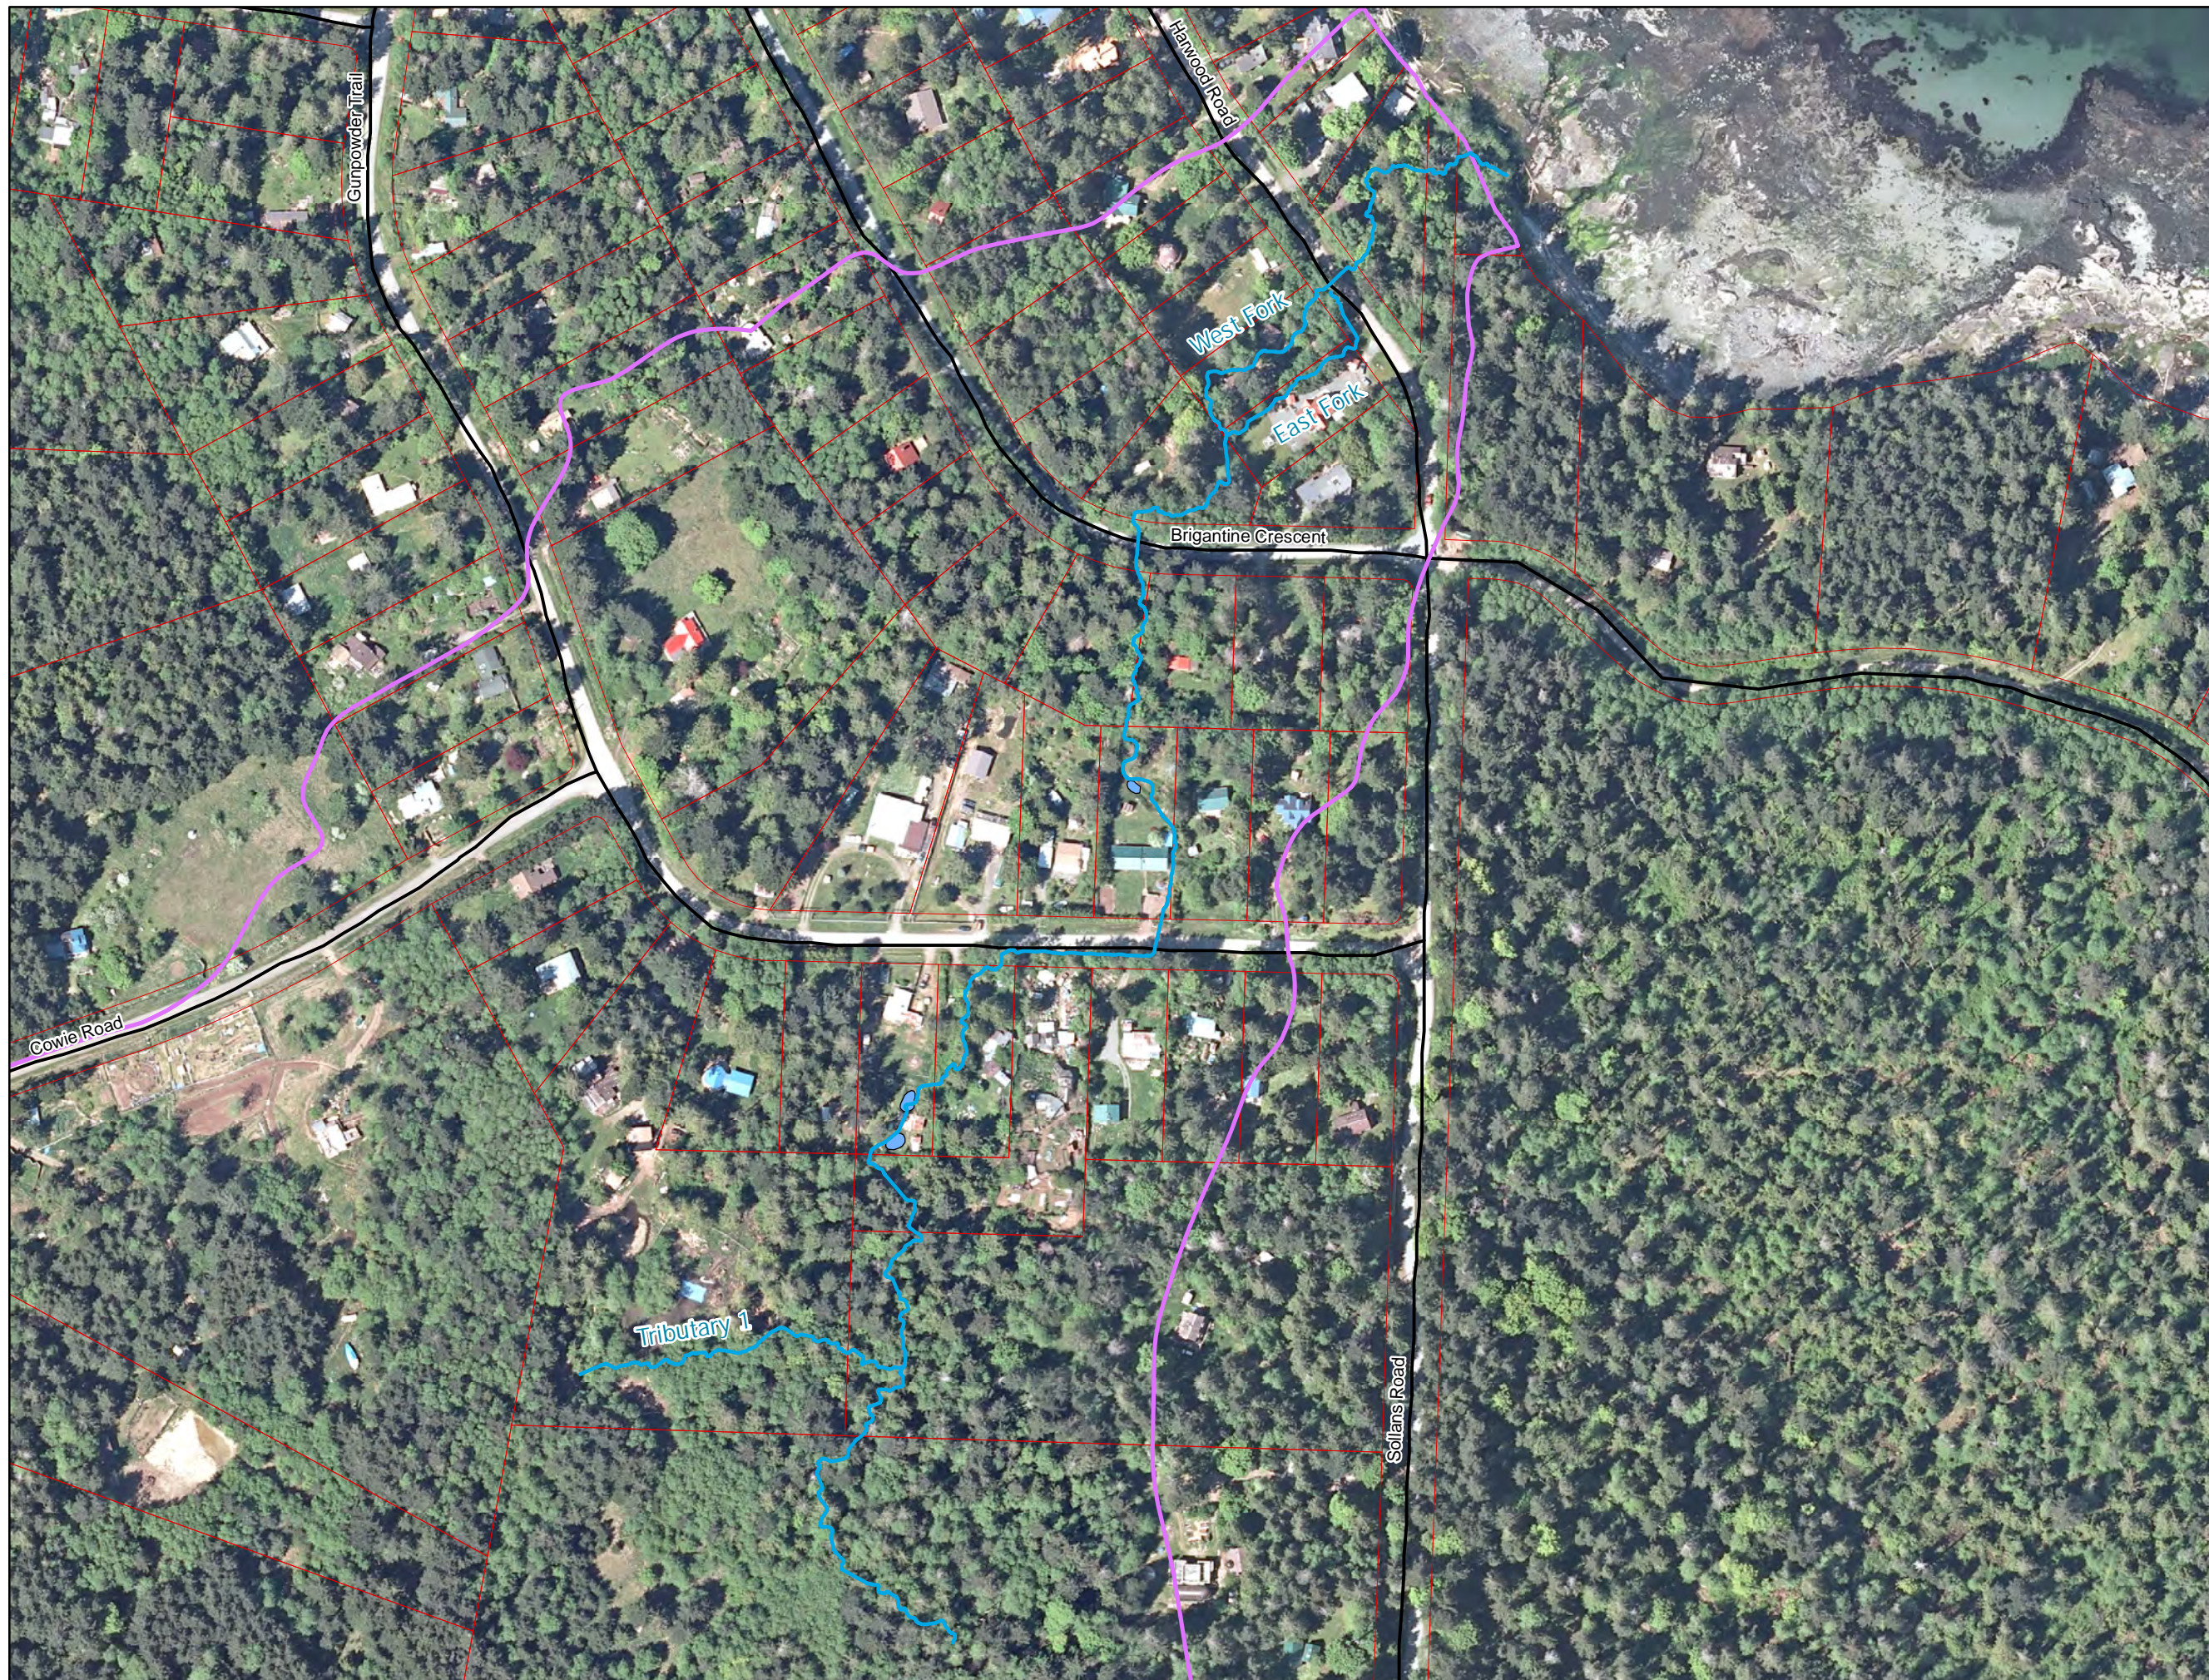
### 3.2.3 Potential RAR Watershed 2 – Figure 5

At the tidal boundary, the stream flows over a bedrock ledge (approximately 1 m in height) and onto a cobble beach. During periods of high stream flows and high tides this feature would likely be passable for anadromous fish species. The lower reaches of the creek flow through mature forest, with red alder, western redcedar and Douglas-fir dominating the tree layer. Pacific ninebark (*Physocarpus capitatus*) and salmonberry (*Rubus spectabilis*) compose a dense shrub layer that extends up to the high water mark of the stream. This vegetation on both banks of the creek is intact and providing proper biological function.

This watercourse was mapped for approximately 150 m, up to a point where access was prohibited by a property owner. It was noted that the drainage continued on an adjacent property to the southwest of the termination point. Anecdotal evidence indicates that the drainage channel was excavated as a measure to deal with storm water run-off. This watercourse represents poor quality fish habitat as it is likely ephemeral and lacks suitable spawning and rearing habitat.

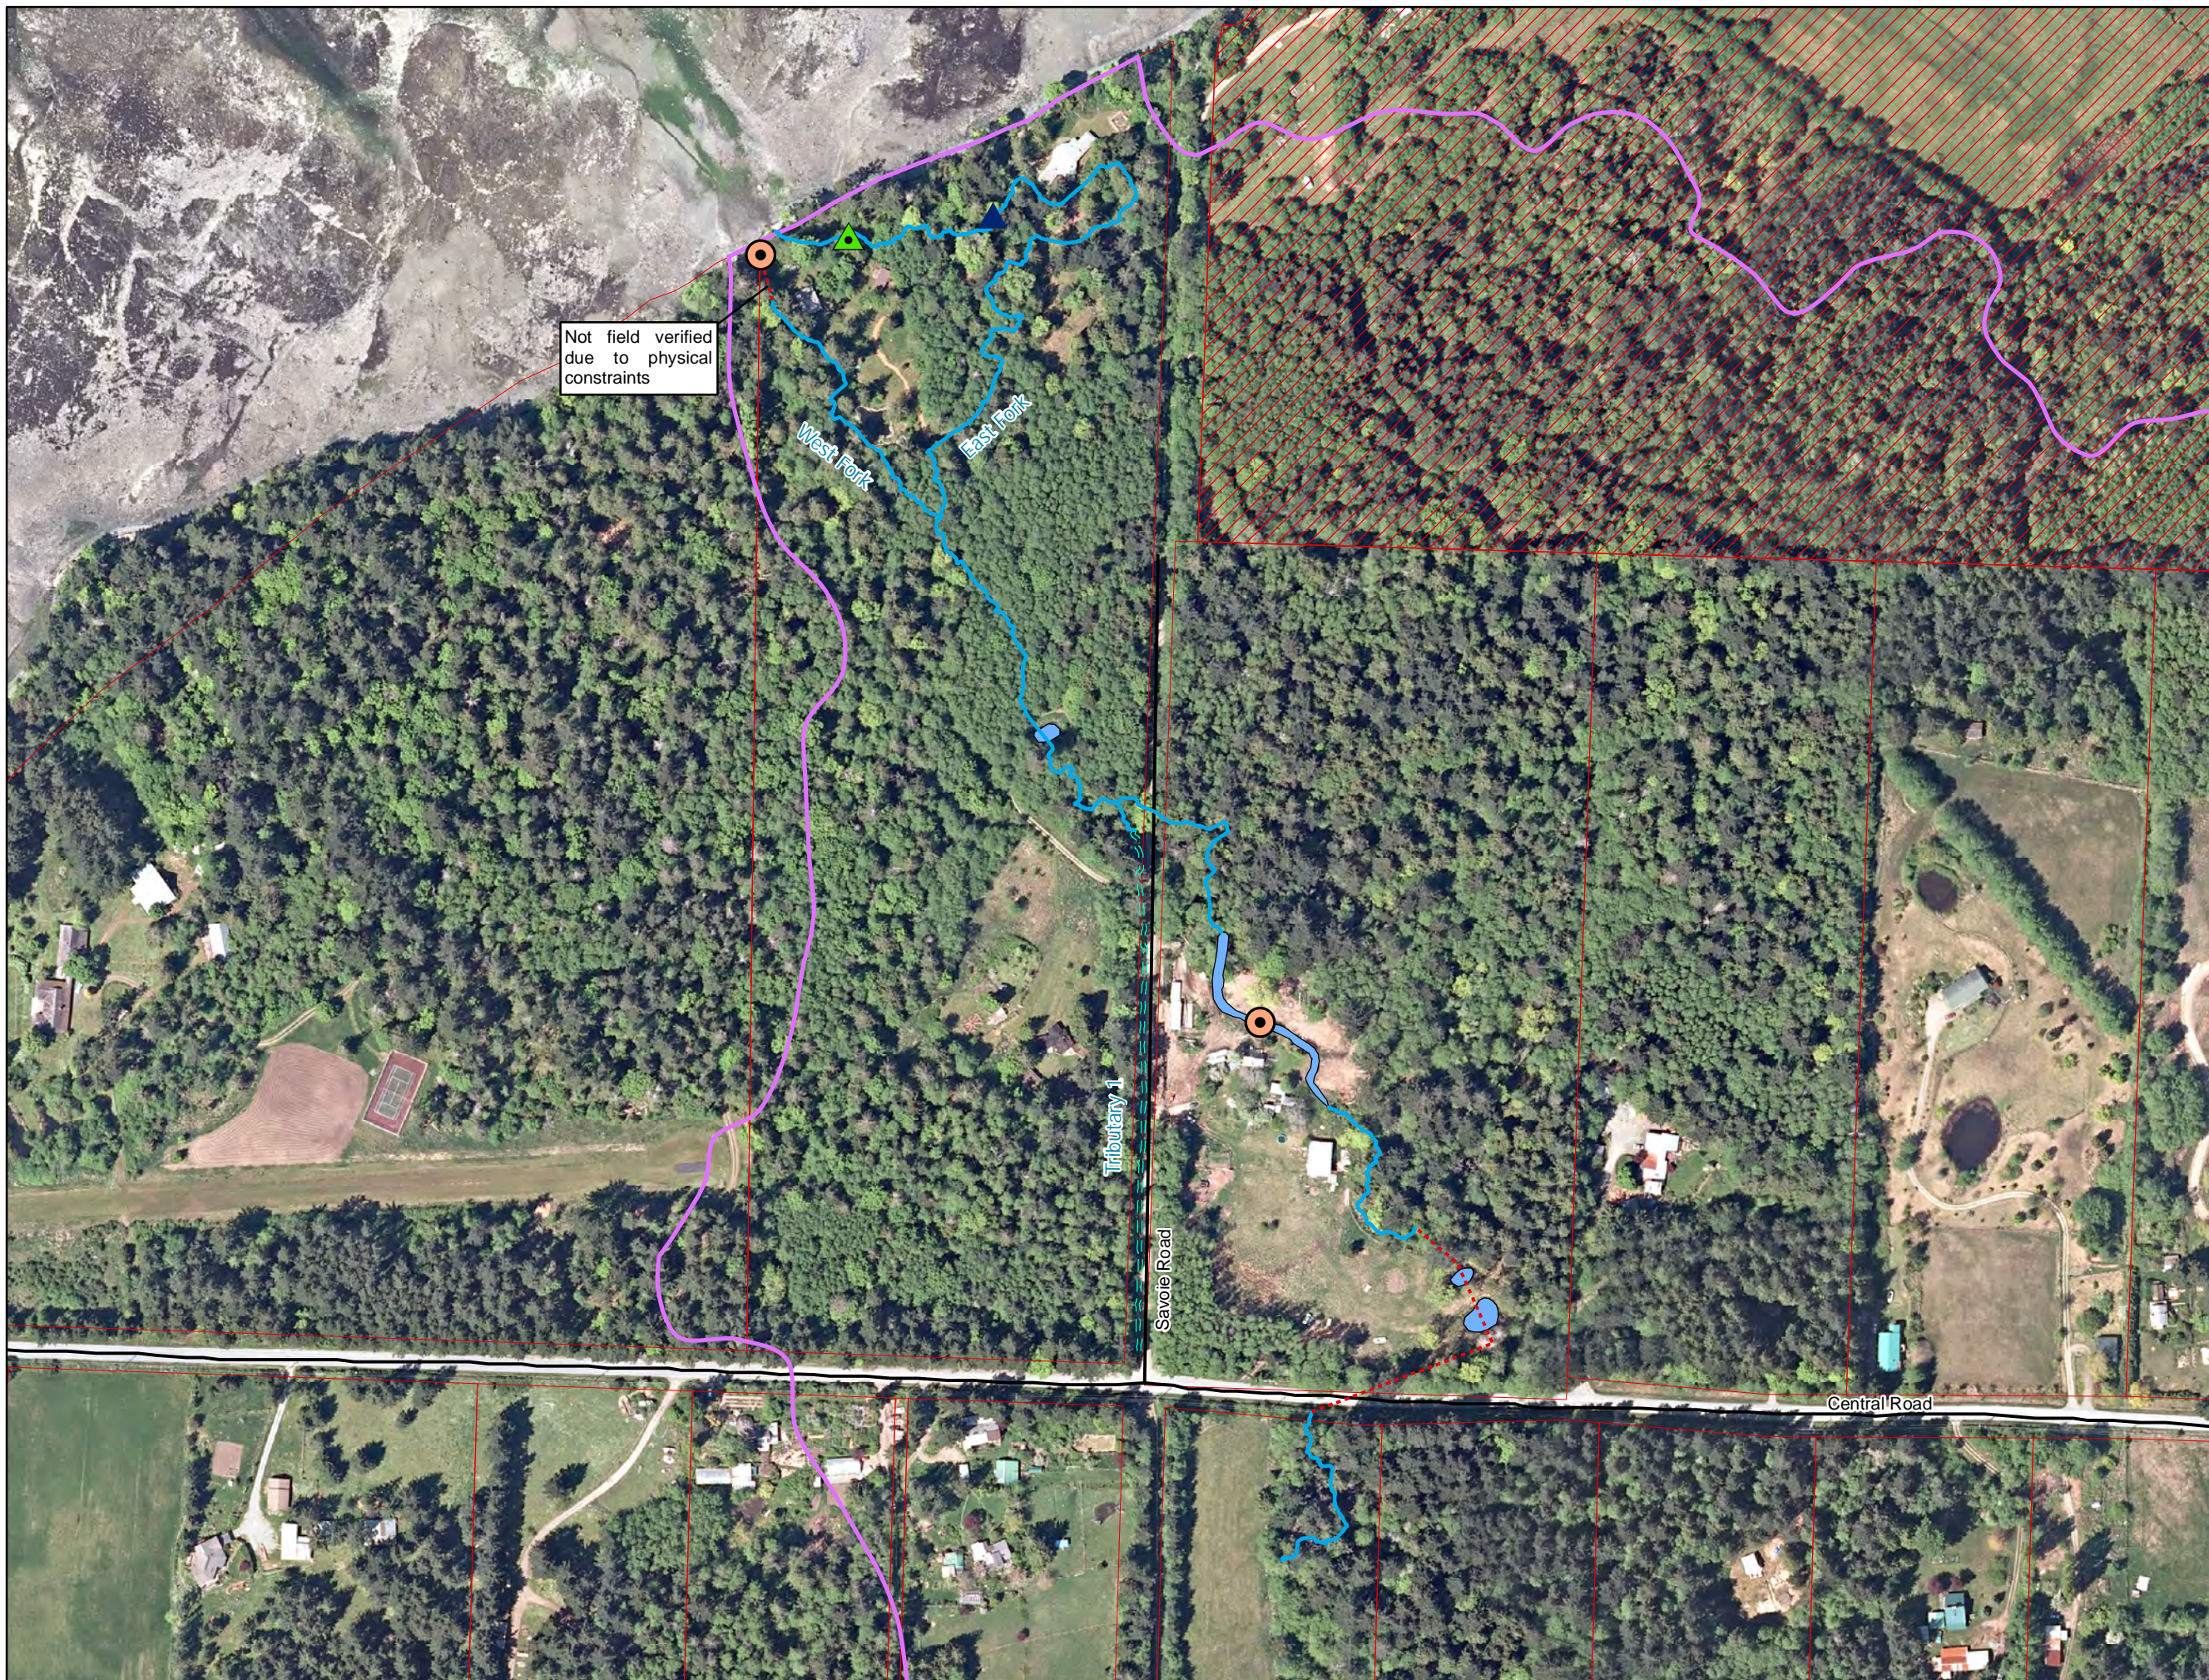
### 3.2.4 Potential RAR Watershed 3 – Figure 6

At the natural boundary of the marine environment, the main watercourse flows over a gravel/cobble beach and into the ocean. Immediately upstream of the confluence with the ocean, the stream flows through a steep sided ravine. The first 20 m – 25 m of the drainage exhibits a low gradient (2% slope) and is up to 3 m wide (bankfull width). In the upper portion of the ravine, the stream channel becomes more confined and is approximately 1.5 m to 2 m wide. The vegetation growing on the ravine walls is contributing biological function by providing bank stability, nutrient input, LWD and shade. Tree growth is composed of both mature and young Douglas-fir, western redcedar and red alder.

The channel morphology throughout the lower reaches of the stream is consistent with a riffle-pool system. The diversity of habitat throughout the lower reaches of the stream provides potential fish habitat, as glides and pools were noted.

In the south-central portion of the residential property, the stream is directed under an access road via a 400 mm culvert. At the southern boundary of the property a dam system has been installed to regulate the flow of water. During periods of low flow, water will be retained behind the dam and provide water for domestic use (*i.e.*, irrigation). At the time the stream was traversed, water withdrawal lines were observed within the stream. The dam structure would not represent a definitive barrier to upstream migration by anadromous salmonids as it would be passable, particularly during high flows.

Upstream of Savoie Road, the stream flows through a portion of a residential property that is composed of an undisturbed mature forest, dominated by western redcedar and Douglas-fir. Dull Oregon-grape and salal were also noted as being abundant. This section of the stream is characteristic of a riffle-pool system. The channel contains spawning gravel and several pools with undercut banks and LWD. Within this section of the stream, the bankfull width ranges between 1.5 m and 2 m.

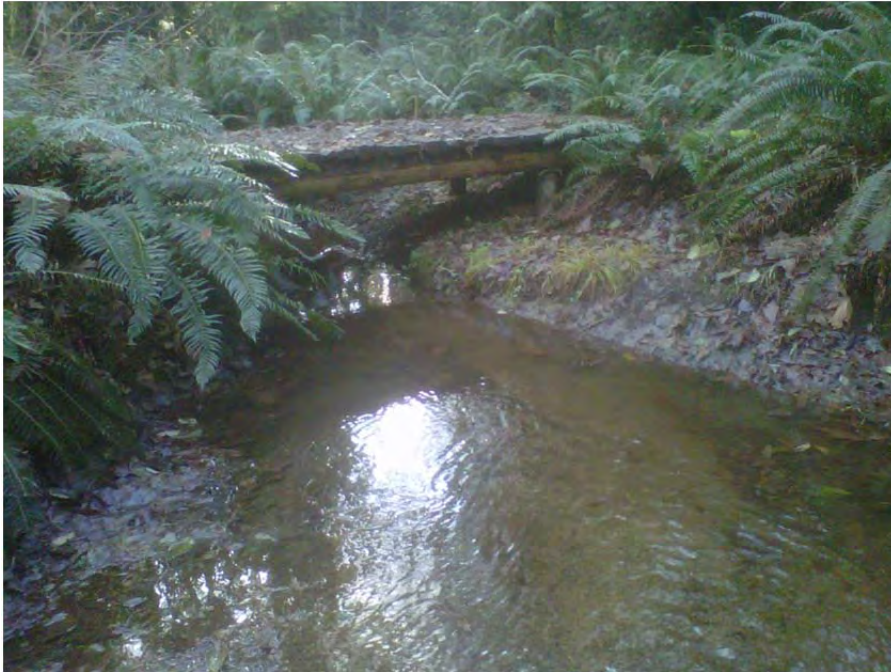
Typical characteristics of Beulah Creek at the mapping start point (Coltsfoot trail crossing) – looking upstream.

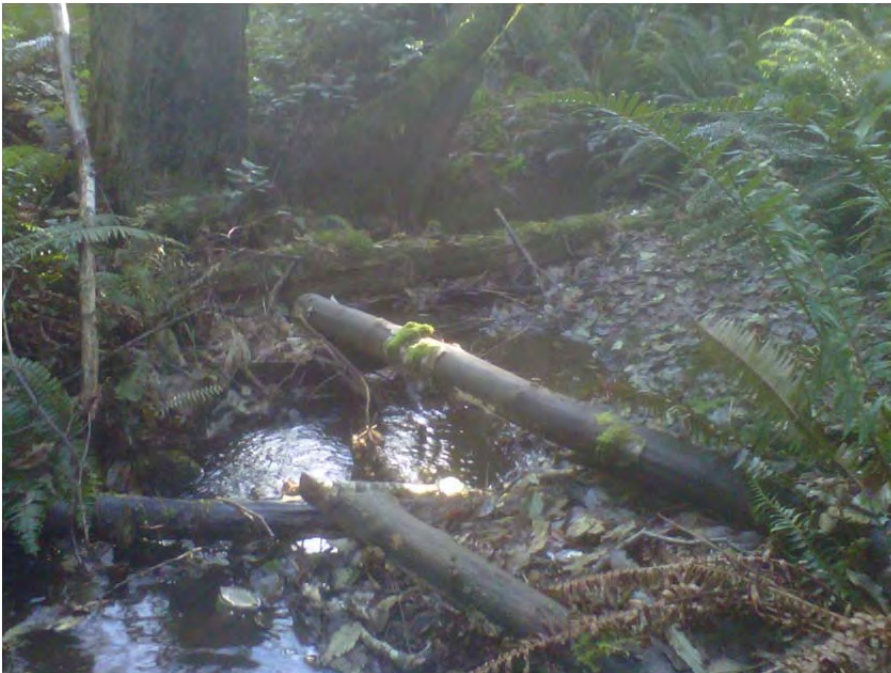
Looking upstream along the middle segment of the mapped portion of Beulah Creek.

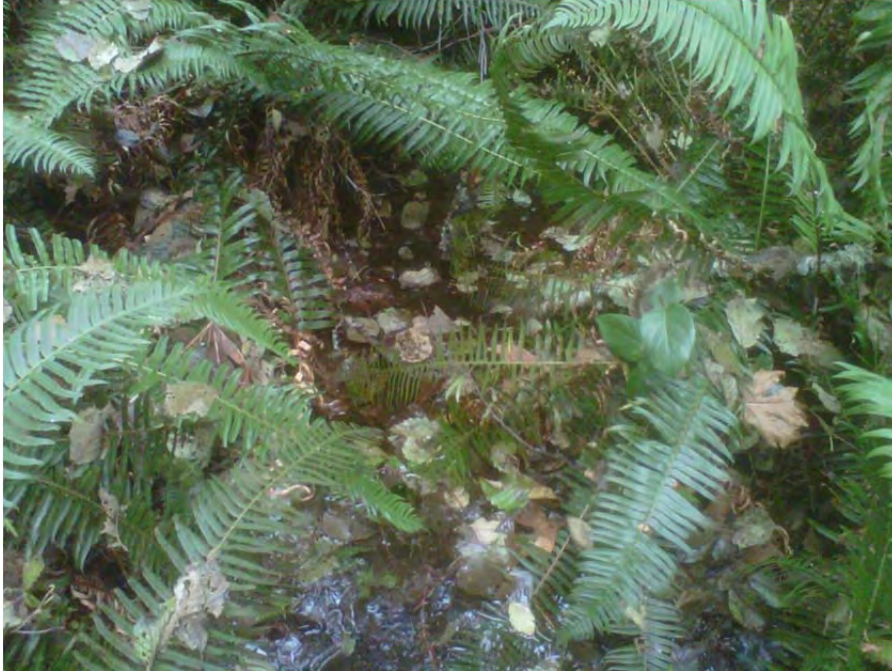
Typical characteristics of the upper segments of the mapped portion of Beulah Creek. Note poorly defined channel morphology and shallow surface flow over an organic substrate.

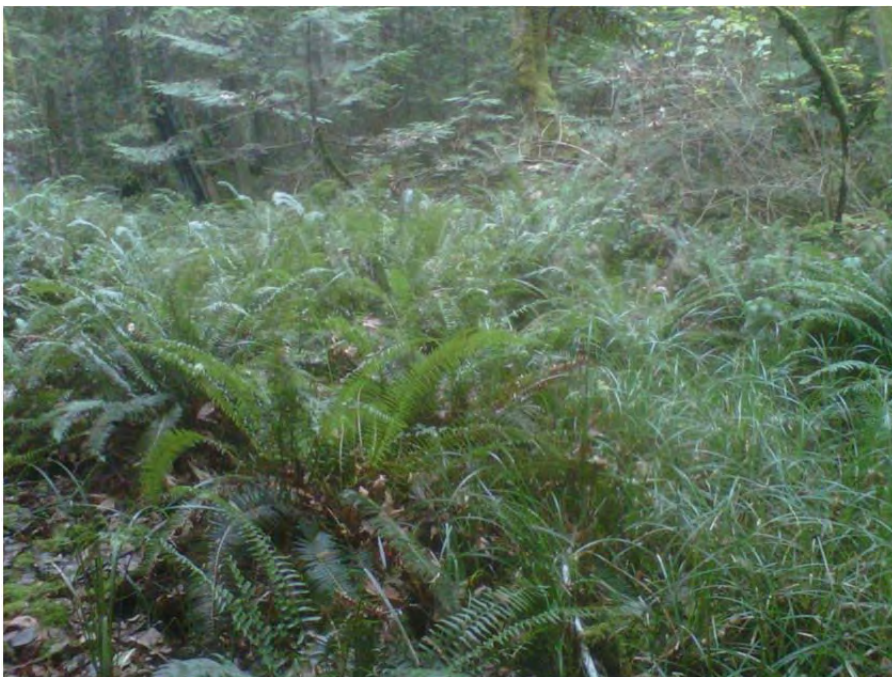
Dense sword fern and slough sedge at the source of Beulah Creek.

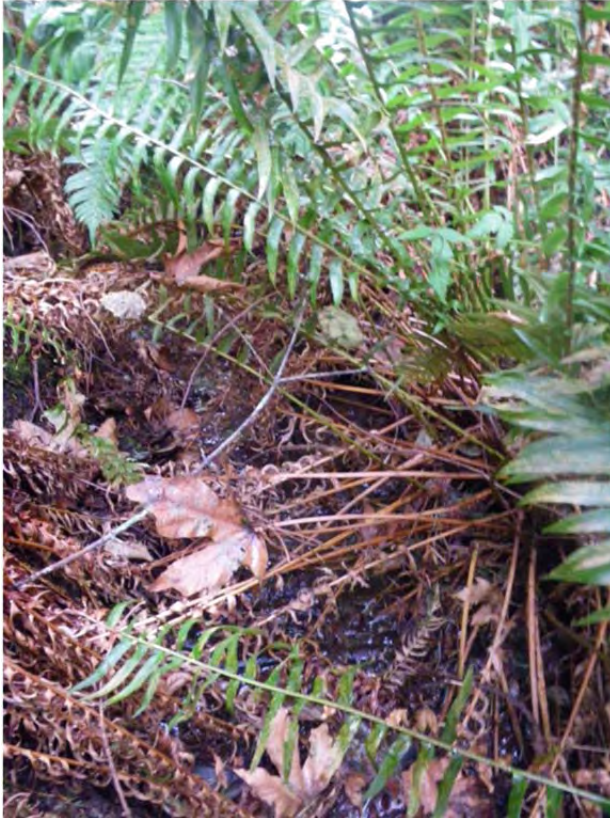
Shallow surface flow through sword fern indicating the characteristics of Tributary 1 at the point where mapping commenced.

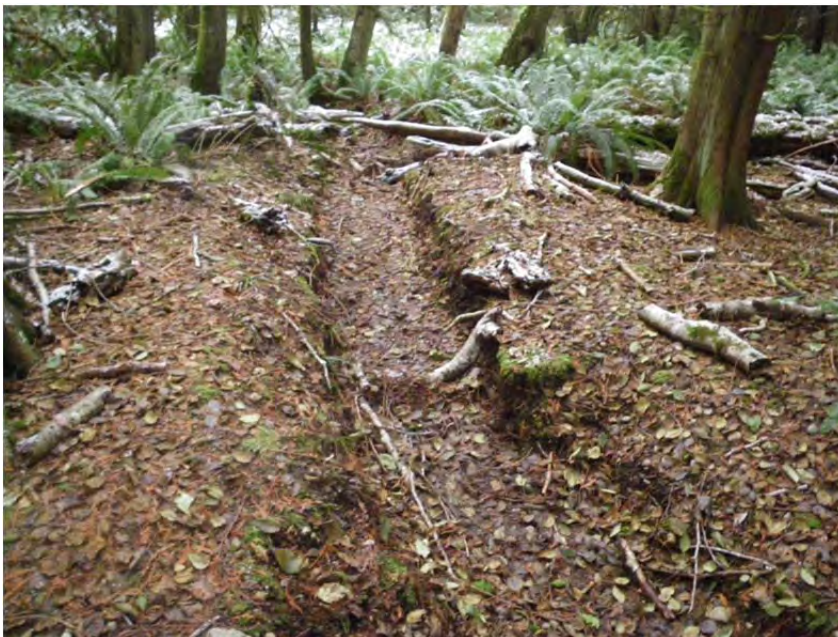
Looking downstream from the first trail crossing over Tributary 1. Note well defined ditch banks merging into a poorly defined channel in the low gradient forested ecosystem downstream.

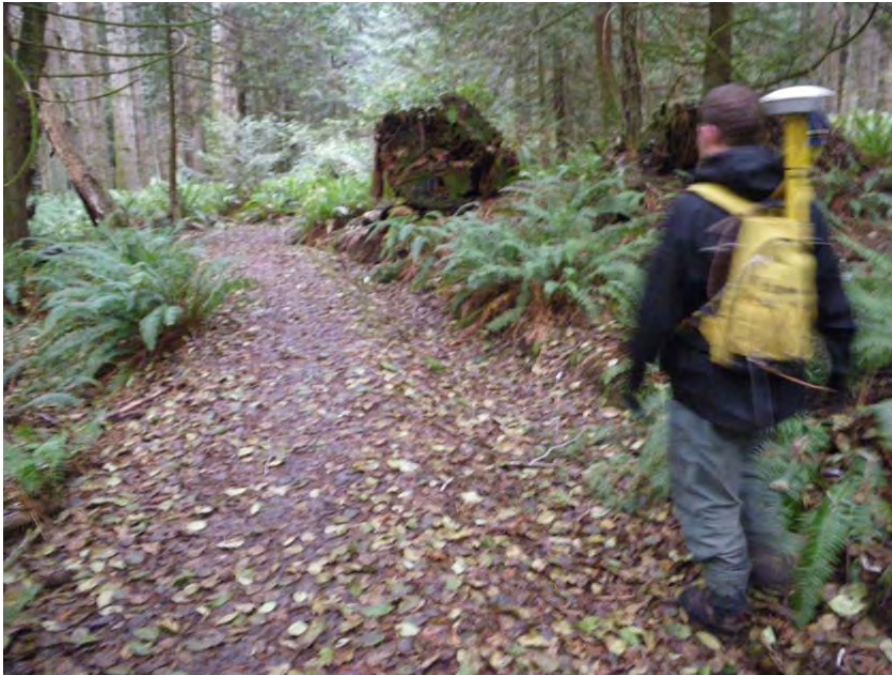
Looking downstream along the ditch branching to the north from the main Tributary 1 ditch line.

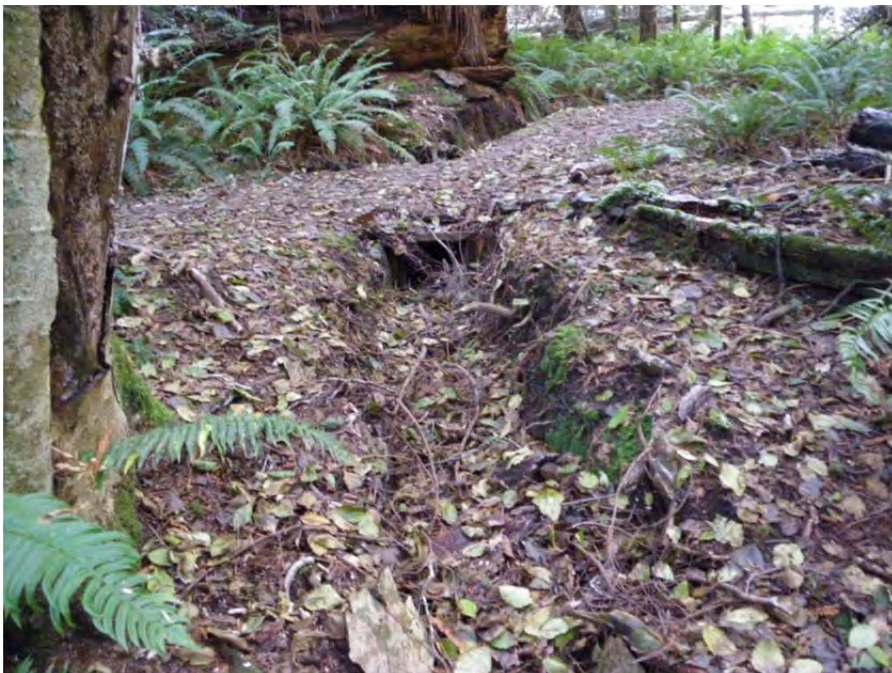
Looking upstream along the ditch pictured above at the crossing under the trail. Note well defined ditch banks.

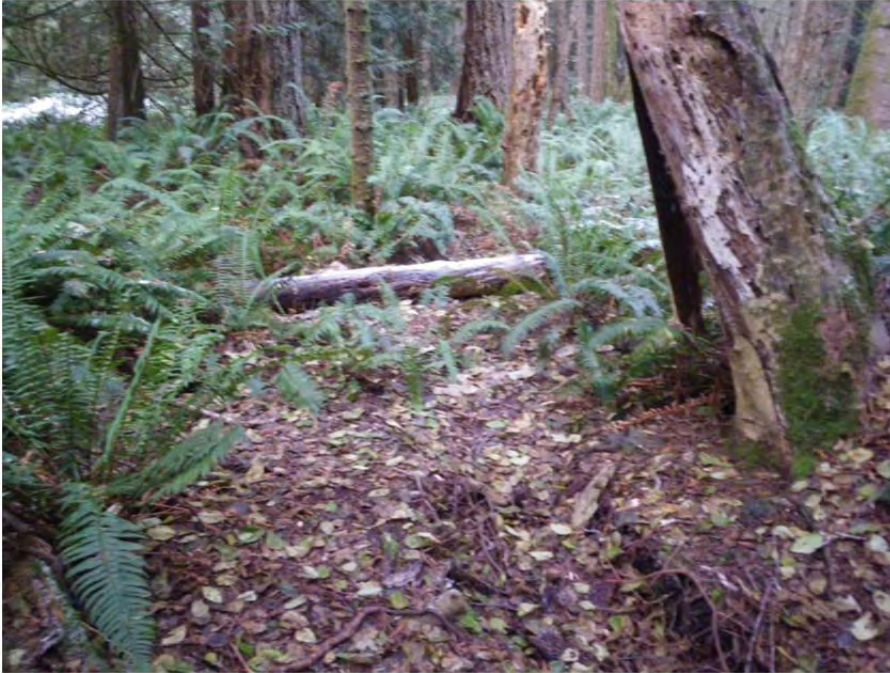
Looking downstream along the ditch pictured above. Note lack of channel definition beyond the ditched section.

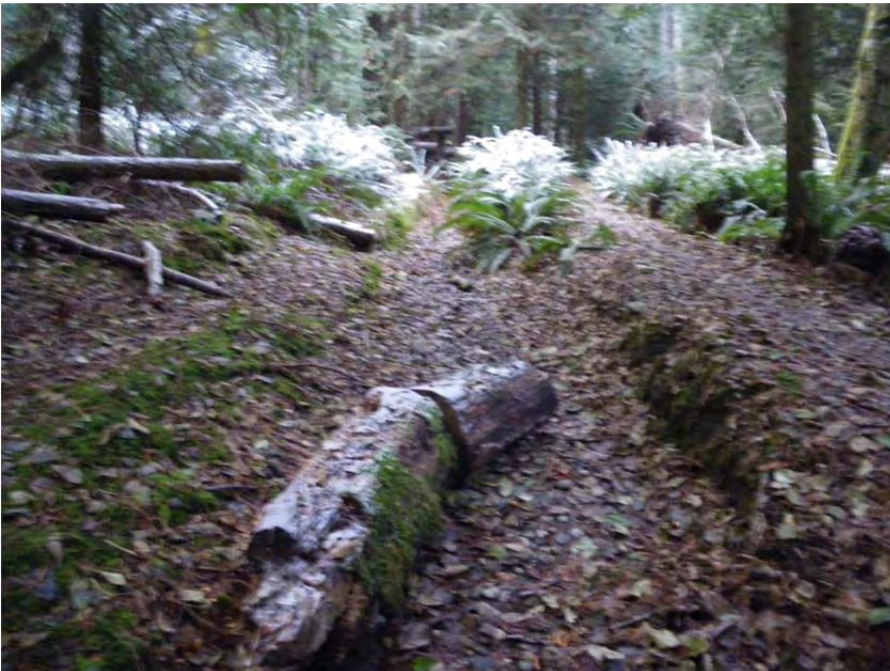
Looking upstream along Tributary 1 where it is ditched immediately upstream of the first trail crossing.

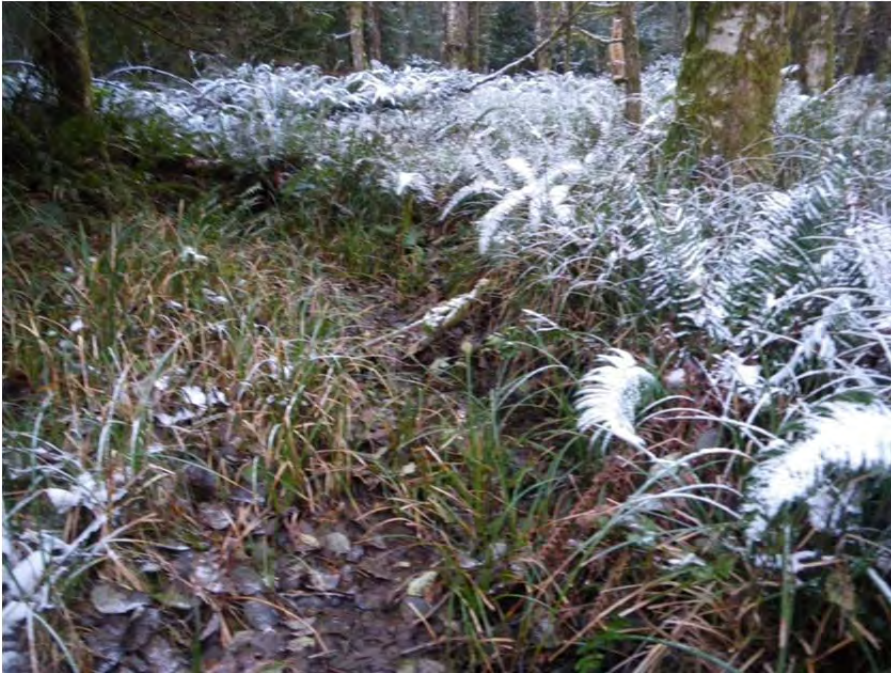
Looking upstream along Tributary 1 where it is not confined along the trail in a ditch. Note poorly defined channel morphology and minimal surface flow through slough sedge.

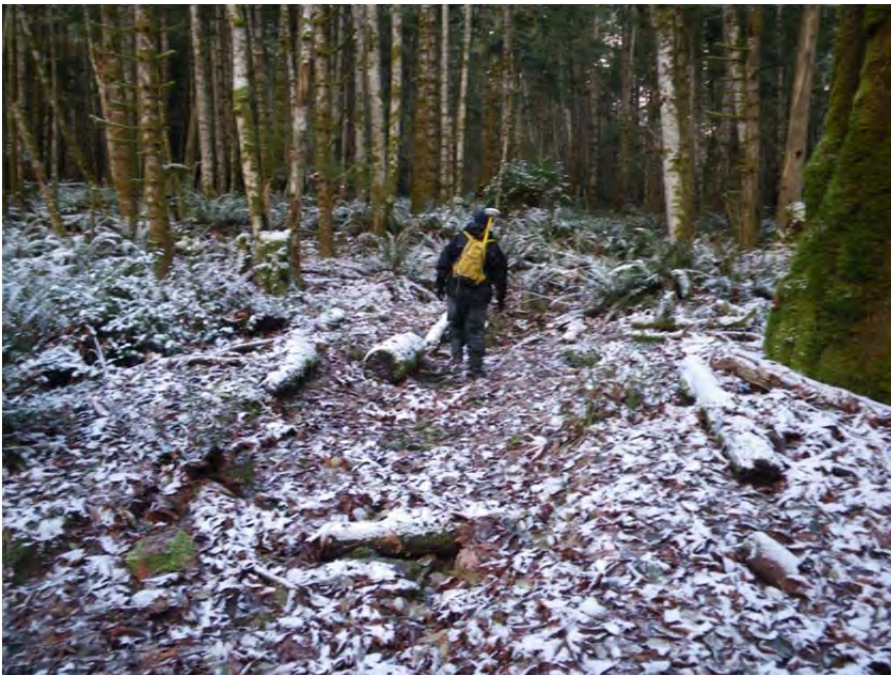
Looking upstream along Tributary 1 immediately upstream of the Coltsfoot trail crossing.

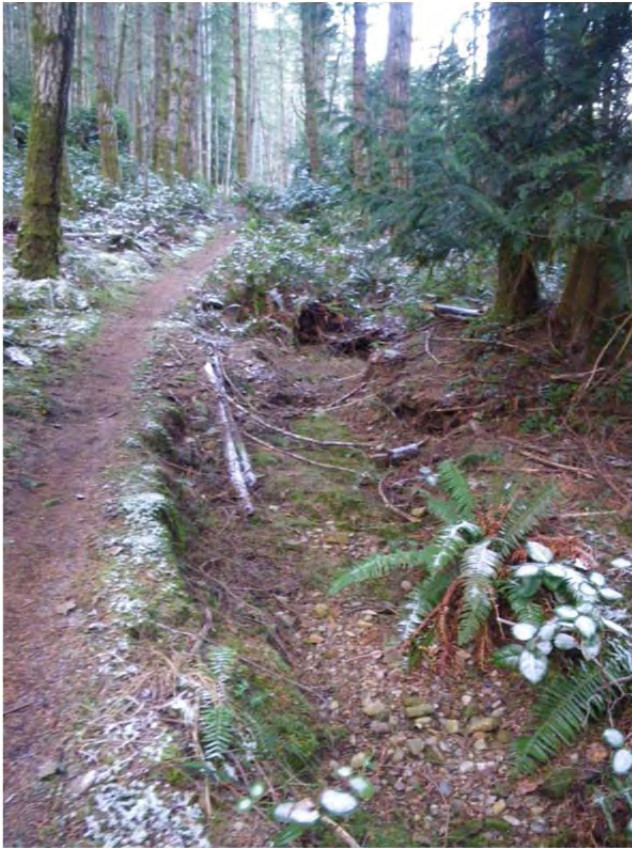
Looking upstream along  
Tributary 1 where it flows  
adjacent to a trail.

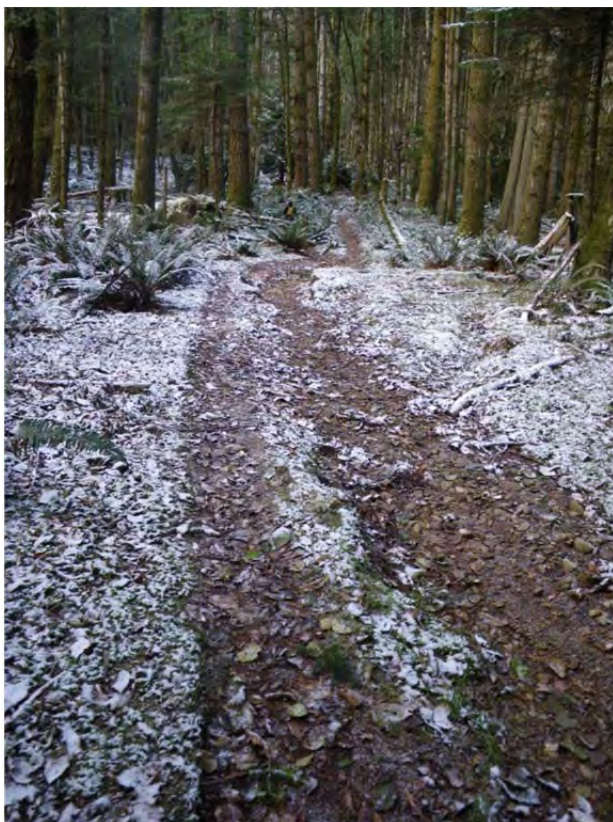
Looking upstream along  
Tributary 1 where it flows over  
Spasm Chasm trail.

It should be noted that the vast majority of mapping that was completed for Beulah Creek occurred throughout a regional park (Mt. Geoffrey Nature Park). The RAR would not currently apply to this park area, but future land use may change. In places, the mapped tributaries (e.g. Tributary 1) become part of the trail system, with water flowing over the trail surface.

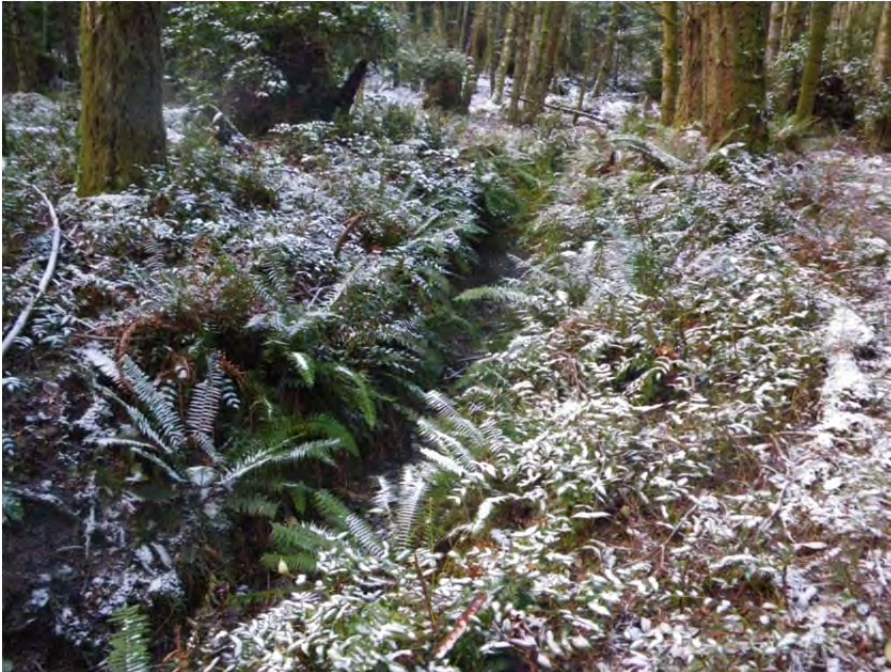
Looking upstream along Tributary 1 where it flows in a high-sided ditch parallel to Spasm Chasm trail.

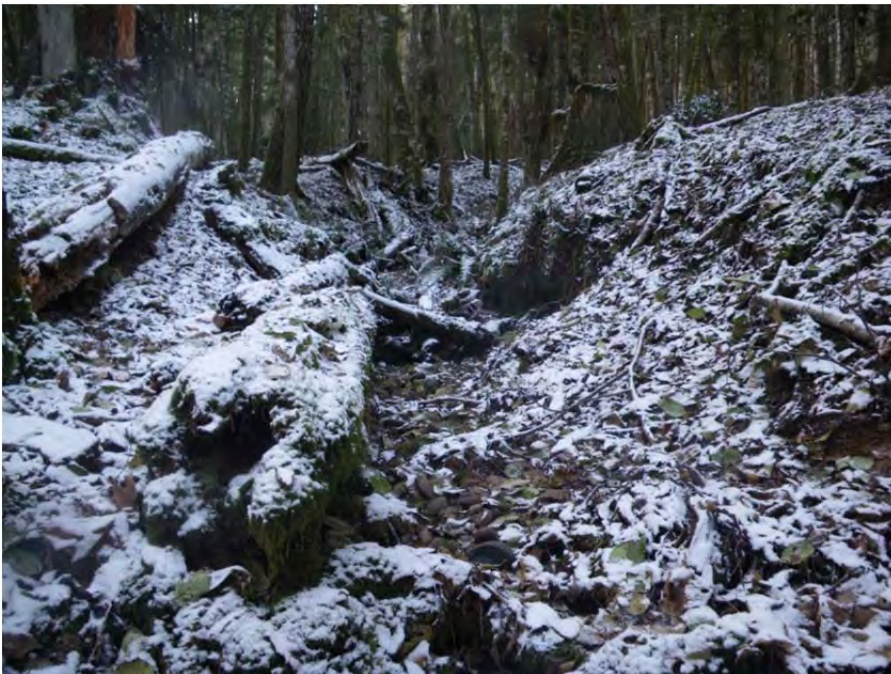
Looking upstream along Tributary 1 upstream of Spasm Chasm trail. Note channel/bank instability and evidence of high, flashy flows.

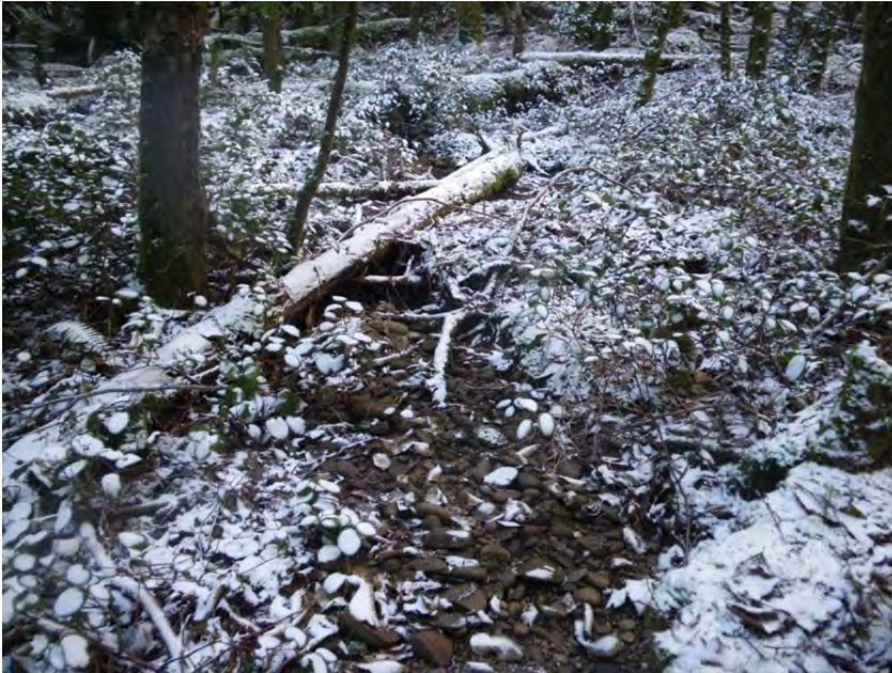
Looking upstream along Tributary 1 upstream of Lox's Bagel trail.

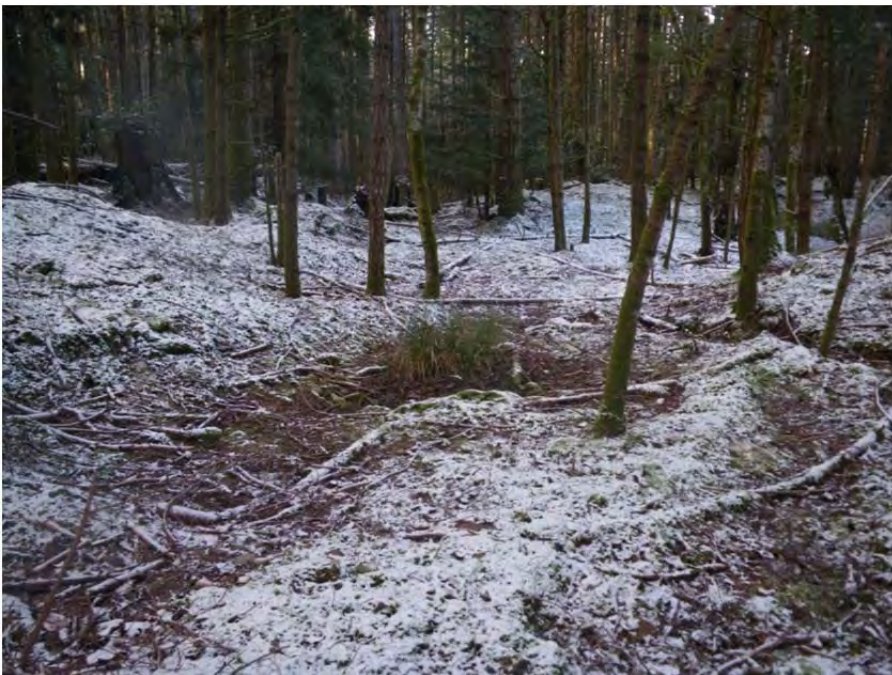
Patchy slough sedge in a depression close to the height of land represents the source of Tributary 1.

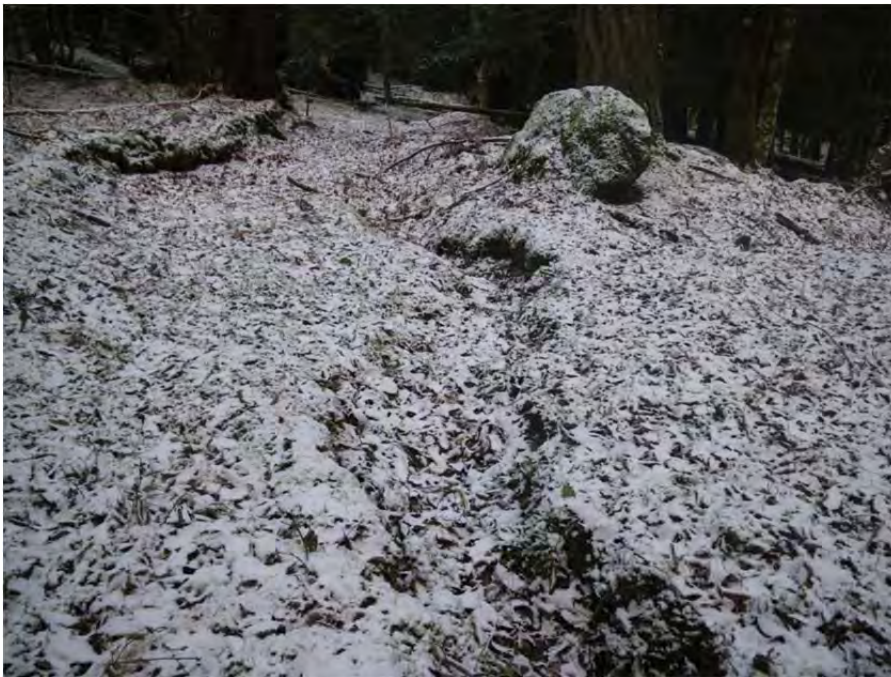
Looking downstream along the middle segment of Tributary 1-1.

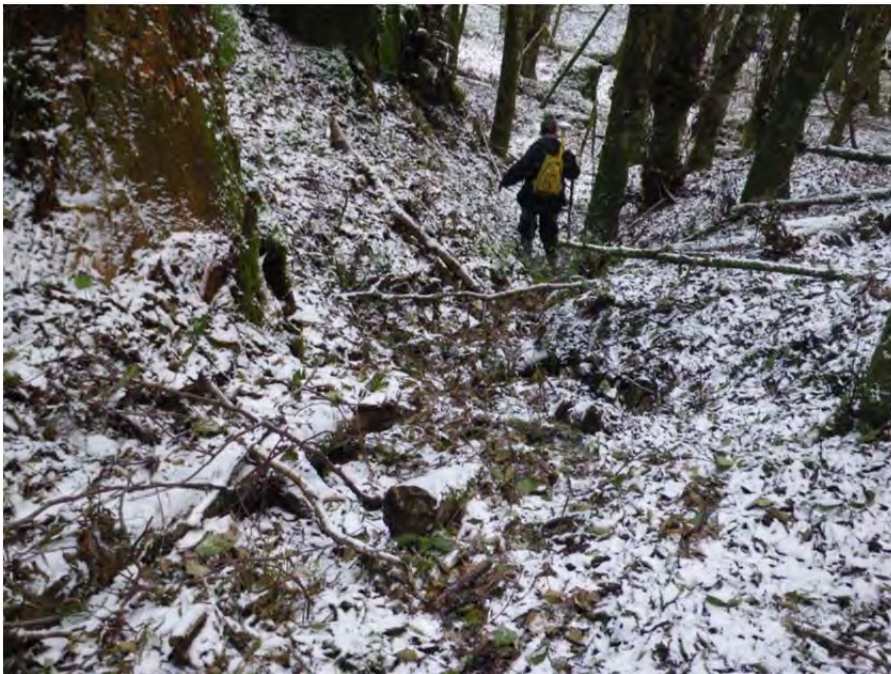
Looking downstream along Tributary 1-1 where it flows through a narrow draw immediately upstream of the Northwind trail.

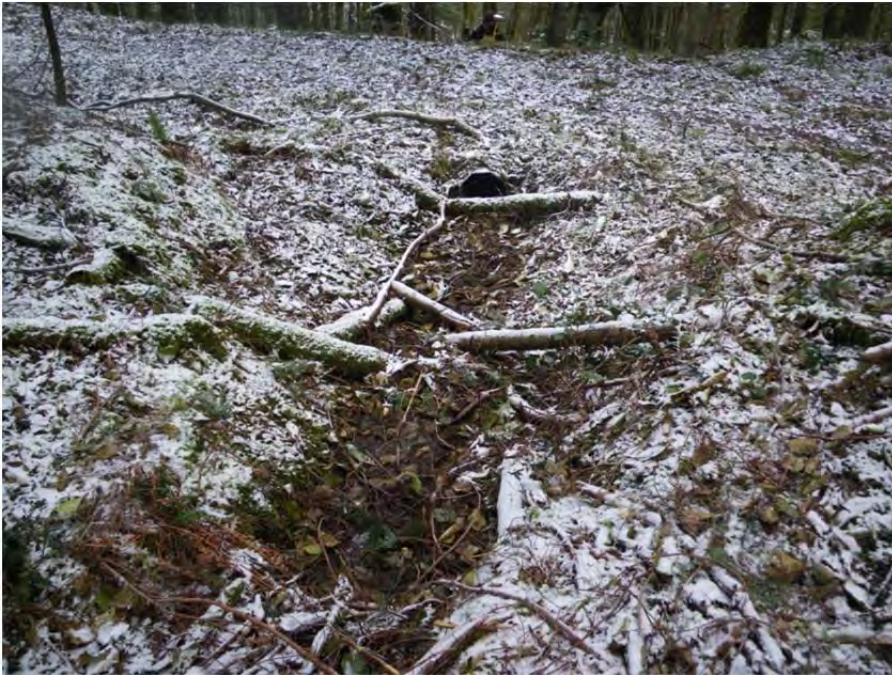
Looking upstream along Tributary 1-1 at the Northwind trail crossing.

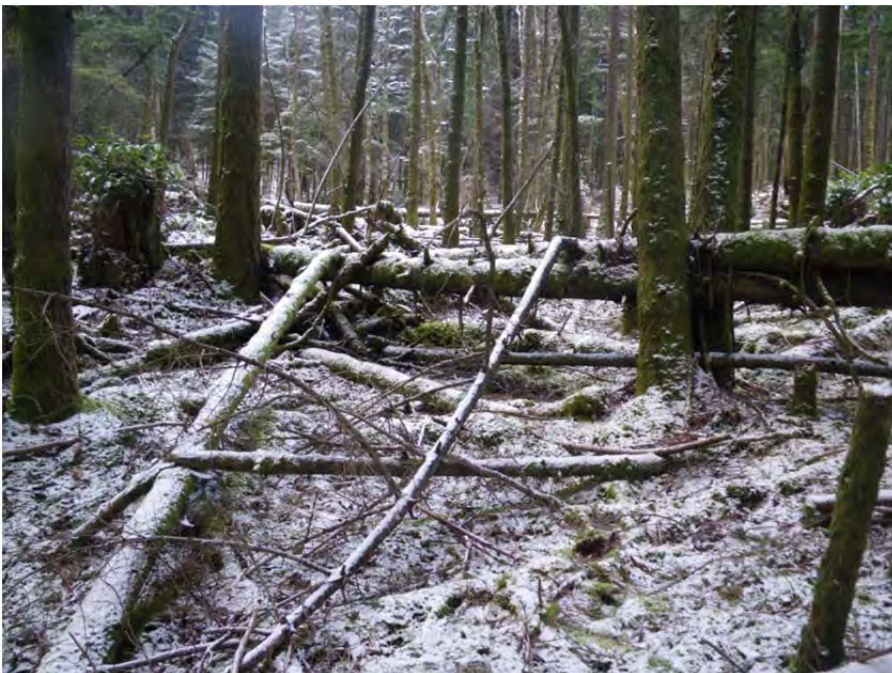
Wide flat area close to the height of land represents the source of Tributary 1-1.

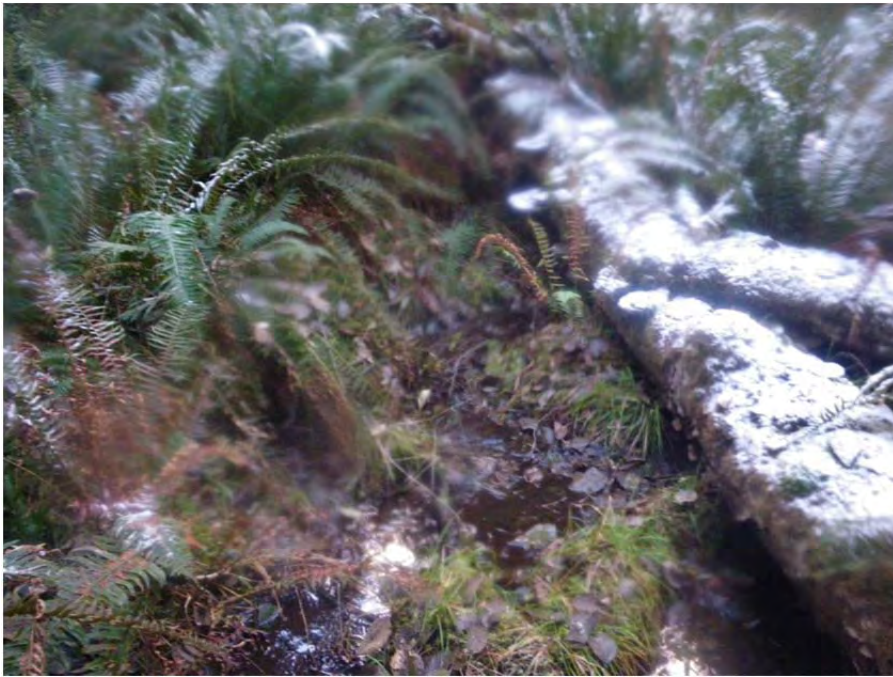
Looking upstream along Tributary 2 close to the confluence with Beulah Creek. Note poorly defined channel morphology and shallow surface flow over an organic substrate.
