**HORNBY ISLAND RIPARIAN AREA  
REGULATION STREAM IDENTIFICATION –  
BEULAH CREEK AND THREE UN-NAMED  
WATERSHEDS**

**Trystan Willmott, B.Sc. A.Sc.T. and  
Justin Lange, B.Sc., R.P.Bio., A.Sc.T.  
MADRONE ENVIRONMENTAL SERVICES LTD.  
1081 Canada Avenue, Duncan, BC, V9L 1V2**

**January 21, 2014**

Dossier 13.0315

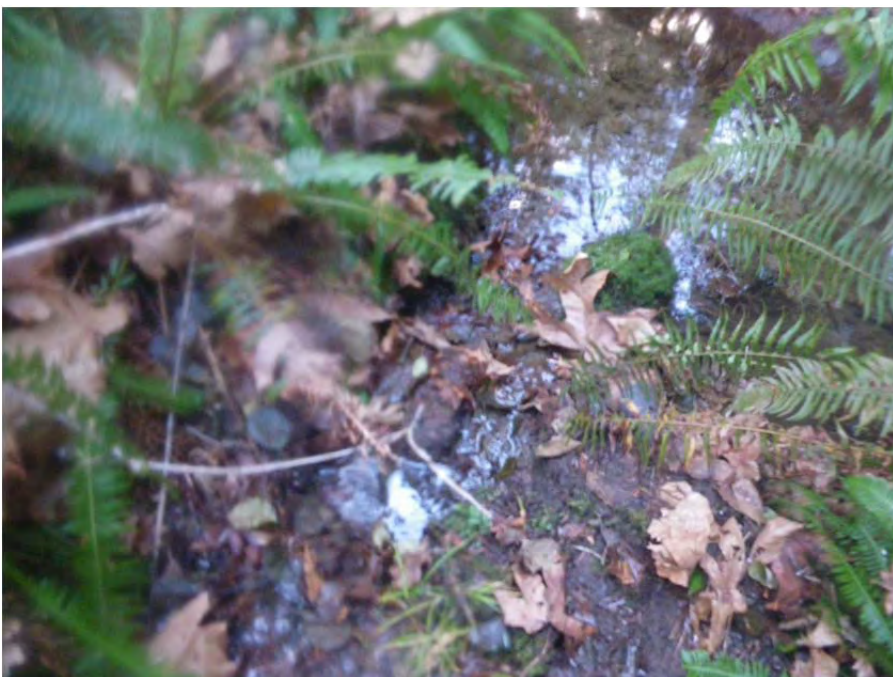
Looking downstream along Tributary 3 at the confluence with Beulah Creek.

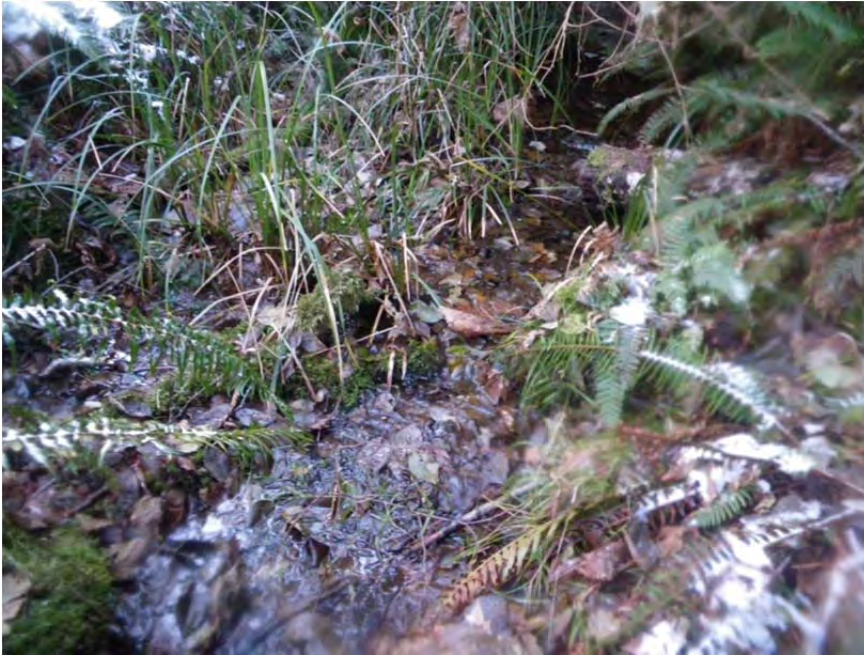
Looking upstream along Tributary 4 close to the confluence with Beulah Creek.

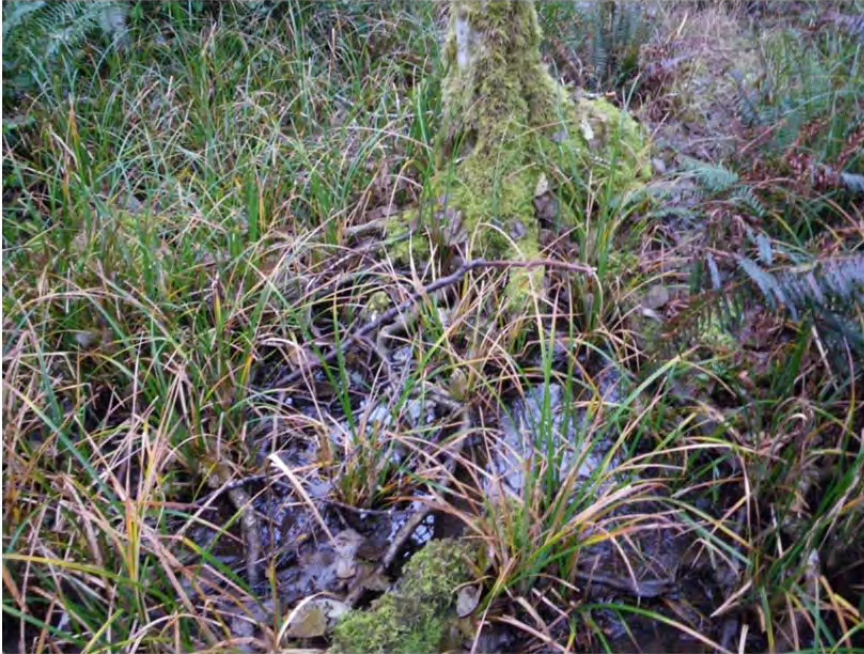
Looking upstream along Tributary 5 close to the confluence with Beulah Creek. Note shallow surface flow through slough sedge over an organic substrate.

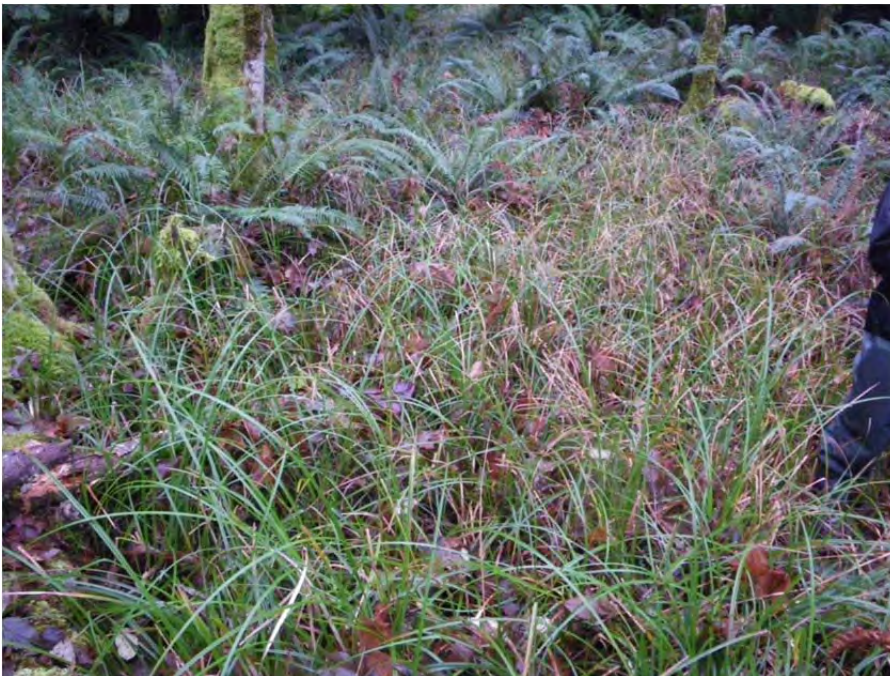
Slough sedge and patches of sword fern and surrounding red alder represents the source of Tributary 5.

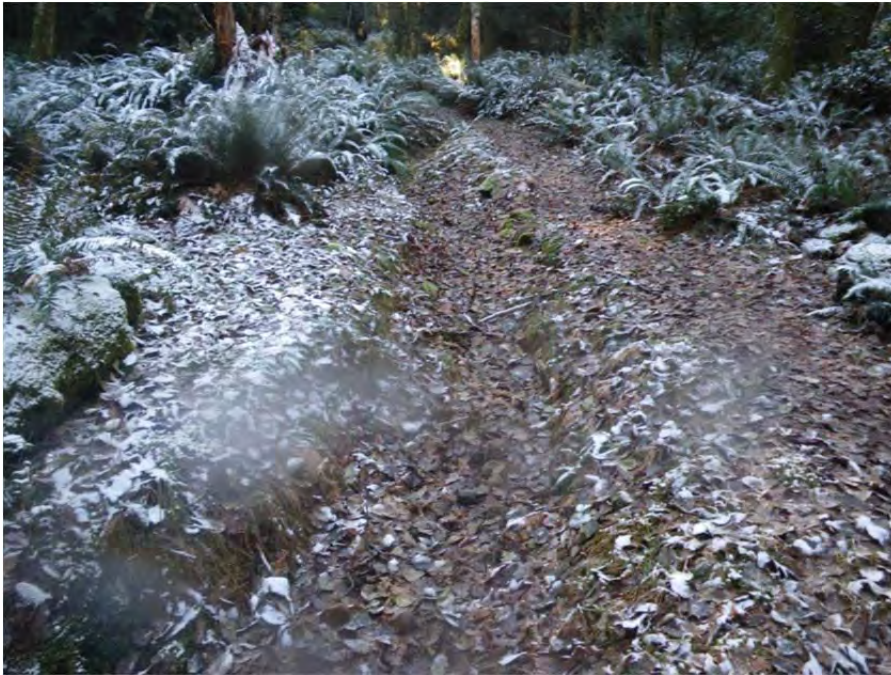
Looking upstream along the watercourse where it is defined in a ditch adjacent to Coltsfoot trail.

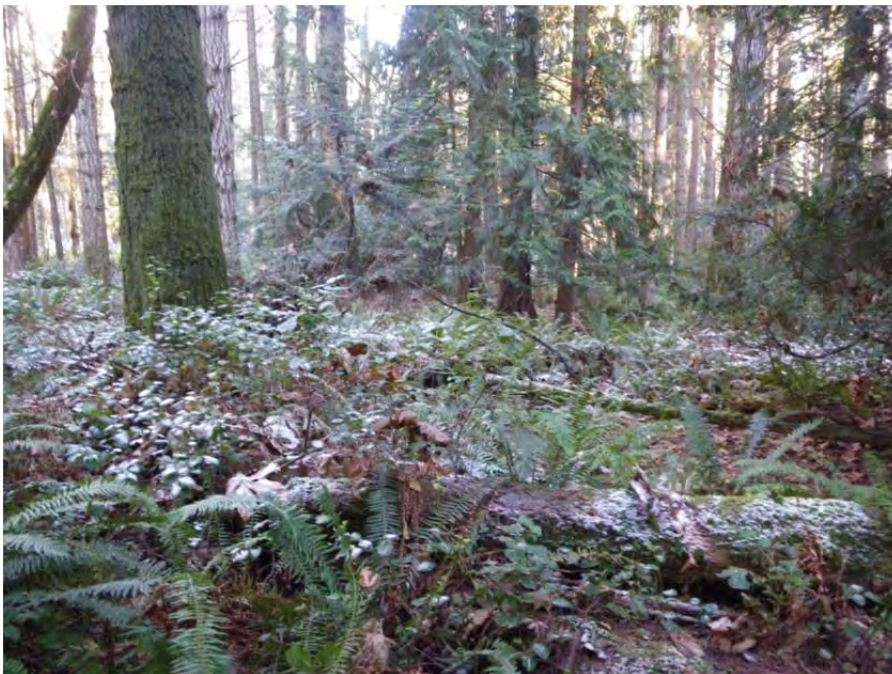
Looking downslope from the defined ditched segment of the watercourse towards the moist, flat forest where water from the drainage appeared to dissipate.

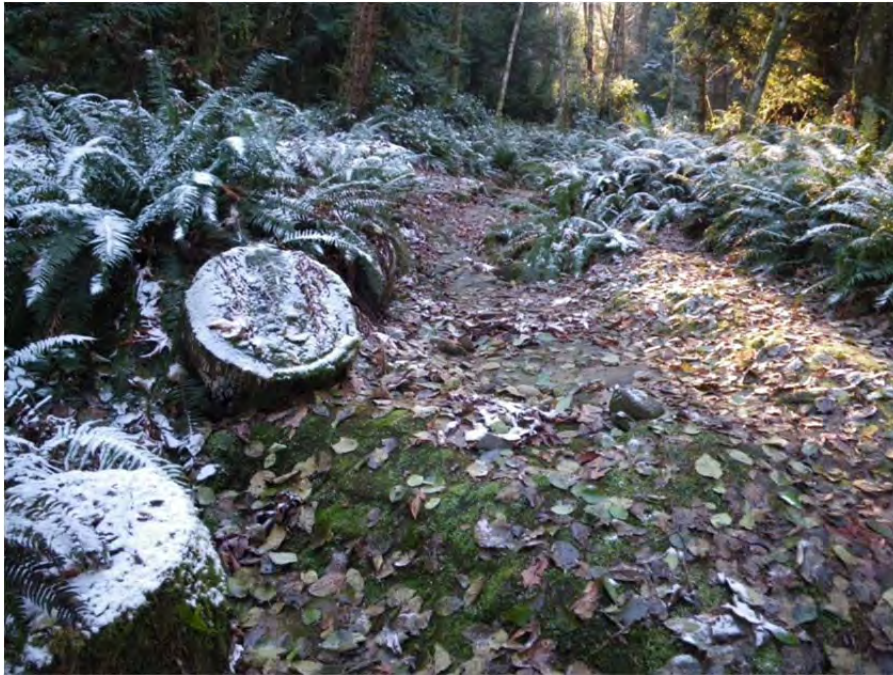
Looking upstream along the watercourse where it flows over Coltsfoot trail.

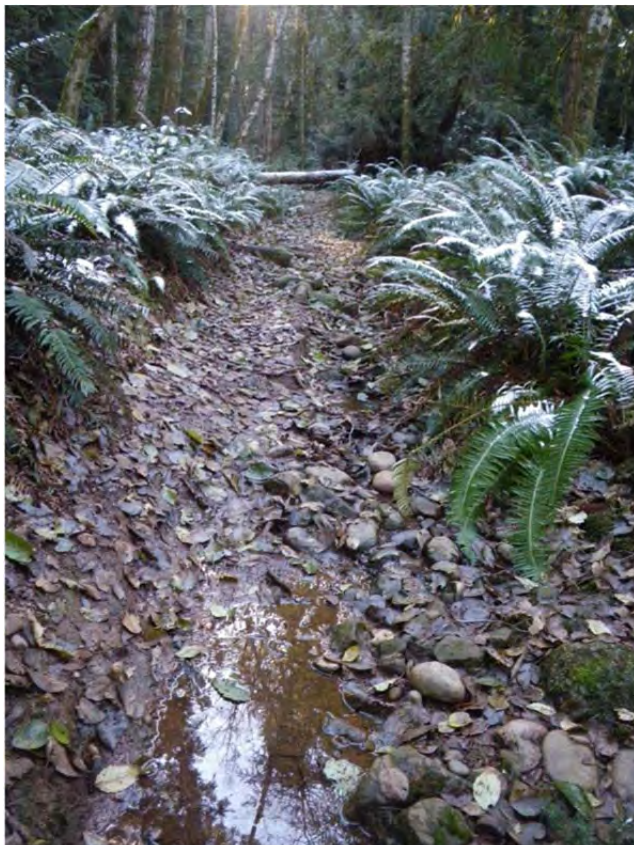
Looking upstream along the watercourse where it flows adjacent to (and over) the Slickrock trail surface. Note surface flowing water (albeit minimal) and cobble substrate.

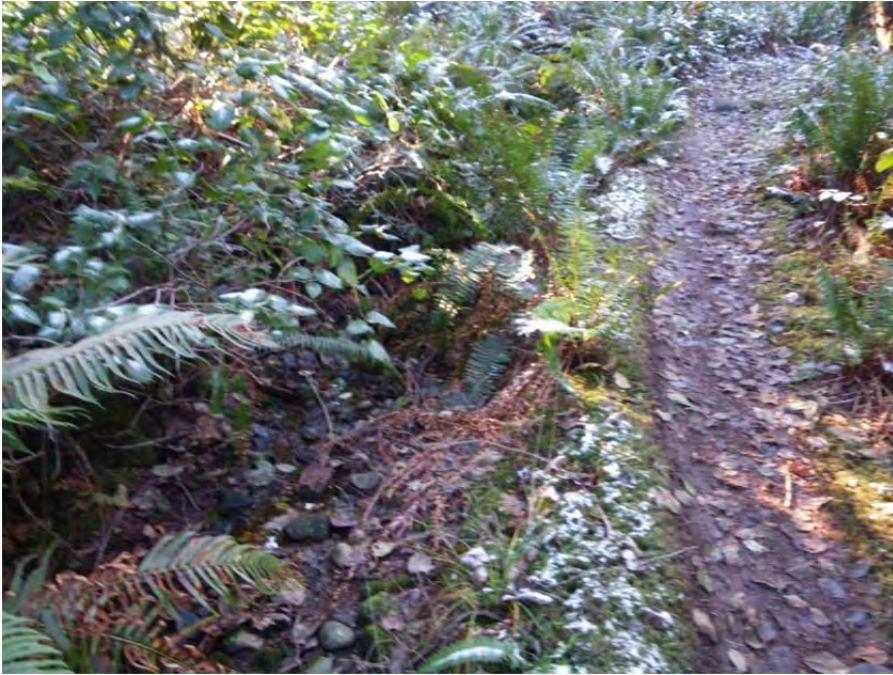
Looking upstream along the watercourse where it is defined adjacent to Slickrock trail.

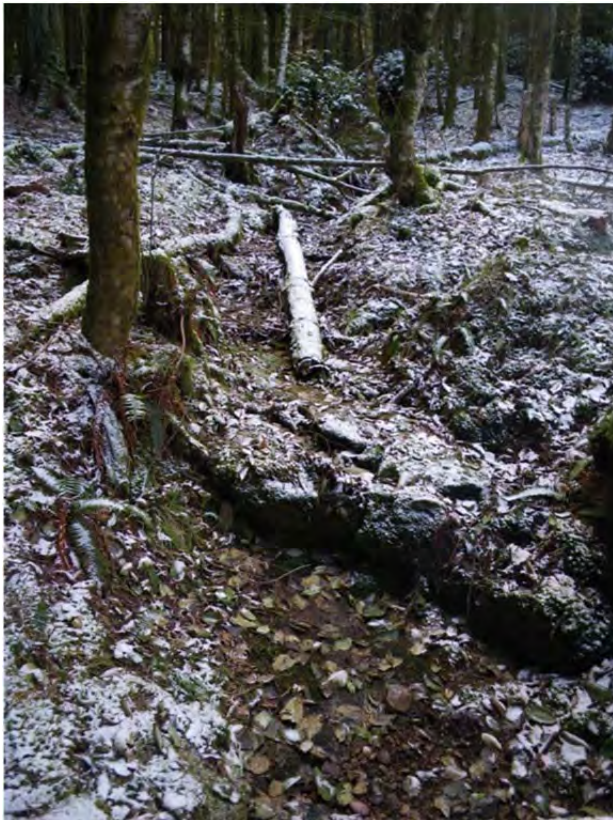
Looking upstream along the watercourse upslope of Slickrock trail.

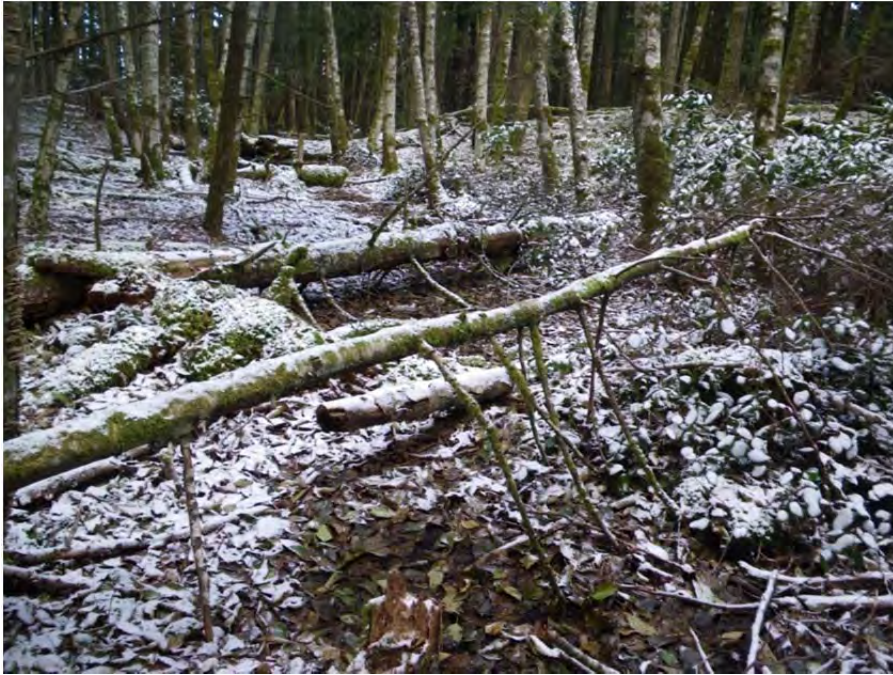
Moist depression with red alder, western redcedar and Douglas-fir represents the source of the watercourse.

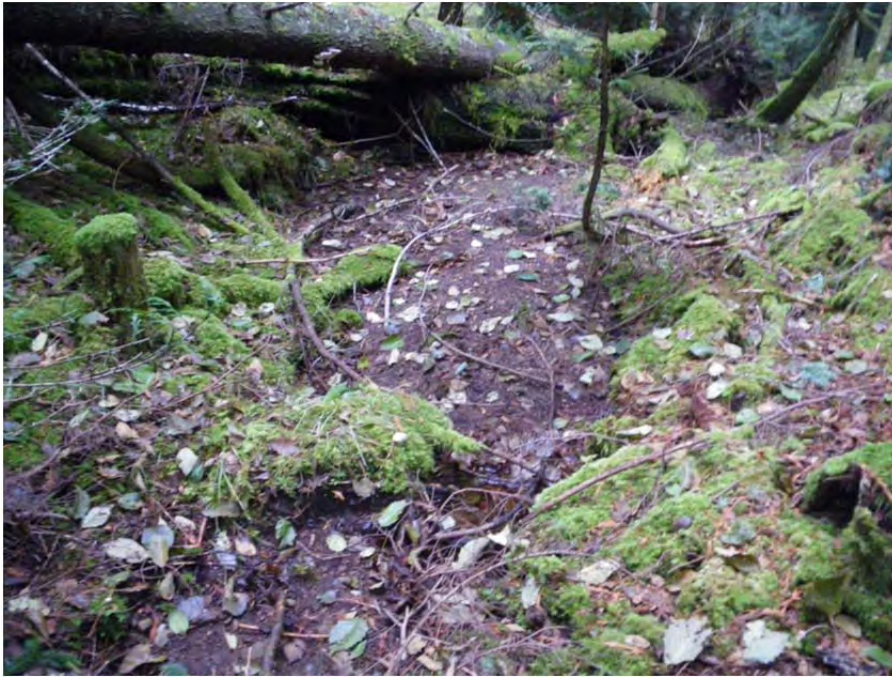
Looking upstream along the mapped extension of the tributary. Note relatively well defined channel and alluvial deposits.

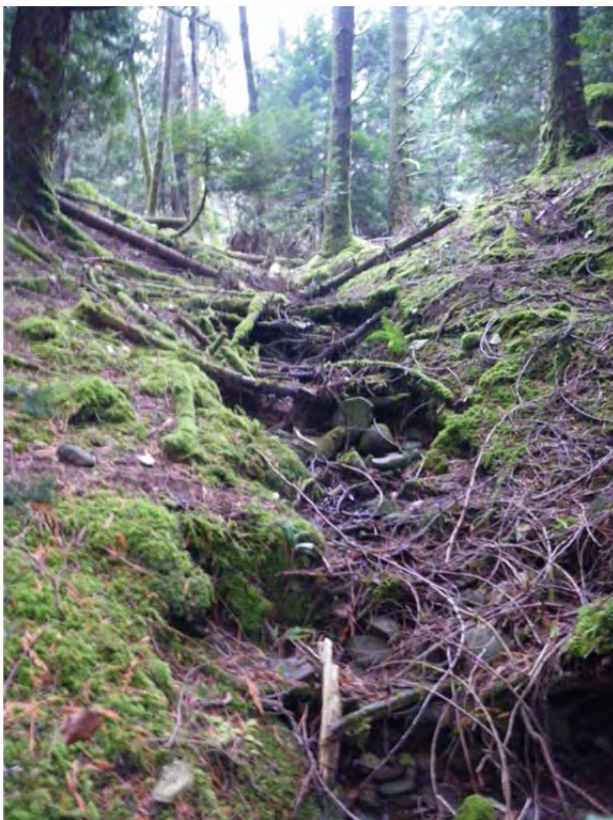
Looking upstream along a higher gradient segment of the mapped extension of the tributary. Note cobble substrate, which indicates high energy seasonal flows.

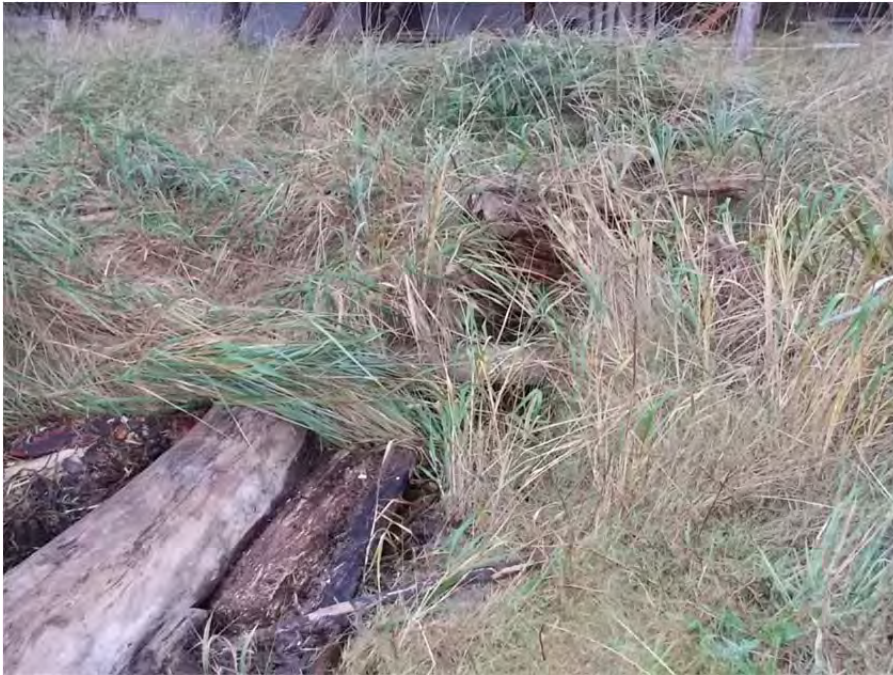
Looking upstream from the natural boundary of the marine environment. Note the accumulation of drift wood and dense reed canary grass growth.

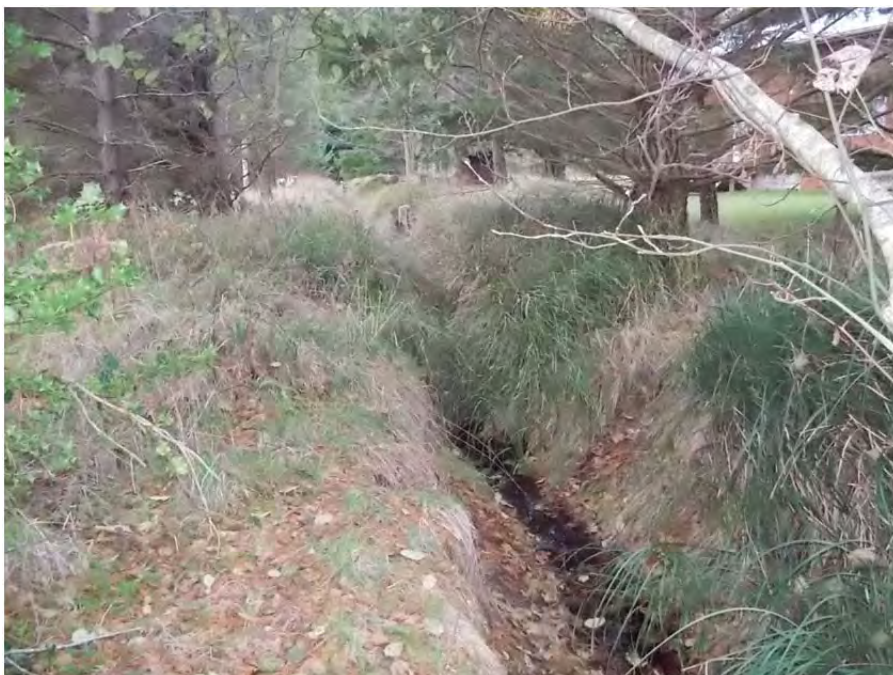
Looking downstream at the subject drainage. Note the channel morphology, which is consistent with that of a constructed ditch.

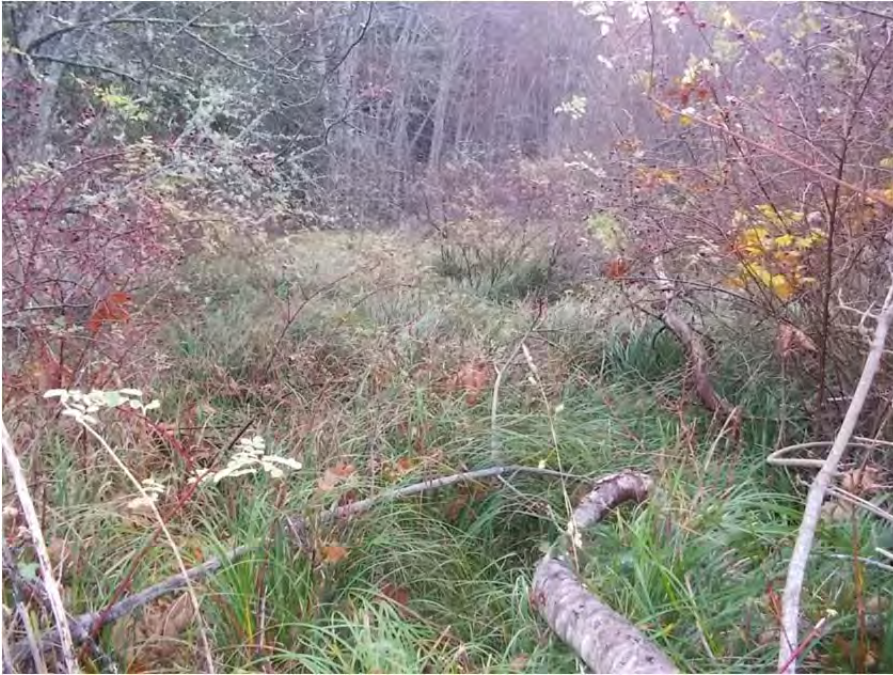
Looking upstream at the headwaters of the subject drainage. This wetland contains a component of both open water habitat and densely vegetated areas.

The watercourse was mapped up to the headwaters, which is a wetland complex composed of hydrophytic vegetation and open water habitat. The wetland is approximately 50 m wide and 250 m long. Within the wetland, vegetation is dominated by Red-osier dogwood (*Cornus stolonifera*), willows (*Salix spp.*), and slough sedge. Along the riparian fringe, the tree layer is composed mainly of red alder. Shrubs noted at the time of the assessment included: baldhip rose (*Rosa gymnocarpa*), evergreen blackberry (*Rubus laciniatus*), and willows. Sword fern dominates the herb layer within the riparian fringe.

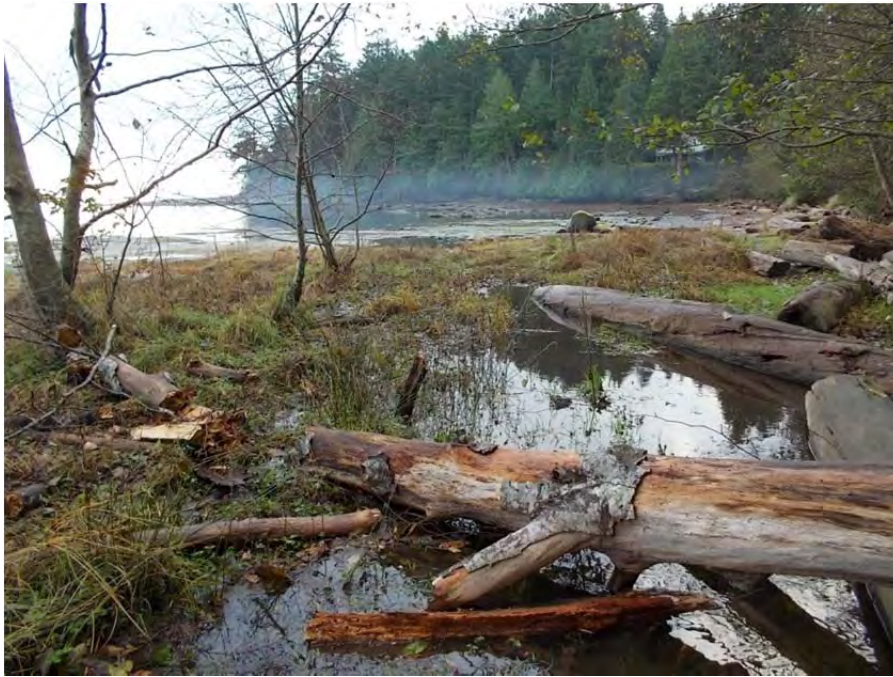
Looking east at the area where the stream flows into the intertidal habitat near Hidden Beach Park.

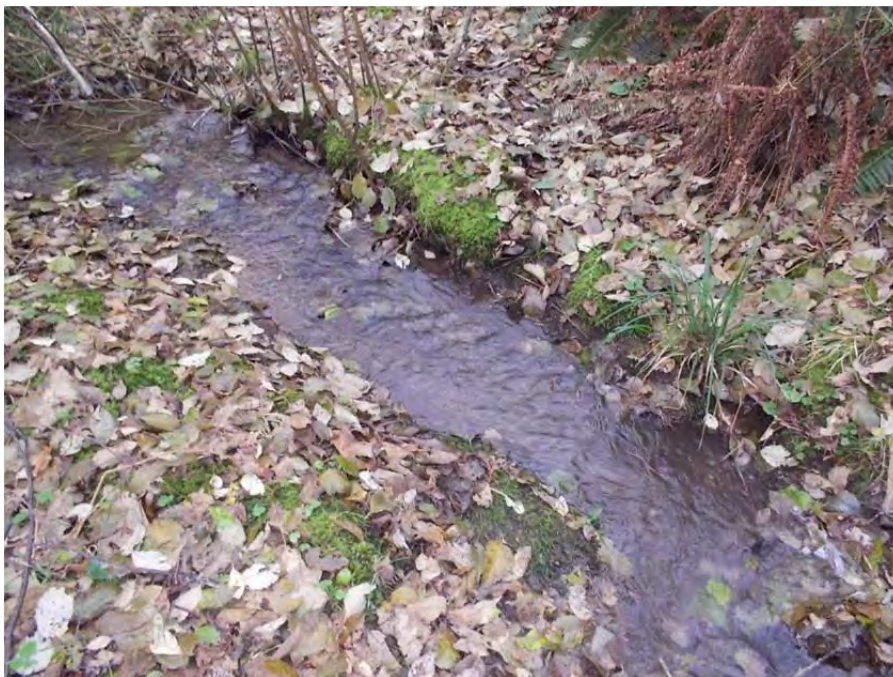
Typical channel morphology of the lower sections of the stream. Note the channel definition and alluvial substrate.

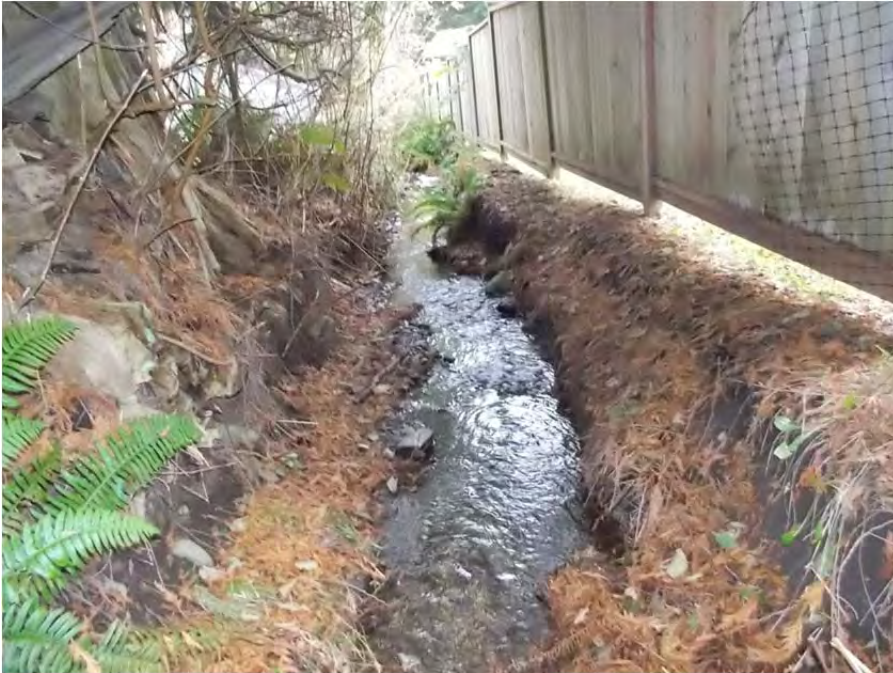
Looking downstream at the channel morphology of the East Fork of the drainage. Note the straight channel and excavated sidewalls, which are typical of ditches.

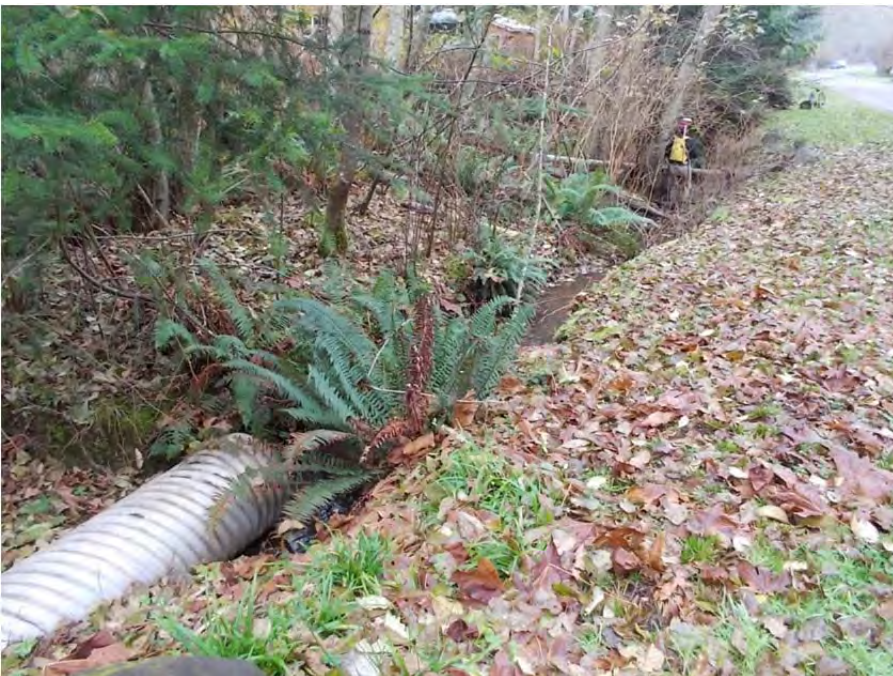
Looking west at the area where the East Fork flows through a roadside ditch immediately upstream of its convergence with the West Fork of the stream.

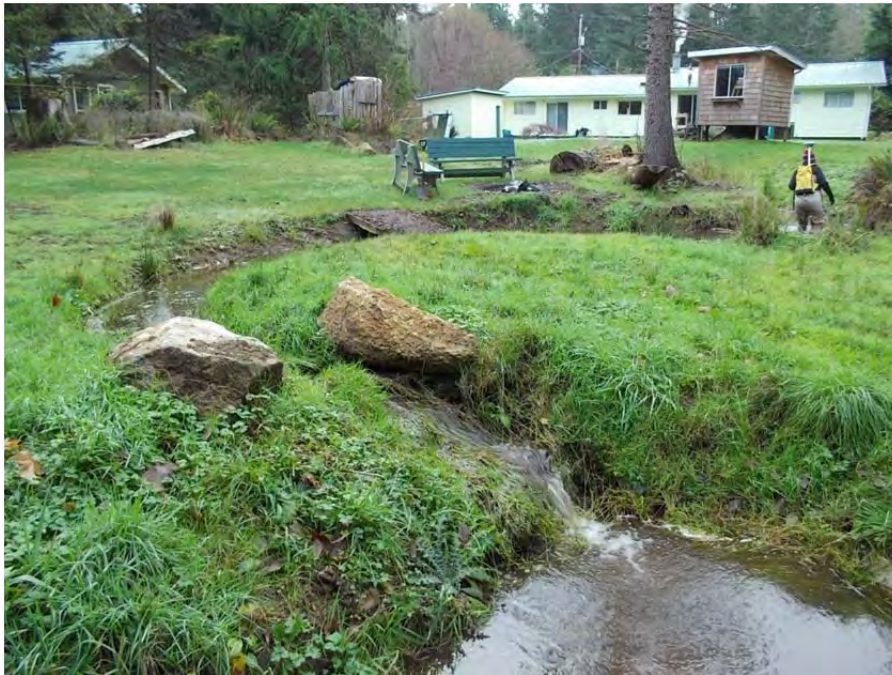
A photo depicting the anthropogenic influence on the subject stream. Note the lack of biologically functioning riparian vegetation, a common observation where the stream flows through residential areas.

It is important that landowners are aware of the benefits of riparian areas. Landowners adjacent to streams often do not realize the financial incentives of maintaining a functioning riparian zone. For example, intact riparian vegetation can help prevent lateral bank movement, thus protecting valuable property from erosion. Potential hazards associated with flooding can also be ameliorated as a result of maintaining a functioning riparian area.

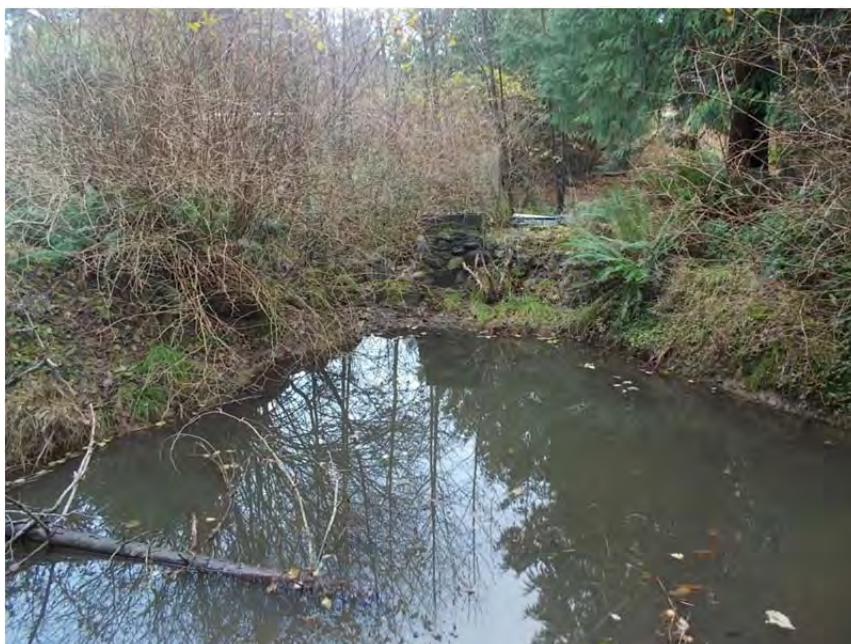
Looking north at a portion of the stream which was excavated, forming a pond. Anecdotal evidence indicated this pond was constructed to provide a viable source of water for residential use.

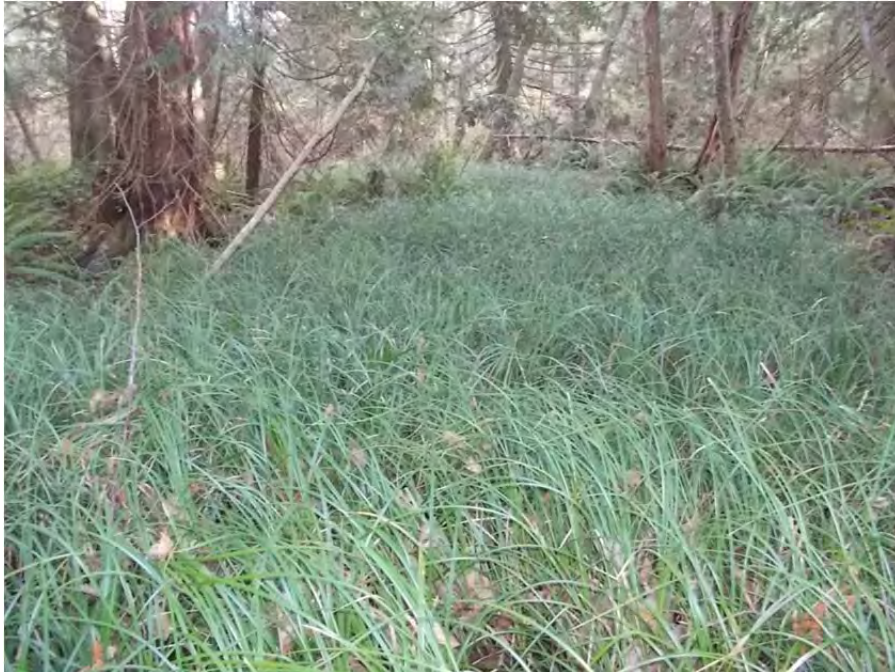
Looking northwest from the high water mark of the slough sedge wetland, which is the headwaters of the watershed. Throughout this area channel definition is lacking and organic substrate dominates.

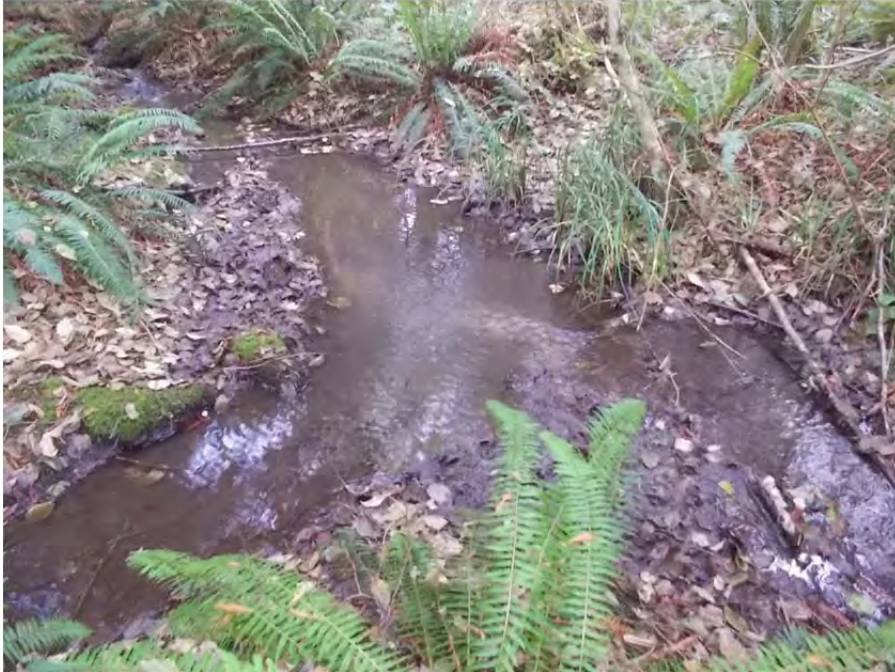
The confluence of Tributary 1 and the main drainage channel. Note Tributary 1 flows from the southwest.

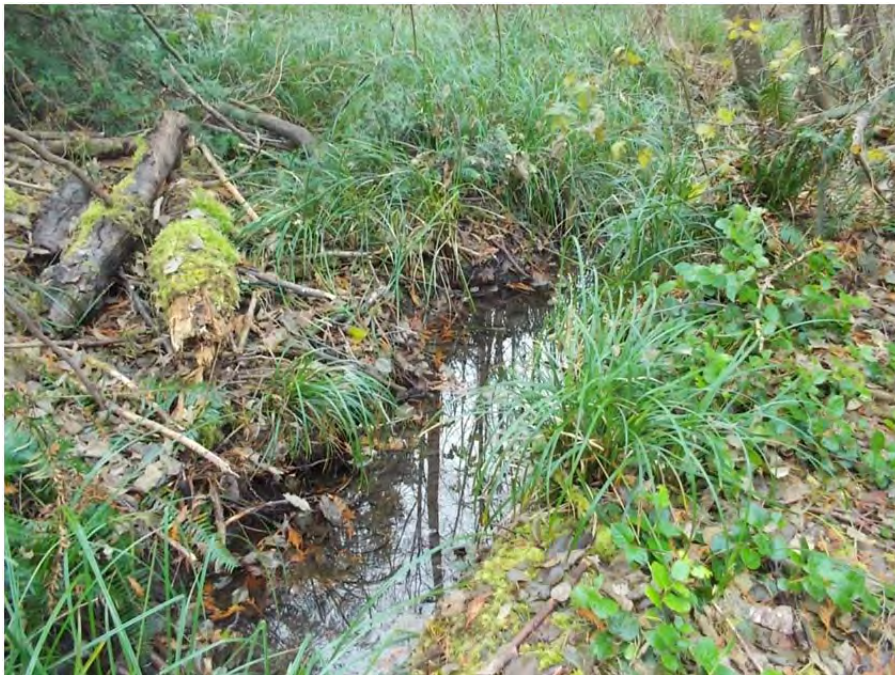
A photo depicting the general channel morphology of Tributary 1 throughout the assessed area. The upper section of Tributary 1 displays evidence suggesting that it is a constructed watercourse.

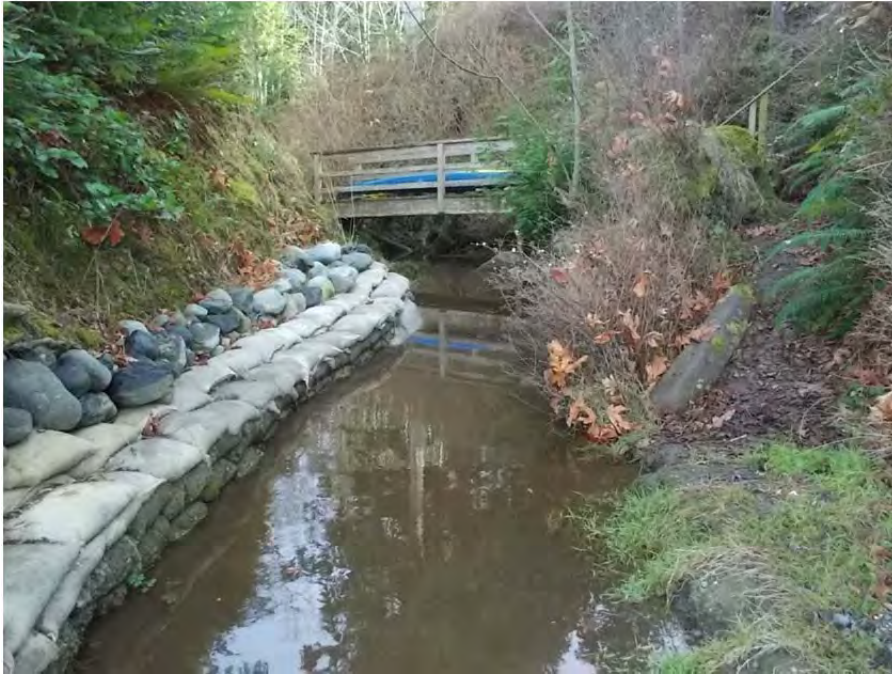
Looking southeast from the natural boundary of the marine environment. Note the placement of boulders, cement and sandbags for the purpose of stabilizing the bank.

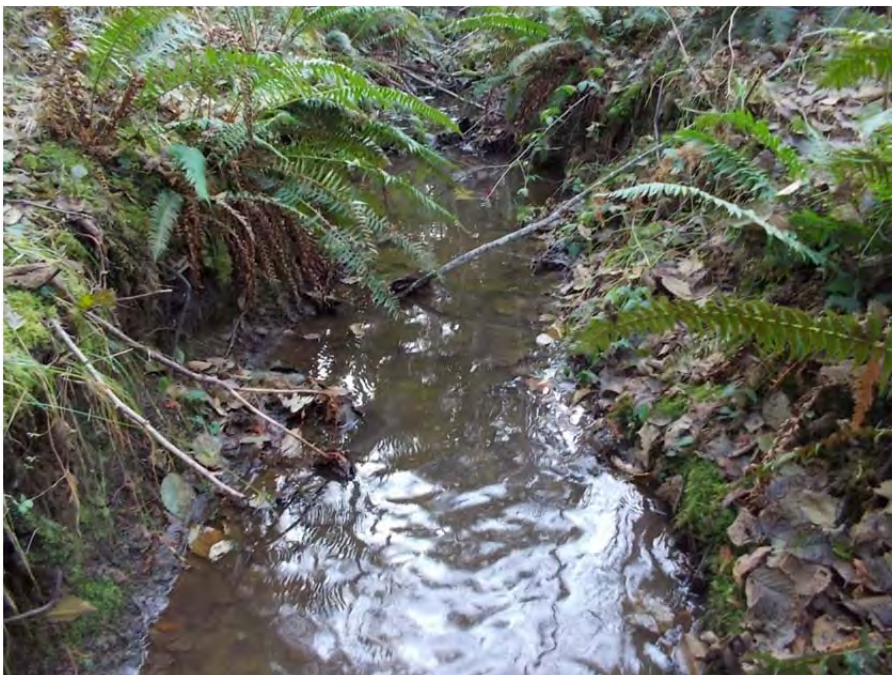
Looking south (upstream) at the stream as it nears Savoie Road.

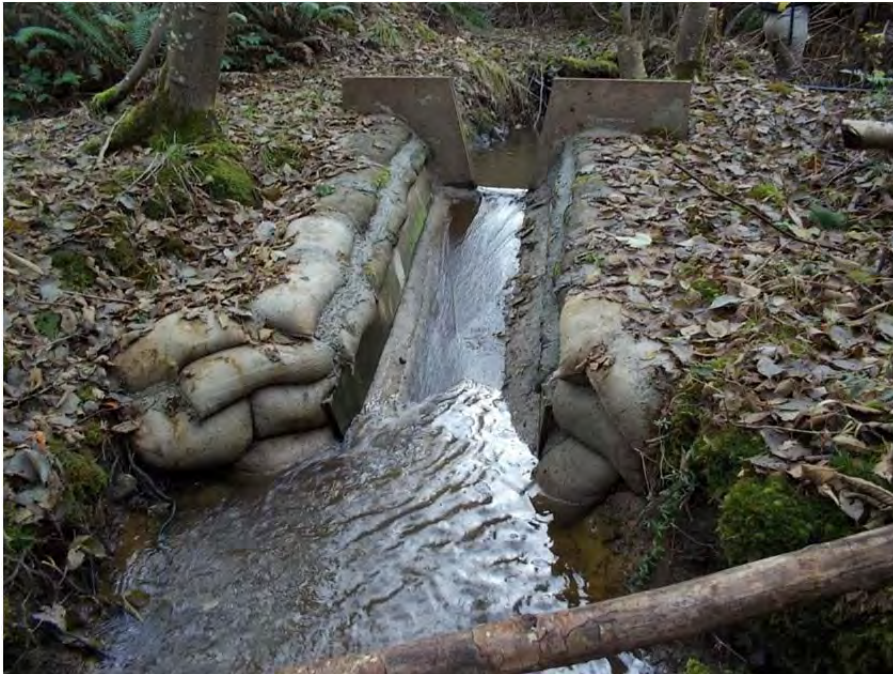
Looking south at a dam system that was likely installed for the purpose of retaining water in particular areas of the stream to provide a water source for residential use.

In the south-central portion of the residential property, the stream is directed under an access road via a 400 mm culvert. At the southern boundary of the property a dam system has been installed to regulate the flow of water. During periods of low flow, water will be retained behind the dam and provide water for domestic use (*i.e.*, irrigation). At the time the stream was traversed, water withdrawal lines were observed within the stream. The dam structure would not represent a definitive barrier to upstream migration by anadromous salmonids as it would be passable, particularly during high flows.

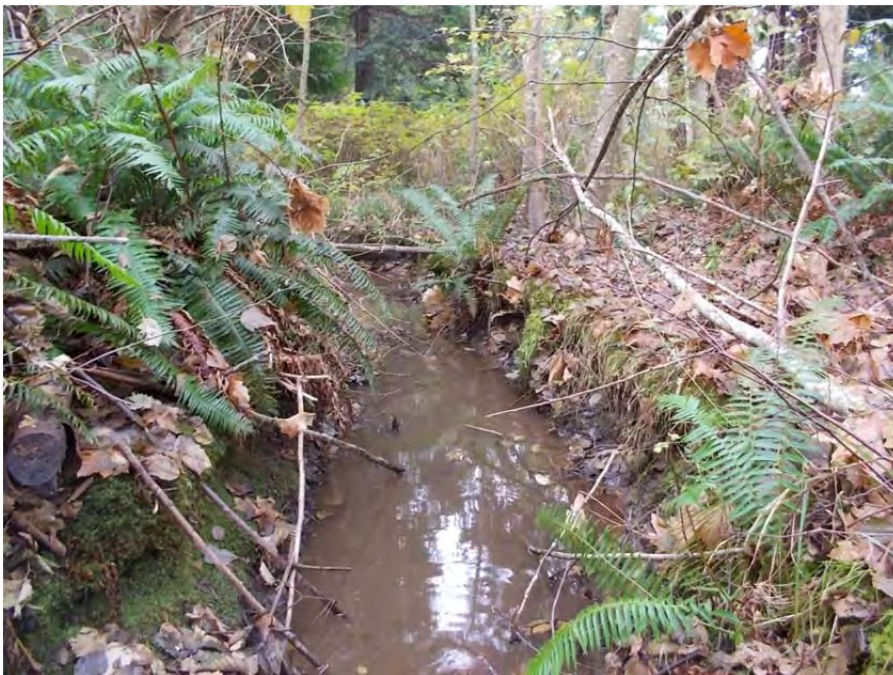
Looking north (downstream) at the West Fork of the stream, which was excavated as a drainage ditch. Note the consistent depth and width of the channel.

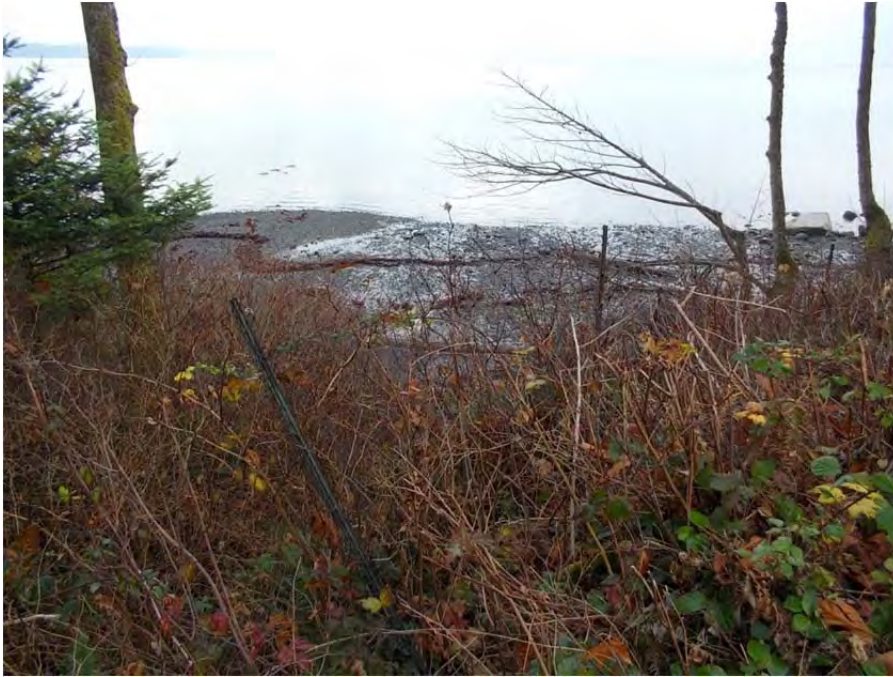
Looking north at the area where the West Fork of the stream flows into the ocean. The drainage flows over a moderately steep ledge and is extensively overgrown.

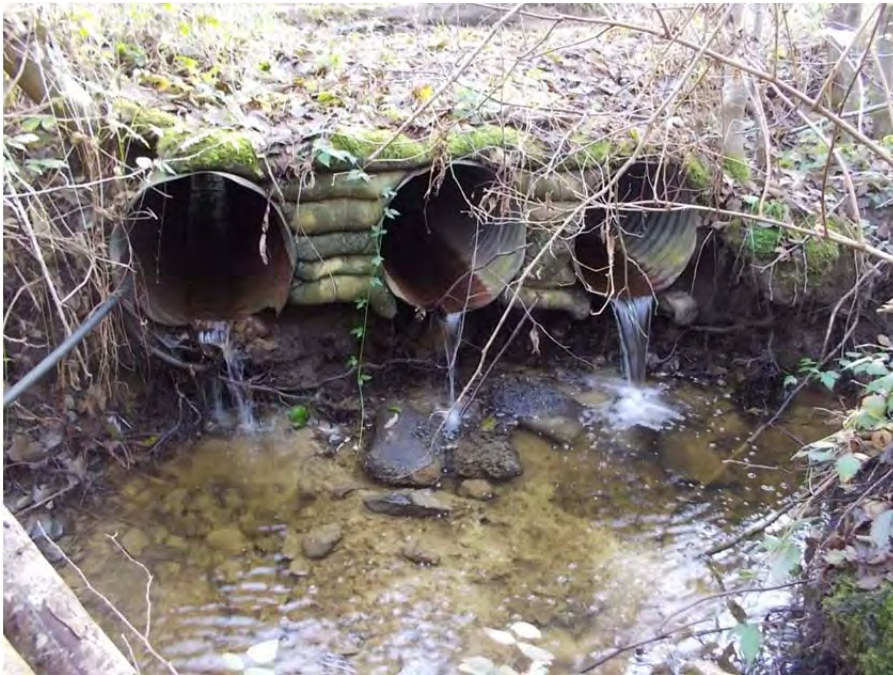
Looking upstream at the culverts that direct the stream under a residential access road.

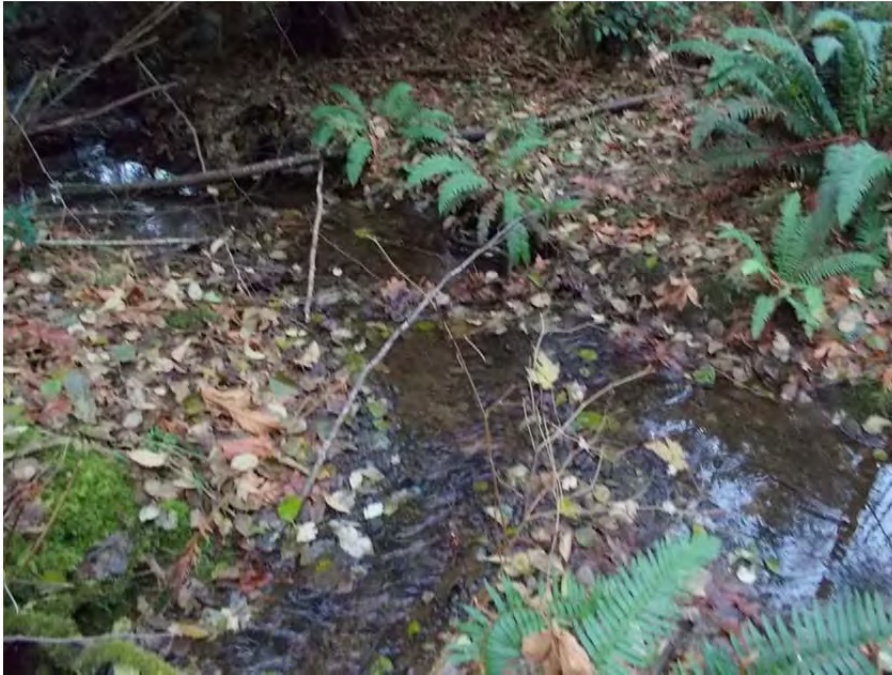
The confluence of Tributary 1 with the main stem of the stream. Note that Tributary 1 is the watercourse in the foreground of the photo.

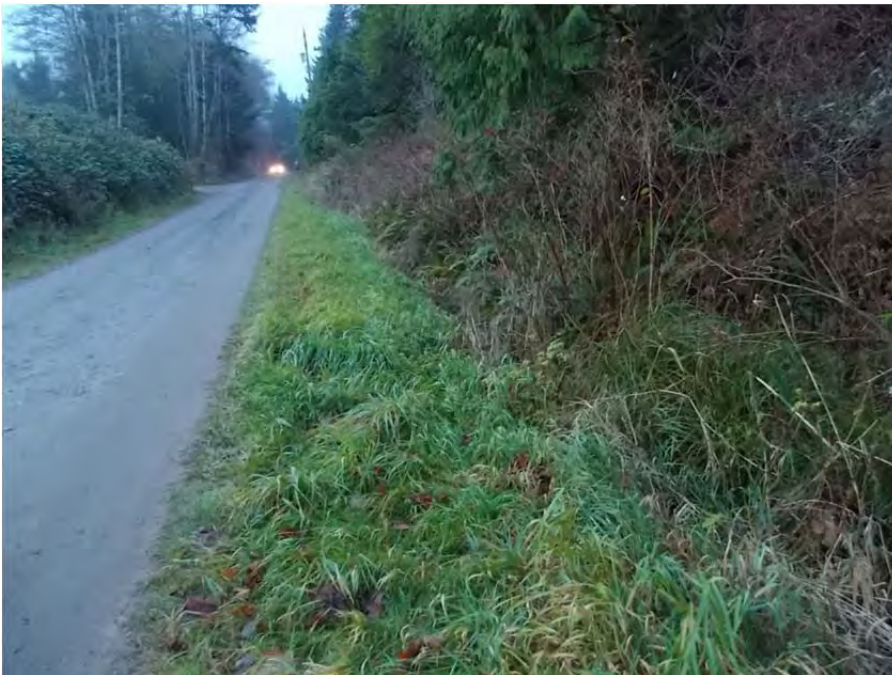
Tributary 1 flows north, adjacent to Savoie Road and possesses channel morphology typically observed in roadside ditches.
