File No.: LA-RZ-2023.1

SUBJECT: Land Use Bylaw Amendment Application – LA-RZ-2023.1  
Applicant: John Carey and Tracee Carey  
Location: LOT 62, SECTION 29, LASQUETI ISLAND, NANAIMO DISTRICT, PLAN 25495  
(PID: 002-917-475)

**RE: Supporting Information to the Application to Amend Lasqueti Island Local Trust Committee Land Use Bylaw**

<b>TOPOGRAPHIC SURVEY</b>	
<b>LOT 62, SECTION 29, LASQUETI ISLAND, NANAIMO DISTRICT, PLAN 25495.</b>	
PID 002-917-475	
PREPARED FOR <b>JOHN CAREY</b>	
OUR FILE : 61580-8	REVISION :

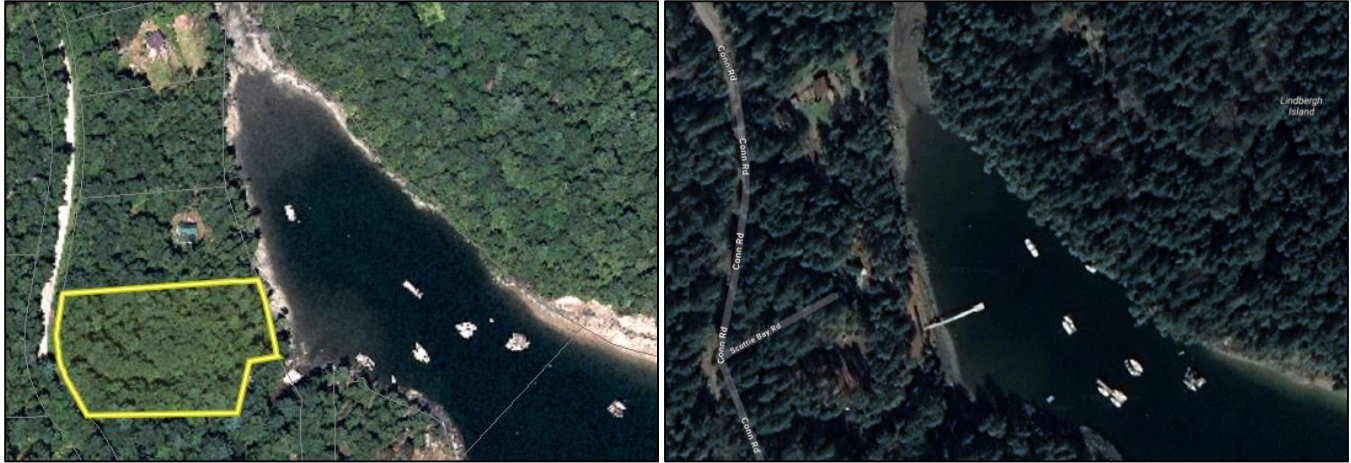
*Figure 1 Subject property prior to dock being installed (Left) and image from google maps showing the dock (Right).*

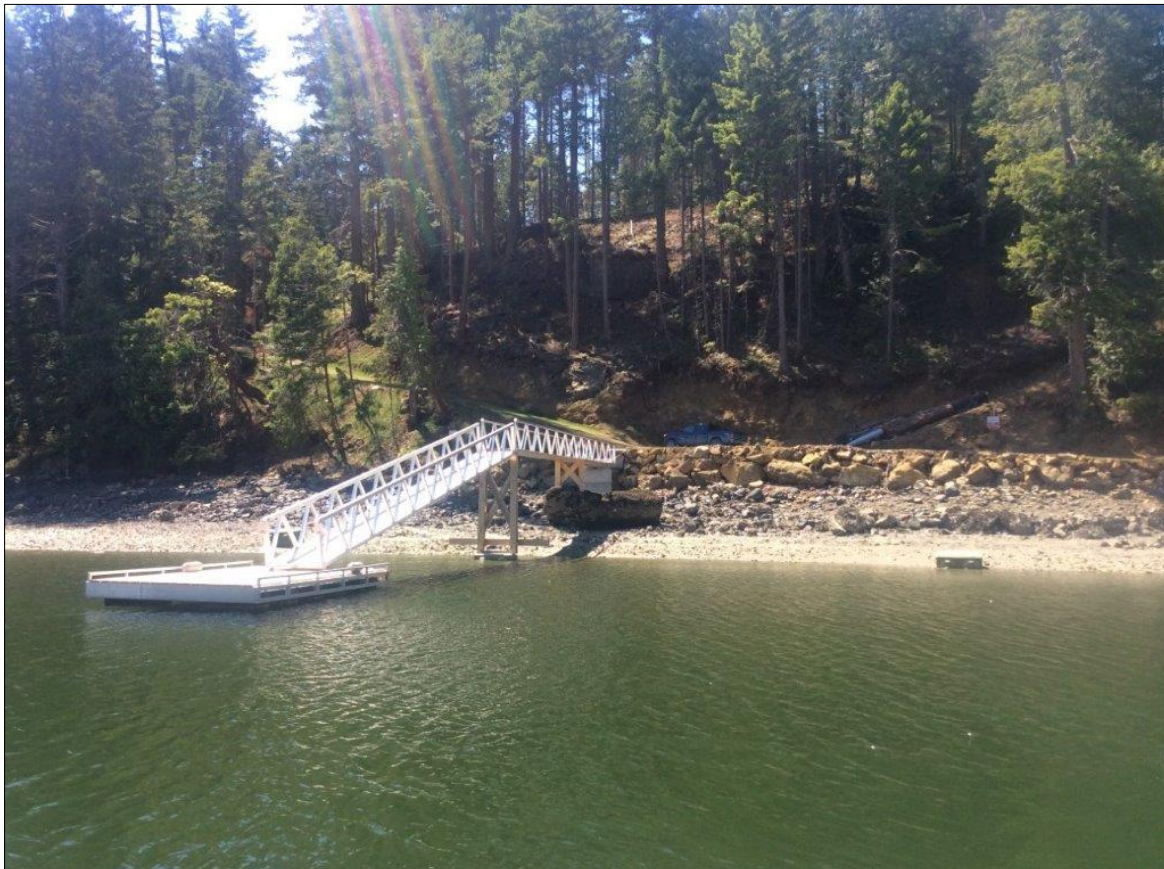
*Figure 2 Photo of the proposed dock from a 2020 Islands Trust Staff Report.*

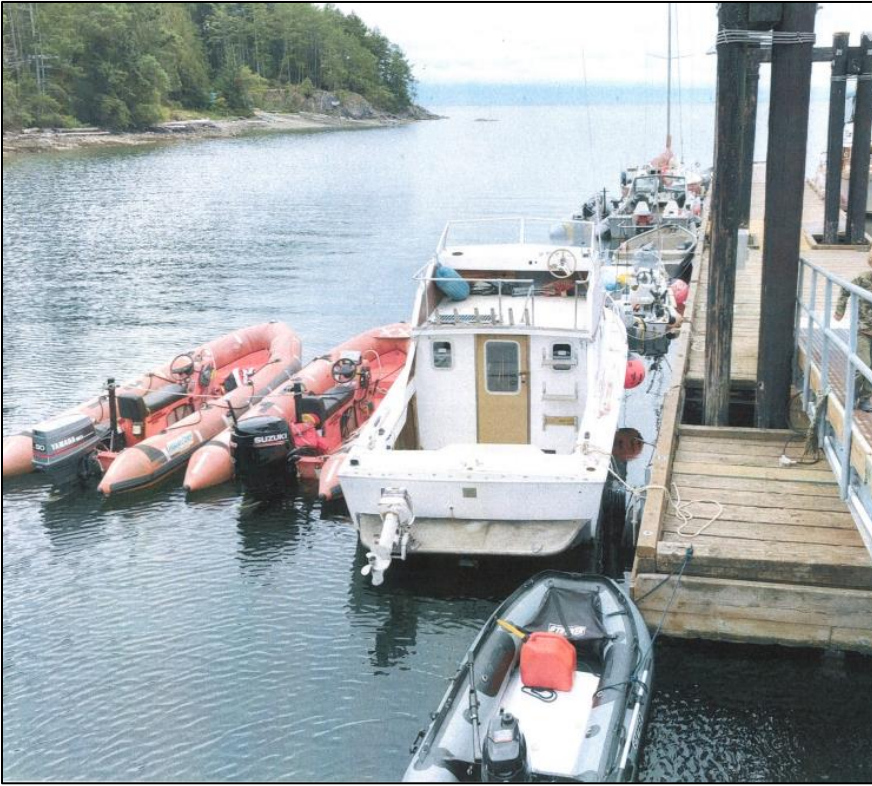
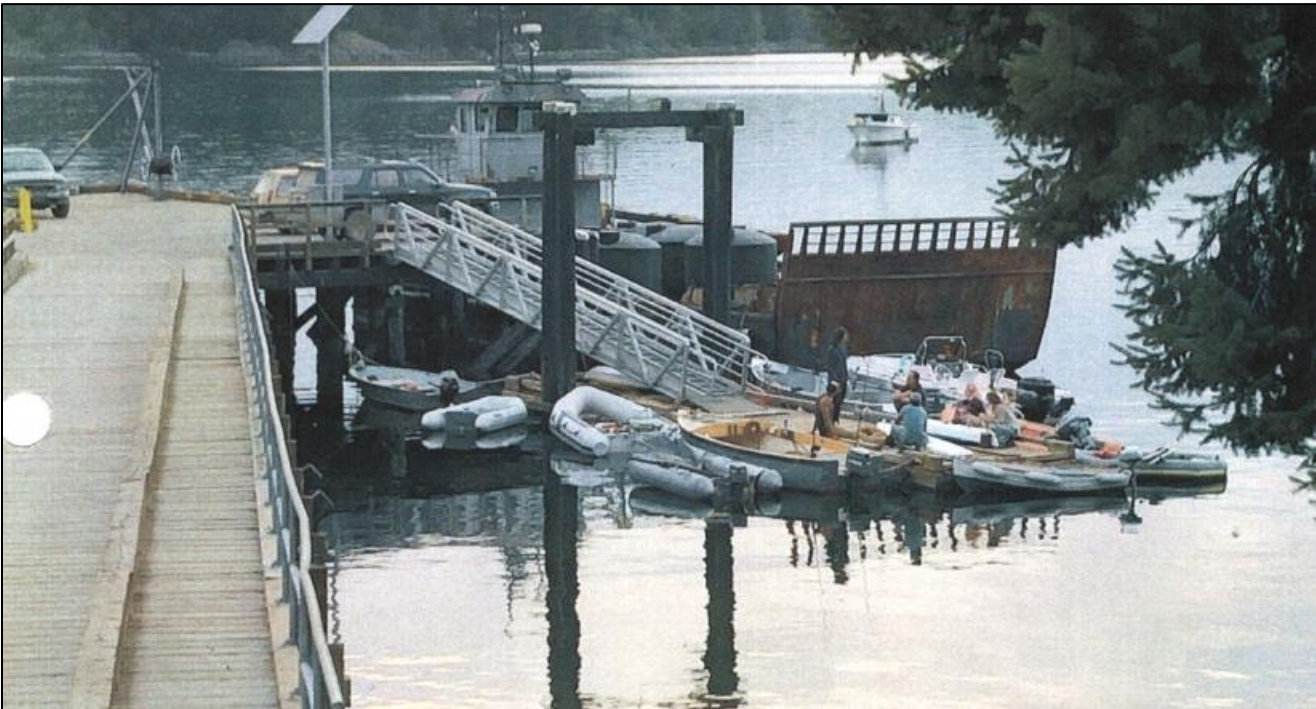
**False Bay Public Dock**

However, the bay is not completely protected from all wind directions and is subject to harsh condition should the west wind come up, so reliable year-round time up is not always suitable for this location.

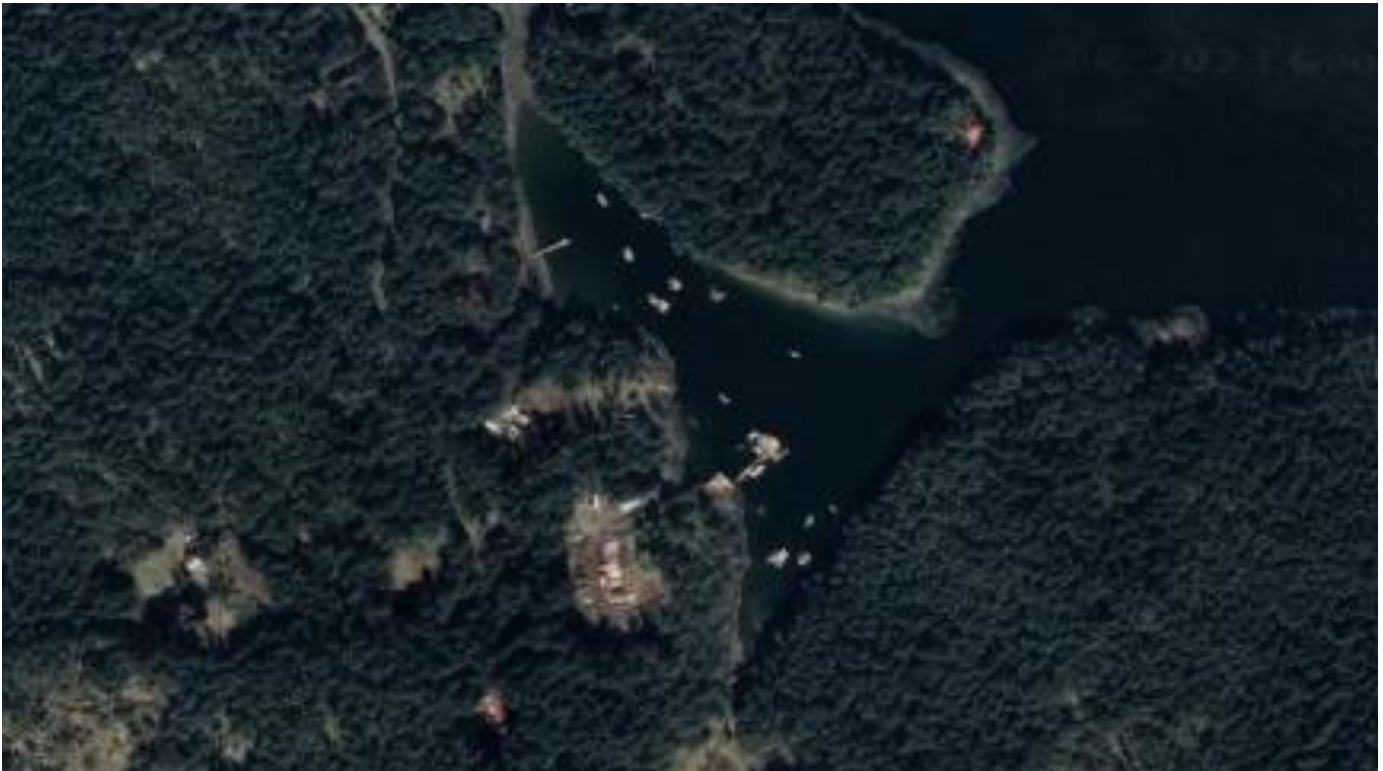
The bay only has one small public beach access that many residents use to get to their boats however the access location is very steep, rocky and slippery at times and there is no float or flat safe space for easy access to transport goods to and from their boats. The access is at the end of a narrow residential road and a dirt path leads to the shoreline. Several residents keep their row boats pulled up on rock bluffs out of the tide so that they can row out to their boats when they would like to use or work on them.

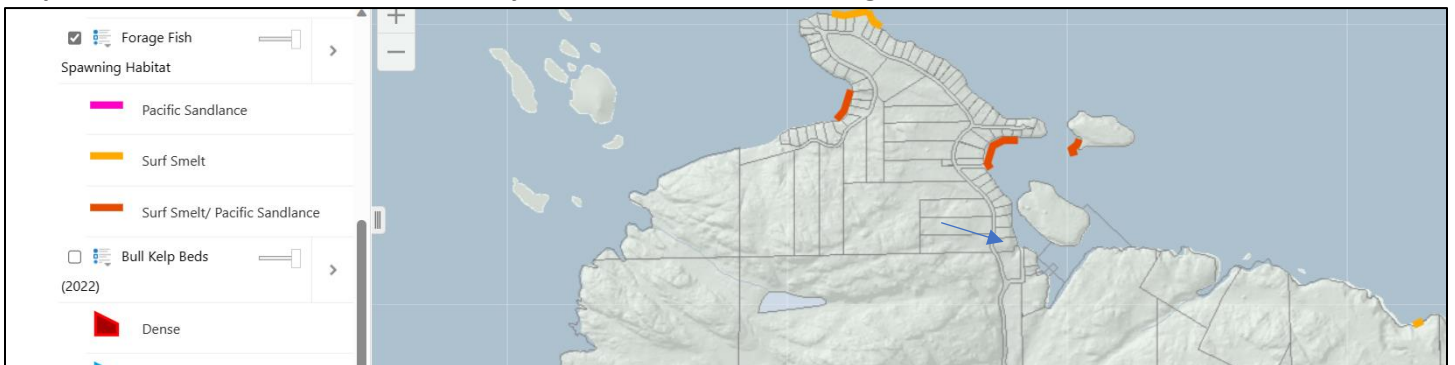
### **MapIt - Screen shot of Lot 62 in Scottie Bay shows no indication of Forage Fish habitat.**

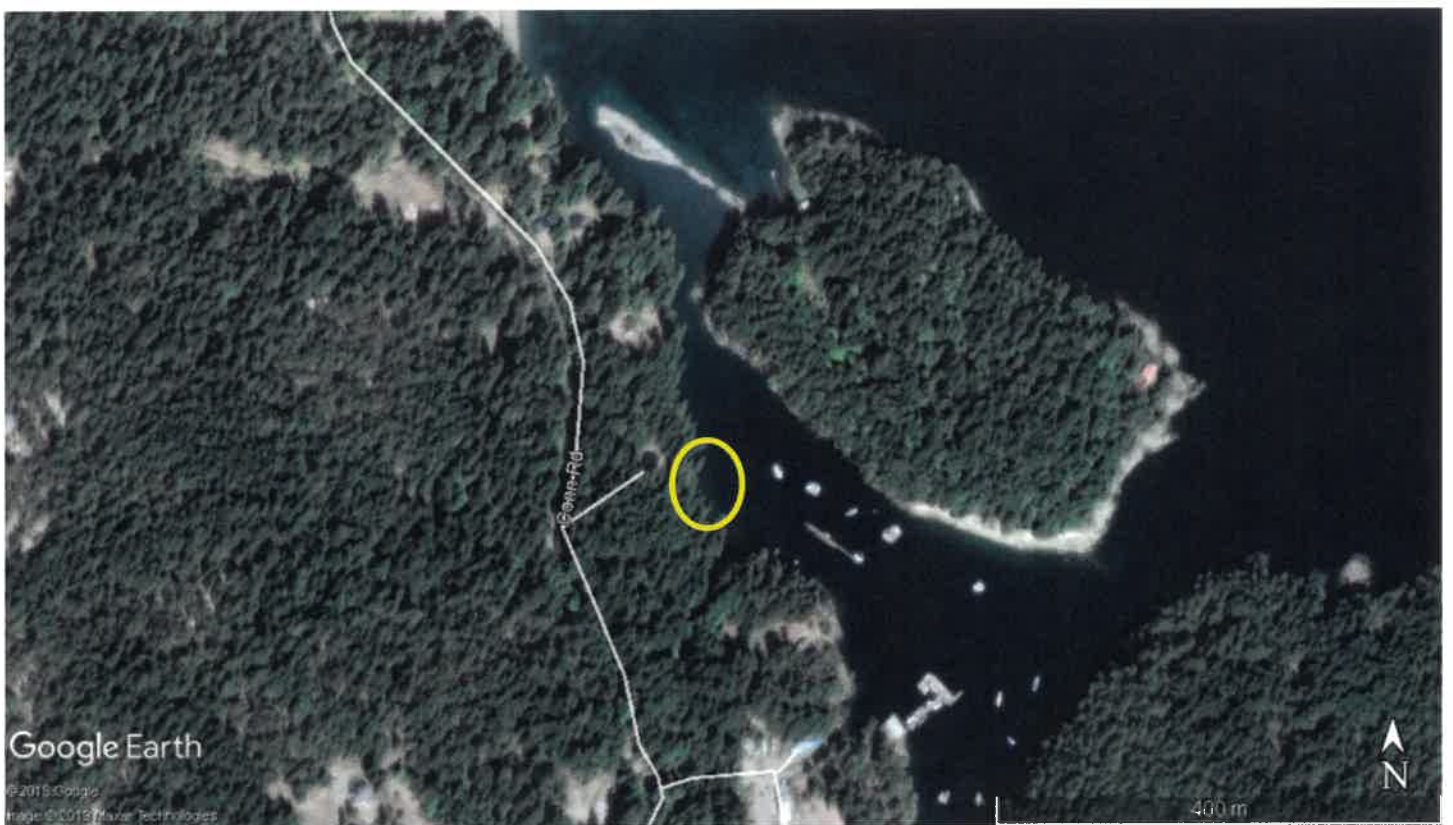
**FIGURE 3**  
**AS-BUILT SURVEY**  
**J. E. ANDERSON & ASSOCIATES**

Aquaparian's Biologist (Sarah Bonar R.P.Bio), completed a post construction impact assessment of the project area on October 22, 2020. The intent of the assessment was to document what was constructed at the site including the dock and the upland road and compare it to the pre-construction site conditions. The assessment was completed concurrently with an as-built survey by J.E. Anderson and Associates. The as-built survey is included as Figure 3.

The Elevation of the Present Natural Boundary has been determined of Ordnance Datum 2.1 m. It has been determined that the bottom of the Rock Wall has been placed at the PNB of Lot 61; however a large boulder and several small boulders extend past the PNB as noted.

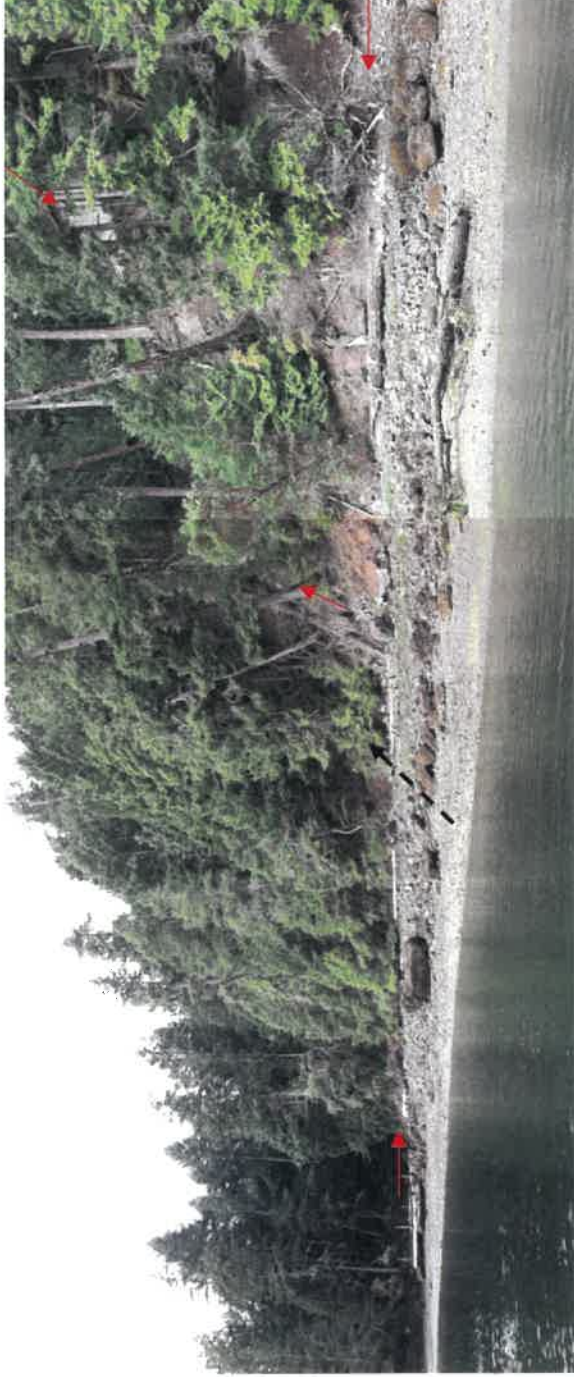
**SCOTTY BAY LASQUETI ISLAND POST CONSTRUCTION OCTOBER 22, 2020**  
**Photo Sheet 1**

Photo 1. Showing the shoreline taken at low tide in July 31, 2020 10:00am at a 0.7m tide prior to construction. Note the location of the house at the top of slope to compare to Photo 2 below and red arrows indicating the high tide line and the same Douglas fir for comparison between photo angles. The black dashed arrow indicates the approximate property line between Lots 61 and 62.

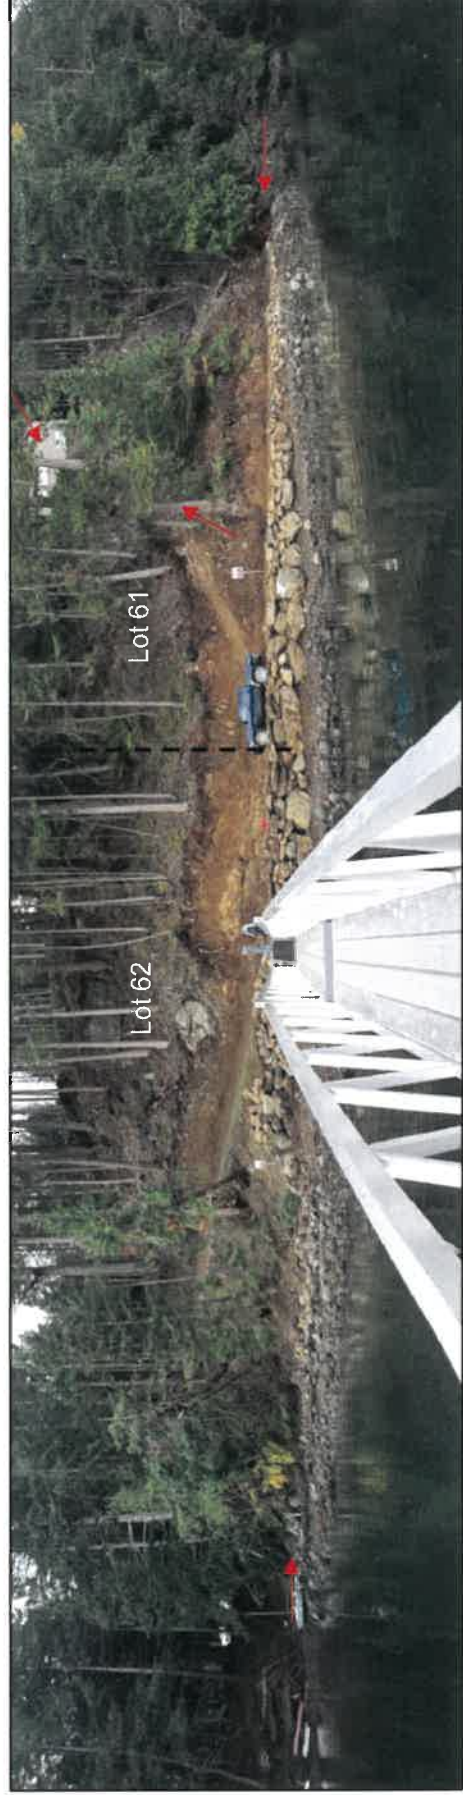
Photo 2. Showing the shoreline taken October 22, 2020 at 9:00am at a 3.6m tide post construction. The rock retaining wall was recently pulled back approximately 2.5m at the toe as it was determined to have encroached past the original Present Natural Boundary of the shoreline. Approximate property line between the two affected parcels is indicated by the black dashed line.

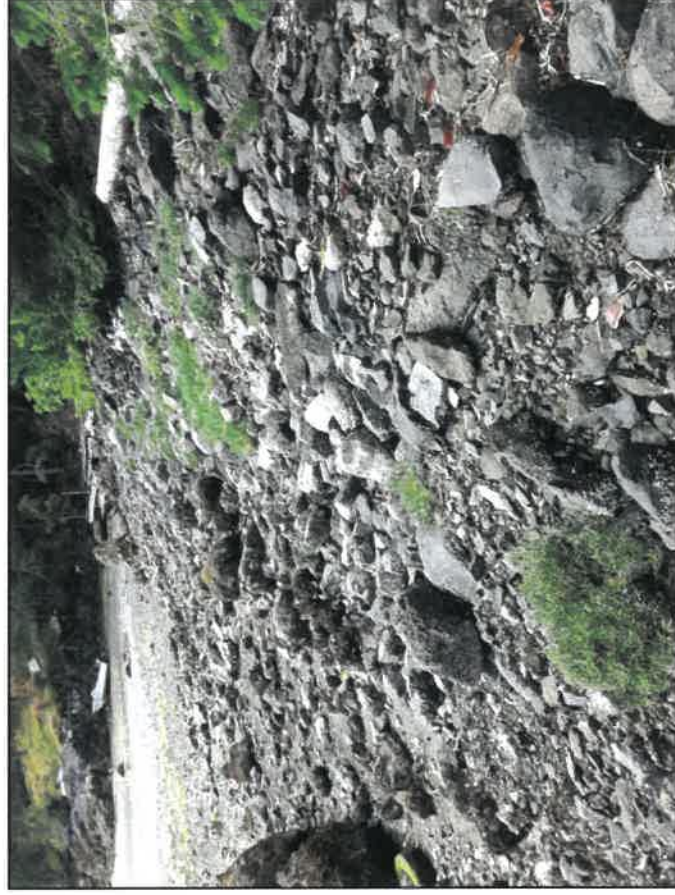
**Photo Sheet 2**

Photo 3. Showing the shoreline in front of Mr. Merl Mann's parcel prior to construction July 31, 2020 during a low tide 0.7m. Note the location of the same reference Douglas fir tree for comparison to post construction in photo 2. This is the approximate location of T7 in the original assessment.

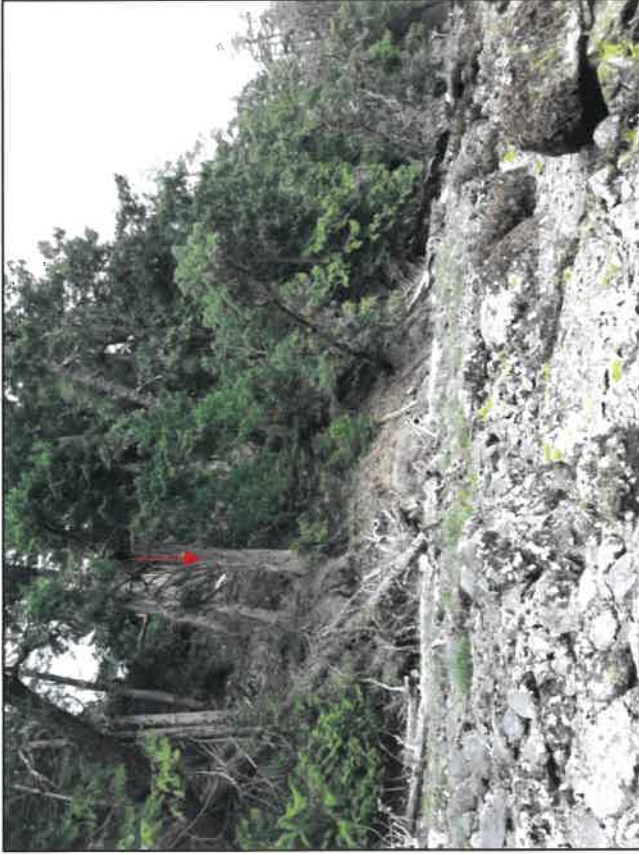
Photo 4. Showing the shoreline in front of Mr. John Carey's parcel prior to construction July 31, 2020 during a low tide 0.7m. A narrow band of sea asparagus (*Sarcocornia pacifica*) was present in the high intertidal zone during the peak growing season.

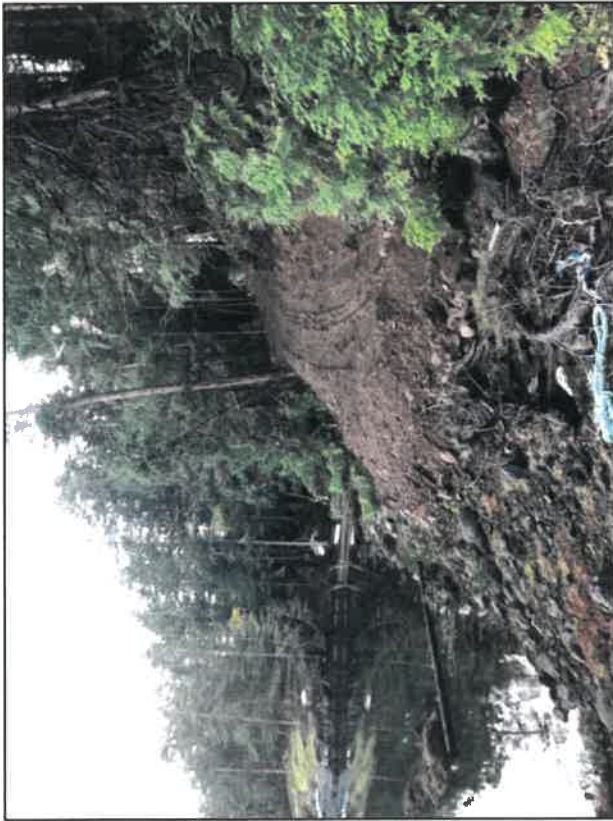
**Photo Sheet 3**

Photo 5. Looking the other direction at Mr. Carey's parcel during the initial construction of the road prior to the initial retaining rock placement. The retaining rocks and soil were subsequently moved back at the toe to make a more vertical wall to remove the bottom row of rocks back to the original high water mark.

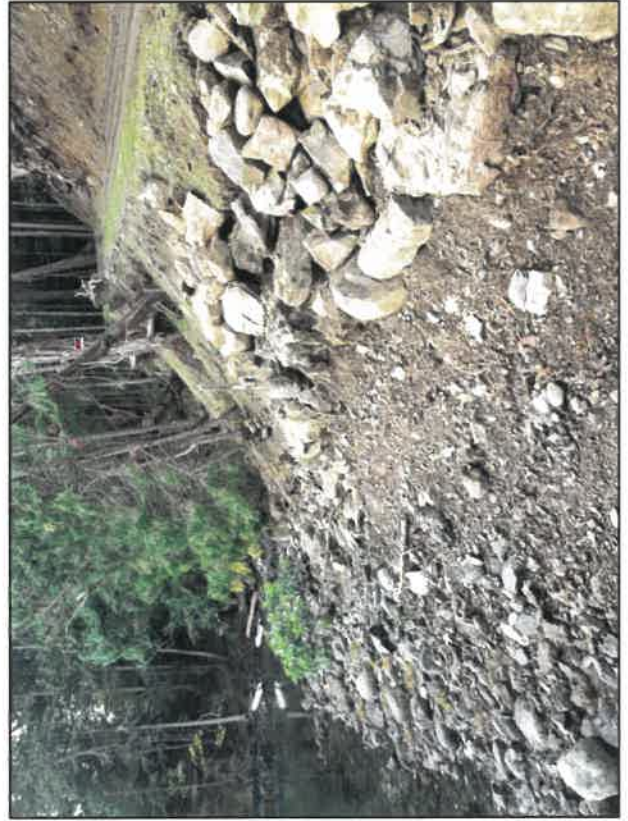
Photo 6. Showing the shoreline in front of Mr. John Carey's parcel post construction October 22, 2020 during a rising tide 3.6m. The narrow band of sea asparagus is still visible but slightly impacted by the initial rock placement that was pulled back to the surveyed high tide line (PNB). This area is expected to regenerate naturally.

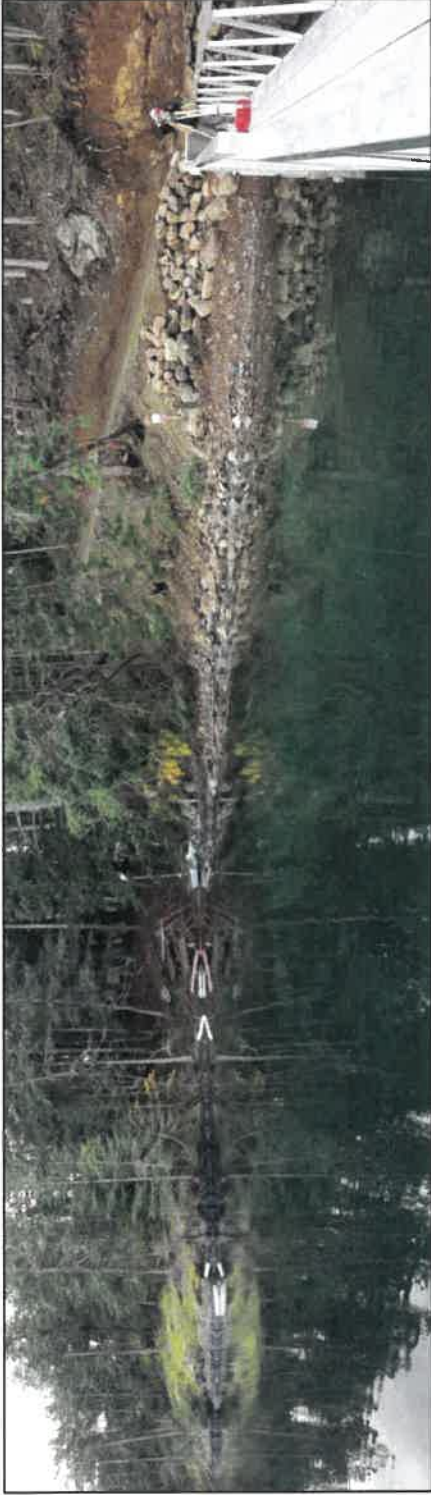
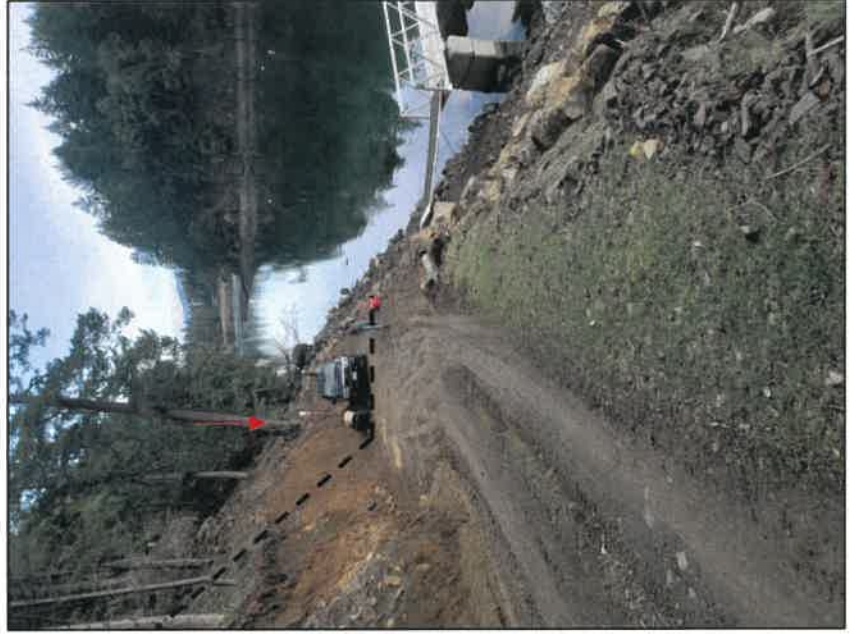
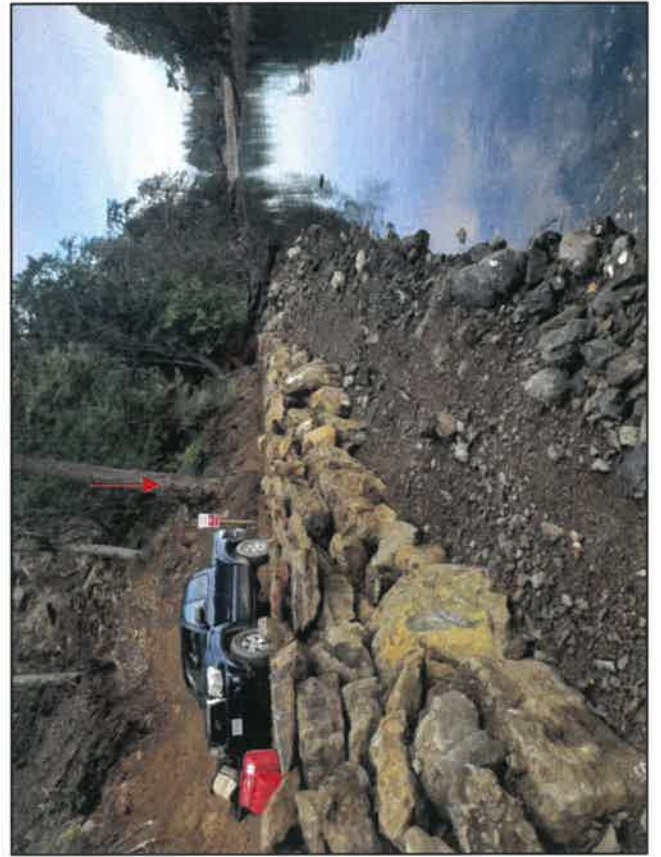
Photo Sheet 4

Photo 7-9. Showing the same section of shoreline post construction at a 3.6m tide looking across Mr. John Carey's shoreline and dock where the slope cut was further back into the slope to create the road. The property line (black dashed line) is approximately at the front of the pick-up truck.

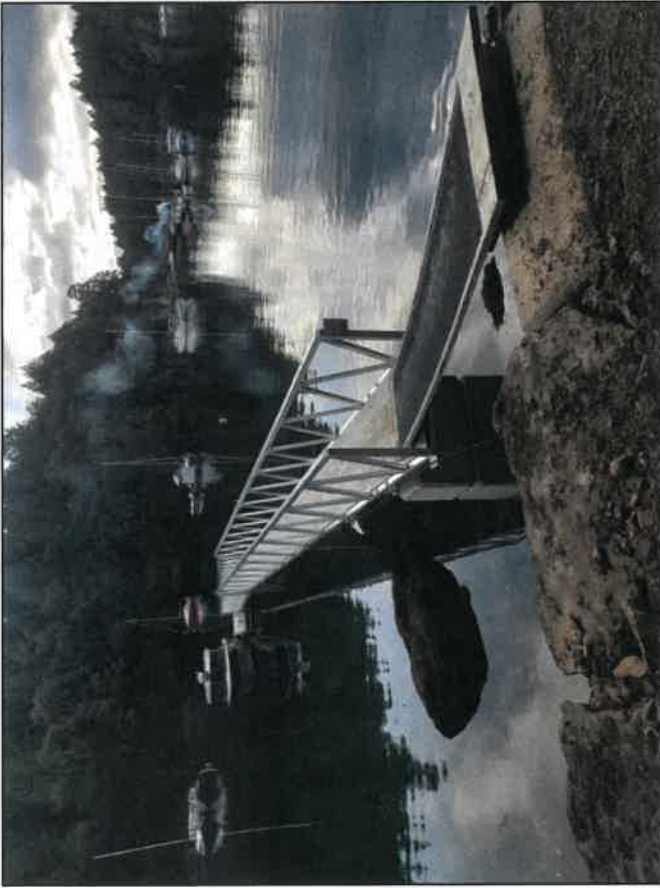
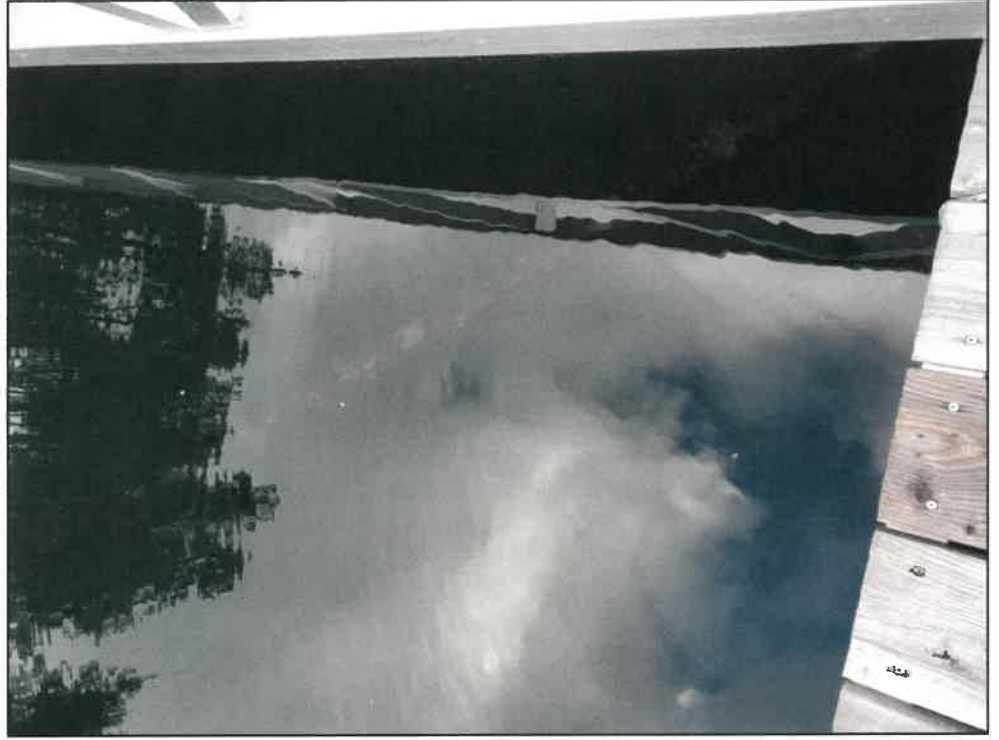
**Photo Sheet 5**

Photo10 & 11. Showing the new dock fronting Mr. Carey's parcel. The shoreline ramp and the end of the dock is supported on lock blocks. The second pier is on a natural bedrock with small wood piers. The third support is lock blocks. The dock is held in place by anchor chains to lock blocks.

The dock ramp and float are consistent with typical small private dock systems. The structure is narrow and oriented east-west. The dock and ramp are aluminum grating which allow light penetration. The small size and solar angle are not expected to result in any shade impact on the sea floor. Pre-construction conditions were found to be low due to poor flushing, derelict boats and other waste as well as several live-aboard boats (two with shacks on sections of old dock) in the bay. The remainder of the shoreline around the bay is forested. Due to the near vertical slope above the subject parcel's shoreline, leaf litter and large woody debris from the upper slope are expected to still drop into the foreshore in time. The shoreline is directly east facing and is therefore exposed to sunlight through the mornings and is shaded through the afternoons as a result of the topography rather than the tree canopy. The tree removal does not appear to have affected shade along this section of shoreline.

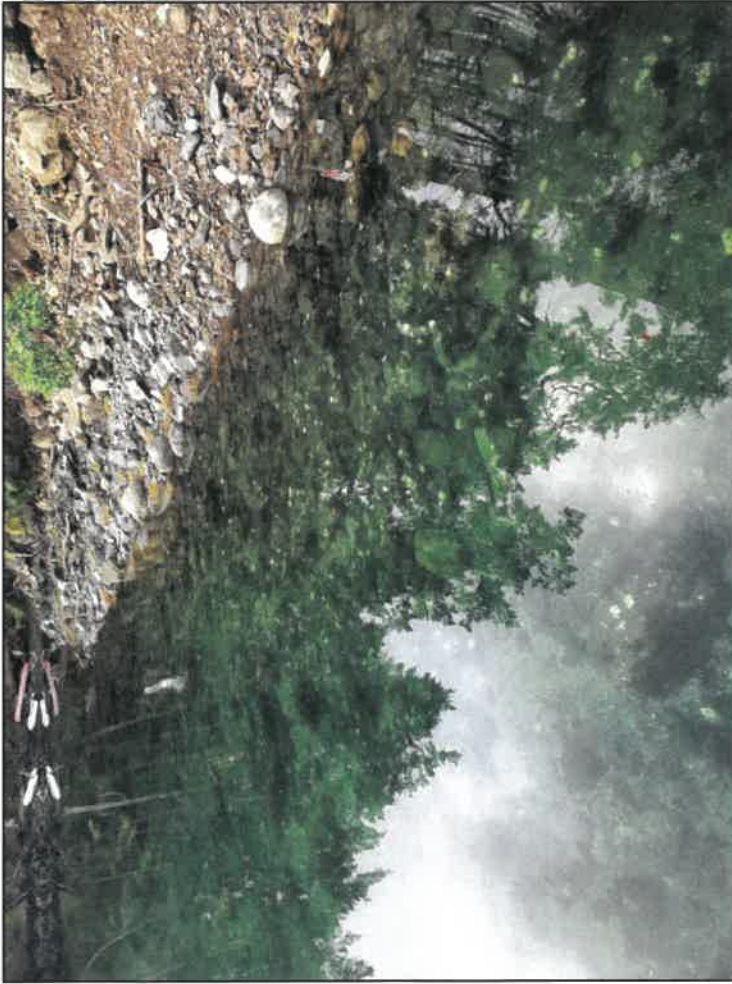
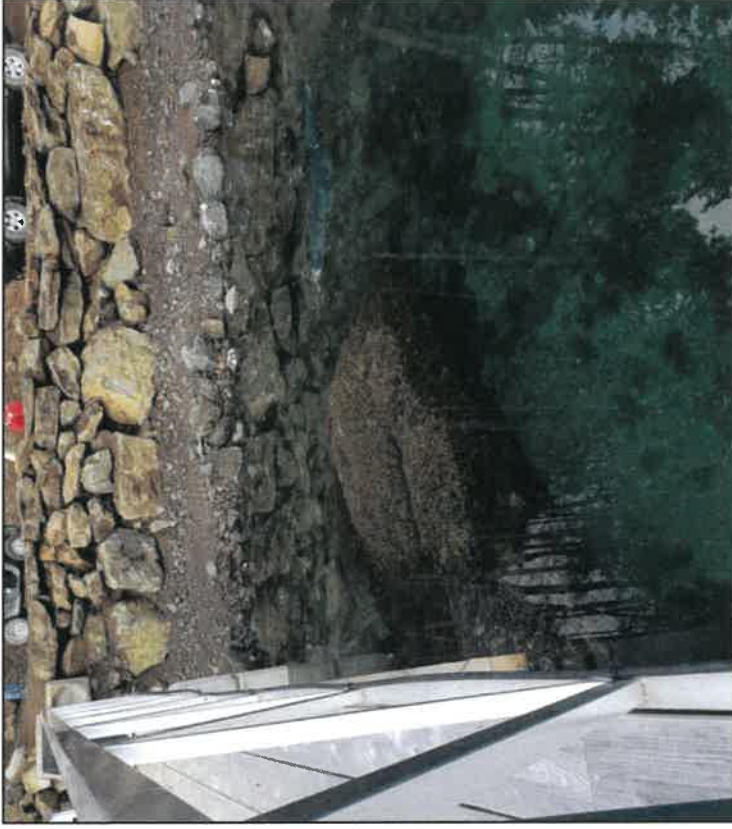
Photo Sheet 6

Photo 12 & 13. Taken each side of the dock Oct 22, 2020 showing the edge of disturbance and water clarity showing the start of the fucus zone at a 3.6m tide. The narrow band of sparse sea asparagus (*Sarcocornia pacifica*) is still visible left of the disturbed area of that band above the tide line in the photo. It is turning slightly yellow due to the time of year – its an annual salt tolerant plant.

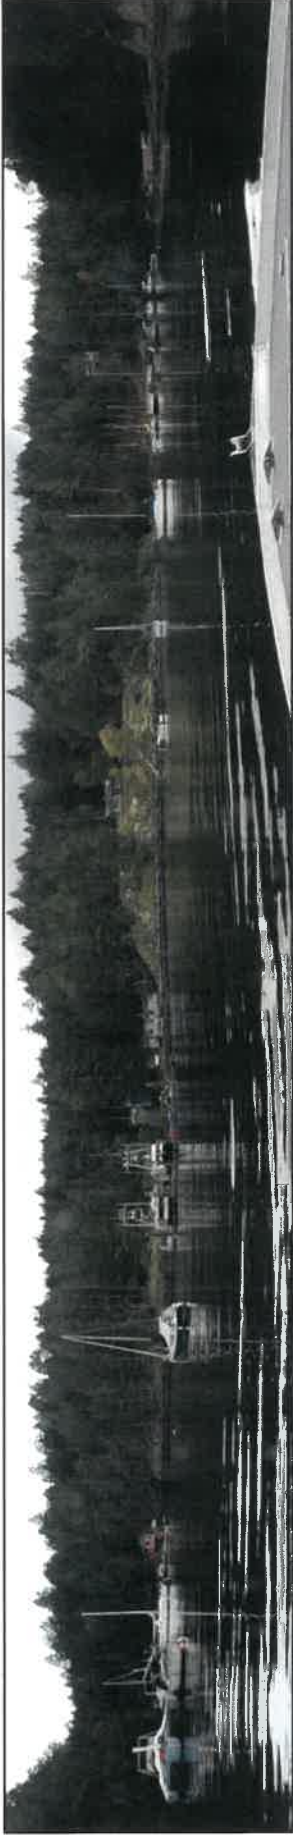
Photo Sheet 7

Photo 14. Looking into Scottie Bay from the entrance toward the parcels showing many boats tied anchored or tied to single point moorings in the bay without legal tenures, some of which are live-aboard. The only legal dock (centre left) has fishing boats tied up and becomes over-used due to lack of docks on the island. A total of 16 boats were counted on moorings or anchors.

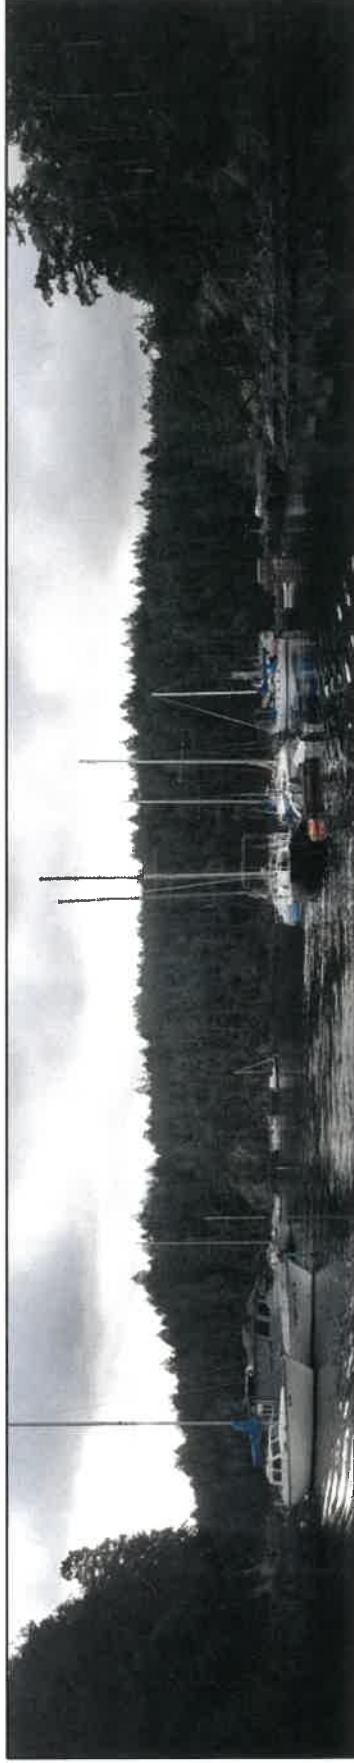
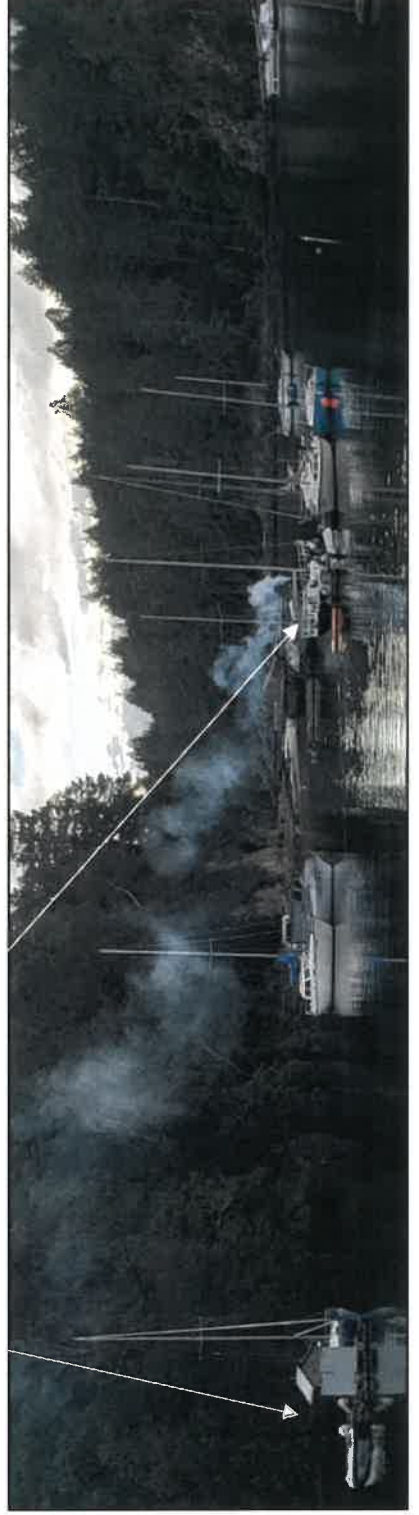
Photo 15 & 16. Looking back across the bay from in front of the subject parcels showing several boats tied together in groups. Some had small floating buildings on sections of old docks.
