STAFF REPORT

File No.: PLBOV20250248

SUBJECT: Siting Variances for Single Family Dwelling, Accessory Building and Retaining

Location: 365 Isabella Point Road, Salt Spring Island

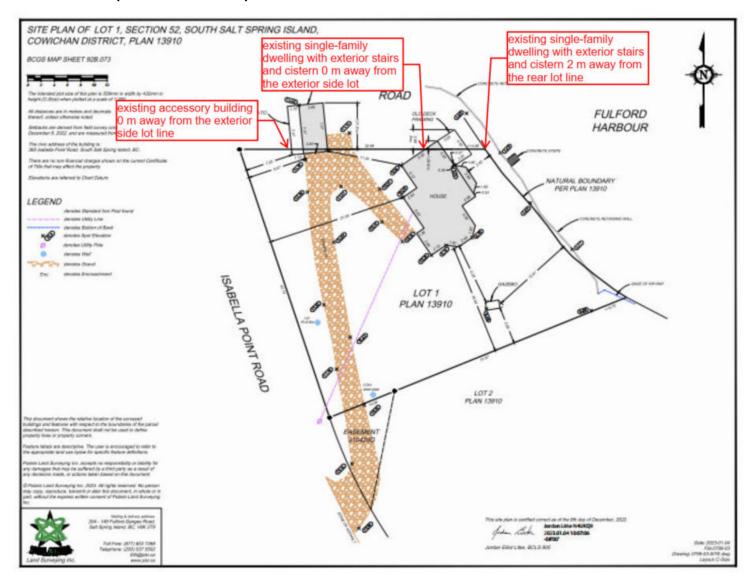
- (1) an existing accessory building 0 m away from the exterior side lot line
- (2) an existing single-family dwelling with exterior stairs and cistern 0 m away from the exterior side lot line and 2 m away from the rear lot line

- is varied to permit an existing single-family dwelling with exterior stairs and cistern 2 m from the natural boundary of the sea.
- 3) Subsection 4.5.1 which states no sewage disposal field or septage pit may be located within 30 m of the natural boundary of the sea,

- is varied to permit a sewage disposal field 14.32 meters from the natural boundary of the sea.
- 4) Subsection 3.11.4 All rooms in a dwelling unit are to be contiguous and accessible from within the dwelling unit; a dwelling unit may not consist of two or more separate suites of rooms joined only by unenclosed space, a passageway, a garage or by any structure that does not function as an enclosed room of the dwelling unit,

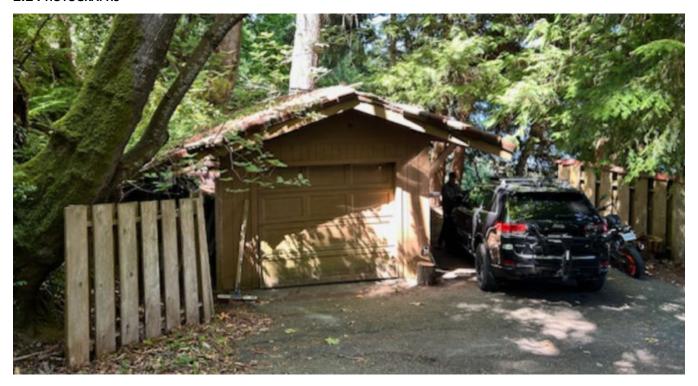
Figure 2.2.1 Existing accessory building, and undeveloped road (Looking North)

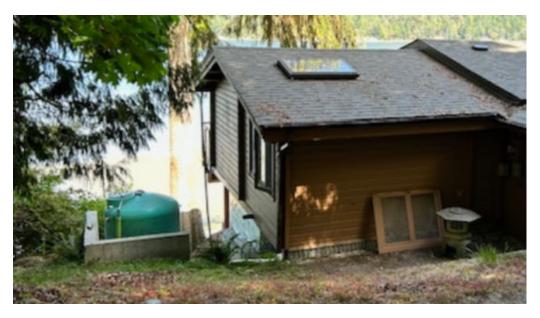
Figure 2.2.2 Existing house and cistern (Looking East)

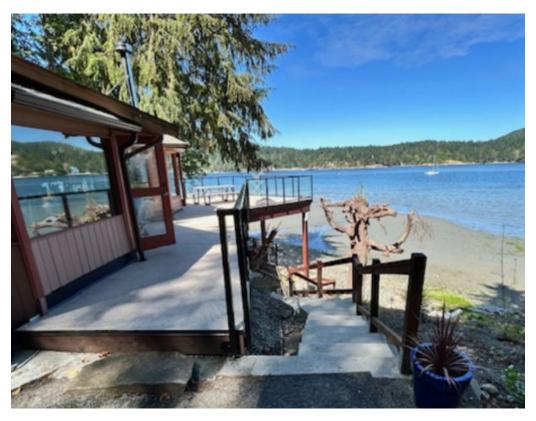
Figure 2.2.3 Existing house deck and stairs (Looking North-East)

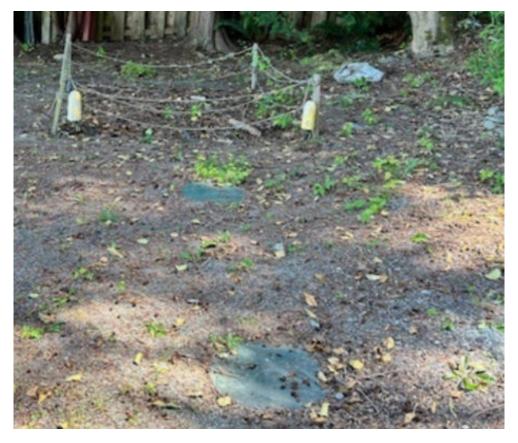
Figure 2.2.4 Existing sewage disposal system (Looking South)

It was also determined that the ~14.32m horizontal setback to SER (Marine) is less than the SPM 15m requirement. While the *in situ* native soils are likely sufficient to treat effluent within that distance, the challenging subsurface conditions results in an elevated risk to the SER, and that mitigation of likelihood is warranted.

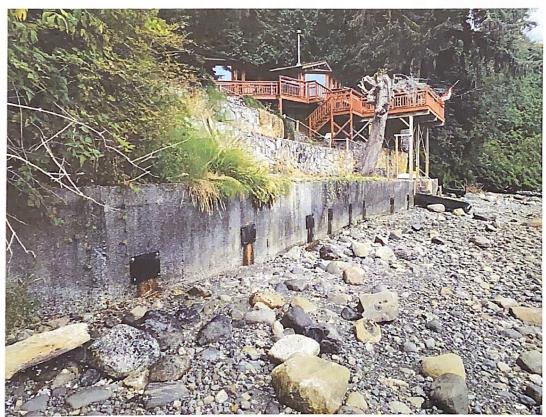
Figure 1. Looking northwest along the shoreline

The retaining walls along the low side of the residence consist of rock and mortar construction within the upper tiers and cast concrete along the shoreline. The overall global tier geometry of the lower slope is up to approximately 45 degrees. The rock and mortar walls are between approximately 1.5 and 2.0 m high and display local indications of rotation/cracks and surface settlement of the backfill behind. The settlement and associated lateral movements appear to extend into the periphery of the residence where sloped floors in the main level and cracks in the basement slab are evident. The lower foundations adjacent to the wall were observed to be

undermined locally and the soils supporting the footing was noted to be loose to a depth in the order of 0.5 m by probing with a steel rod. The foundation of the residence at the closest point is set back approximately 5 m horizontally from the 2 m high retaining wall. Furthermore, a post of the deck above bears atop the crest of the middle retaining wall in an area where cracks and rotation are apparent. The lowest cast concrete wall appeared to be relatively stable and was noted to include active weep holes at 3 - 4 m spacing. It was noted that possible fines migration from behind the walls was being deposited out of the weeps. The general conditions of the shoreline and subject retaining walls are shown in the photos below.

We consider that there would be several options with respect to remediation of the retaining walls and foundation settlement of the residence. Such could include underpinning of the foundations and reconstruction of the retaining walls to various degrees depending on the desired level of repair. However, at a minimum, we recommend that the foundation of the residence be

underpinned and the rotating sections of rock and mortar below the building be remediated to ensure safe occupancy of the residential site is maintained. It was also noted that the mature coniferous tree present at the west end of the walls should be considered for removal as toppling of this tree would likely result in collateral damage to the walls and possibly the residence.

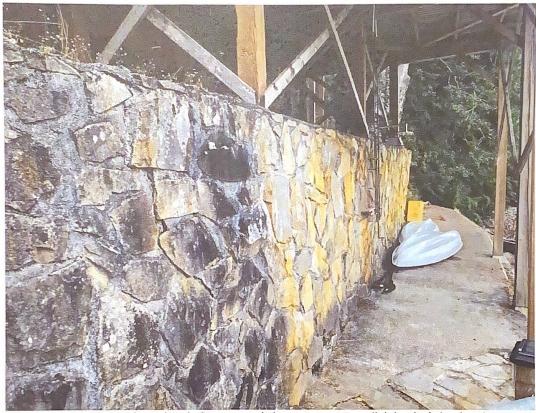
Figure 2. Looking northwest along the first tier towards the rotating retaining walls below the deck and residence

Based on our observations, we consider that the retaining walls may be at local risk of toppling in the long term or as a result of seismic ground motions. Toppling of the walls may also result in reduced support of the building and deck foundations above which could potentially have adverse structural implications to the building. The mechanism of failure of the walls may be due to insufficient thickness of the gravity wall section, settlement of weak/loose subgrade and backfill soils, as well as possible hydraulic pressure due to shallow groundwater, or a combination of these conditions.

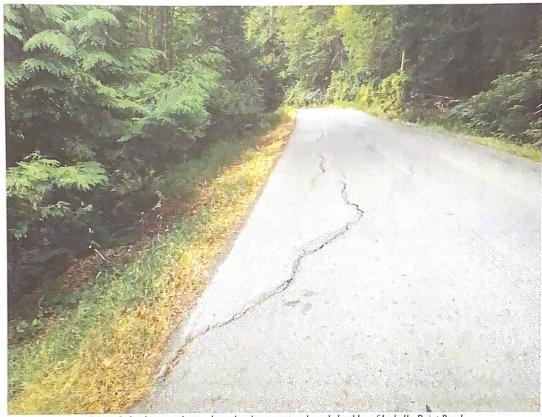
Figure 3. Looking southeast along the slope crest and road shoulder of Isabella Point Road

We also observed there to be arcuate cracks within the asphalt of the road surface above the site which suggest that settlement of the slope crest along the property frontage has occurred. The vegetated slope below this area is inclined at approximately 40 degrees from horizontal and is up to approximately 7 m high above the driveway. The stability of this slope with respect to risk of failure is unknown, however, these types of settlement along rural roadway corridors are often controlled by long term consolidation of historic fills. The presence of shallow groundwater can reduce the stability of the slope and we note that failure of the slope would likely result in blockage of the driveway by slumped materials and possible collateral effects of fallen trees. A photograph of this area is shown below looking southeast along Isabella Point Road.

With respect to the noted cracking of Isabella Point Road which suggests potential for slope instability, we recommend that this crack be monitored for signs of movement and that the Ministry of Highways and Infrastructure be contacted to advise of the situation in this regard.

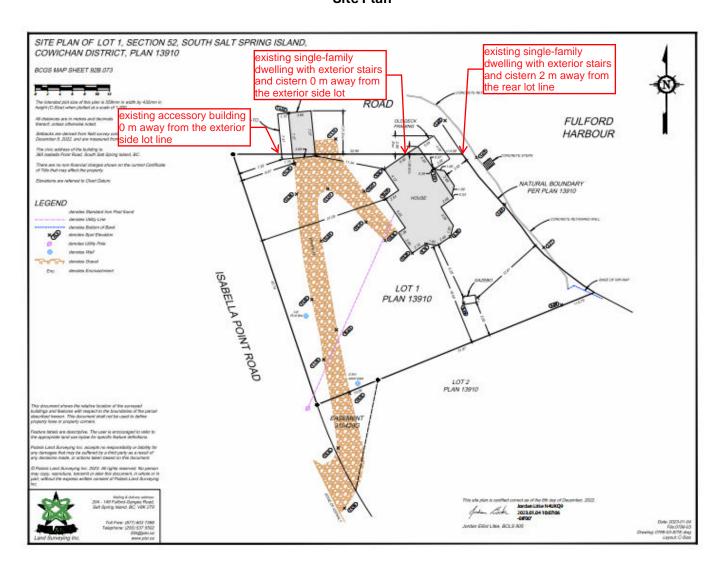
Schedule A Site Plan

- 2. We repaired the existing stairs to the retaining wall that had been covered to allow access to the foundation while the repairs were on-going. (See 4) And the cistern was put outside the cabin as a prudent way to protect the cabin from floods. (Schedule A)

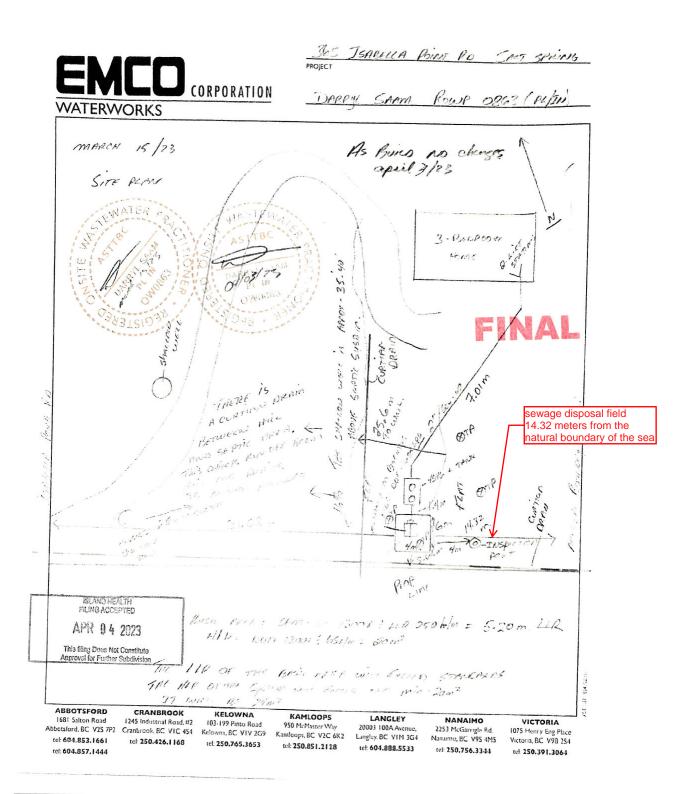
Schedule B Septic Plan

- 3. We installed a new septic system (Schedule B) This was done under the supervision of a Hydro Engineer.
- 4. Initially we were only planning on underpinning the cabin to repair the foundation. But during the work it was discovered the main building was built over blue clay (which expands and contracts seasonally with moisture) Our Structural Engineers and Geotechnical Engineers advised us to install Helix Piles. This meant we had to remove the deck (which had not previously been planned) and cover the stairs to get the machinery in. At that time we decided to lower the basement 8-12 inches so that Stuart, who is 6'4", would not hit his head. We were unaware that would be problematic. (Schedule C)

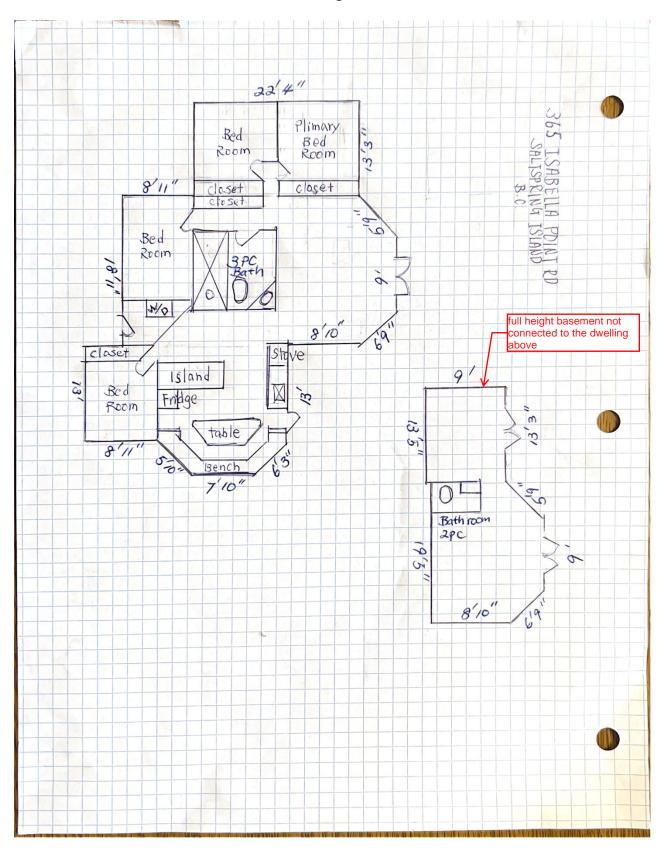
Schedule C Building Plan

- is varied to permit a full height basement not connected to the dwelling above as shown in building plans.
