MEMORANDUM

File No.: PLDP20240056 - 235 Quarry Dr.
X-Ref PLDP20240057 - 239 Quarry Dr.
File: PLDP20240058 - 431 Baker Rd.

DATE: May 2, 2025
TO: Legislative Clerk
Salt Spring Island Team
FROM: Stefan Cermak, Director, Planning Services
COPY: Oluwashogo Garuba, A/Planner 2
Chris Hutton, Regional Planning Manager, Salt Spring
SUBJECT: Delegated Development Permit Application
Applicant: Bradley Fossen
Location: 235 Quarry Drive, Salt Spring Island, BC

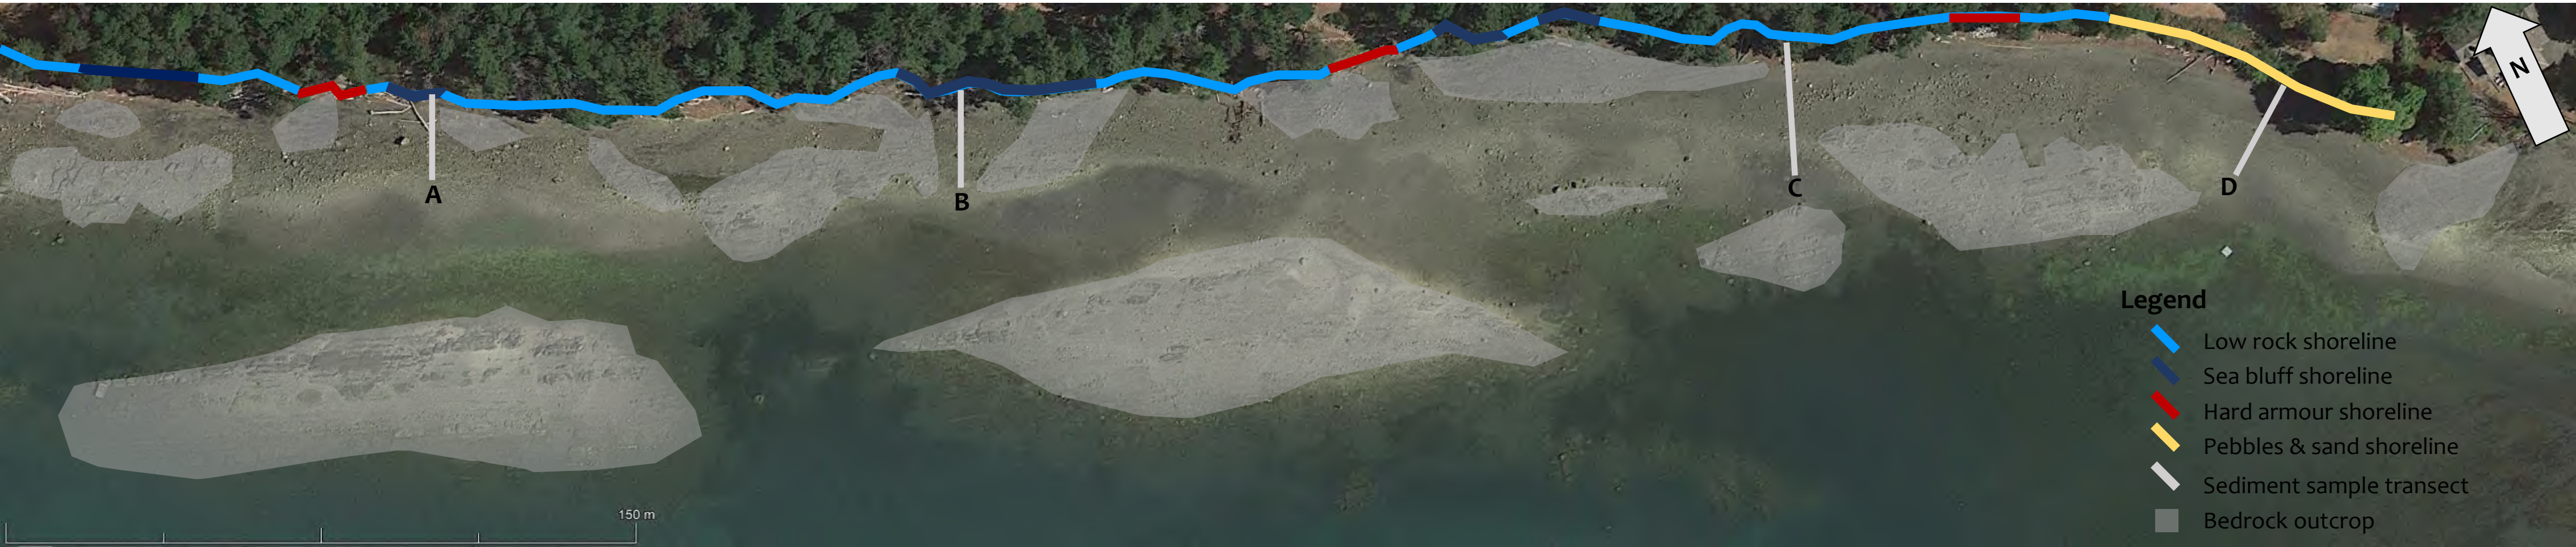
Figure 3. Shoreline types, sediment transects and bedrock outcroppings

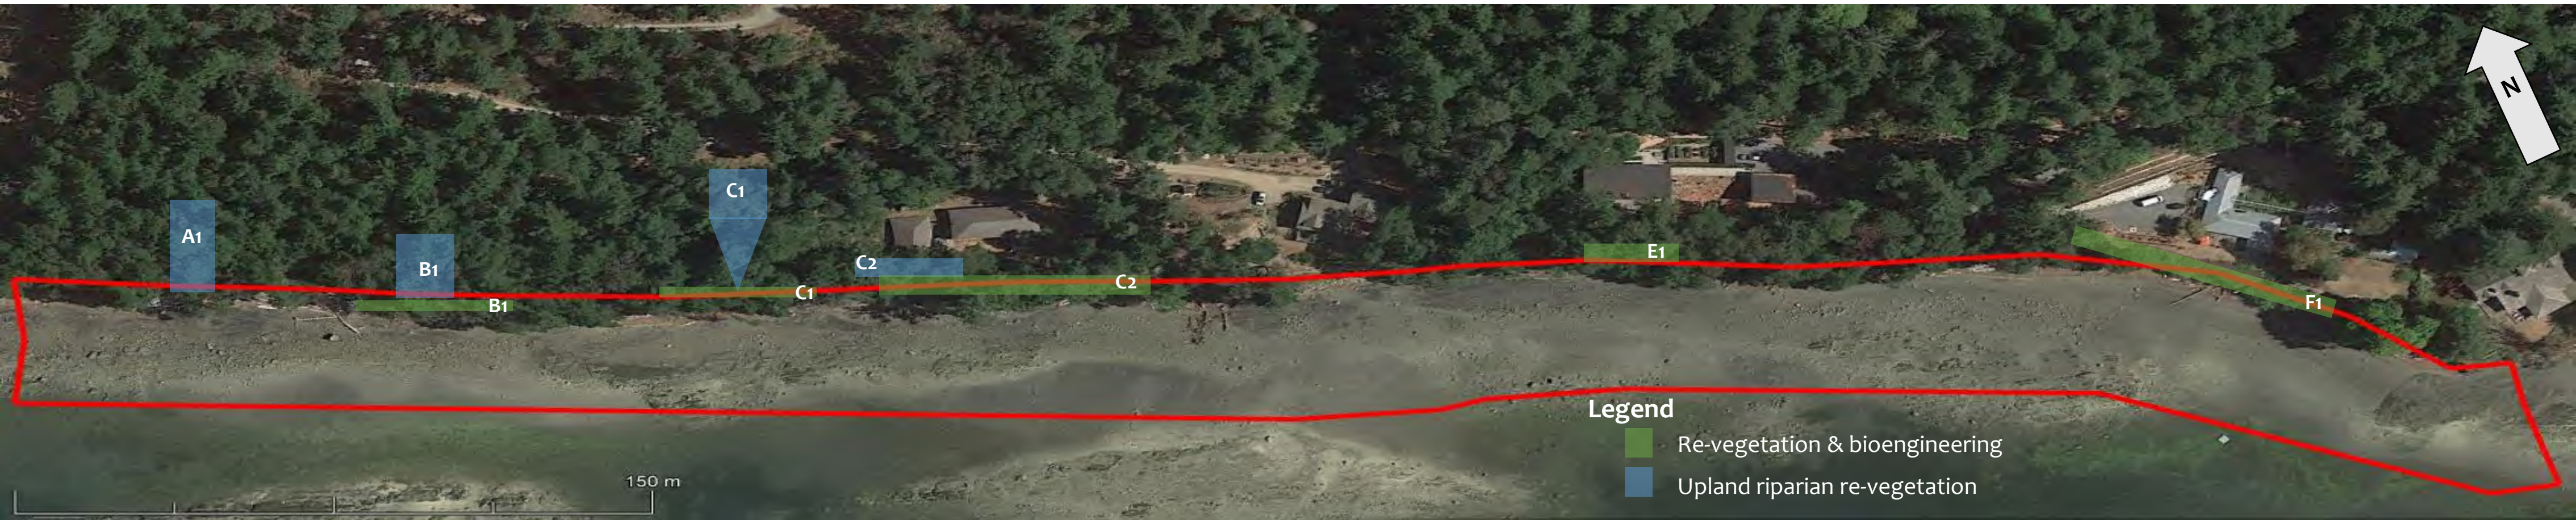
Figure 1. Areas recommend to undergo riparian and coastline revegetation

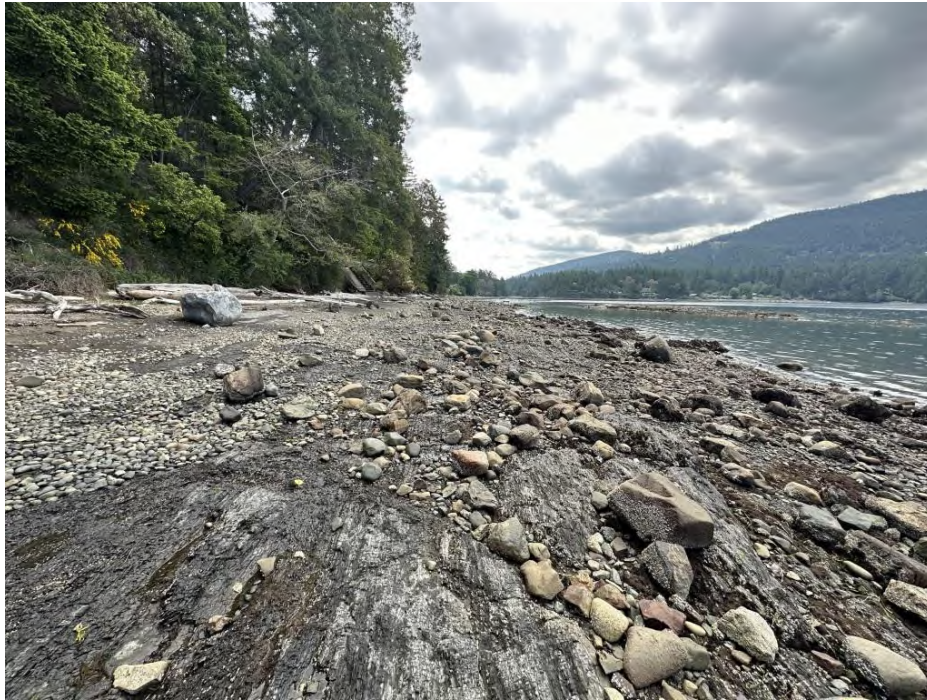
Photo 1. Close-up of foreshore ground, looking southeast. May 30, 2023.

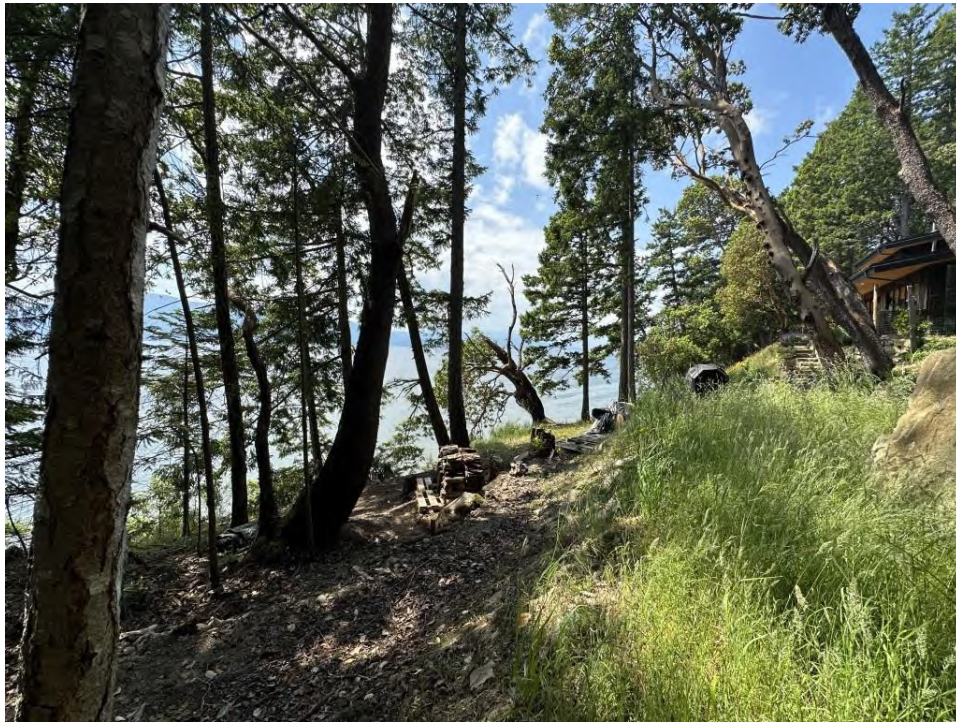
Photo 7. Southwest view of backshore environment at 235 Quarry Road. May 30, 2023.
