MEMORANDUM

File No.: PLDP20240057 - 239 Quarry Dr.

SUBJECT: Delegated Development Permit Application
Applicant: Bradley Fossen
Location: 239 Quarry Drive, Salt Spring Island, BC

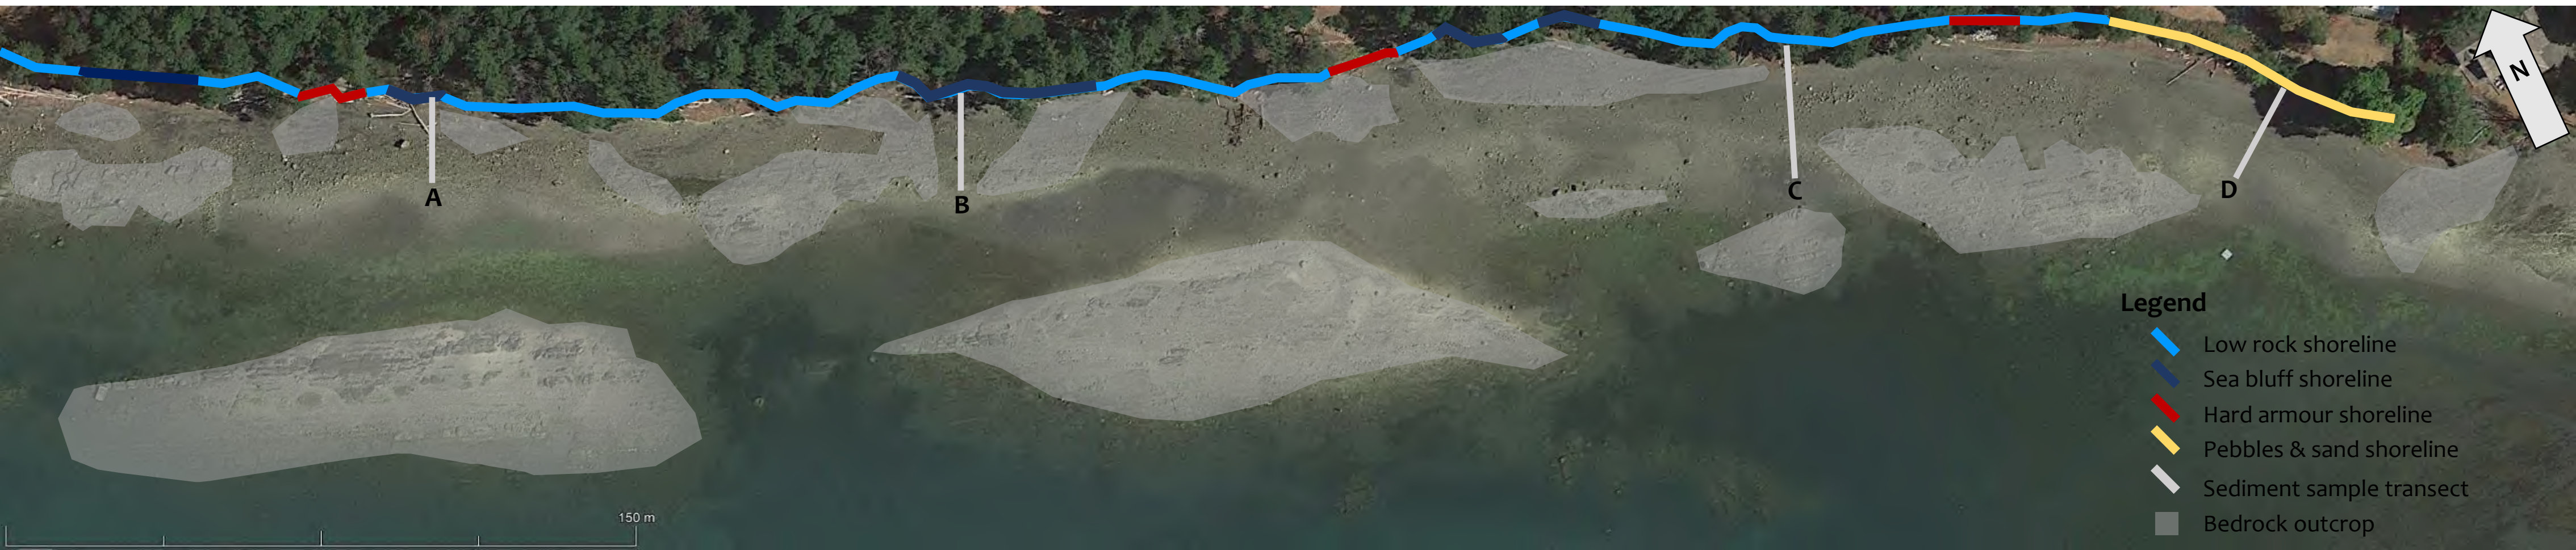
Figure 3. Shoreline types, sediment transects and bedrock outcroppings

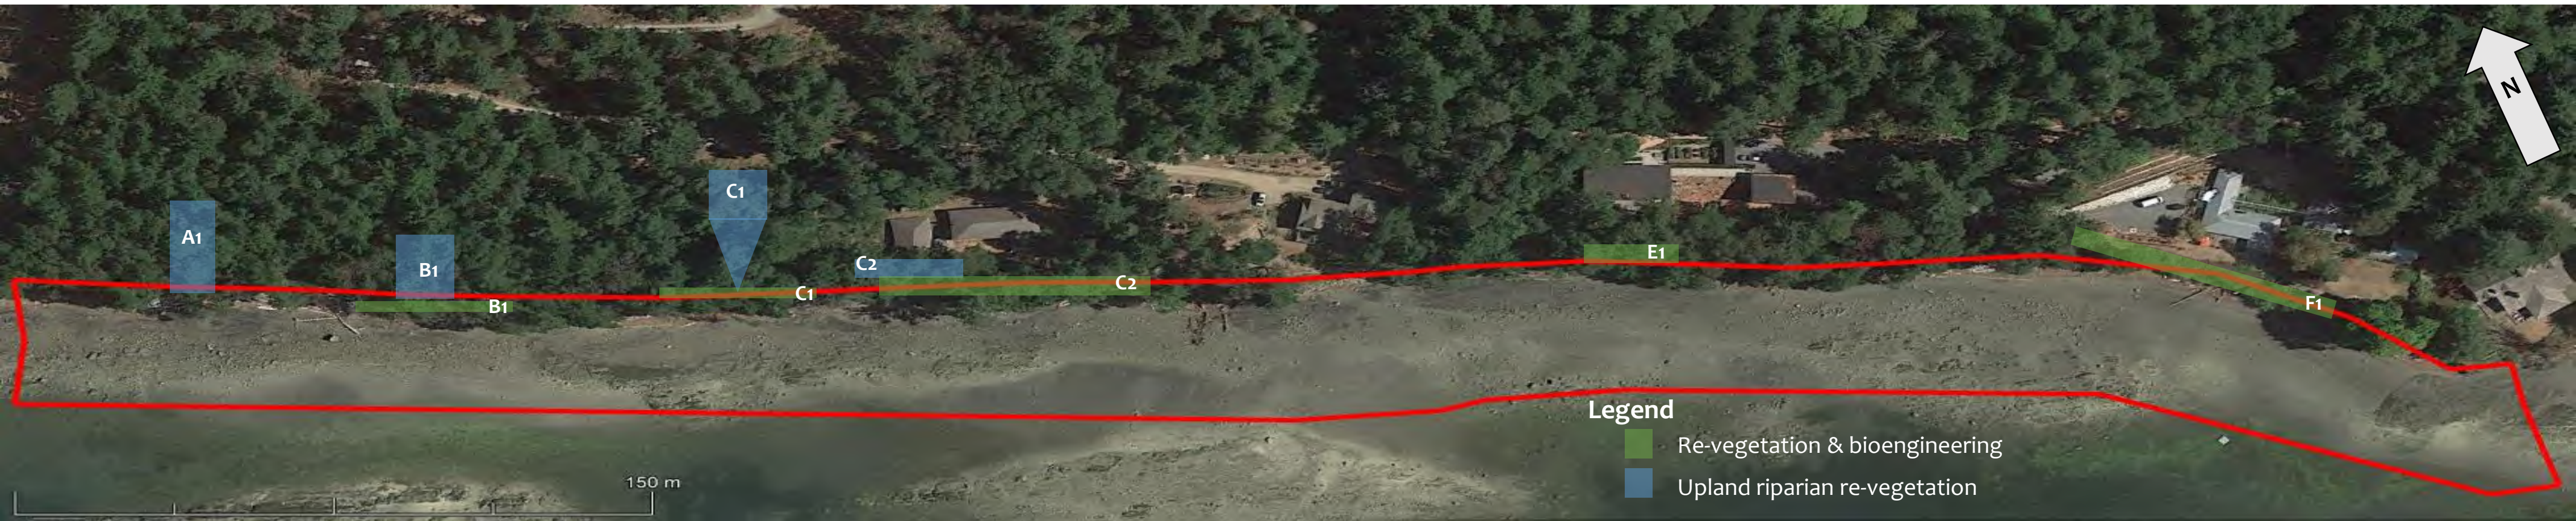
Figure 1. Areas recommend to undergo riparian and coastline revegetation

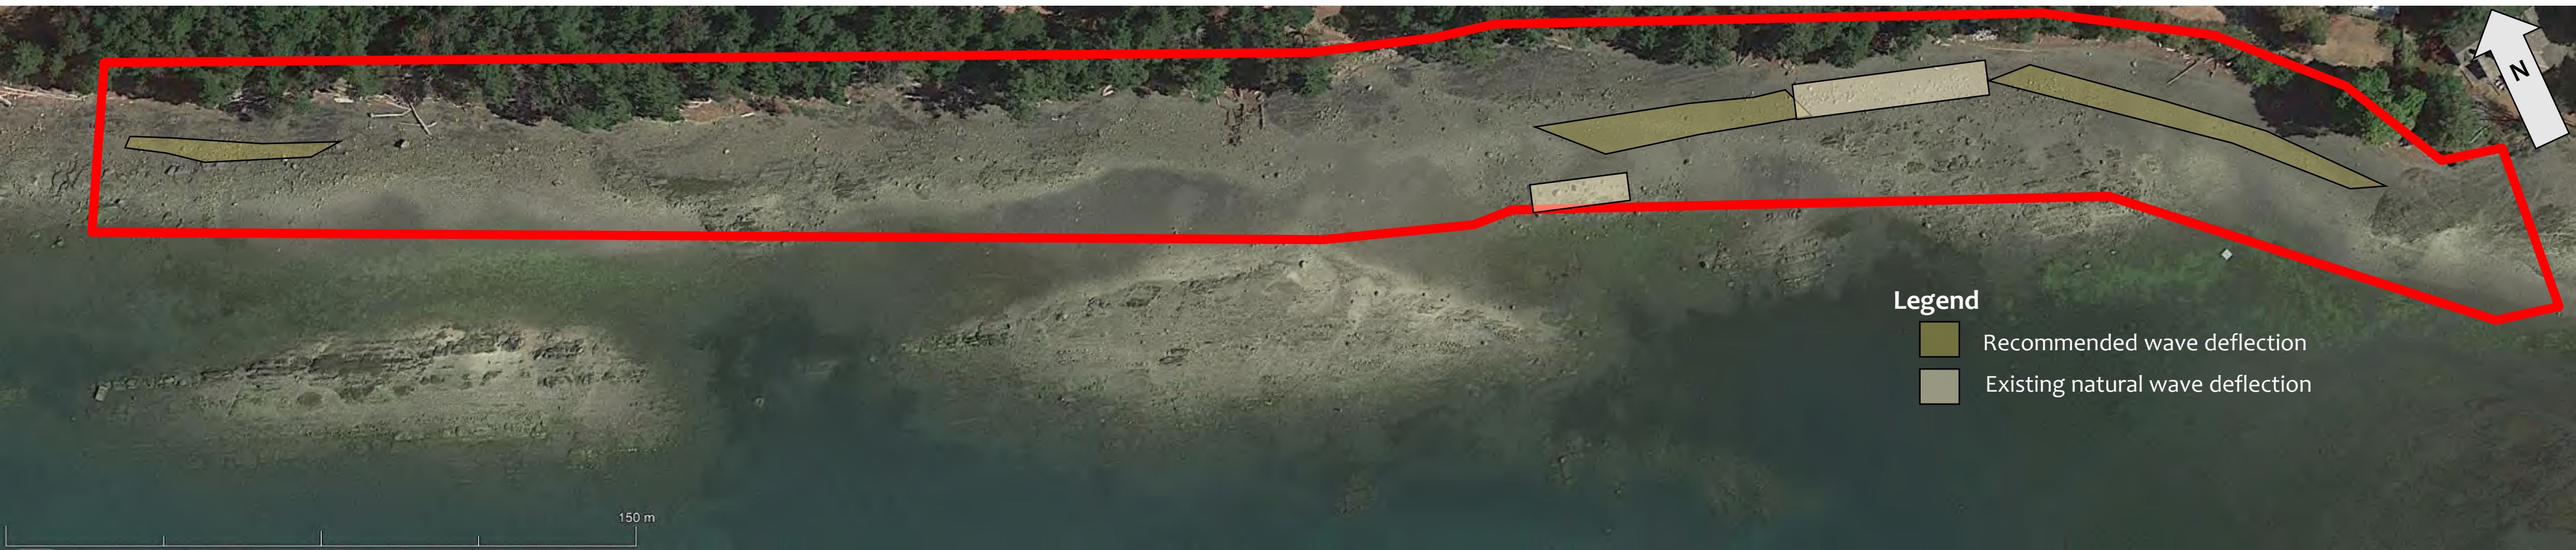
Figure 2. Areas recommended for wave deflection installations

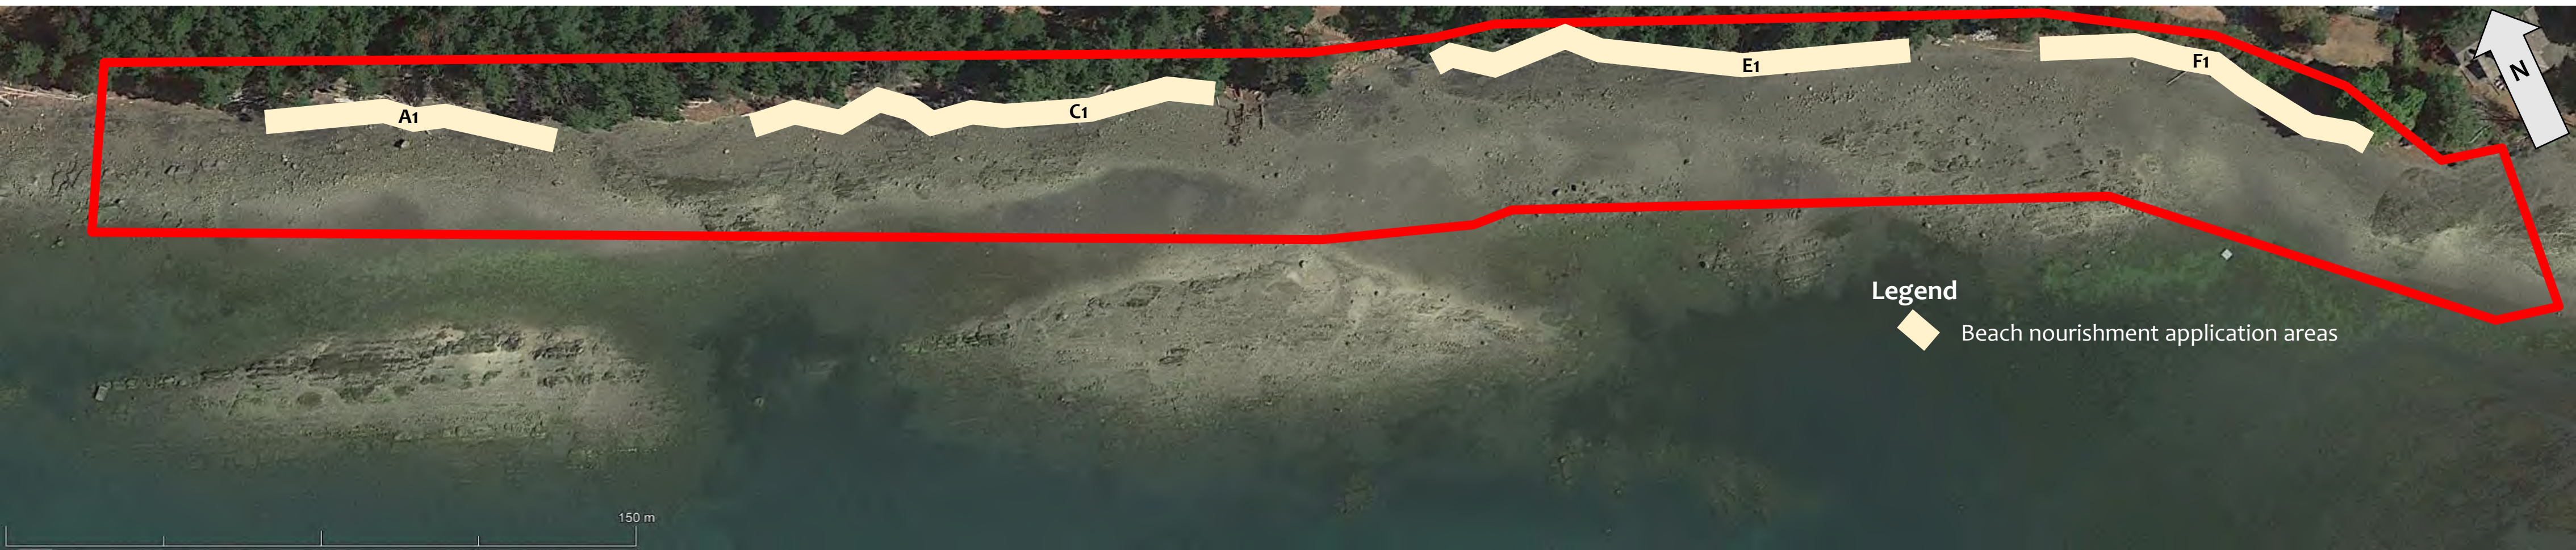
Figure 3. Areas recommended to receive beach nourishment

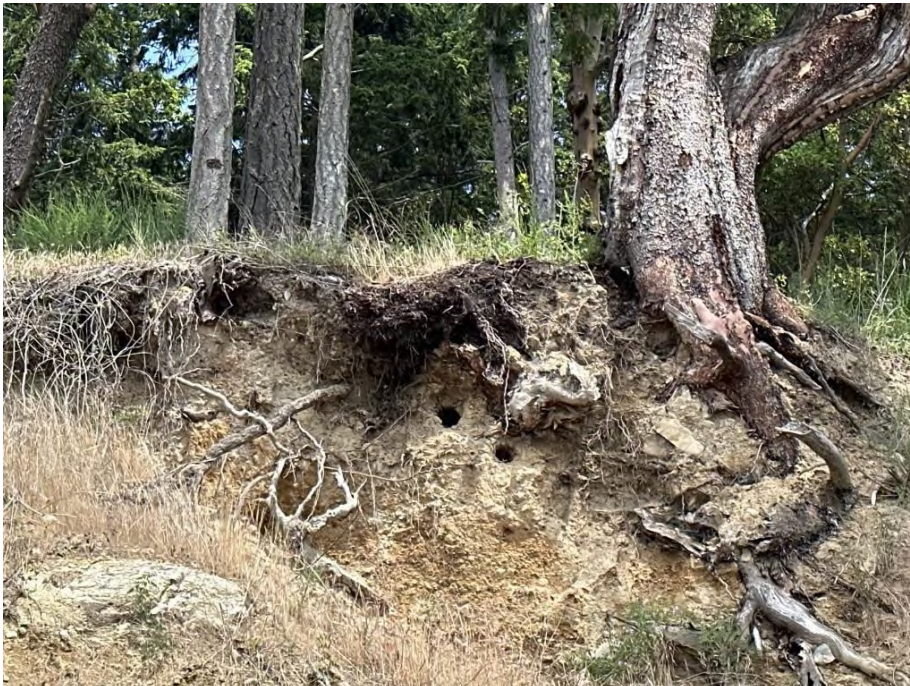
Photo 4. Northeast view of belted kingfisher nesting burrows. May 30, 2023.

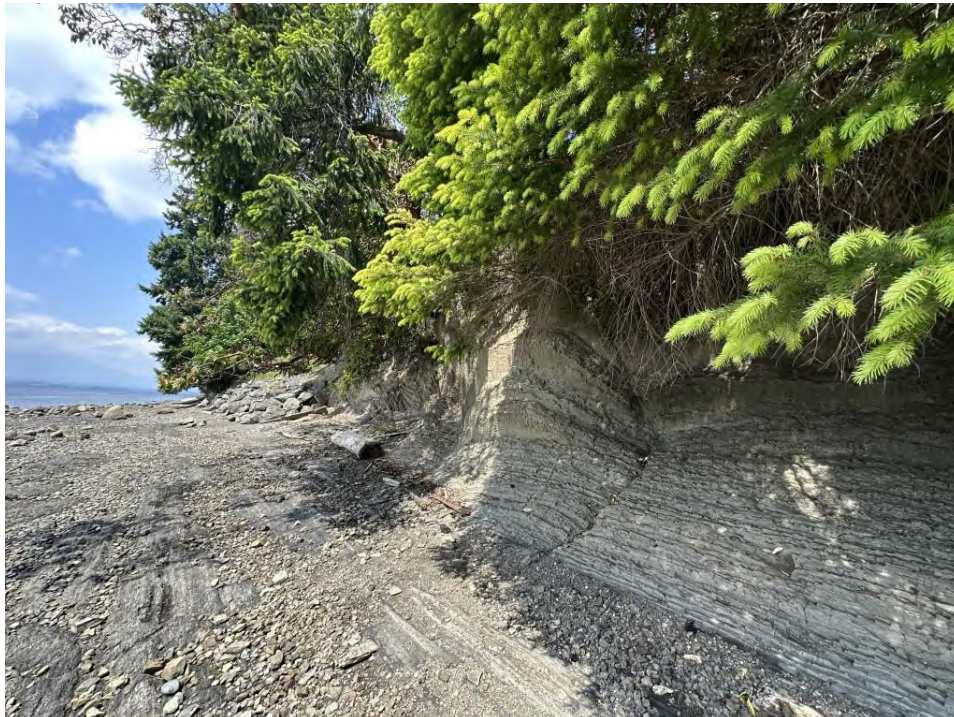
Photo 6. View of cliff/shoreline bank, looking west. May 30, 2023.

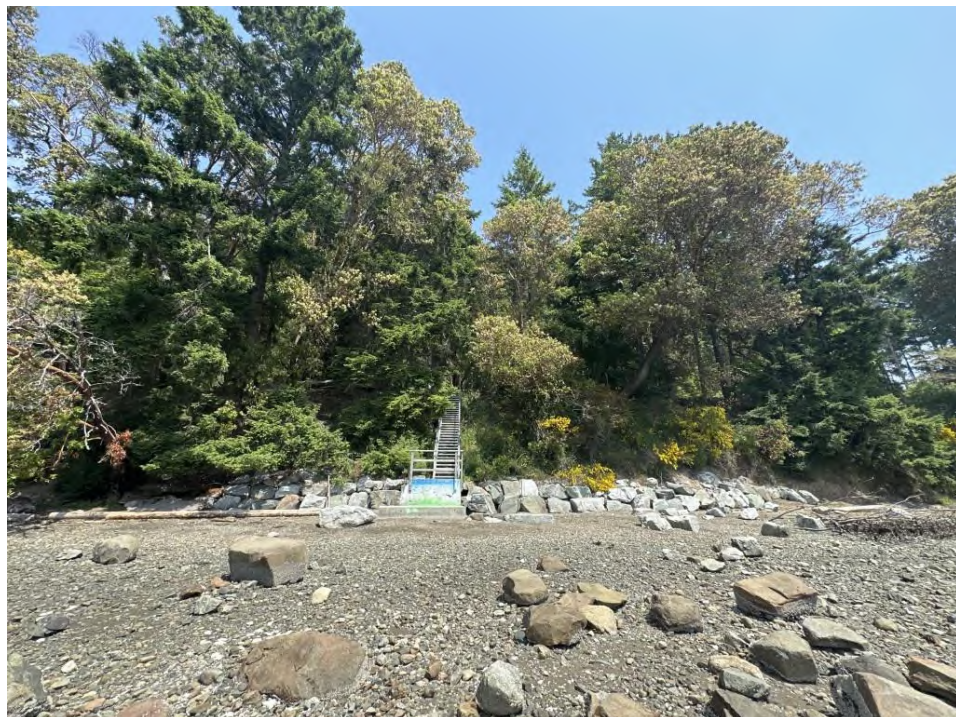
Photo 8. North view of riprap placement at CRD beach access near 431 Baker Road. May 30, 2023.
