Regarding SS-RZ-2017.3 2188 North End Road

McFadden Creek and Watershed

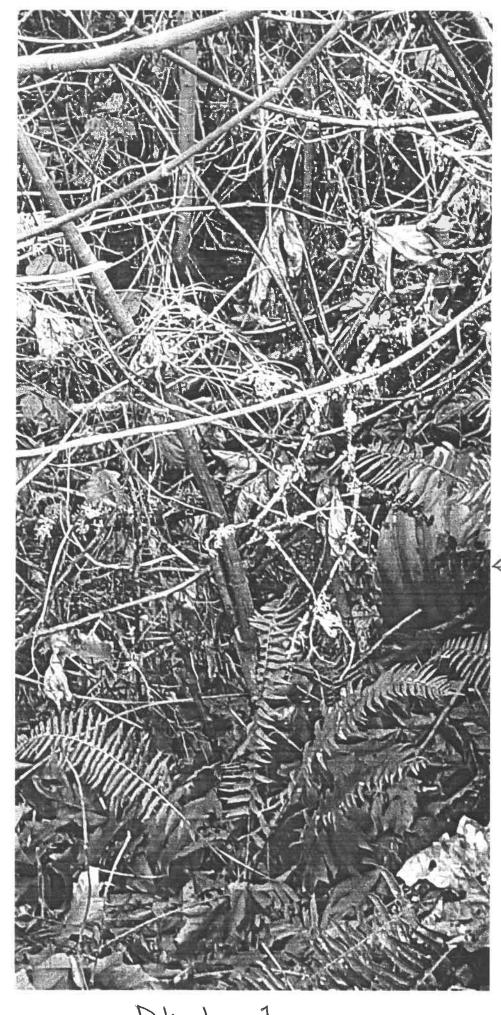
Photo 1

Photo 1. culvert North side of Mariko Place at 124 Mariko.

From that culvert the water flows onto a corner of 127 Mariko Place, across 2140 North End Road in proximity to another drinking water well and then continues south across property in proximity to drinking water well. It is joined by other surface water and the ditch water mentioned above into a inch interior diameter, 14 inch exterior diameter concrete culvert at 2121 North End Road.

Culvert 124 Mariko Pl.

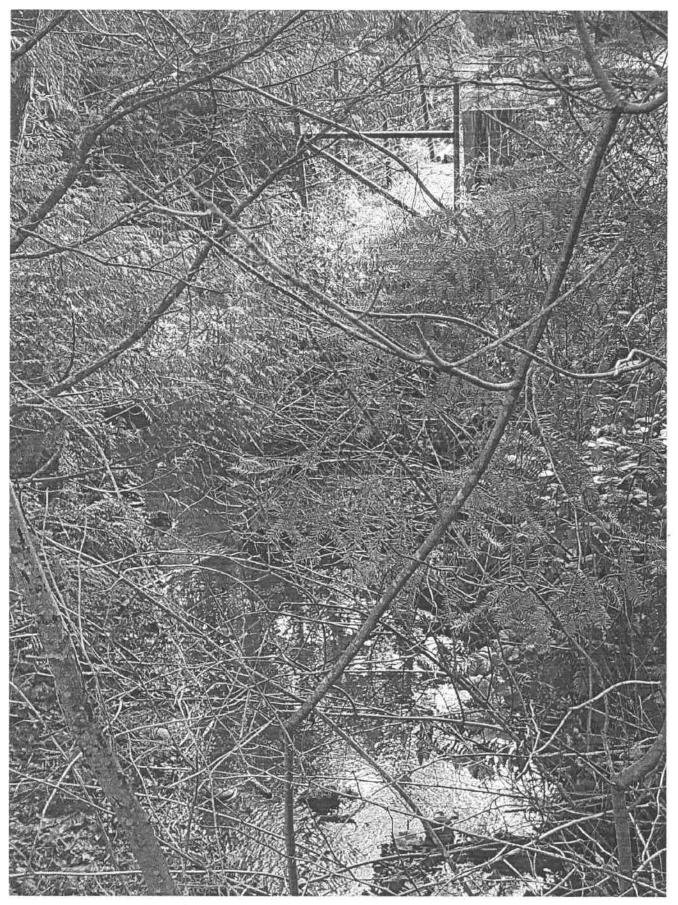
Photo 2. Water collection side of Mariko Place at 124 Mariko.

Water at 124 Mariko Pl.
Photo 2

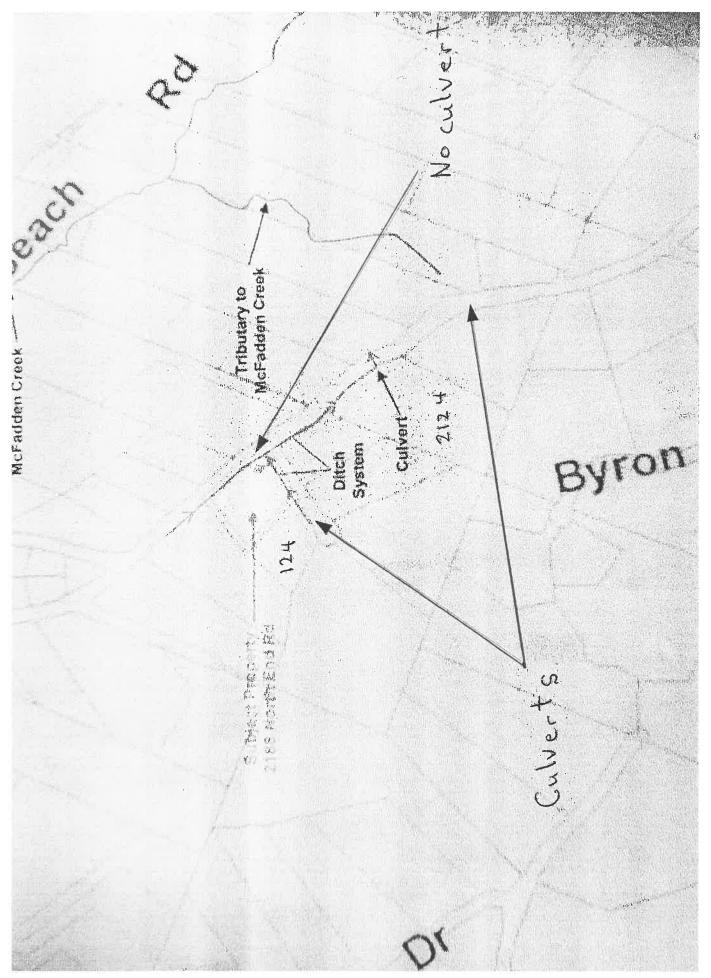
Map 1

In addition to our water license the residents at 2300 North End Road also applied for a water license. These are marked on map #1. Further documentation of the well and water licenses is available.

Map 1. observed drainage of the "lower portions" of Weisner Brook, water licenses noted

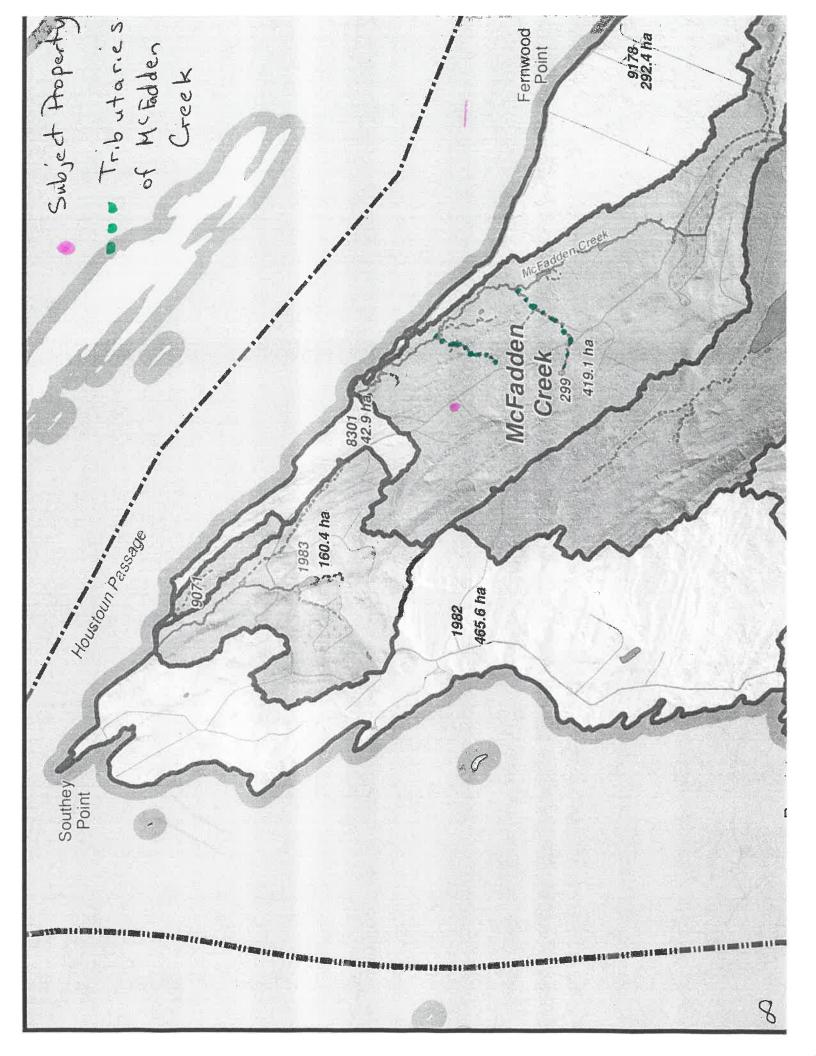
Map 2

From the submission by the applicant "the culvert appears to drain along North End Road to a tributary of McFadden Creek."

Map 2. portion of drainage from the application with culverts shown. Map 3 McFadden Creek Watershed
