ELANCO ENTERPRISES LTD.

November 1, 2024

Re: Hydrogeological Assessment of Yield and Source Protection for a Well Located at 1400 Northwest Road, Denman Island, B.C.

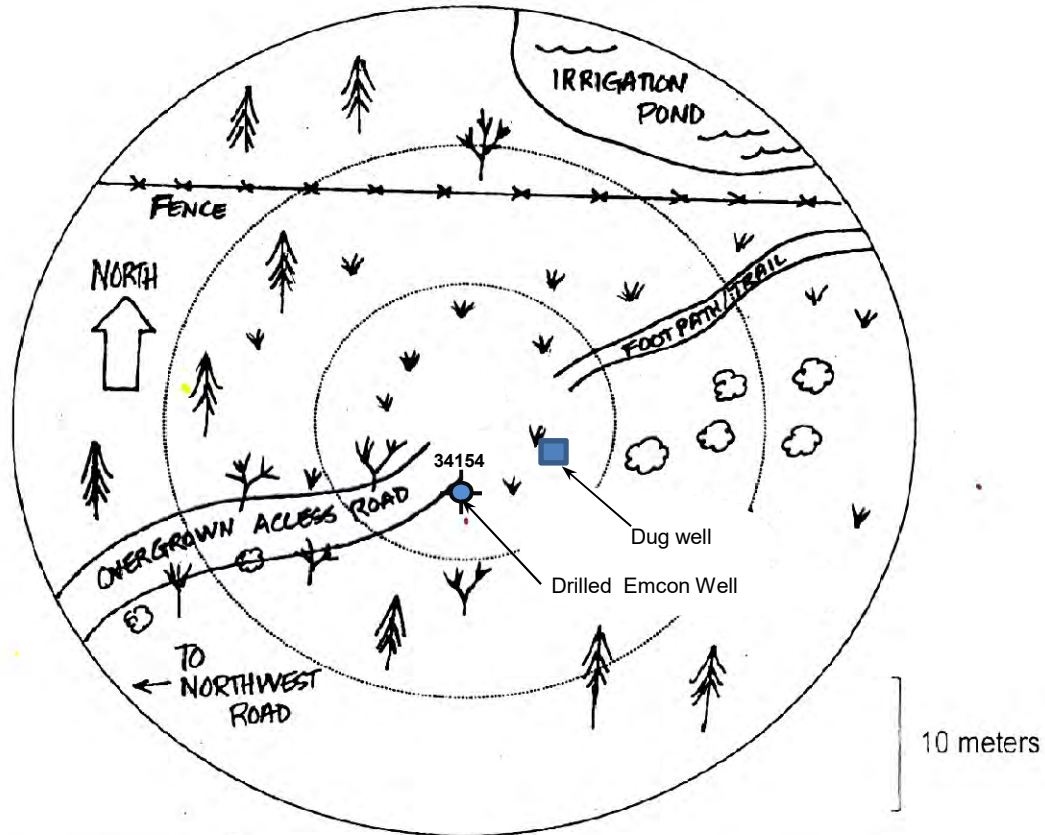
</p>	<p>Fig. 4</p>

Diagram of sanitary area (30 meter radius) around the well

1. The area around the existing well should be re-contoured with low permeability soil with a surface graded away from the well casing to a distance of about a metre.
2. Emcon should be consulted to determine their future water needs.
3. Prior to commissioning a water supply, the well and the pipe leading from the well to the pump house should be shock chlorinated to remove potential bacterial growth.
4. If the well water salinity becomes an issue in future, consideration should be given to the feasibility of plugging the lower fracture zone
5. If a higher well yield is required in future, consideration should be given to diverting the discharge at the well head and running a 3-day test at a rate higher than 0.25 L/s during a dry time of the year.

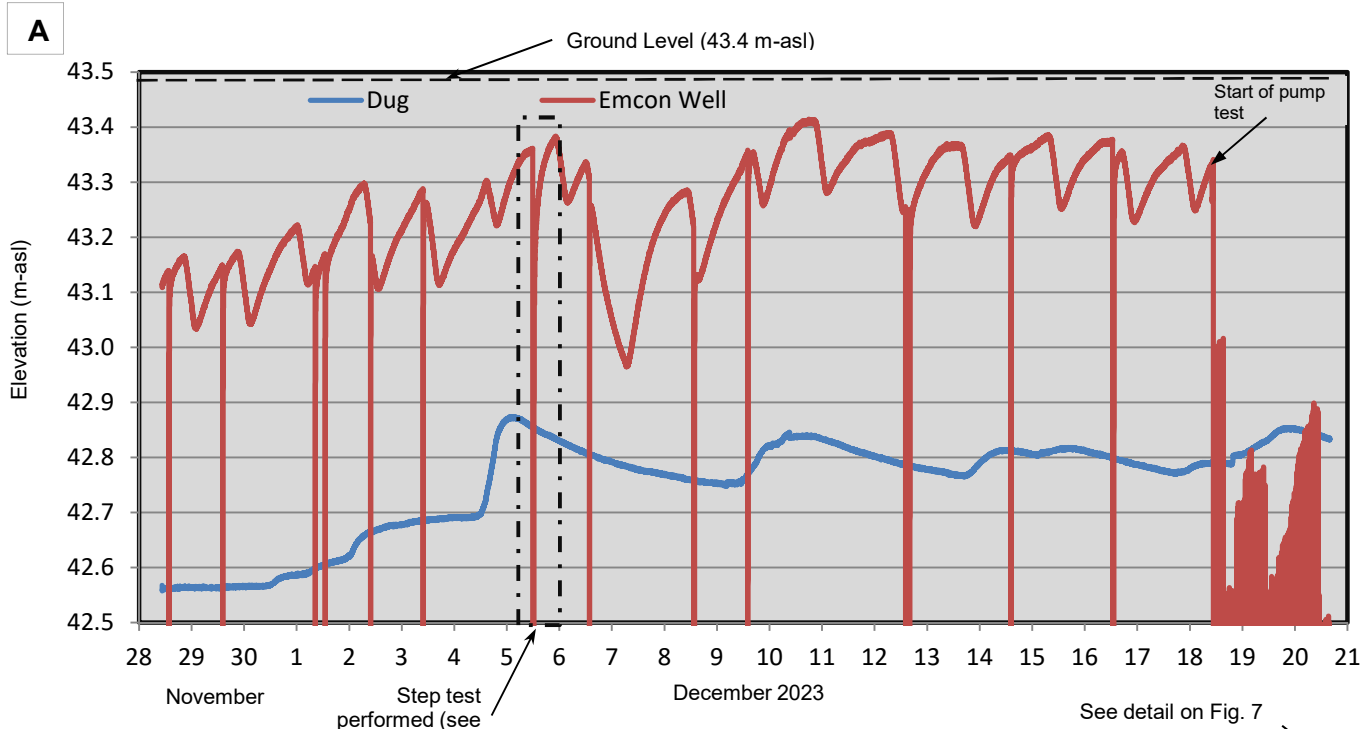
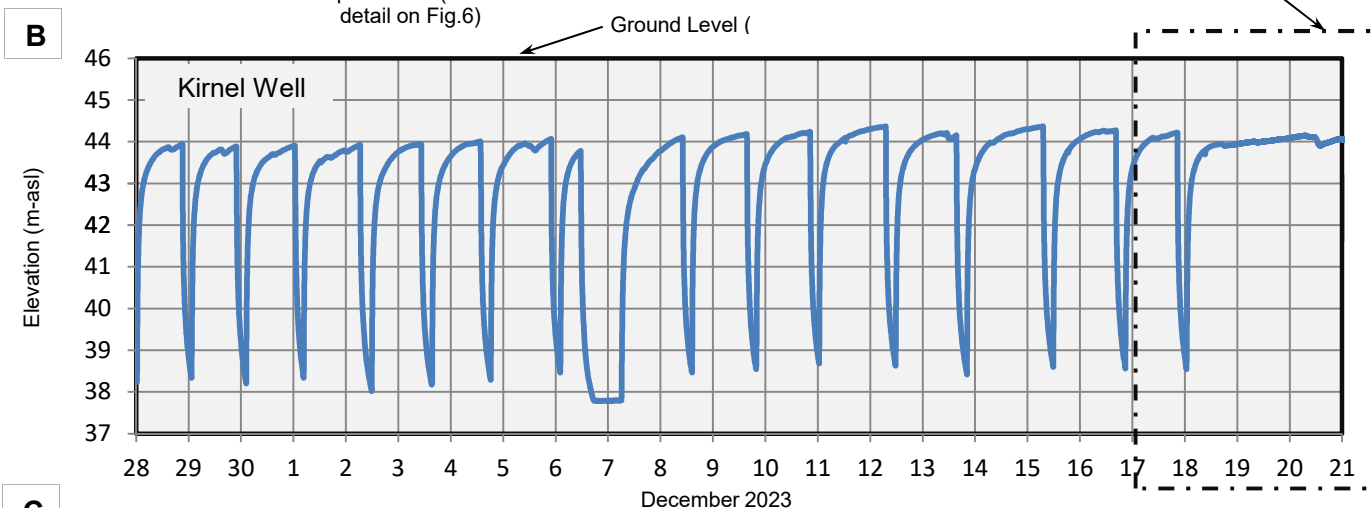
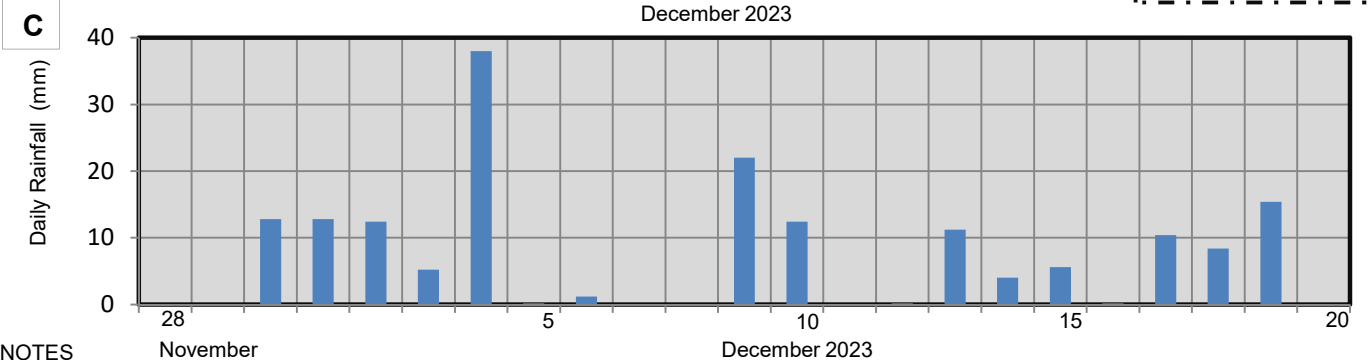
As indicated on Fig. 5A, rainfall during the 2023 monitoring period clearly had an impact on the water levels in both the dug well and in the Emcon drilled well. There was very little rainfall during the August and September 2024 monitoring period, resulting in a gradual decline in water levels in both the Emcon and Kirnel wells (see Figs. 9A, 9B and 9C). The exception was a rise in the Kirnel well following the September 25th rainfall event.

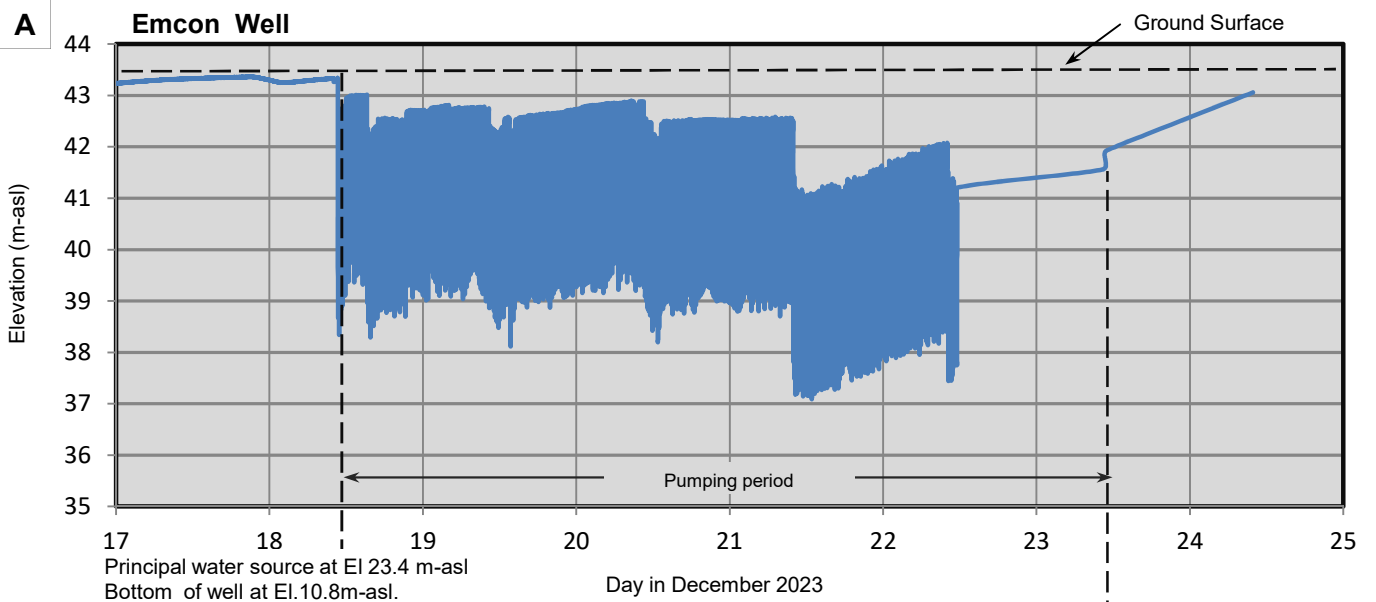
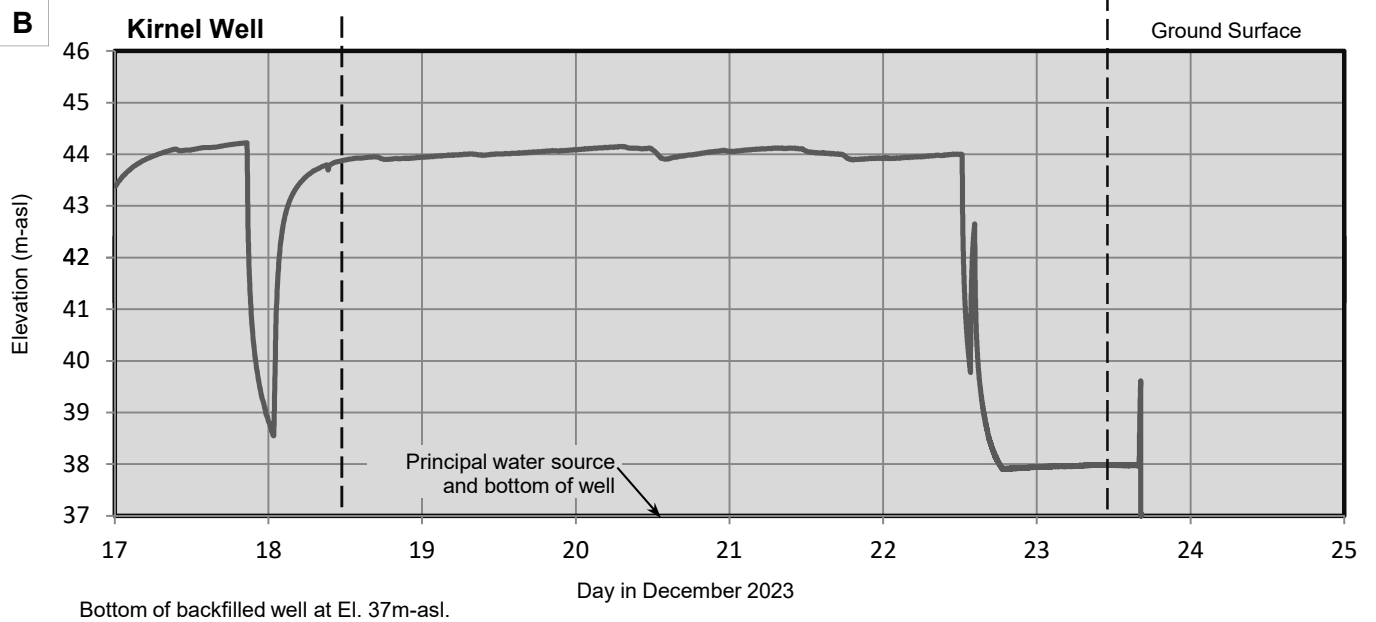
As would be expected, the water elevations were about a metre lower than they were in December 2023. The water levels in both the drilled and dug wells during the 20 day 2024 monitoring period declined by about 0.2m. The series of drawdown spikes that can be seen on the Fig. 9A graph, prior to and after the pumping test were the result of pumping for the Emcon facility water supply.

As with the 5-day 2023 pumping test the water levels during the test fluctuated over a range of about 3m over an 11 minute cycle but did not show any evidence of a decline as the test proceeded (see Figs. 9A and 10A and 10B).

A graph of water levels recorded in the Kirnel well for the period August to September 2024 is presented on Fig. 9B. This graph clearly shows the impact of the well being intermittently pumped. Also of note is that when the pumping frequency increases the water level in this well is slightly depressed. The red arrows on Fig. 9B span the most significant high frequency periods. While one of these periods almost coincides with the start of the 9-day pumping tests the others do not. The graph presented on Fig 13 clearly illustrates that pumping at a rate of 0.23 L/s from the Emcon Well does not have an impact on the Kirnel well.

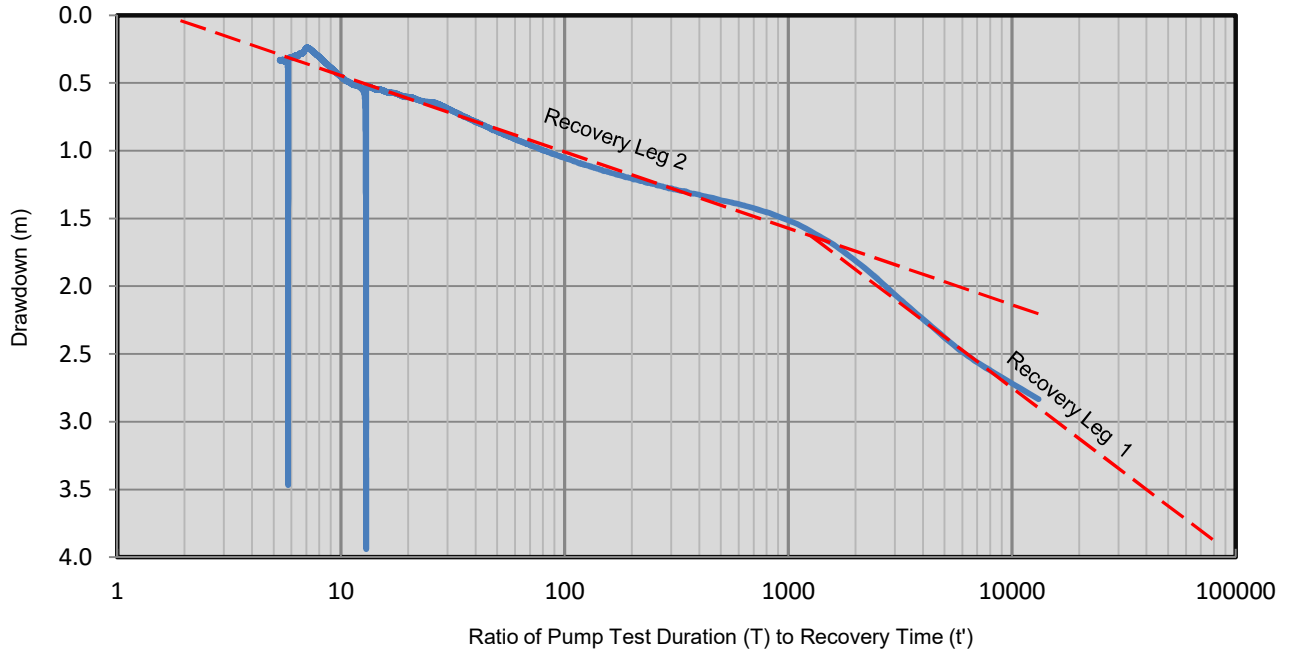
Fig. **12**

The water level during the post test recovery was used to estimate the aquifer transmissivity. As set out in the table on Fig. 12 the initial apparent transmissivity (Recovery Leg 1 on the graph) was about $8.4 \times 10^{-6} \text{ m}^2/\text{s}$ and for the latter part the transmissivity was $3.2 \times 10^{-5} \text{ m}^2/\text{s}$. As the well casing holds 18.5 litres per metre of casing the corrected initial transmissivity is about $1 \times 10^{-5} \text{ m}^2/\text{s}$.

As indicated in Table VI and on Fig. 12B, the step test was run at four different pumping rates for 30 minutes that ranged from 0.26 to 1.0 L/s. The specific capacity at the end of each step ranged from an initial 0.086 L/s/m down to 0.062 L/s/m at the end of the test. The pumping level in the well at the end of the test was about 2m above the principal water bearing fracture in the well (see Fig. 3 and graphs on Figs. 12B and 12C).

The drawdown vs. pumping rate graph (Fig. 12D) shows that the relationship between these two parameters is linear except for the last rate. This confirms that the well is relatively efficient and can sustain a rate much greater than the average 0.23 L/s pumping rate during the 9-day test.

The drawdown trend during the first step of the test and the well recovery after the test were used to estimate the aquifer transmissivity. As set out in the Table at the bottom of Fig. 12 the apparent transmissivity is $8.4 \times 10^{-6} \text{ m}^2/\text{s}$ for the steeper portions and in the flatter portions the range is from 1.5×10^{-5} to $3.9 \times 10^{-5} \text{ m}^2/\text{s}$. After accounting for the well casing volume the corrected initial transmissivity is about $1 \times 10^{-5} \text{ m}^2/\text{s}$.

Q (L/s)	ΔS (m)	T (m ² /s)
Recovery (Leg 1)	0.23	5	8.4E-06
Recovery (Leg 2)	0.23	1.3	3.2E-05
