Shoreline Stability Assessment: Anson Rd Property, Horton Bay, Mayne Is

prepared for: The Capital Regional District
prepared by: John Harper, P.Geo., Coastal & Ocean Resources
Paul de Greeff, Murdoch de Greeff Inc. Landscape Architects

Summary

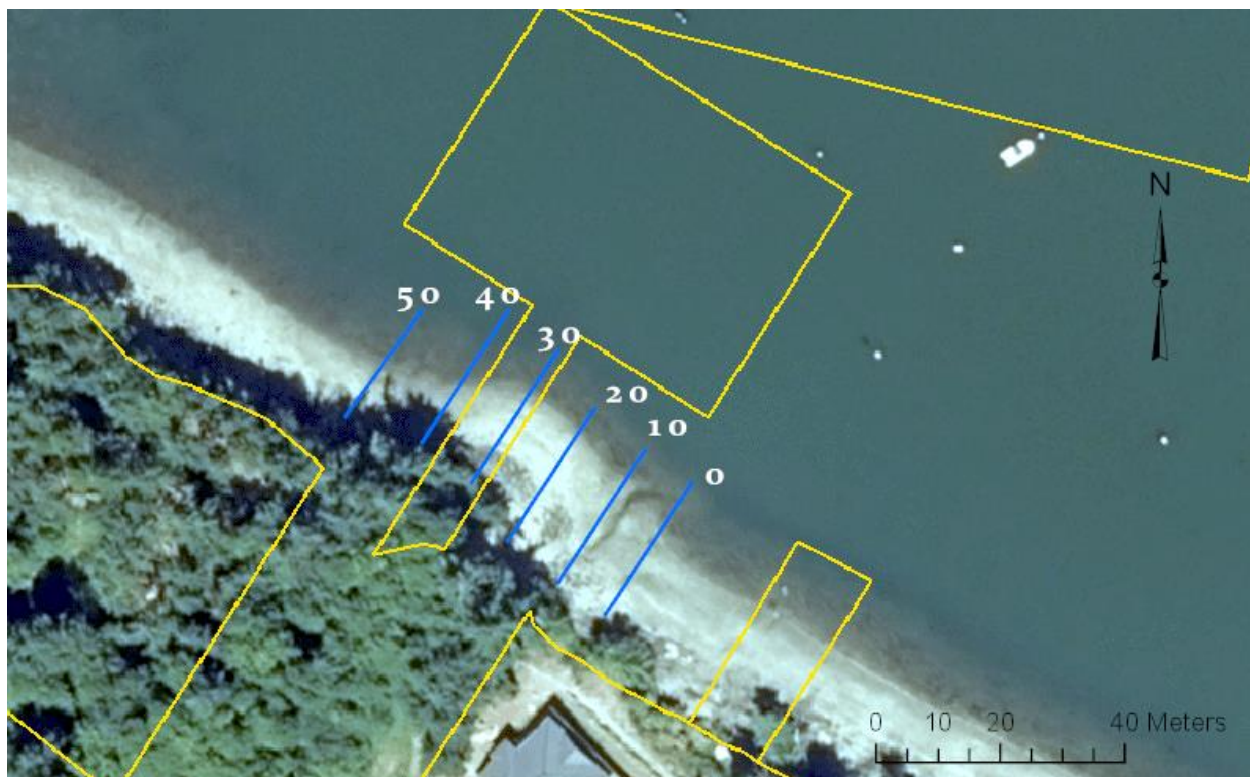
Figure 2. General layout of the Anson Rd Property with respect to adjacent properties and the foreshore lease area that will accommodate the proposed wharf. A tape was laid out along the shore from a boundary post (0-m) immediately above the High-Water Line (HWL) just beyond the eastern side of the property to a boundary post at the western edge of the property (50m). The blue line spacing indicates 10-m long sections along the shore and are used to reference other observations.

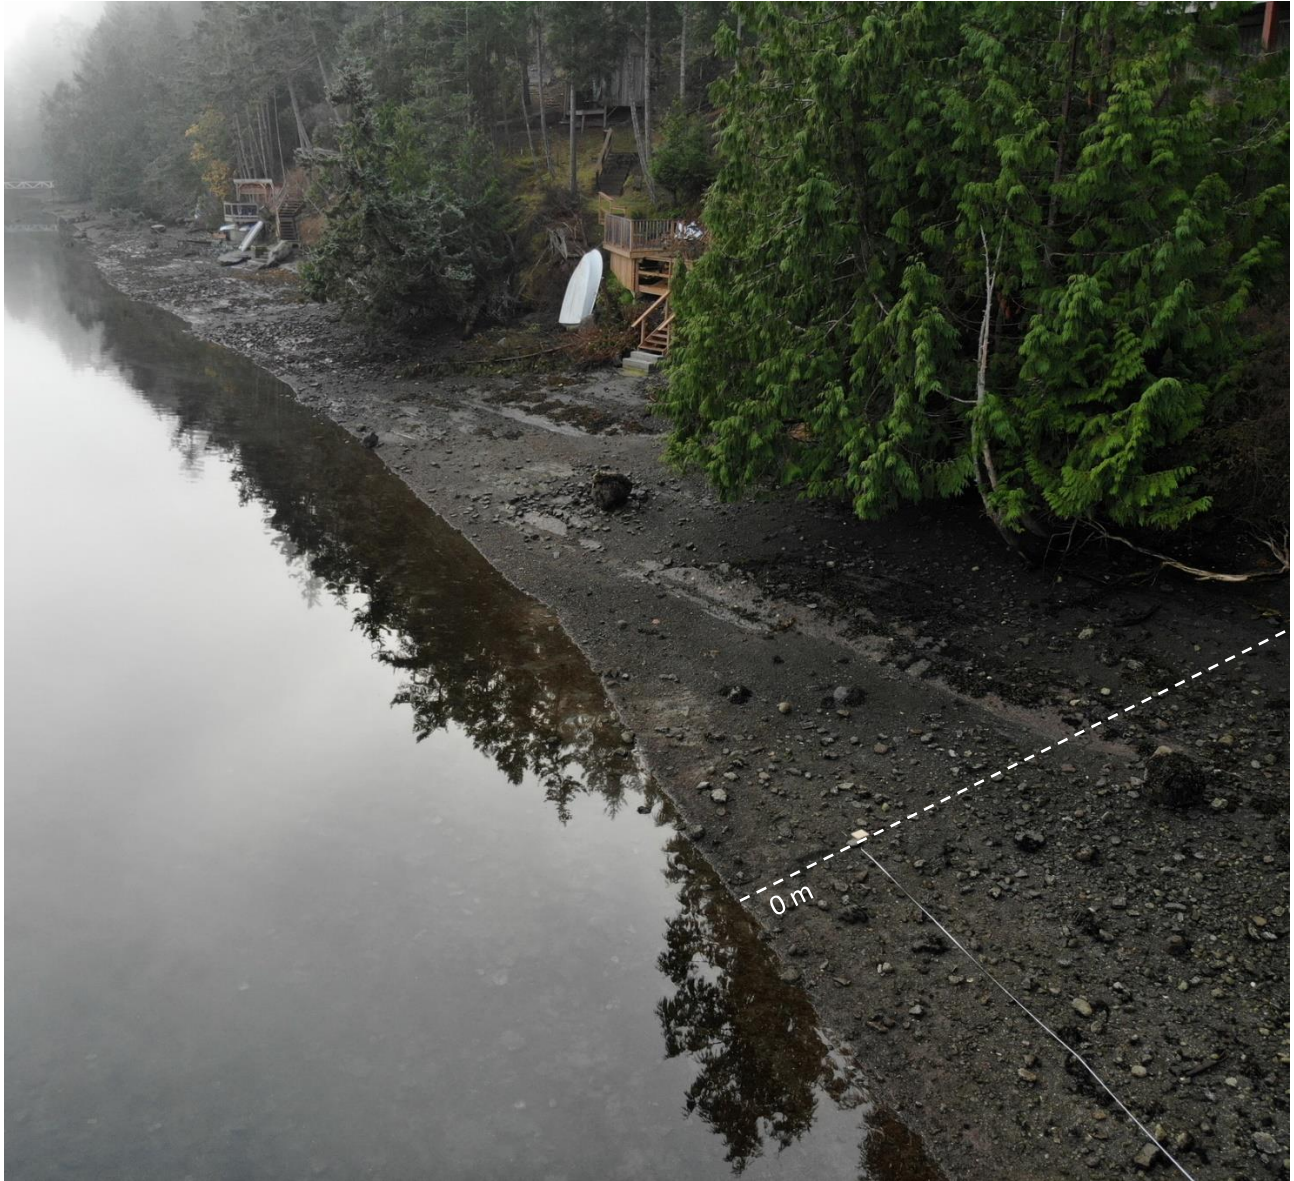
Figure A-1. Drone photo of Section 0-m looking east.

Section Distance (m)	Scarp Height (m)	Riparian Overhang (m)	Notes
0	None	4	White, wooden 30cm-high property boundary marker noted on the upper scarp (not visible in photos); bedrock at base of vegetated scarp; beach is pebble-cobble-boulder veneer (sub-angular) over sandy gravel; small bedrock outcrop in upper intertidal zone (Fig. B-1).
10	0.8	6	Mostly vegetated scarp with v poorly sorted diamicton including angular cobbles; beach has a concentration of well-rounded cobbles on surface, maybe moved from west to create a sandy area to haul up boats (analogous to a canoe run). (Fig. B-2)
17	1.5		Stairs; scarp cut into diamicton w well-rounded cobbles; beach is angular pebble-cobble veneer w clear zone of cobbles suggesting people selectively moved the cobbles (Fig. B-3).
20	1.7	8	Diamicton with pebbles & cobbles in a fine matrix; large roots growing from the cliff face; large Douglas Fir w trunk 40cm dia; beach is barnacle-covered, sub-angular cobble-pebble veneer (Fig. B-4).

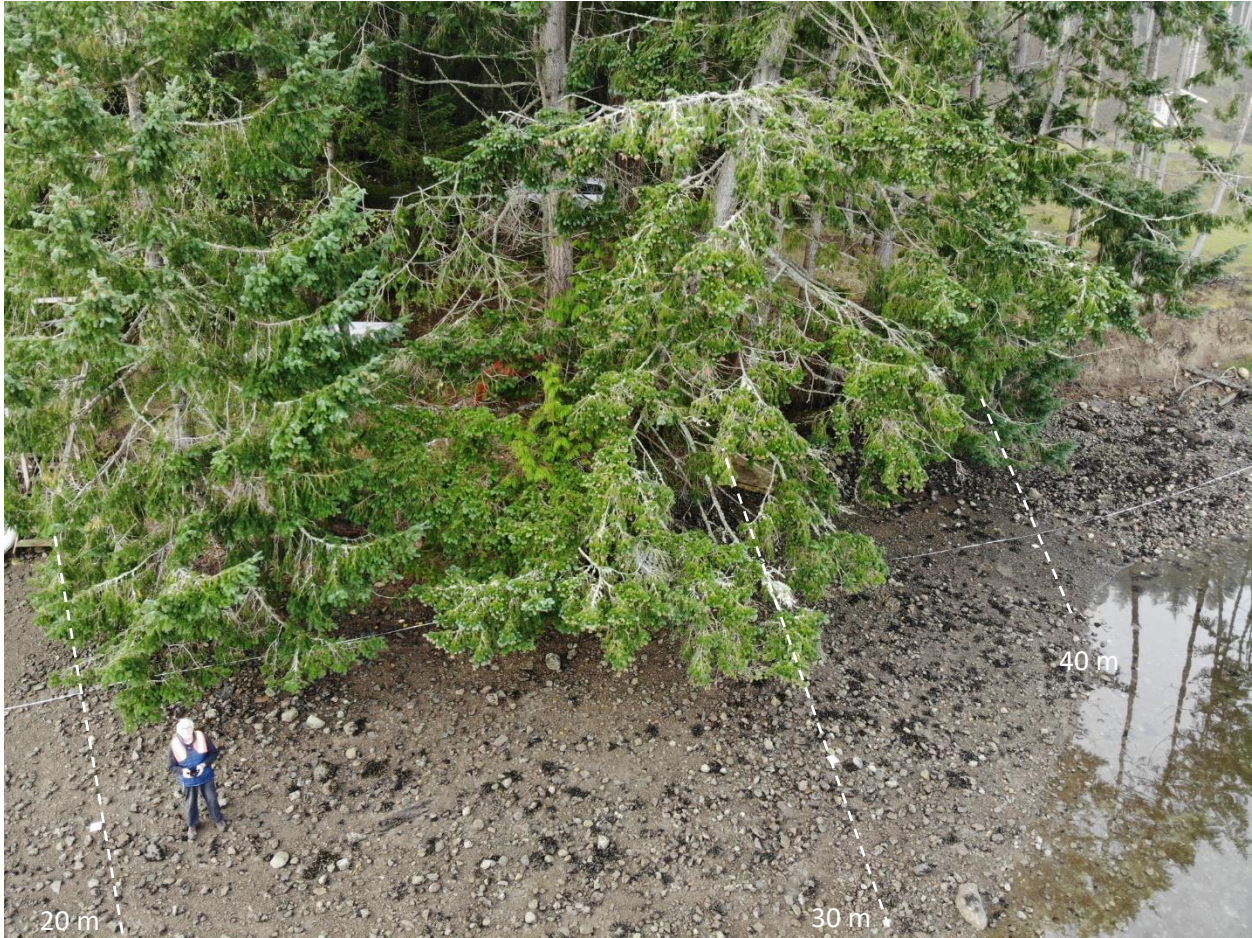
Figure A-4. Drone photo of Sections 20-m, 30-m and 40-m looking south.

30	1.8	10	“nose” of shoreline w large Douglas Fir and roots protruding from bank; scarp is undercut so there is an overhang; there is a stiff clay layer outcropping on the upper beach (~2m in width); the lower portion of the visible beach is angular to sub-angular pebble-cobble veneer over sandy gravel (Fig. B-5).
40	1.9	11	Poorly-sorted diamicton noted on scarp face with pebbles and cobble within a fine matrix; a large Douglas Fir (~75 cm dia) is protruding from the cliff face; beach is a cobble-pebble veneer over sandy gravel; cobbles are generally well-rounded suggesting a glacial till origin (Fig. B-6).
50	2.5	4.5	The scarp here is cut into mostly fine material with some pebbles, cobbles and boulders visible; trees above the scarp have been de-limbed (lower branches removed); The beach has a coarser veneer than other stations (Fig. B-7) – well rounder cobble-pebble, probably of mostly glacial origin; property boundary marker seen just about the 50m in drone photo (Fig. A-6).
