Anson Road Dock Facility Aquatic Effects Assessment / Environmental Impact Assessment

Contract No: 2019-478

Mayne Island, BC

July 2019

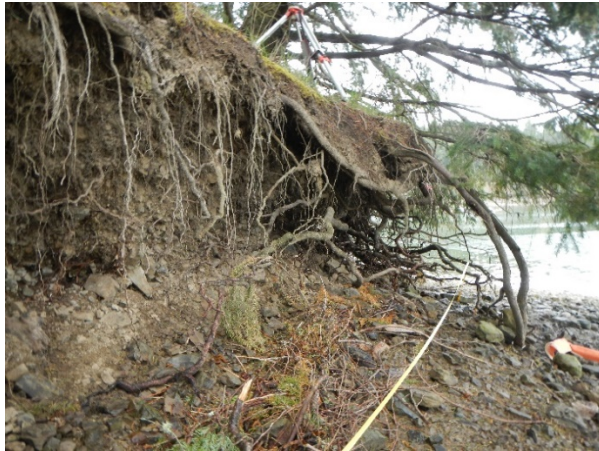
Photo 1. Steep eroding bank at the high tide line of the intertidal transect (Transect 3, Figure 2). Higher high-water swash is at the base of the bank.

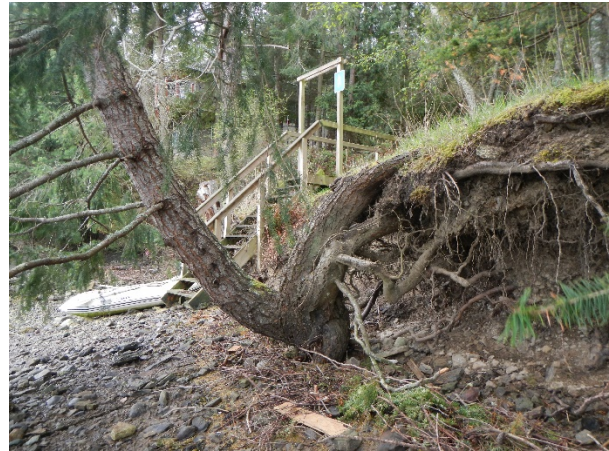
Photo 2. View east from head of transect, showing overhanging Douglas fir eroded roots and current staircase for shore access from Anson Road.

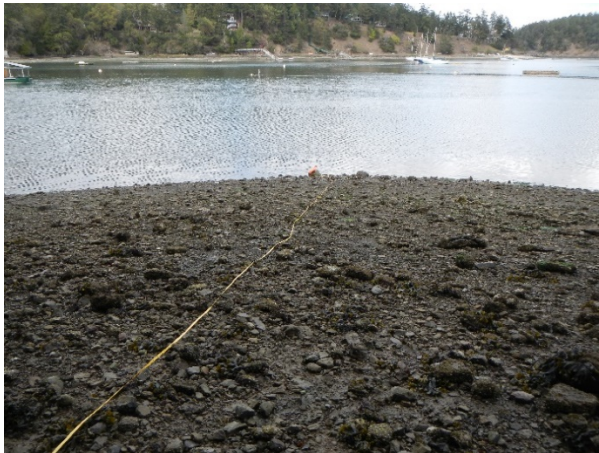
Photo 3. Transect across the beach along the proposed dock alignment, looking north.

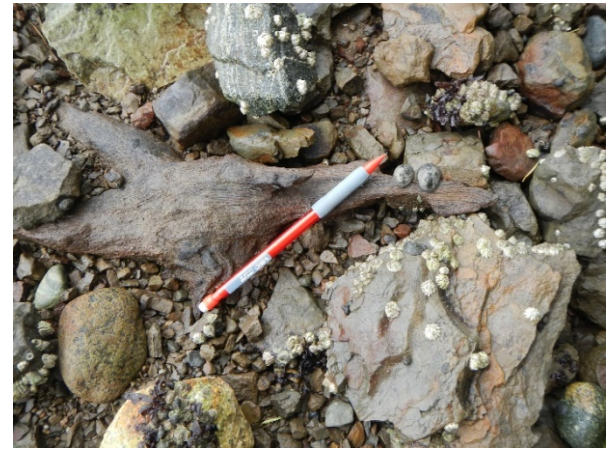
Photo 4. Characteristic substrate in the upper intertidal zone consisting of angular cobble/pebble with embedded wood debris.

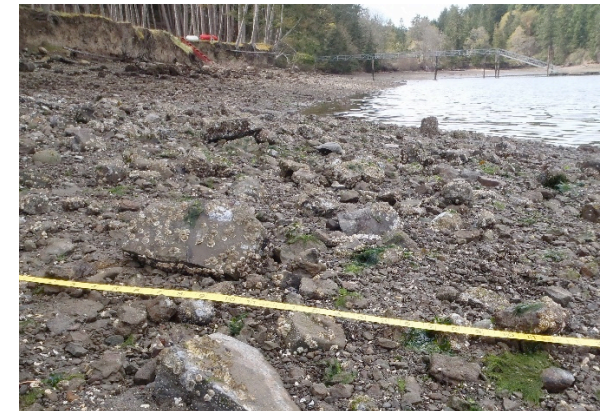
Photo 6. View across mid-transect, looking northwest to head of Horton Bay. Note scattered boulder with sparse cover of barnacle and foliose green algae.

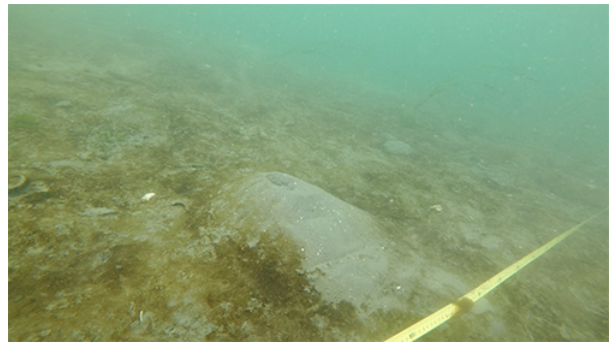
Photo 4. Soft bottom with diatom cover and infaunal mounds with trace (<5%) eelgrass in background on T2.

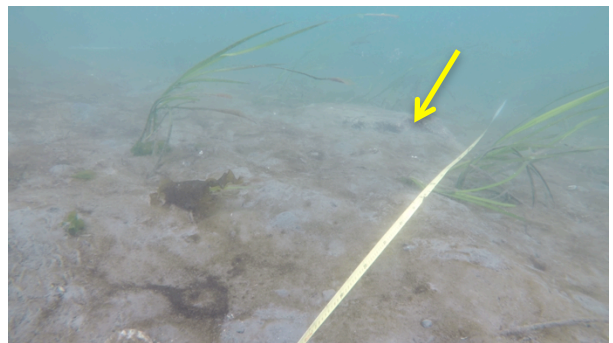
Photo 6. Nearshore edge of trace (<5%) to low (5-25%) eelgrass cover on T2 with bedrock outcrop.

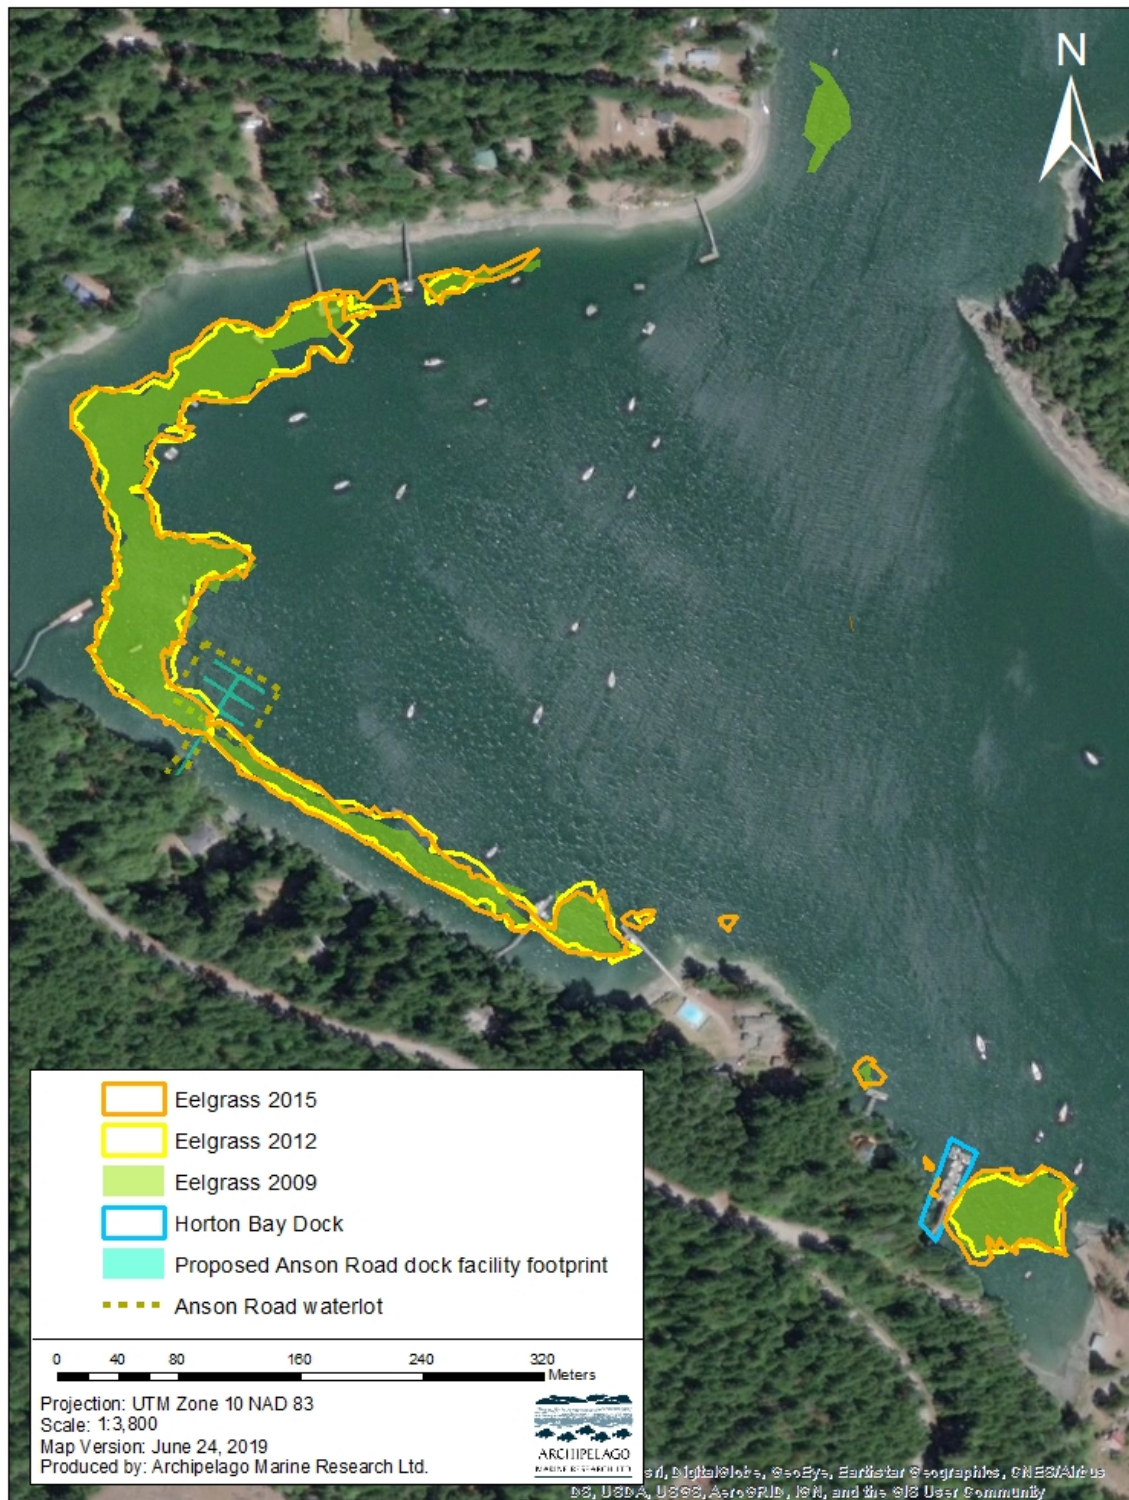
Figure 6. Mayne Island Conservancy 2009, 2012 and 2015 delineated eelgrass areas in Horton Bay relative to the Project site and footprint.

the east. The Islands Trust's online resource mapping tool (MapIT) identifies the presence of patchy and continuous eelgrass that extends along the shoreline from the unnamed point to the east of the Project site, through the proposed dock footprint, and to Aitken Point located to the north of the Project site (Islands Trust 2019) (Figure 5). This mapped eelgrass is based on an eelgrass inventory completed by the Mayne Island Conservancy between 2008 and 2012, which only shows the extent of the eelgrass (i.e. line feature) and not the delineated area of the eelgrass (i.e. polygon feature). However, the Mayne Island Conservancy directly provided⁶ their eelgrass survey data that was collected in 2009, 2012 and 2015 and that delineates the area of the eelgrass bed (Figure 6 and Figure 7).

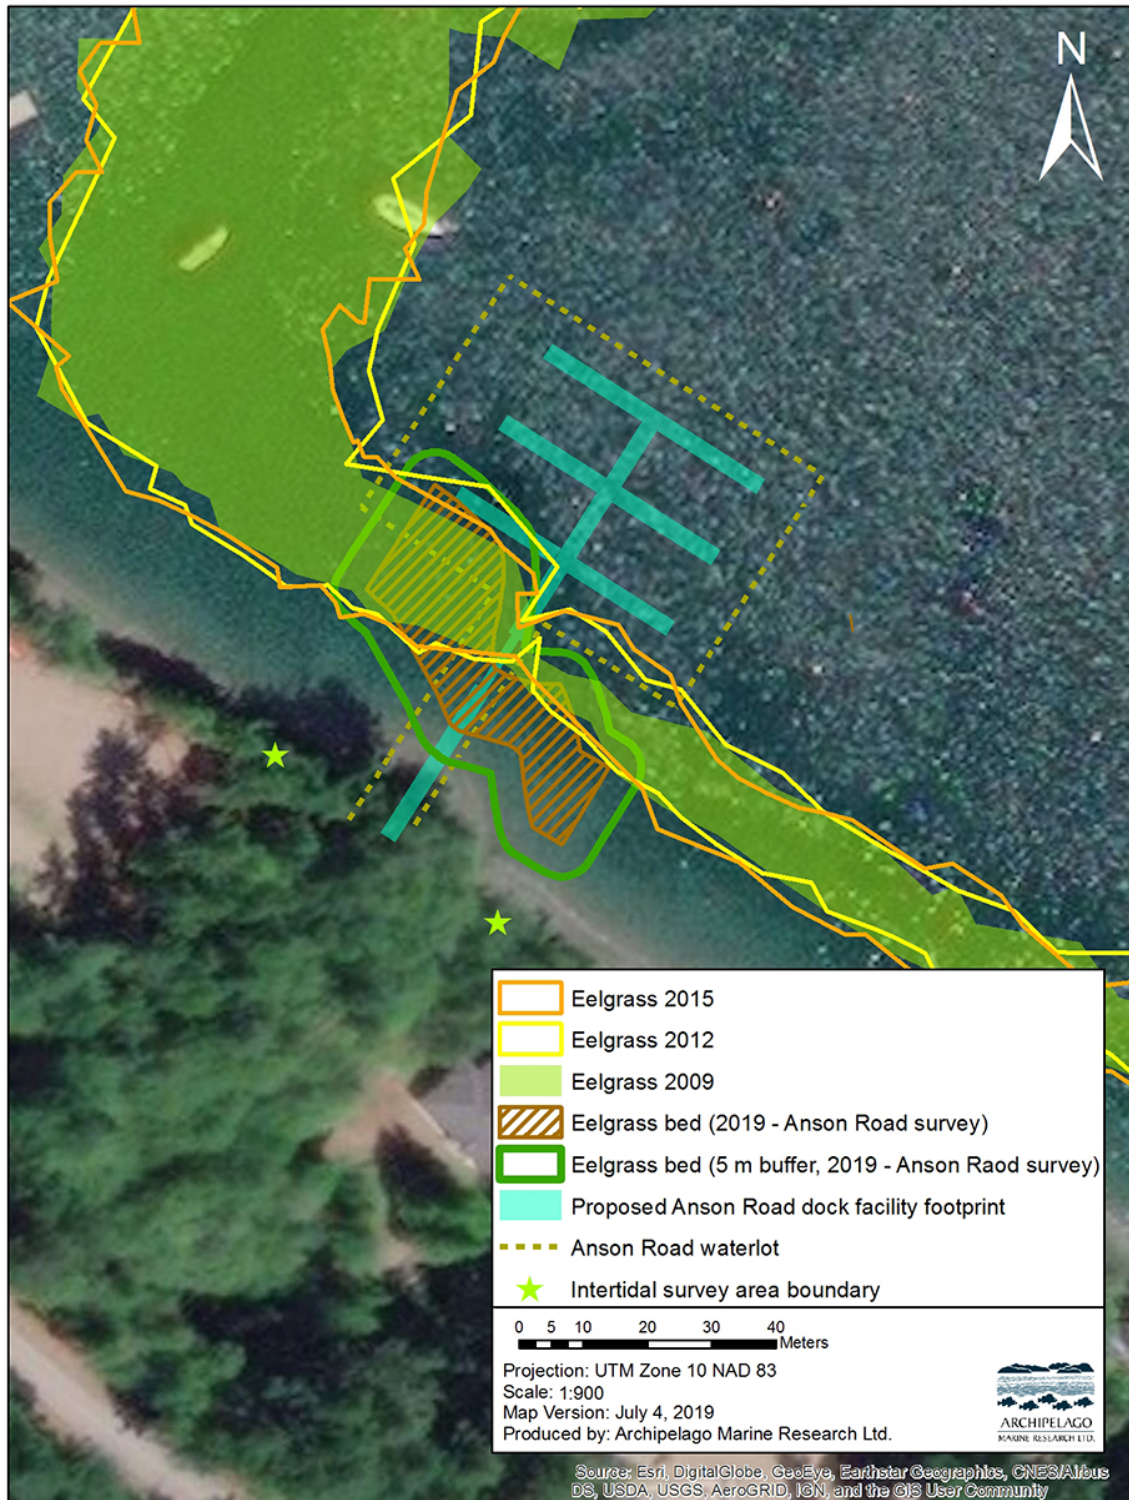
Figure 7. Mayne Island Conservancy 2009, 2012 and 2015 delineated eelgrass areas relative to the Project site, footprint and 2019 subtidal dive survey data (without the 5 m buffer).

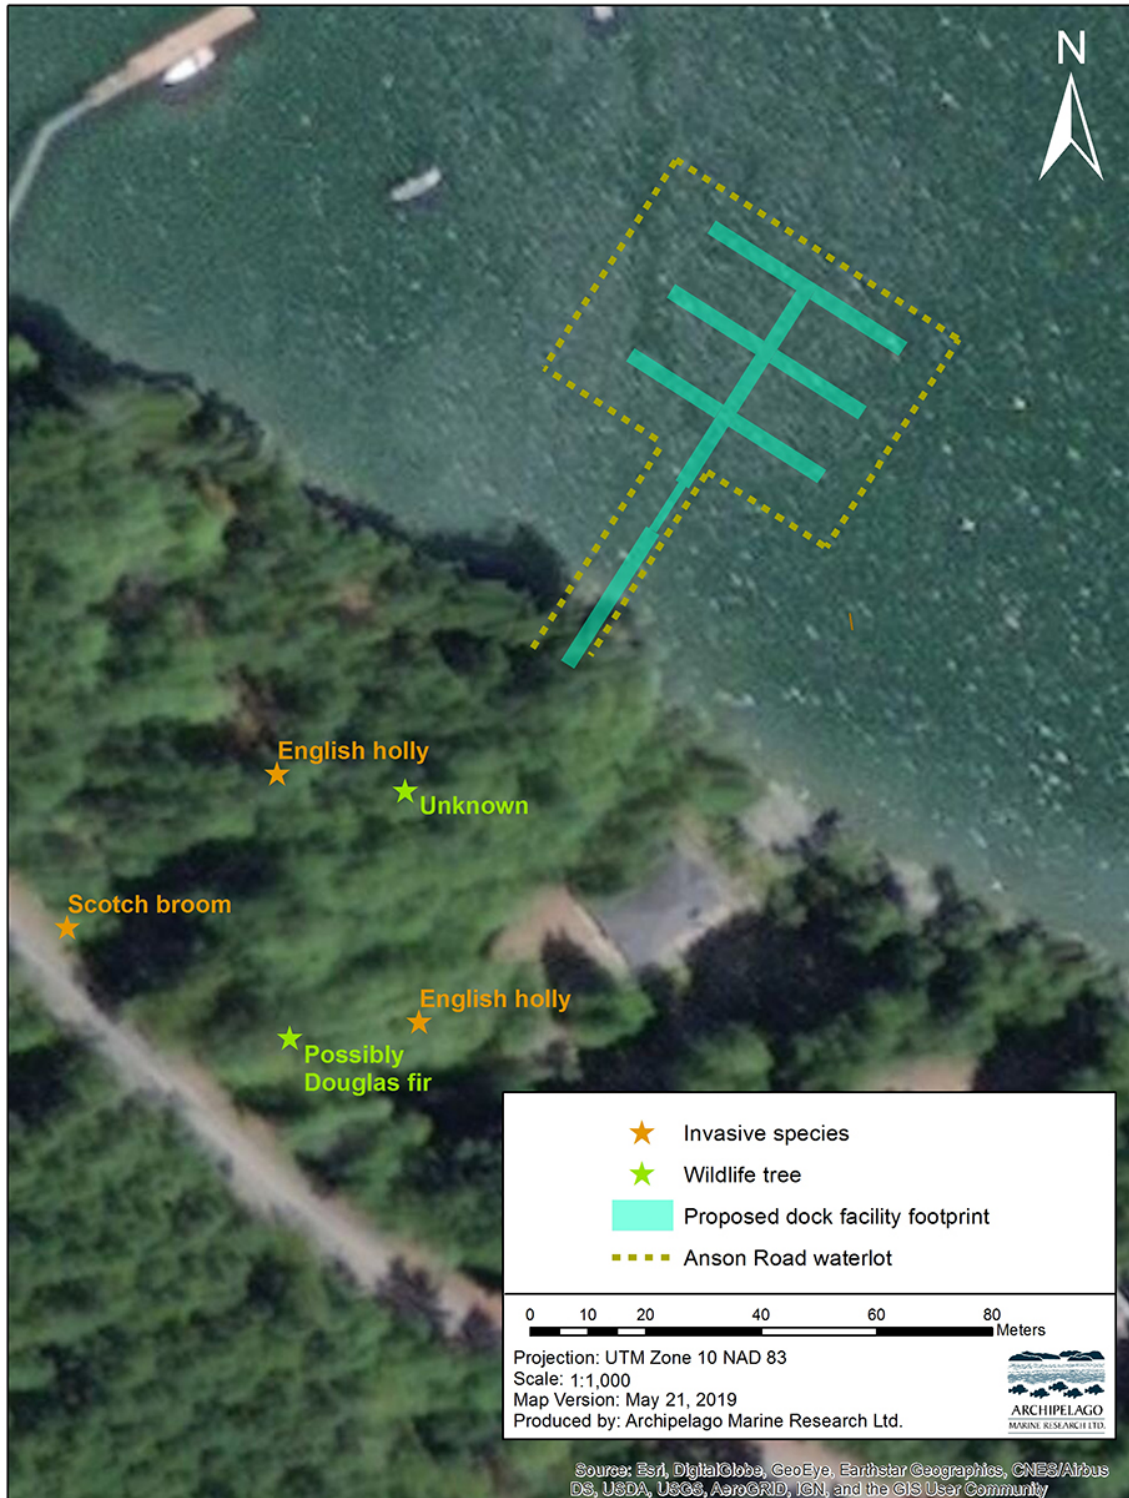
Figure 9. Invasive species and wildlife tree observations during the upland survey at the Anson Road Project site.

The Project site is bounded by the properties of 686 Horton Bay Road to the west and 694 Horton Bay Road to the east. There is a dirt driveway that intersects the Project site. The property slopes from approximately 25 m above sea level along Horton Bay Road to approximately 2 m above sea level at the boundary with the intertidal zone. The canopy covers the majority of the Project site, with the understory less developed and partially cleared by a large gravel driveway intersecting the property. The canopy at the property is dominated by Douglas-fir (*Pseudotsuga menziesii*), grand fir (*Abies grandis*) western hemlock (*Tsuga heterophylla*), red alder (*Alnus rubra*), bigleaf maple (*Acer macrophyllum*), and western red cedar (*Thuja plicata*). Shrub and understory species include Oregon grape (*Berberis* spp.), sword fern (*Polystichum munitum*), red-flowering currant (*Ribes sanguineum*), salal (*Gaultheria shallon*), huckleberry (*Vaccinium* spp.), oceanspray (*Holodiscus discolor*), stinging nettle (*Urtica dioica*), salmonberry (*Rubus spectabilis*) and Indian plum (*Oemleria cerasiformis*). There was an occurrence of a large English holly (*Ilex aquifolium*) within the property, and one adjacent to the Project site (Figure 9). A number of small Scotch broom (*Cytisus scoparius*) plants were observed along Horton Bay Road (Figure 9).

During the upland survey, numerous passerine species were observed at the site including song sparrow (*Melospiza melodia*), common raven (*Corvus corax*), brown creeper (*Certhia americana*), red-breasted nuthatch (*Sitta canadensis*), Oregon junco (*Junco hyemalis*), American robin (*Turdus migratorius*), chestnut-back chickadee (*Poecile rufescens*), Pacific wren (*Troglodytes pacificus*), ruby-crowned kinglet (*Regulus calendula*), Anna's hummingbird (*Calypte anna*), and golden-crowned kinglet (*Regulus satrapa*). Other avian species observed included Northern flicker (*Colaptes auratus*), hairy woodpecker (*Leuconotopicus villosus*), bald eagle (*Haliaeetus leucocephalus*), turkey vulture (*Cathartes aura*), bufflehead (*Bucephala albeola*) and gulls (*Larus* spp.). Many of the passerine species were observed calling, singing and feeding on the Project site. No nest of any bird species were observed. In particular, no eagle, osprey, heron or falcon nests, which are protected at all times, per *The Wildlife Act*, were observed within or immediately adjacent to the Project site. Two trees with evidence of extensive wildlife use by woodpeckers or other species ("wildlife trees") were observed during the upland survey (Figure 9).

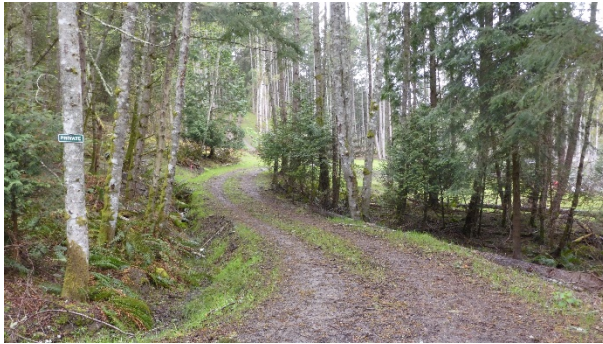
Photo 9. Section of dirt driveway where culvert that runs underneath may be re-aligned or relocated.

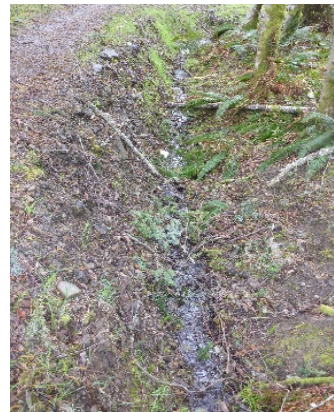
Photo 10. Ditch running along dirt driveway, leading to Northwest culvert.

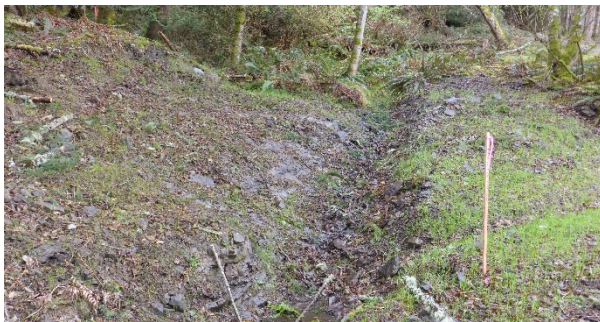
Photo 11. Habitat upstream of Northwest culvert. Property boundary at right-hand side of photo.

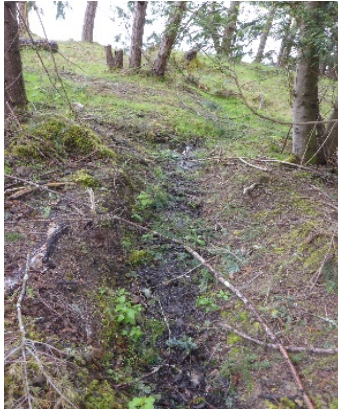
Photo 12. Entrance to Northwest culvert.

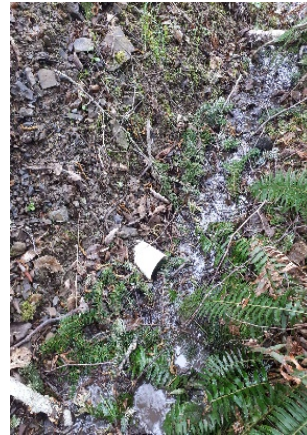
Photo 13. Habitat downstream of Northwest culvert.

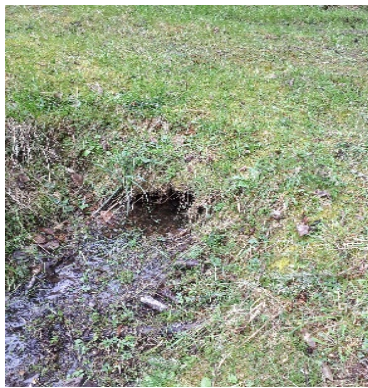
Photo 14. Upstream end of North culvert and surrounding habitat.

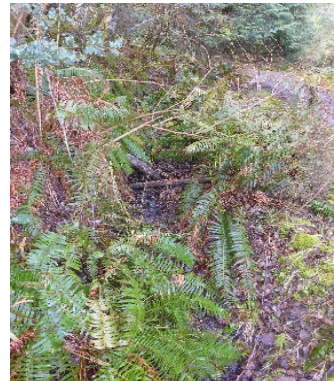
Photo 15. Outlet of East culvert.

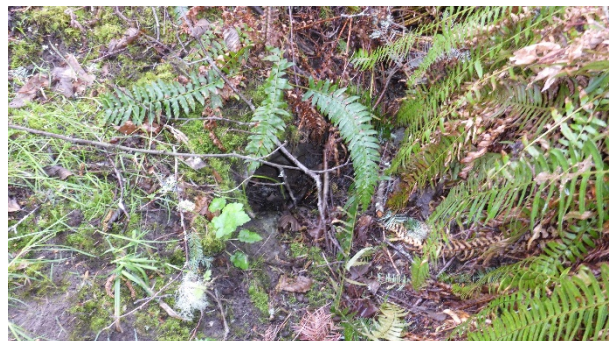
Photo 17. Habitat downstream of West culvert.

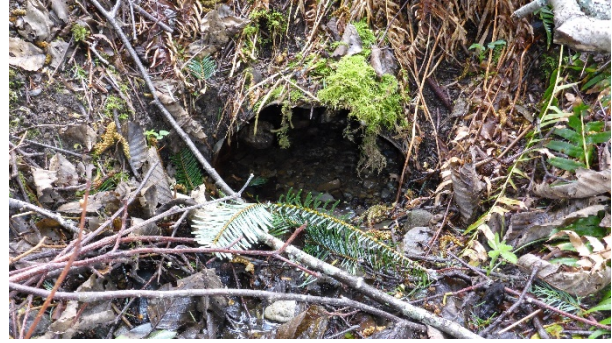
Photo 19. Habitat looking upslope and upstream from West culvert.

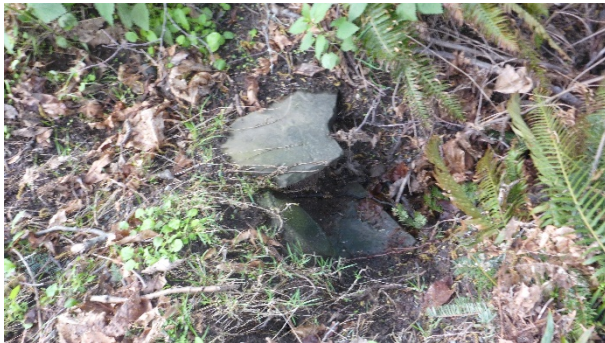
Photo 20. Outlet of South culvert. Culvert 50% blocked with debris.

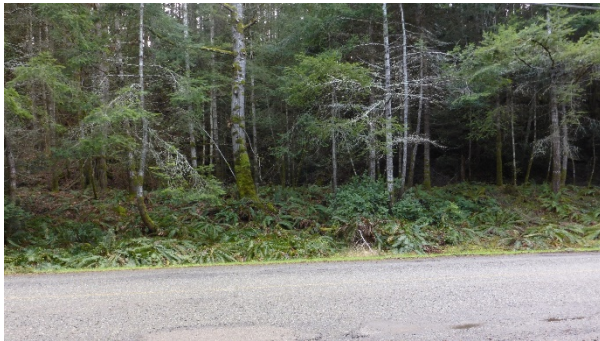
Photo 22. Habitat downstream of top-of-bank culvert.
